PUBLIC UTILITY DISTRICT NO. 1 of CHELAN COUNTY

Re: Chelan River Project Monthly Report

Chelan River Project – Monthly Report Lake Chelan Hydroelectric Project – FERC No. 637 Public Utility District No. 1 of Chelan County

November 15th, 2008

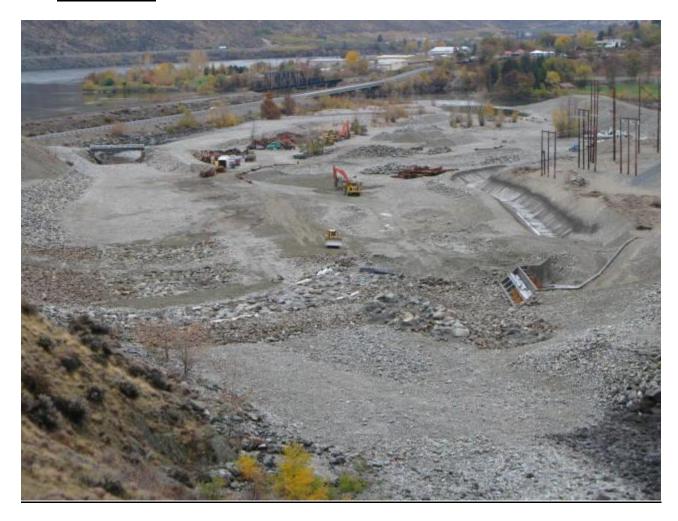
This shows Reach 4 looking south, on November 7th, 2008. The pumped water conveyance canal has been shotcreted. Concrete forms removal is underway on the Pumped Water Outlet Structure. The Hydraulic Control Structure is 75% complete, including grouting. Reach 4 (spill channel) is 95% complete. Grading of the Habitat Channel is 95% complete.

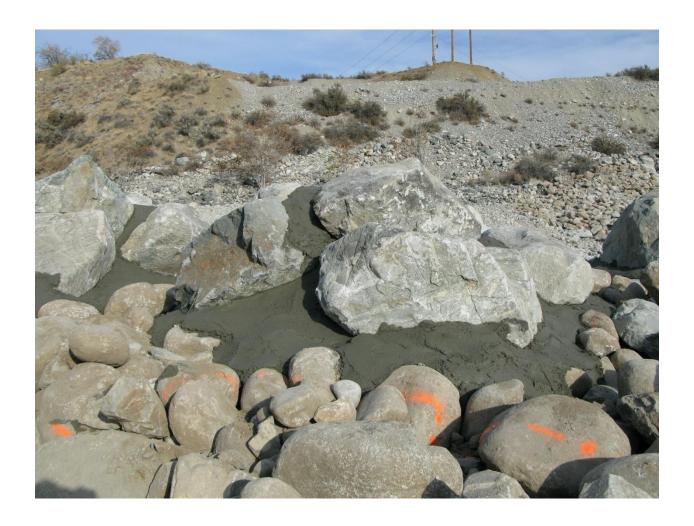
Picture taken on 10/29/08 showing a typical boulder cluster. The newly placed grout locks the boulders together to create a structure that will dissipate energy from flows entering the habitat channel.

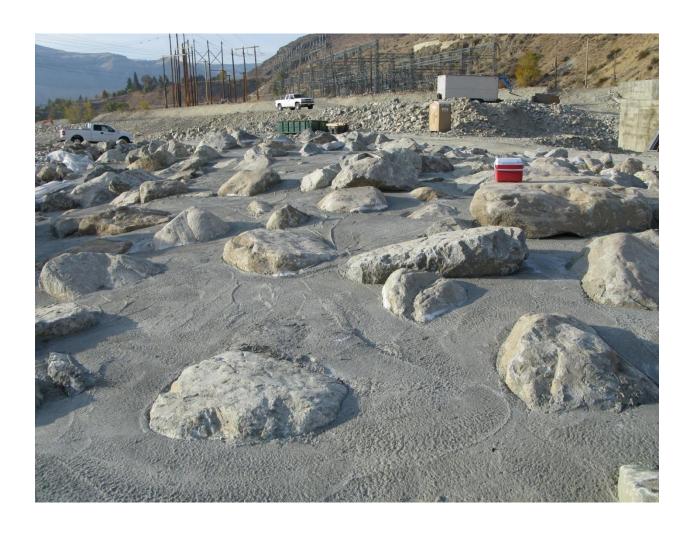
This is the high elevation portion of the hydraulic control structure. Picture taken on 10/29/08, showing previously placed concrete, intended to lock the structure together.

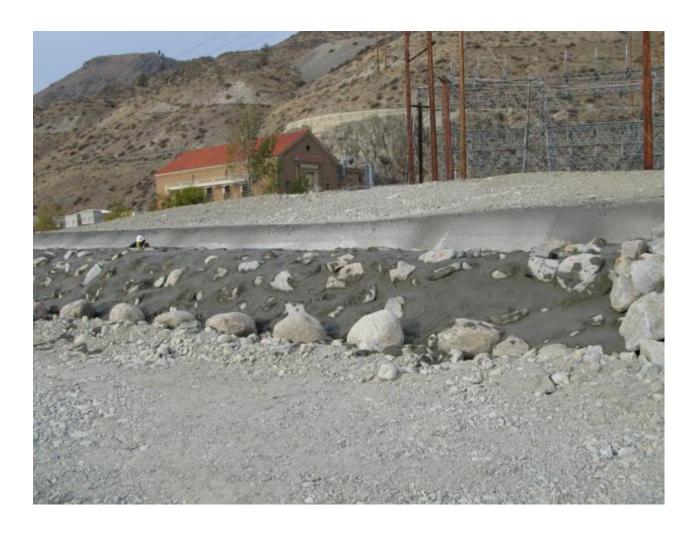
Conveyance canal overflow spillway section under construction, 10/30/08. Boulders have been installed and grout was placed this day.

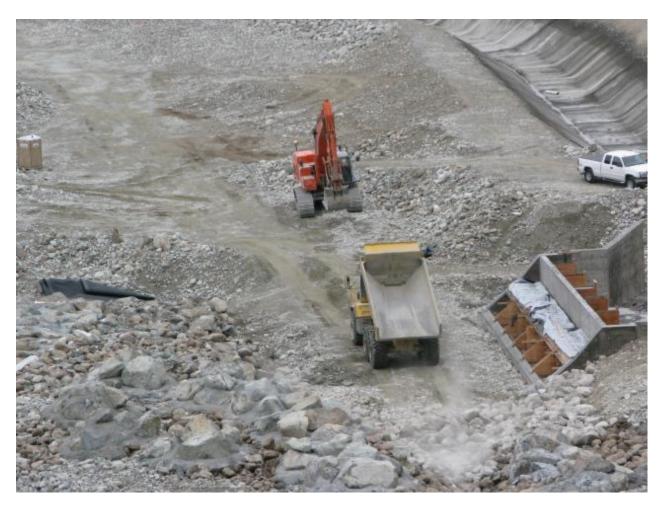
Picture taken on 11/3/08. Concrete for the pumped water outlet structure has been completed, and forms are still in place. Rock embankment material placement is underway.

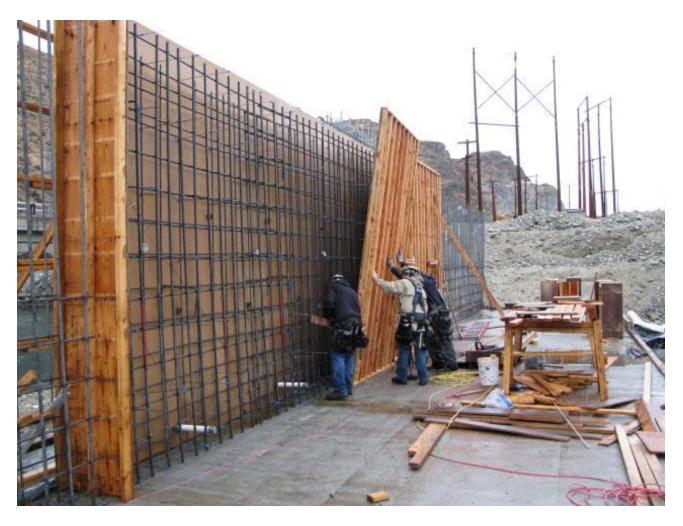
Pump station foundation slab and grade beams have been placed. Retaining wall forms and rebar underway. 11/4/08

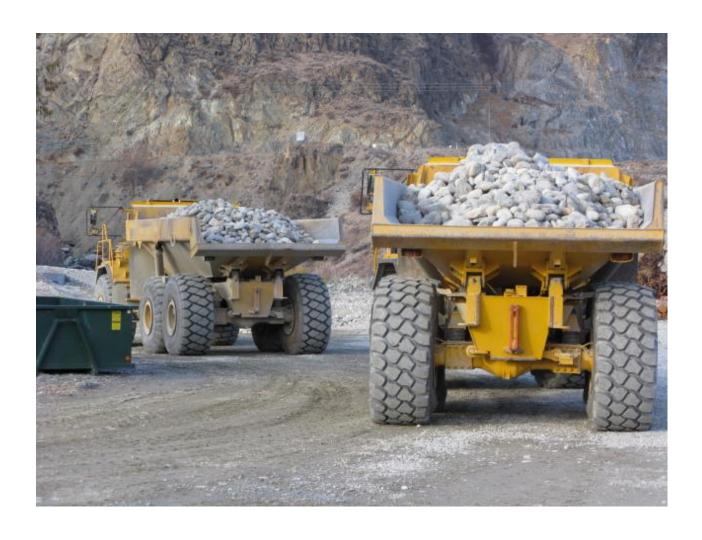
6X6 Off-road dump trucks hauling riffle mix to the habitat channel. 11/5/08

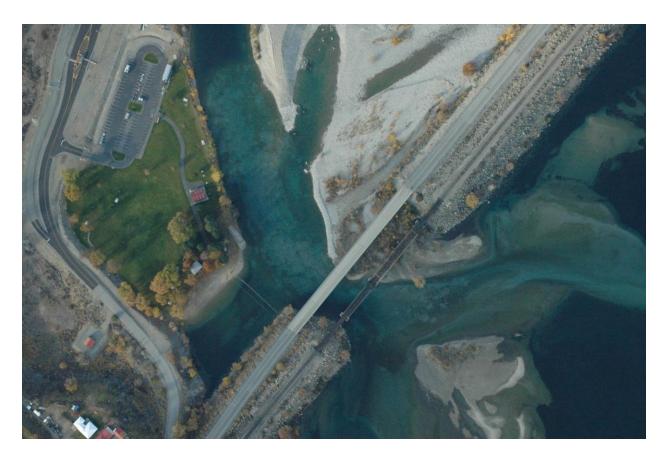
Aerial photo of lower tailrace habitat, Nov 5, 2008. The lighter-colored areas on the tailrace channel bottom are "redds" which salmon have prepared for spawning. Note that the newly placed habitat fill is being heavily used for spawning.

A large number of salmon are currently spawning in the lower tailrace habitat. The habitat fill was constructed to design lines and grades, using the specified fish mix. The final test is whether the areas is actually used. The area has clearly passed this last test.
