Re: Chelan River Project Monthly Report

Chelan River Project – Monthly Report  
Lake Chelan Hydroelectric Project – FERC No. 637  
Public Utility District No. 1 of Chelan County

June 12<sup>th</sup>, 2009

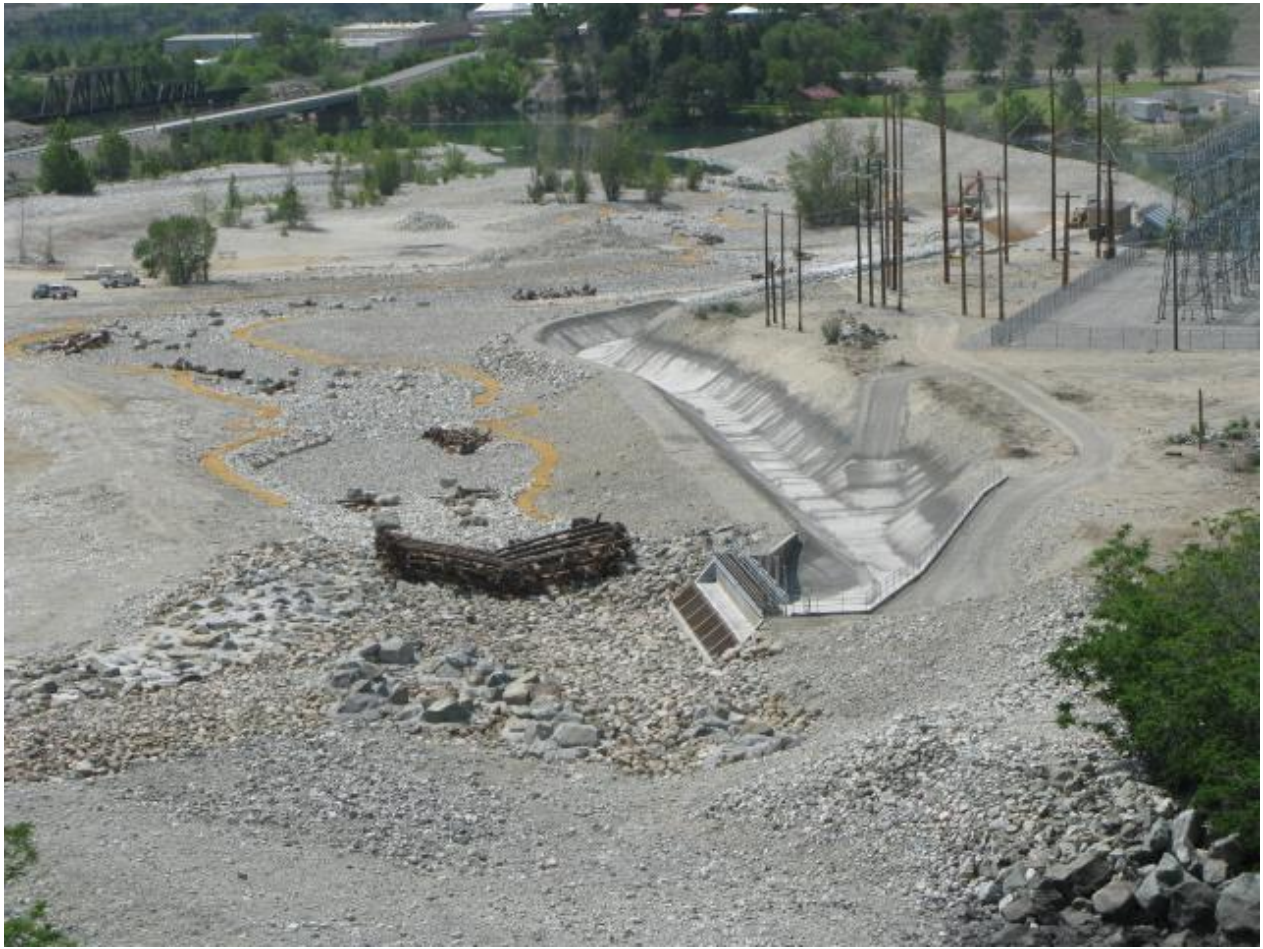
This is a picture of the head end of the habitat channel, taken on June 5<sup>th</sup>, 2009. The entrance log jam is shown along with the conveyance canal and outlet structure. All large woody debris structures and rock features are in place. The riparian strip, made up of topsoil and fabric, is noticeable along the edges of the habitat channel. Plantings will be installed during the 2009 dormancy period, this fall.

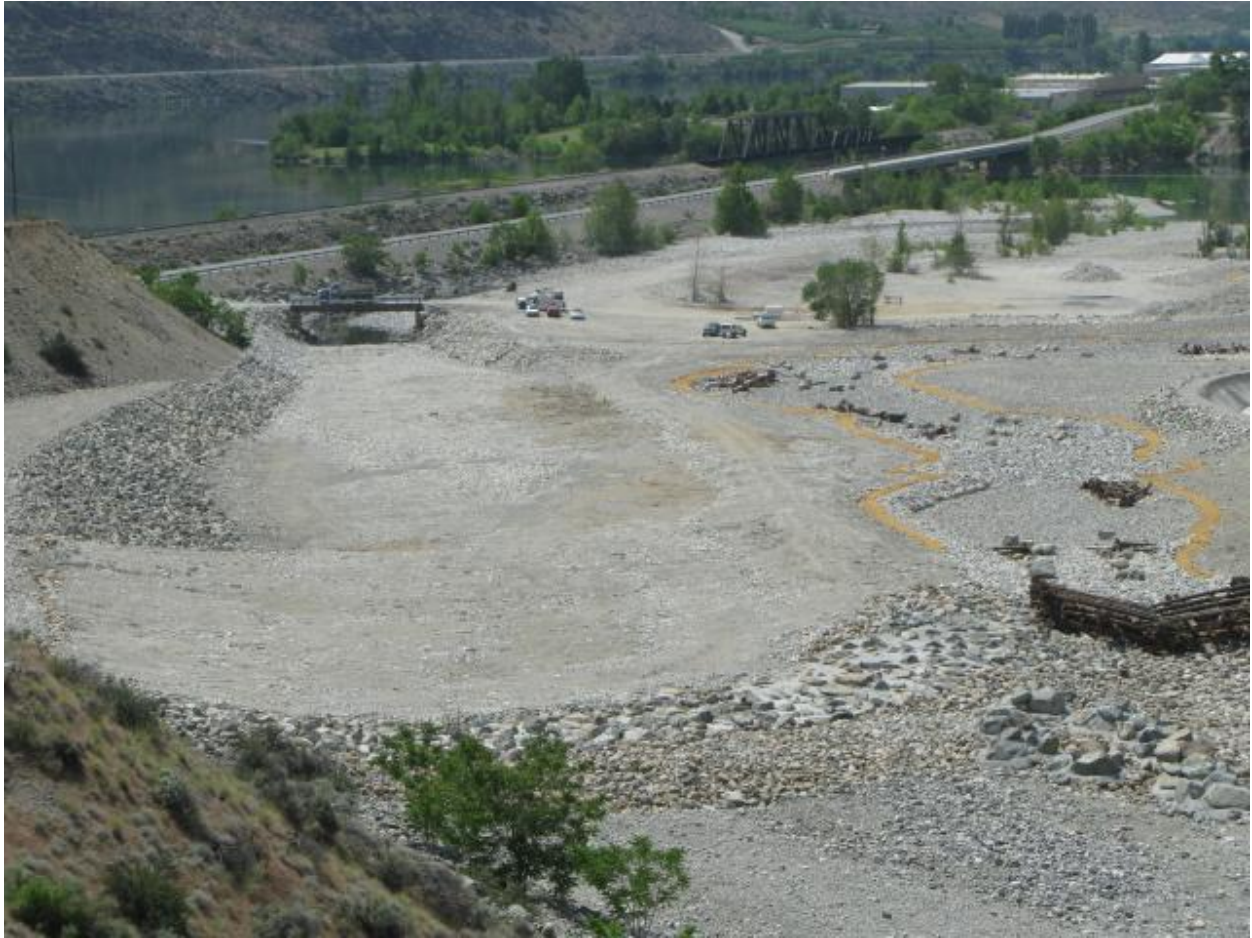
This is a picture of the head end of the spill channel, also taken on June 5<sup>th</sup>, 2009. The hydraulic control structure is complete, with its visible grout along the strip at the entrance to the spill channel.

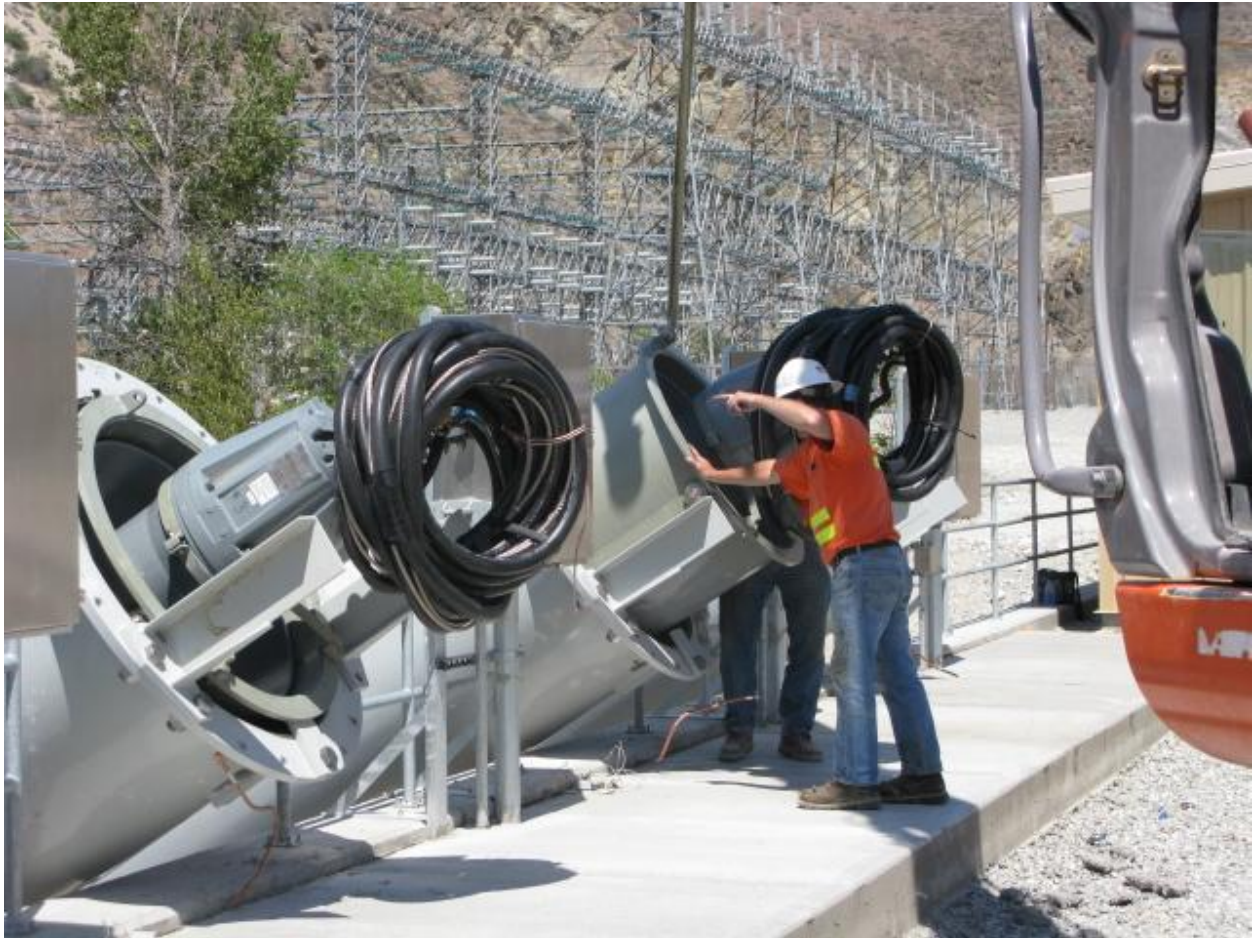
The five pumps have been mounted inside the pump carriers, and the pump carriers have been temporarily set inside the pump tubes. This picture was taken on May 20<sup>th</sup>, 2009. This was done in preparation for checking rotation with the permanent power system supplied from the control building.

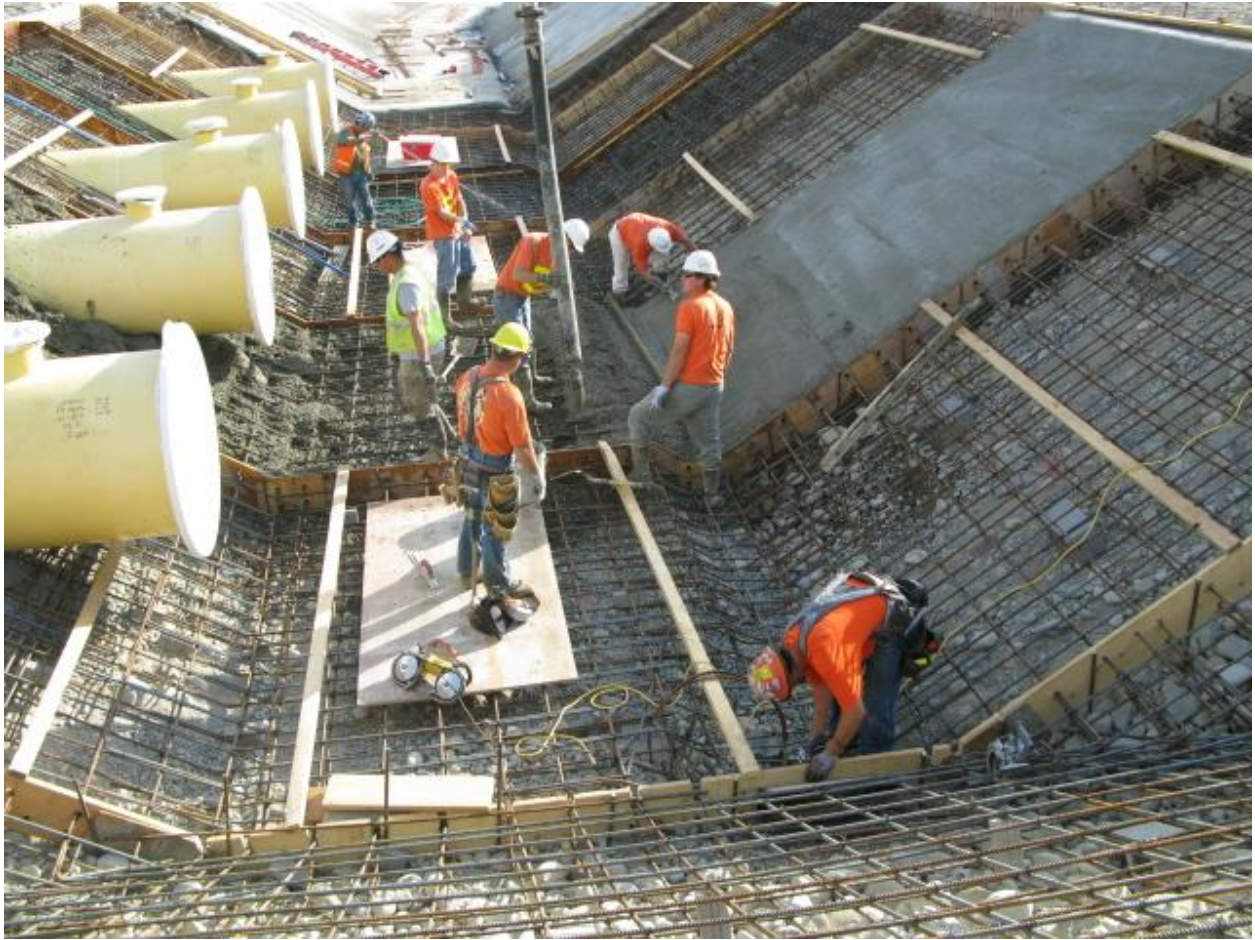
This is a picture of the afterbay at the pump station. This was the first day of 3 days of concrete placements, where 165 cubic yards of concrete was scheduled. Picture was taken on June 1<sup>st</sup>, 2009.

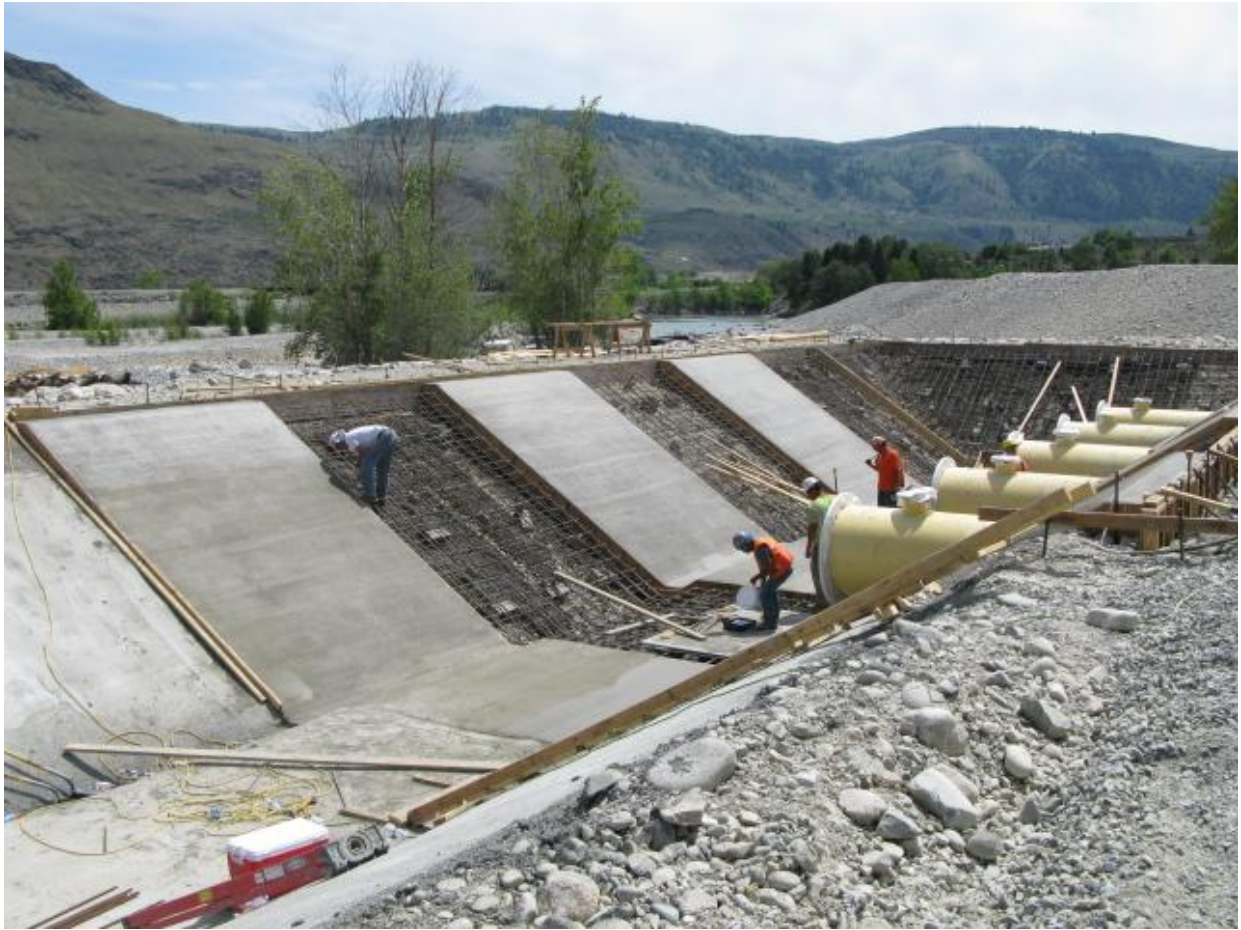
Picture taken of the afterbay at the end of the day, June 1<sup>st</sup>, 2009. Notice the contractor's placement method of skipping sections so there would be access to finish the concrete.

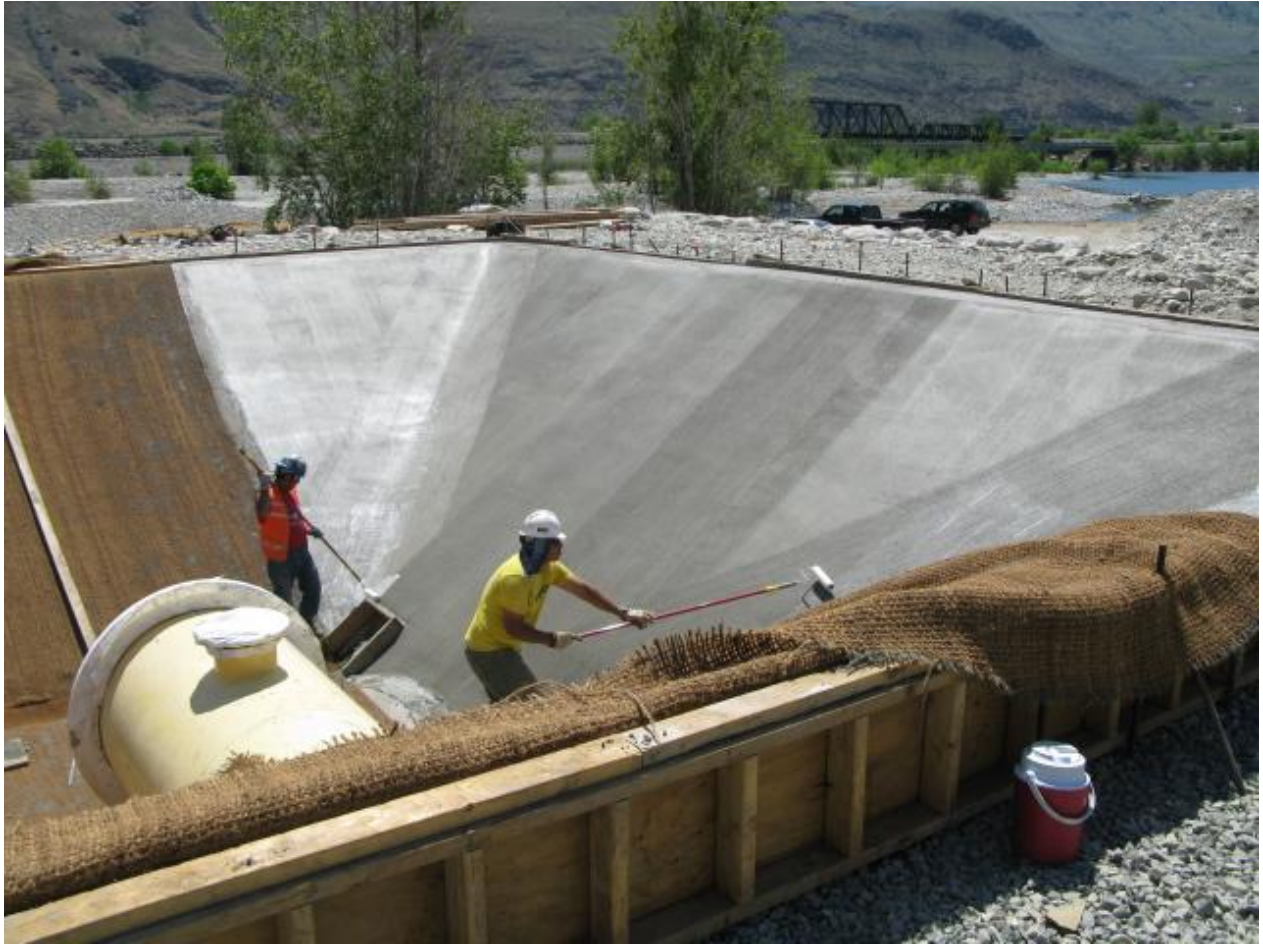
At the end of the day, June 3<sup>rd</sup>, 2009, concrete curing was applied to the last concrete placed. Burlap was placed afterward, and kept wet.

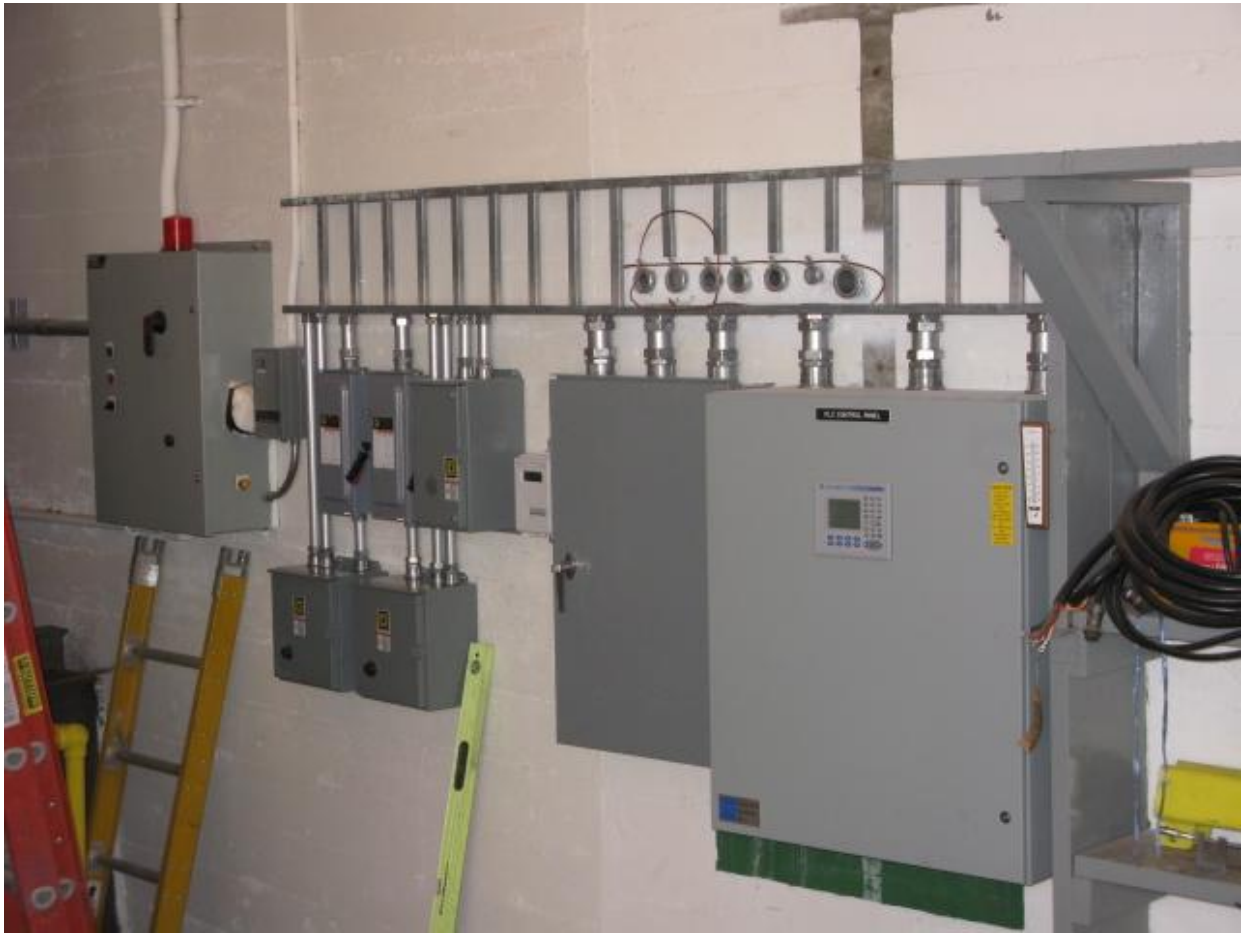
This is a picture of the new panel installation in the valve house at Chelan Dam. Picture was taken on June 4<sup>th</sup>, 2009.

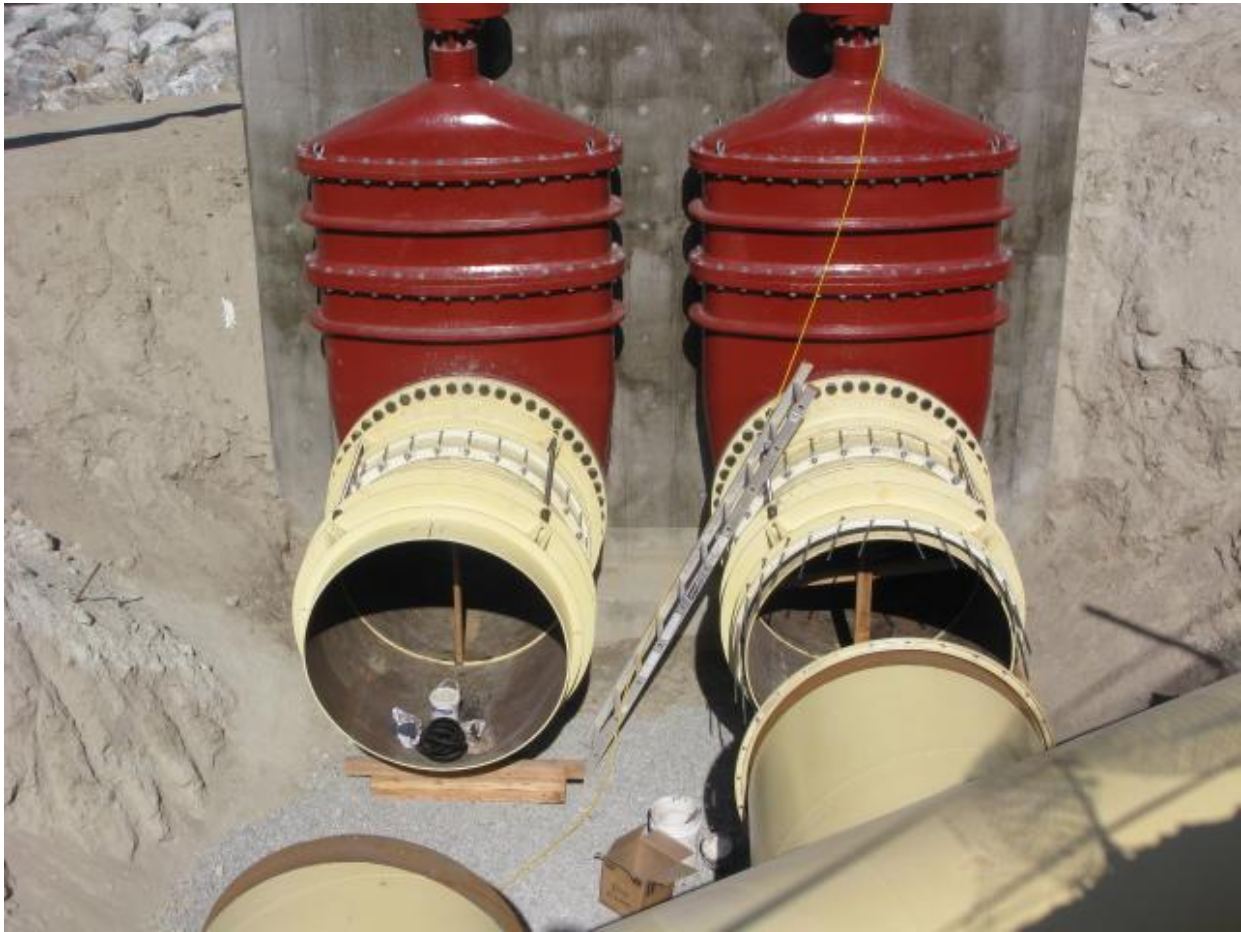
This is a picture of the two 60" gate valves before welding was completed. Picture was taken on May 11<sup>th</sup>, 2009.

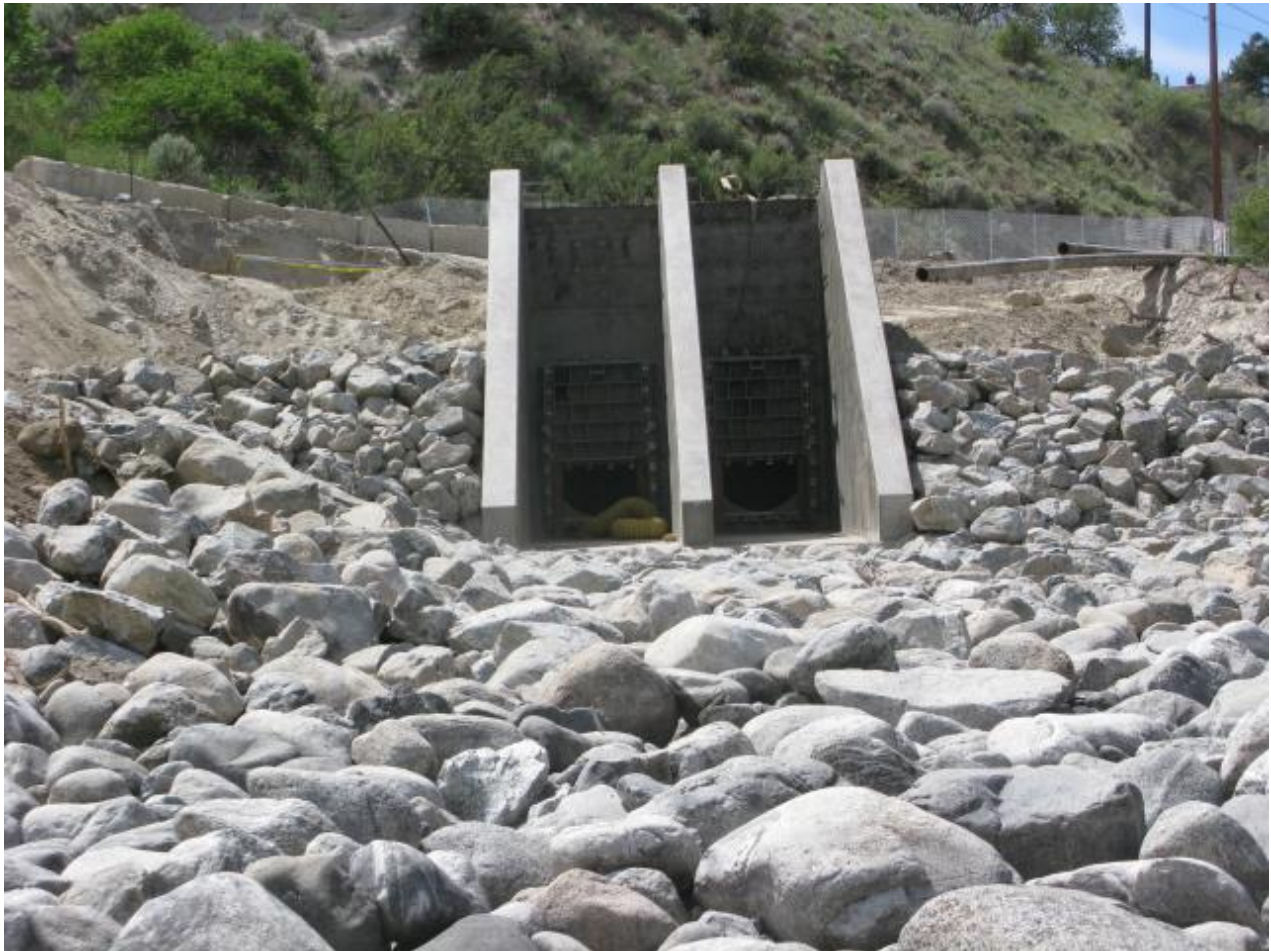
This is a picture of the LLO outlet structure, looking upstream. Picture was taken on May 27<sup>th</sup>, 2009. The rip rap has been placed and backfill behind the structure is underway.
