PUBLIC UTILITY DISTRICT NO. 1 of CHELAN COUNTY
P.O. Box 1231, Wenatchee, WA 98807-1231 • 327 N. Wenatchee Ave., Wenatchee, WA 98801
(509) 663-8121 • Toll free 1-888-663-8121 • www.chelanpud.org

April 18, 2013

RE: Lake Chelan Hydroelectric Project No. 637 (Project)
Report on Minimum Flow Deviation for Chelan River

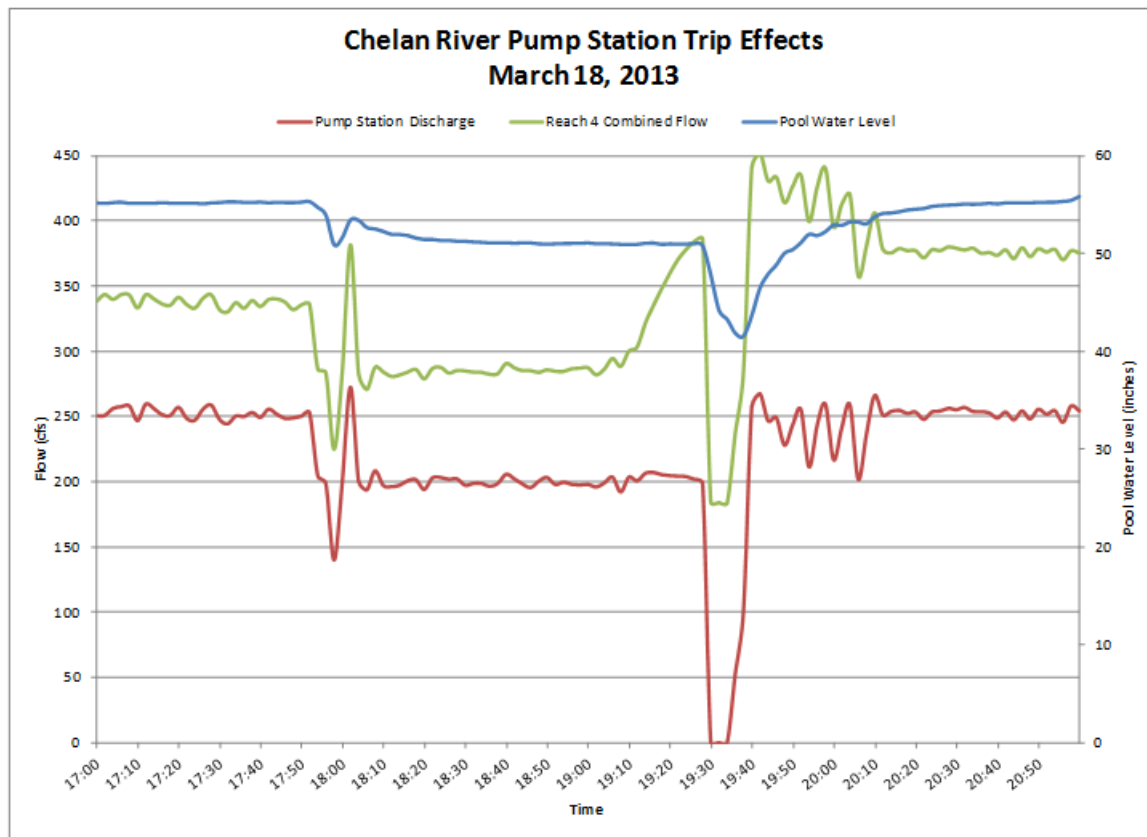
This event resulted in brief drops in water levels in the pool at the pump station canal outlet structure at the head of the Reach 4 Habitat Channel. The water level drop was approximately 4 inches over the time period from hours 17:52 – 18:52, then a water level drop of about 9 inches occurred over a 12-minute period between hours 19:28 – 19:40. Water levels were back to the previous level by hour 19:50. Also, the flow into Reach 4 of the Chelan River was below the 320 cfs minimum for approximately two hours, based on the time lag necessary for increased flows from the LLO to arrive at Reach 4.

This event resulted in brief drops in water levels in the pool at the pump station canal outlet structure at the head of the Reach 4 habitat channel. Also, the flow into Reach 4 of the Chelan River was below the 320 cfs minimum for approximately two hours, based on the time lag necessary for increased flows from the LLO to arrive at Reach 4. The water level drop was approximately 4 inches over the time period from hours 17:52 – 18:52, then a short water level drop of about 9 inches occurred over a 12-minute period between hours 19:28 – 19:40. Water levels were back to the previous level by hour 19:50. The flow and water level effects of the pump station trips, on two-minute intervals, are shown in the figure below.

The LLO was left at 124 cfs for the remainder of the night and was adjusted to 86 cfs over the course of the next day (March 19, 2013) with ramp rates observed. Programming for the screen cleaning air burst/differential control system air system was in manual mode (normal for current operations) and the compressor was in the off position. A faulty valve in the air burst system allowed pressure to deplete from the control system causing an erroneous differential signal which initiated the trip. The control system air compressor was left in the auto setting and the blast valve seat was tightened to minimize leakage. The faulty valve was identified, ordered and replaced on March 21, 2013. New LLO outlet controls are purchased and on site for May 2013 installation which will allow remote operation of the LLO.

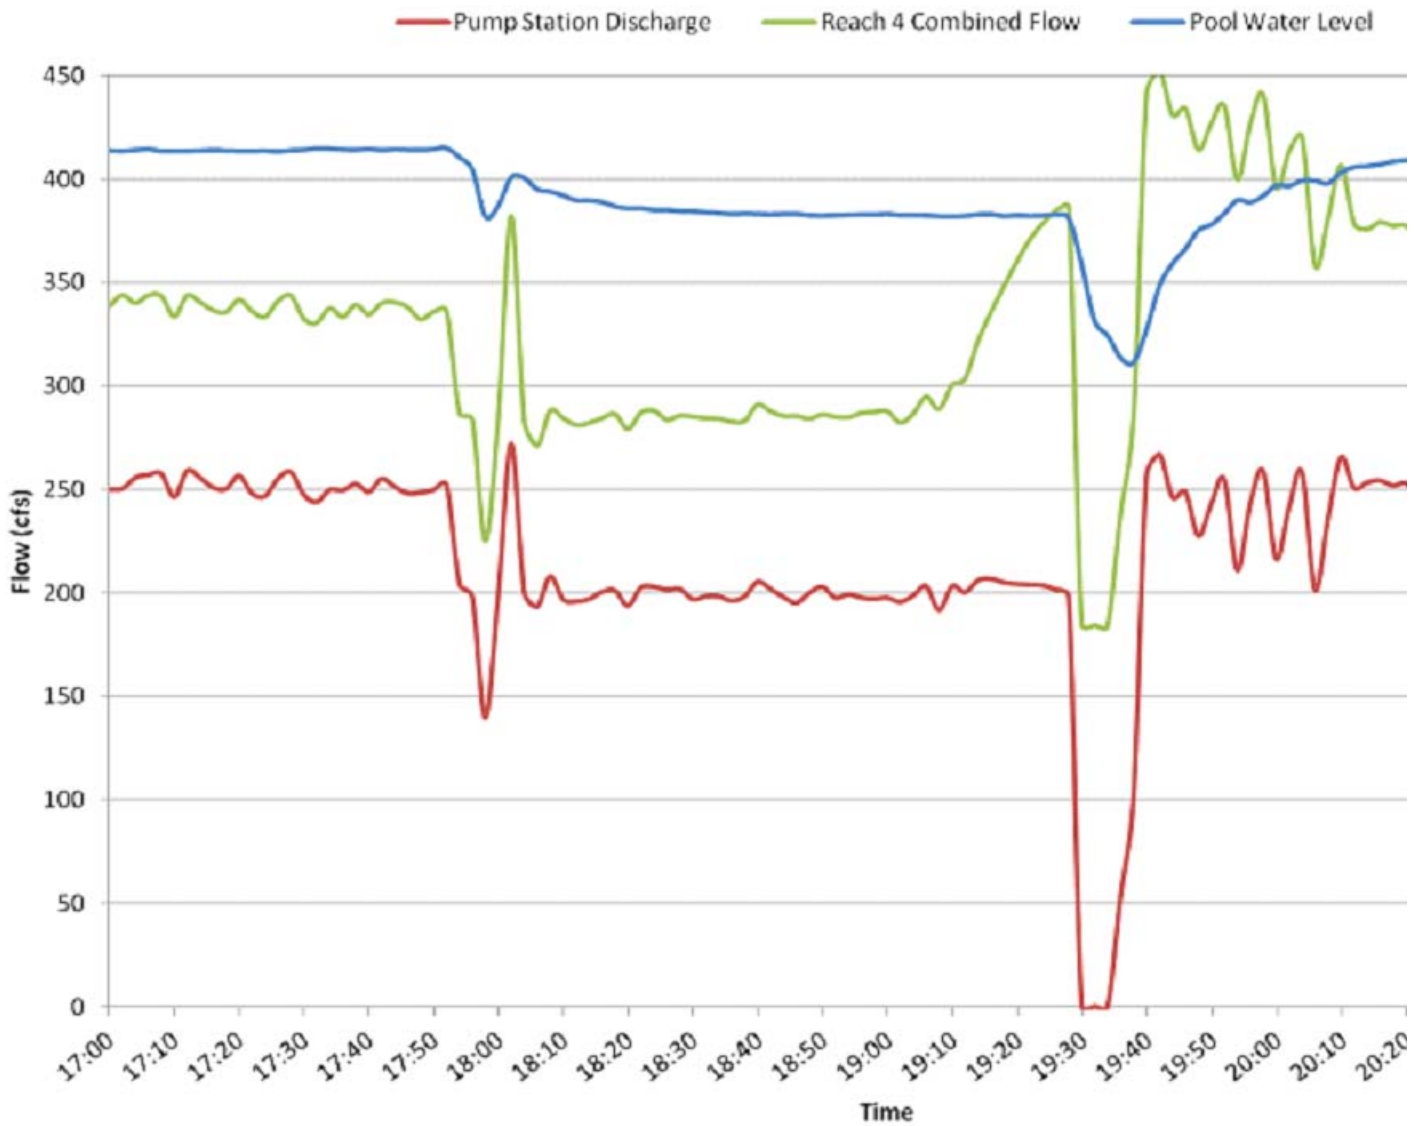
Chelan River Pump Station Trip Effects March 18, 2013

This event resulted in brief drops in water levels in the pool at the pump station canal outlet structure at the head of the Reach 4 habitat channel. Also, the flow into Reach 4 of the Chelan River was below the 320 cfs minimum for approximately two hours, based on the time lag necessary for increased flows from the LLO to arrive at Reach 4. The water level drop was approximately 4 inches over the time period from hours 17:52 - 18:52, then a short water level drop of about 9 inches occurred over a 12-minute period between hours 19:28 - 19:40. Water levels were back to the previous level by hour 19:50. The flow and water level effects of the pump station trips, on two-minute intervals, are shown in the figure below.
