PUBLIC UTILITY DISTRICT NO. 1 of CHELAN COUNTY
P.O. Box 1231, Wenatchee, WA 98807-1231 • 327 N. Wenatchee Ave., Wenatchee, WA 98801
(509) 663-8121 • Toll free 1-888-663-8121 • www.chelanpud.org

June 3, 2013

RE: Lake Chelan Hydroelectric Project No. 637 (Project)
Report on Ramping Rate Deviation for Reach 4 Stream Habitat Channel

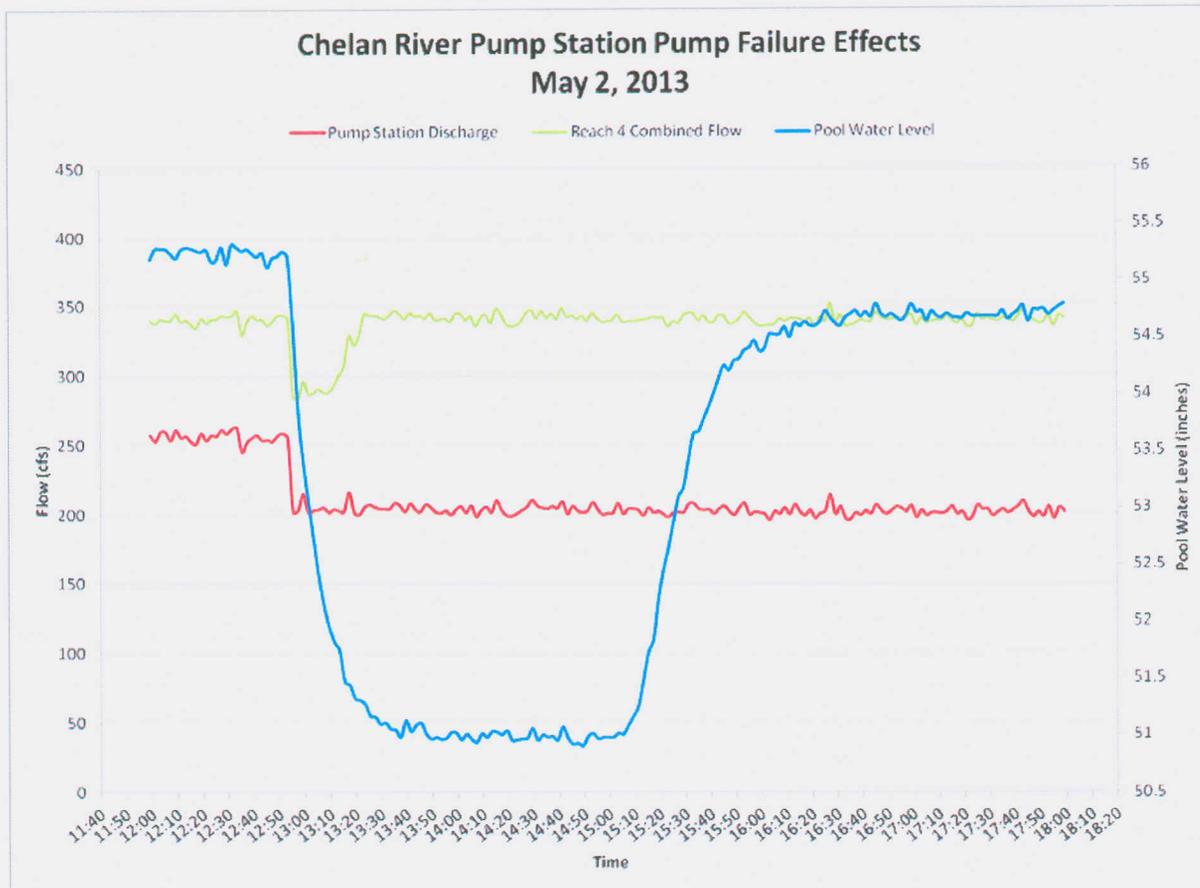
At approximately 12:53 pm on Thursday, May 2, one of the five pumps that delivers water from the Project tailrace to the Habitat Channel tripped off-line, reducing flows from the required 320 cfs to about 270 cfs. To bring flows back to 320 cfs, water was immediately released from the low level outlet at the Project dam. Coincidentally, Chelan PUD, Washington Department of Fish and Wildlife, and Ecology biologists were in the habitat channel conducting depth and velocity transect studies at the time of the event. They observed what appeared to be a 4-inch to 5-inch drop in surface water elevation in the habitat channel after the pump failed. There were no staff gauges or other indicators to determine a precise calculation of the water level change in the habitat channel. Water level monitoring in the pool at the pump station, which is continuously monitored, showed a drop in water level of 4.25 inches (see figure below). Ramping rates are set at approximately two inches per hour during the period when fry may be present. The drop was sustained for about three hours until water from the low level outlet reached the habitat channel. Water levels reached the previous points in the habitat channel by 4:30 pm. Though numerous Chinook fry were rearing in the habitat channel, none were observed stranded due to the drop in water elevation.

The pump alarm indicated that water had likely leaked past the seal into the pump. Since the schedule for pumped water to the habitat channel was due to end on May 15, the required flow was maintained between May 2 and May 15 by providing that flow from the low level outlet. After May 15, the required flow of 200 cfs for all sections of the Chelan River must be provided from the low level outlet; therefore, all pump station flow ended on May 15. The pump will be repaired during its regularly scheduled maintenance period in the summer. Pump station operation is not scheduled to resume until October 15, 2013.

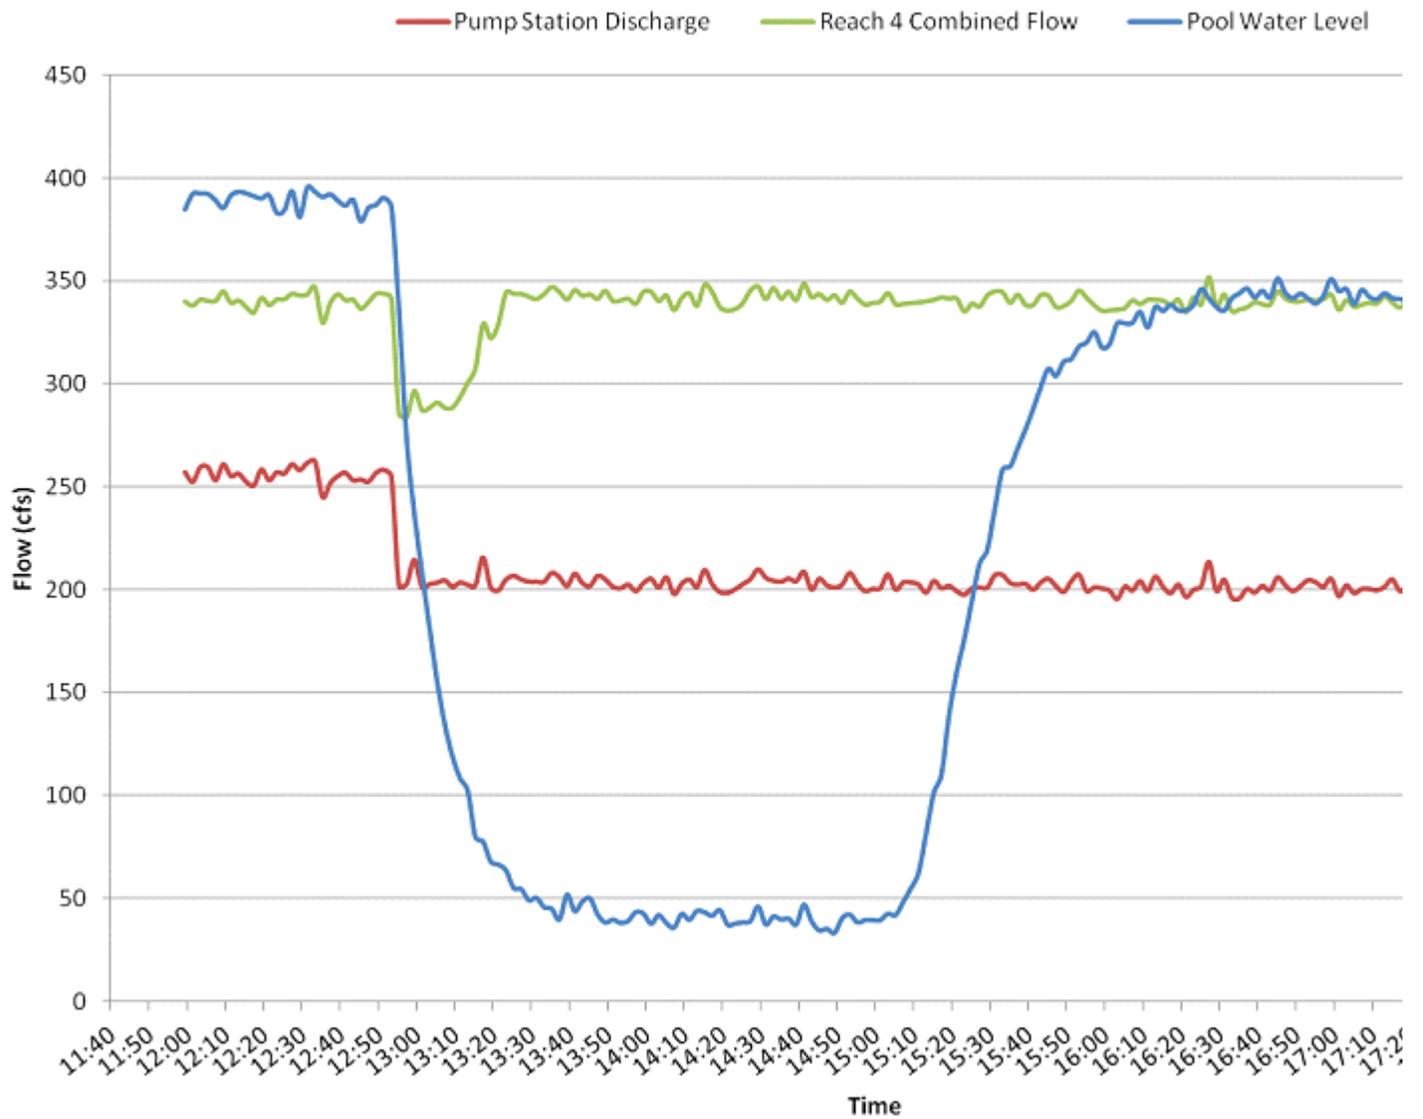
Chelan River Pump Station Pump Failure Effects May 2, 2013

At approximately 12:53 pm on Thursday, May 2, one of the five pumps that delivers water from the Project tailrace to the Habitat Channel tripped off-line reducing flows from the required 320 cfs to about 270 cfs. To bring flows back to 320 cfs, water was immediately released from the Low Level Outlet at the Dam. Coincidentally, Chelan PUD, WDFW, and Ecology biologists were in the Habitat Channel conducting depth and velocity transect studies at the time of the event. They observed what appeared to be a 4" to 5" drop in surface water elevation in the Habitat Channel after the pump failed. There were no staff gauges or other indicators to determine a precise calculation of the water level change in the habitat channel. Water level monitoring in the pool at the pump station, which is continuously monitored, showed a drop in water level of 4.25 inches (see figure below). Ramping rates are set at approximately two inches per hour during the period when fry may be present. The drop was sustained for about 3 hours until water from the Low Level Outlet reached the Channel. Water levels reached the previous points in the Habitat Channel by 4:30 p.m.

Though numerous Chinook fry are currently rearing in the Habitat Channel, none were observed stranded due to the drop in water elevation.

Until the cause of the pump failure is known and repairs are made, flows of 320 cfs are being provided through combination of pumps and the Low Level Outlet. A detailed report will be filed within 30 days.
