Treatment Effectiveness and Maintenance and Safety Monitoring for erosion control sites on Lake Chelan: Prince Creek (Site 55), Corral Creek (Site 11), Deer Point (Site 58) and Mitchell Creek (Site 59)

Lake Chelan Hydroelectric Project
FERC Project No. 637

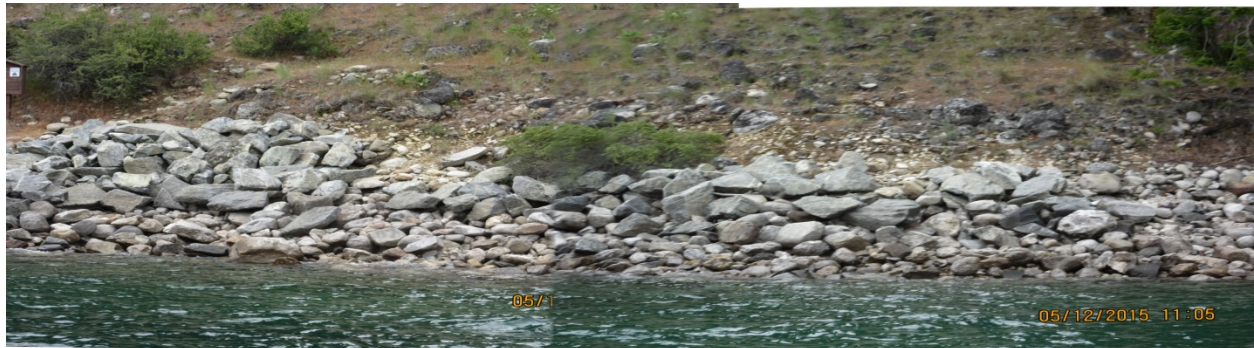
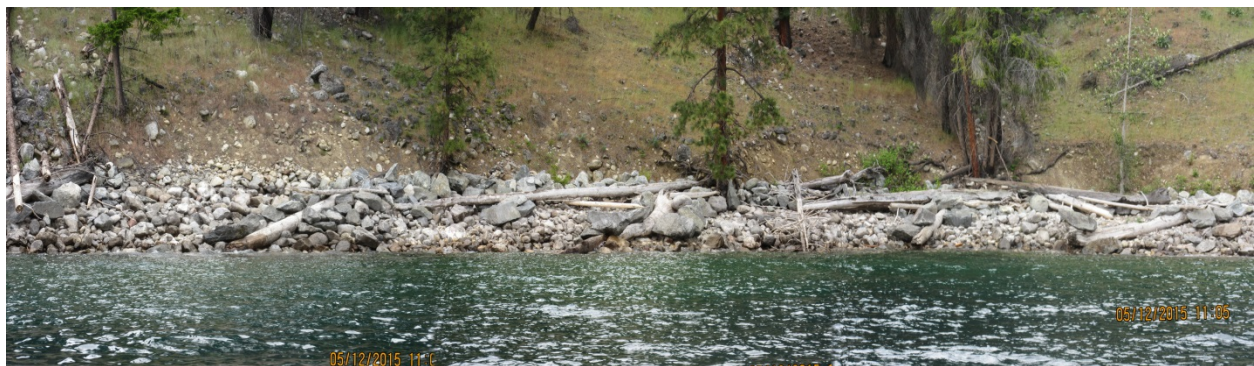
On May 12, 2015 Gene Yow, Paul Willard and Lori McAllister (Monitoring Team) visited the site. Previous cursory inspections by Forest Service personnel found that the treatments appeared to be very effective. The Monitoring Team found the treatments at the Prince Creek site to be very successful at this time. A few rocks had rolled after their initial placement in treatment Zones A and C1 but were determined to be of very limited consequence to the overall stability and effectiveness of the treatment. These rocks will potentially be moved back into the treatment zone when the Prince Creek Dock is replaced (2016). Overall, treatment is effective; all LWD is in place and stable. No new erosion was found and the old erosion scars above the treatments are stabilizing and naturally revegetating.

1. Inspection of LWD systems and recommended repairs.
Safety Comments: None
Stability Comments: # 7 log - 1 of 3 cables have failed, # 8 log - 1 of 3 cables have failed, # 9 log - 1 of 3 cables have failed. However, logs are stable and in the same positions as when placed in 2009-2010.
2. Repair conducted on LWD systems
Safety Repairs: None at this time
Stability Repairs: None Needed
3. Toe Rock Stability
Linear feet of toe rock needing maintenance: <5 individual rocks Comments: Limited rock rolling in Areas A-C1 only.
4. Inspection of vegetation (planted and naturally occurring).
Are additional actions needed: None

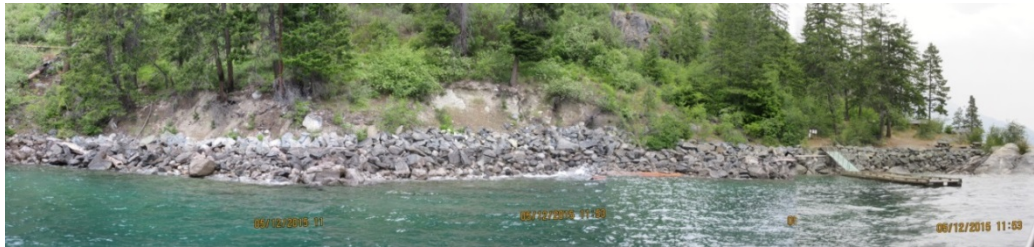
On May 12, 2015 Gene Yow, Paul Willard and Lori McAllister (Monitoring Team) visited the site. Previous cursory inspections by Forest Service personnel found that the treatments appeared to be very effective. The Monitoring Team found the treatments at the Corral Creek to site to be very successful at this time. Overall, treatment is effective and all LWD is in place. No new erosion was found and the old erosion scars above the treatments appear to be stabilizing but natural revegetation is occurring at a slow pace.

1. Inspection of LWD systems and recommended repairs.
Safety Comments: None
Stability Comments: None
2. Repair conducted on LWD systems
Safety Repairs: None at this time
Stability Repairs: None, all is good.
3. Toe Rock Stability
Linear feet of toe rock needing maintenance: None Comments: None
4. Inspection of vegetation (planted and naturally occurring).
Are additional actions needed: None at this time. Trend is positive but growth rate appears limited. Continue to monitor.

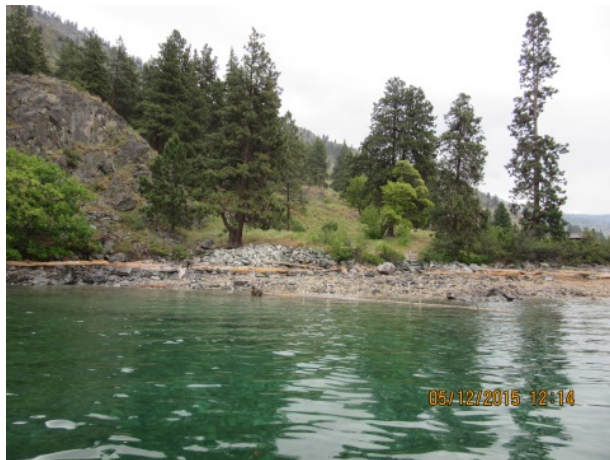
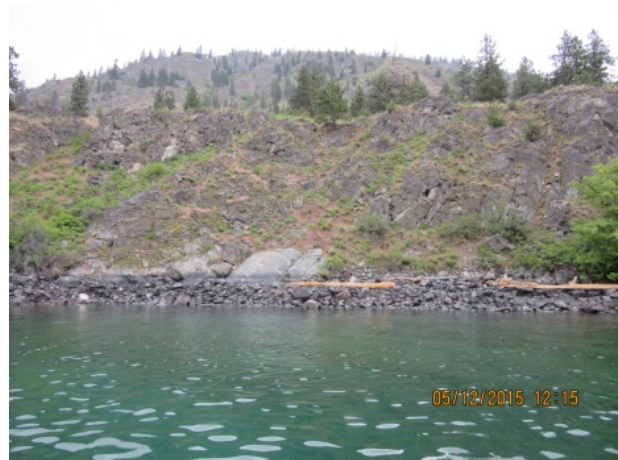
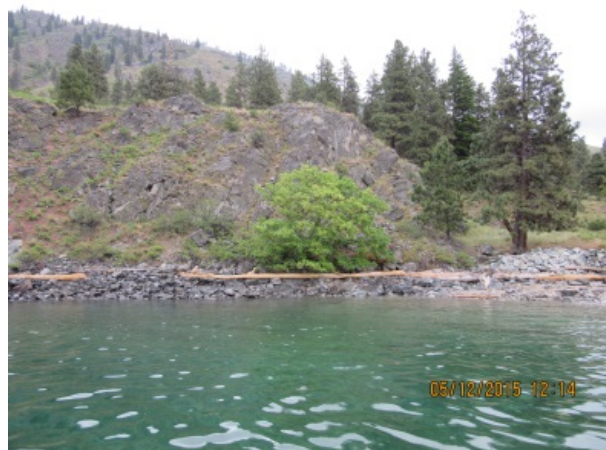
On May 12, 2015 Gene Yow, Paul Willard and Lori McAllister (Monitoring Team) visited the site. Previous cursory inspections by Forest Service personnel found that the treatments appeared to be very effective. In 2010 LWD was repaired with additional cables. The Monitoring Team found the repair work done at the Deer Point site to be acceptable. All repaired LWD are in place and others have been added with naturally occurring LWD. Native vegetation looks good. The treatment tended to terminate at the top of the cut slopes, so there were very limited eroded sections above the treatment. Therefore, very limited areas were available to establish additional vegetation. No new erosion was found and the old erosion scars above the treatments are stabilizing and naturally revegetating.

1. Inspection of LWD systems and recommended repairs.
Safety Comments: None
Stability Comments: None
2. Repair conducted on LWD systems
Safety Repairs: None at this time
Stability Repairs: None.
3. Toe Rock Stability
Linear feet of toe rock needing maintenance: None Comments: None
4. Inspection of vegetation (planted and naturally occurring).
Are additional actions needed: No

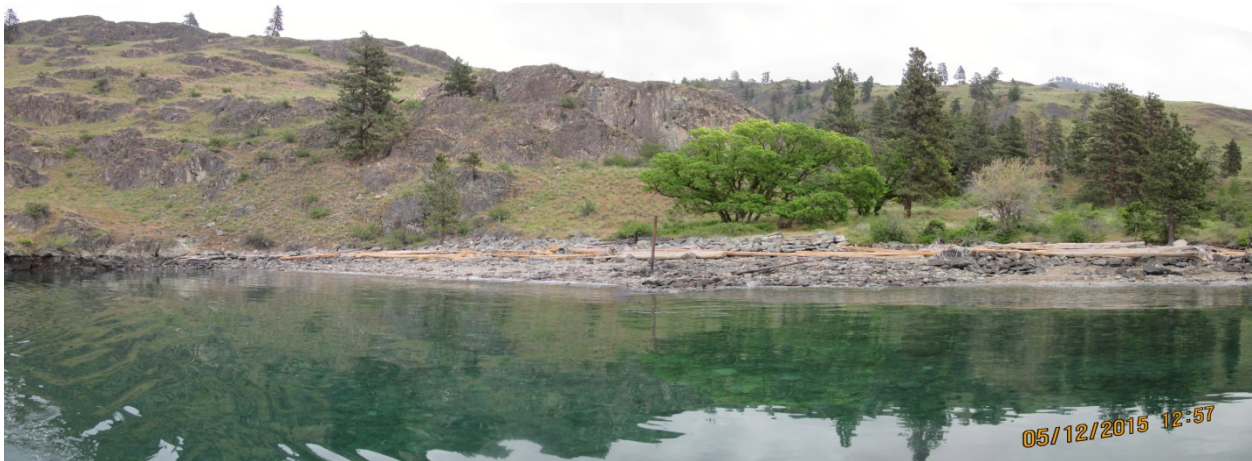
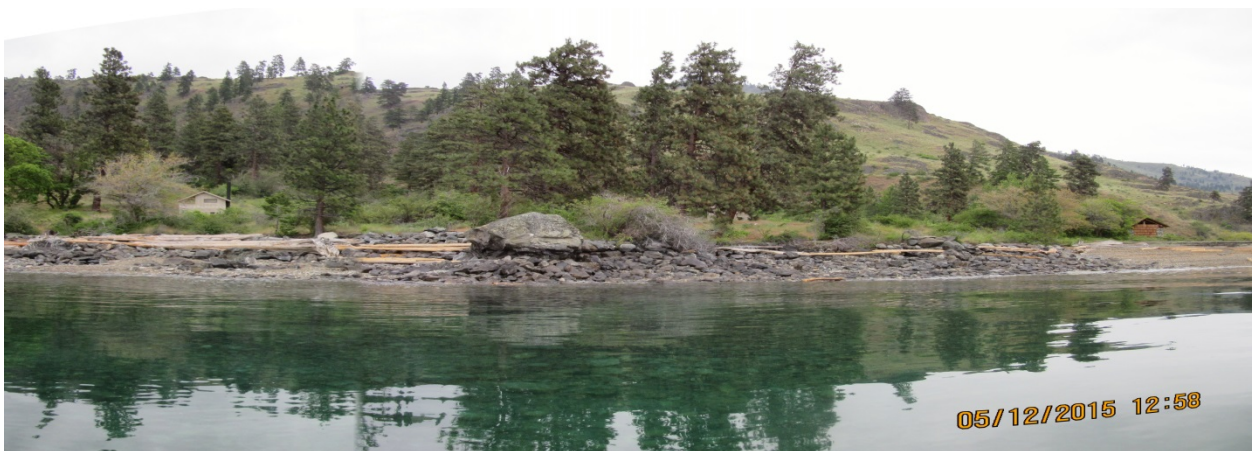
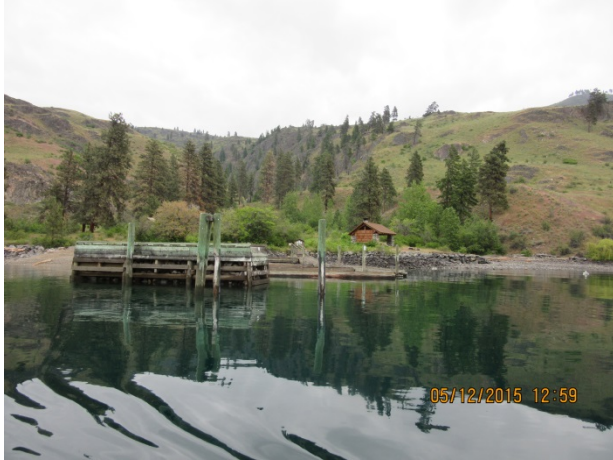
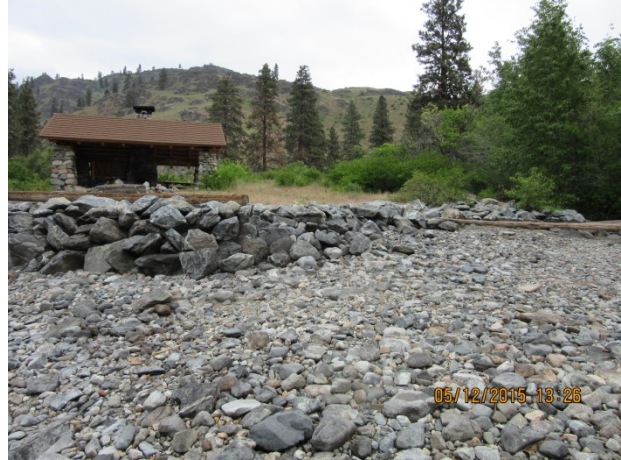
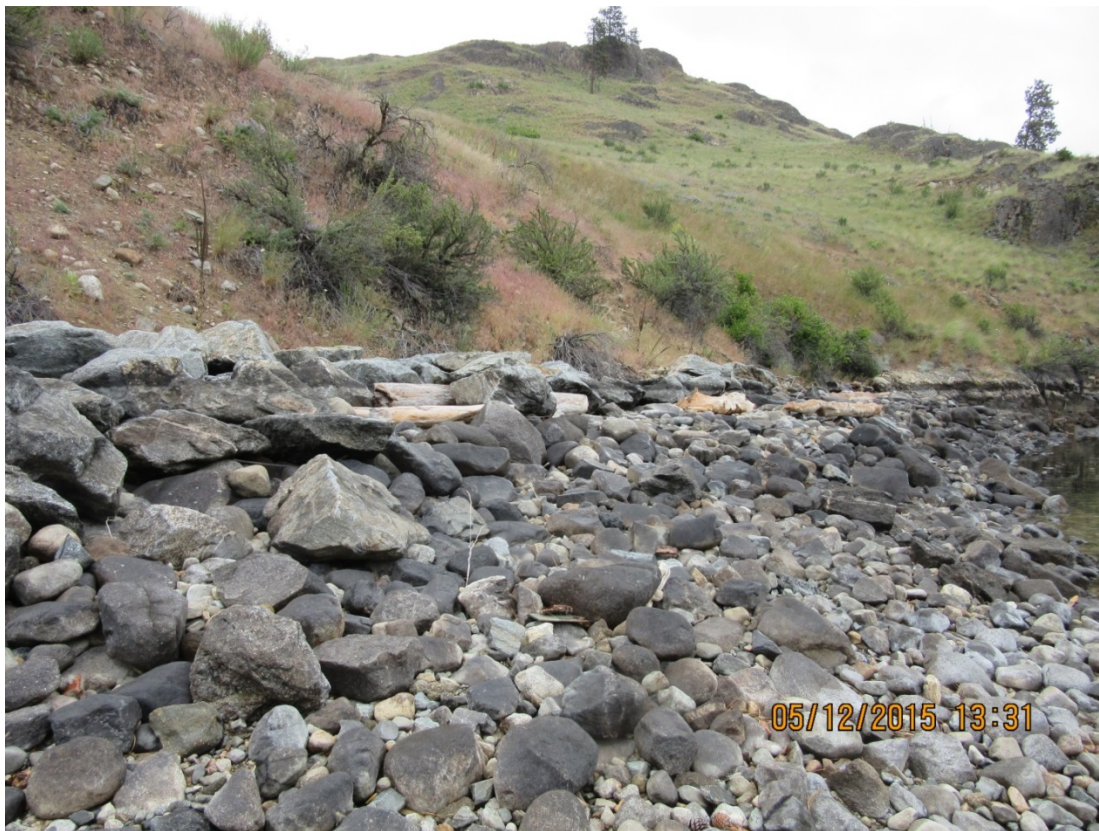
On May 12, 2015 Gene Yow, Paul Willard and Lori McAllister (Monitoring Team) visited the site. Previous cursory inspections by Forest Service personnel found that the treatments appeared to be very effective. This site has been repaired once in 2010 by repairing cables on LWD. The Monitoring Team found the repair work done at the Mitchell Creek site to be acceptable. Natural LWD recruitment and lacustrine deposits on top of LWD made it difficult to discern every placed LWD log. However, the site has more LWD than prior to treatment. It appears that the LWD introduced at the site helps retain naturally occurring LWD near the ordinary high water line. Several of the remaining logs have broken cables but are stable. Native vegetation looks good. The rock treatment tended to terminate at the top of the cut slopes, so there were very limited eroded sections above the treatment. Therefore, very limited areas were available to establish additional vegetation. No new erosion was found and the old erosion scars above the treatments are stable and naturally revegetating.

Y/N Presence of noxious weeds before treatment. Species of weed(s): Knapweed, Cheat grass
Y/N Current presence of noxious weeds. If yes, give species of weed(s): Knapweed, Cheat grass
4. LWD objective: Ensuring LWD is stable. Y/N Yes If no, then provide comment: 30% no longer attached but are buried in lacustrine deposits and/or have been replaced with natural logs.

1. Inspection of LWD systems and recommended repairs.
Safety Comments: None
Stability Comments: The monitoring team was unable to specifically identify LWD #2, #3, #4, #8, and #10. Additional natural LWD recruitment and lacustrine deposits on top of LWD made it difficult to discern every placed LWD log. However, due to natural recruitment the site has more LWD than prior to treatment. The cables on LWD #9 were broken but the log is stable due to naturally improved lacustrine deposits and additional natural LWD on-site.
2. Repair conducted on LWD systems
Safety Repairs: None at this time
Stability Repairs: None Needed
3. Toe Rock Stability
Linear feet of toe rock needing maintenance: None Comments: None
4. Inspection of vegetation (planted and naturally occurring).
Are additional actions needed: No
