Treatment Effectiveness and Maintenance and Safety Monitoring for Erosion Control Sites: Domke Falls Campground (Site 24), Refrigerator Harbor Campground (Site 25), Lucerne Campground (Site 26) and Lucerne Guard Station (Site 27)

Lake Chelan Hydroelectric Project FERC Project No. 637 ARTICLE 401(a) Condition Appendix A, Articles 1(a)1, 1(a)2 and 1(a)3 required Chelan PUD to complete and submit an Erosion Control Implementation Plan, Site-Specific Erosion Control Plans, and an Erosion Monitoring and Maintenance Plan respectively. These plans provide a comprehensive approach to address shoreline erosion associated with the operation of this project. A number of erosion control sites described in the aforementioned plans have been treated to inhibit shoreline erosion on Forest Service lands on Lake Chelan.

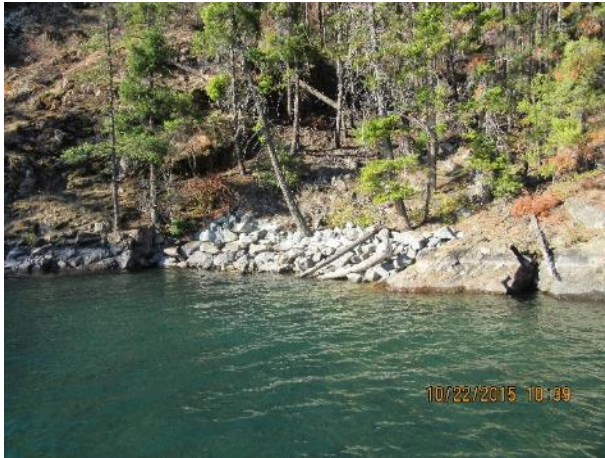
Domke Falls Treatment Zones A and A1

On October 22, 2015 Paul Willard and Lori McAllister (Monitoring Team) visited the site. Previous cursory inspections by Forest Service personnel found that the treatments appeared to be very effective. The Monitoring Team found the treatments at the Domke Falls Campground to be very successful at this time. All rocks were stable and had not shifted at all. Overall, treatment is effective; one log is gone but 2 new logs have floated in. Picnic area that was reestablished above Treatment T5 is

stable and has not lost any gravel. No new erosion was found and the limited erosion scars above the treatments are stabilizing and naturally revegetating.

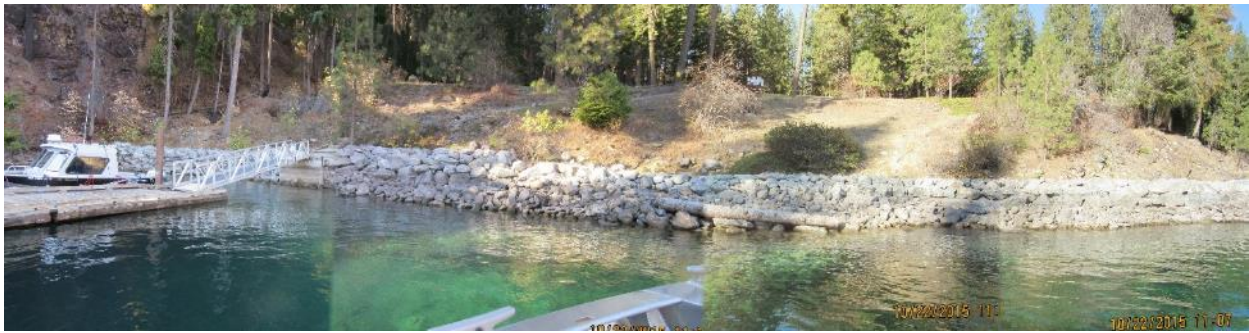
Refrigerator Harbor Treatment Zone A and B

On October 22, 2015 Paul Willard and Lori McAllister (Monitoring Team) visited the site. Previous cursory inspections by Forest Service personnel found that the treatments appeared to be very effective. The Monitoring Team found the treatments at the Refrigerator Harbor to be very successful at this time. All rocks at the crib wall were stable and had not shifted at all. Overall, treatment is effective; one log is gone and one log has shifted slightly but all remaining 11 pieces are in place and

stable. No new erosion was found and the old erosion scars above the treatments are stabilizing and naturally revegetating.

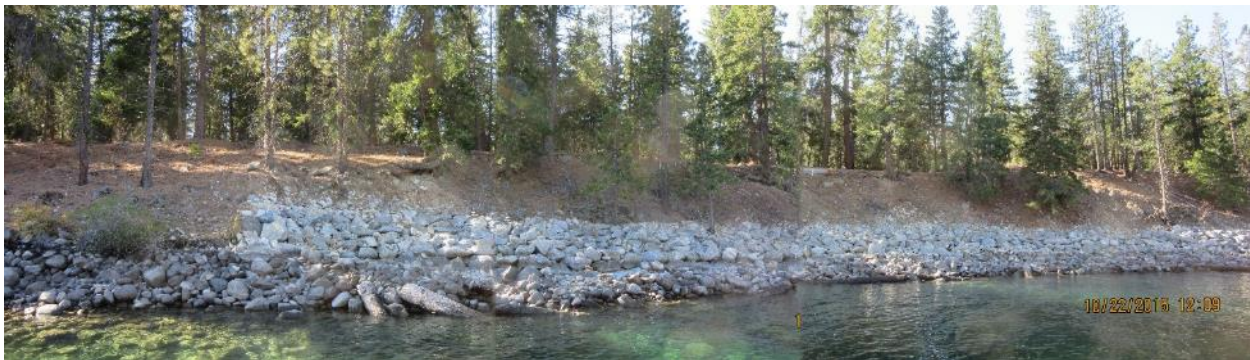
Lucerne Campground Treatment Zones A, B and C

On October 22, 2015 Paul Willard and Lori McAllister (Monitoring Team) visited the site. Previous cursory inspections by Forest Service personnel found that the treatments appeared to be very effective. The Monitoring Team found the treatments at Lucerne Campground to be very successful at this time. All rocks at the crib wall were stable and had not shifted at all. Overall, treatment is effective; 2 logs have shifted slightly but all remaining logs are in place and stable. No new erosion was found and the old erosion scars above the treatments are stabilizing and naturally revegetating.

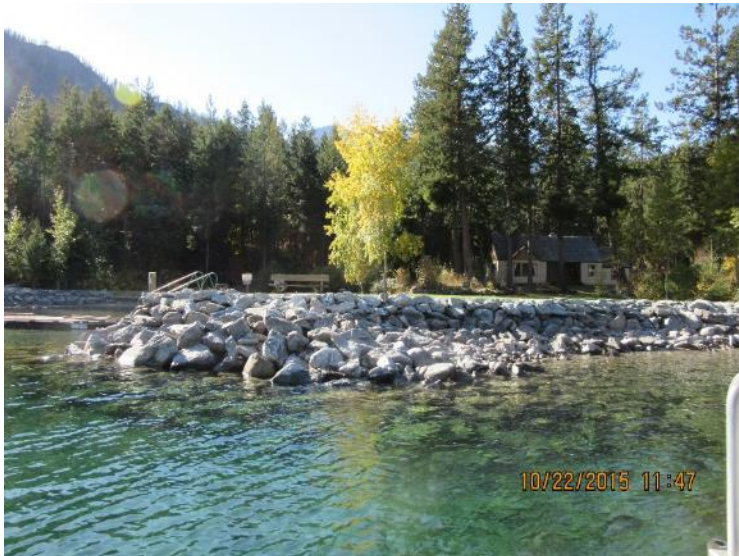
Lucerne Campground Treatment Zones F3 and G

1. Slope Stabilization Objective: 90% success rate in treated areas
Observed Success Rate: 90% Comments: Very stable overall. Treatment Zones F3 and G have experienced some erosion from extreme wave action in front of the Guard Station. Will need to add 6-7 larger rocks at top of treatment to prevent further erosion. Gravel will need to be brought in to re-establish the trail that has eroded.
No new raveling above other erosion treatments.

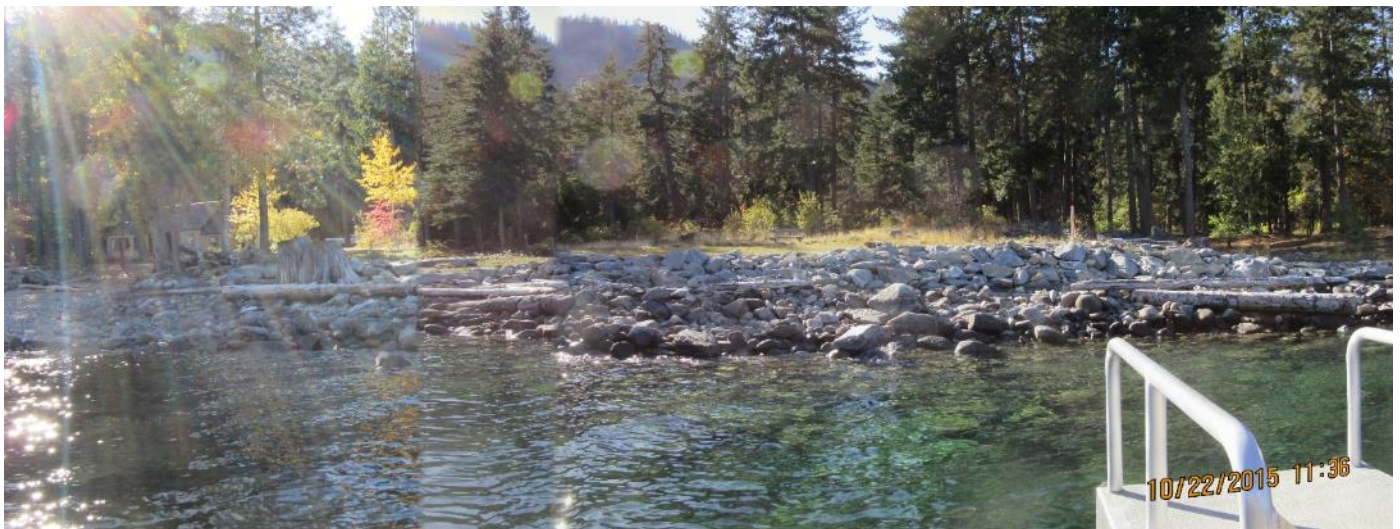
Lucerne Guard Station Treatment Zones A, B and C

On October 22, 2015 Paul Willard and Lori McAllister (Monitoring Team) visited the site. Previous cursory inspections by Forest Service personnel found that the treatments appeared to be very effective. The Monitoring Team found the treatments at Lucerne Guard Station to be very successful at this time. All rocks at the crib wall were stable and had not shifted at all. Overall, treatment is effective; one log has shifted slightly but the remaining pieces are in place and stable. No new erosion was found and the minimally exposed area at the interface of the top of the treatments and bank are stabilizing and naturally revegetating.
