MEMORANDUM

RE: Investigation of June 13, 2018 Incident at Rock Island Dam, Gate No. 17

EXECUTIVE SUMMARY

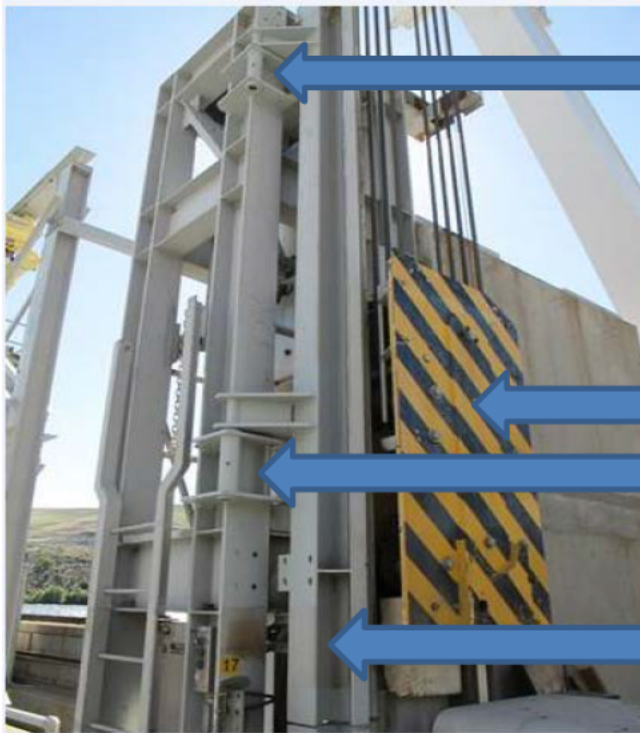
Photo No. 2

Gate 17 Upper Swing Rail Hinge (south side)

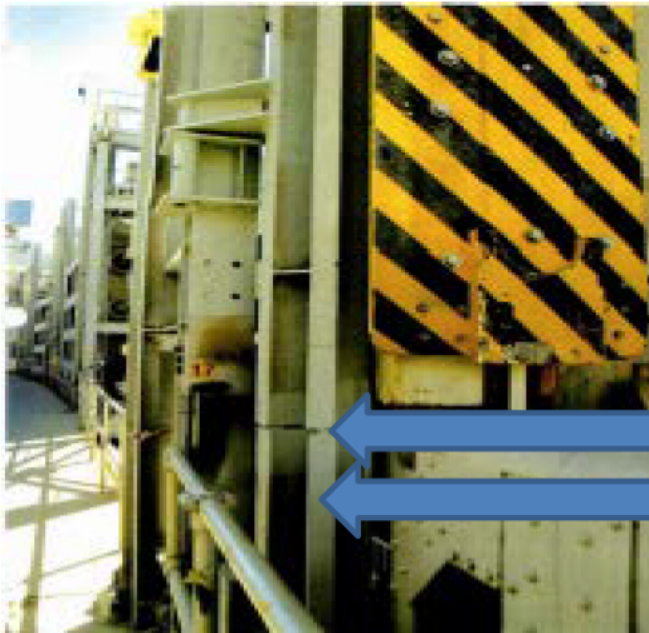
Photo No. 3

Horizontal split in rail creating swing rail above split

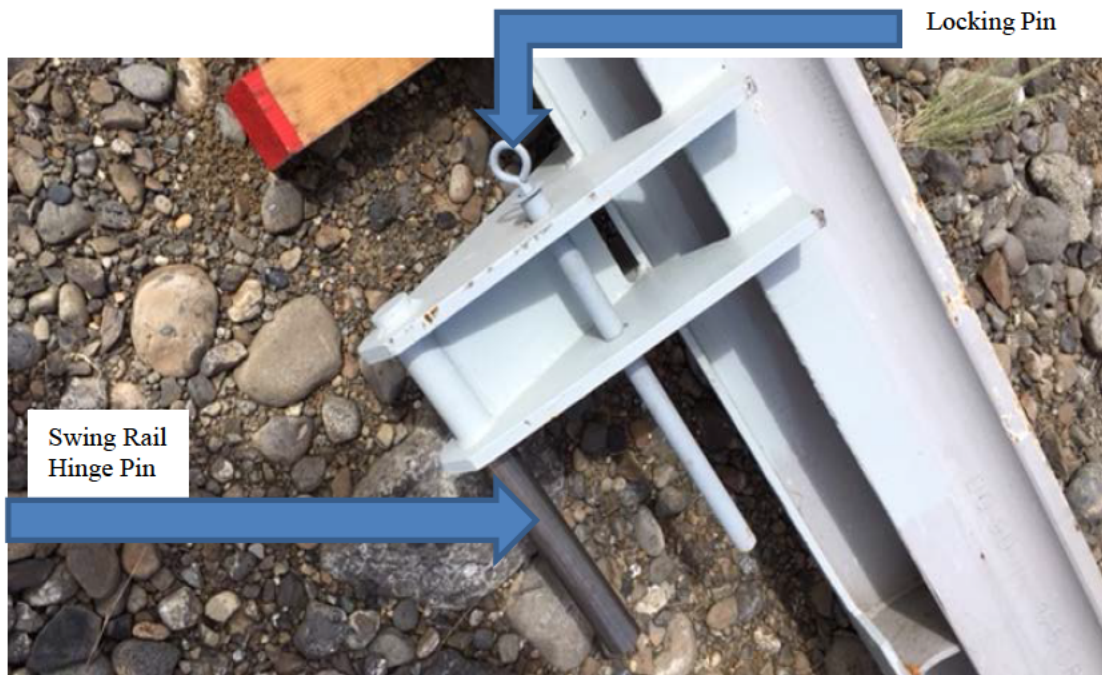
Photo No. 4 - Gate 17's north swing rail lower hinge assembly with hinge pin (left) and locking pin (right). The swing rail was removed from the spillway after the incident and relocated to a maintenance yard adjacent to the Dam.

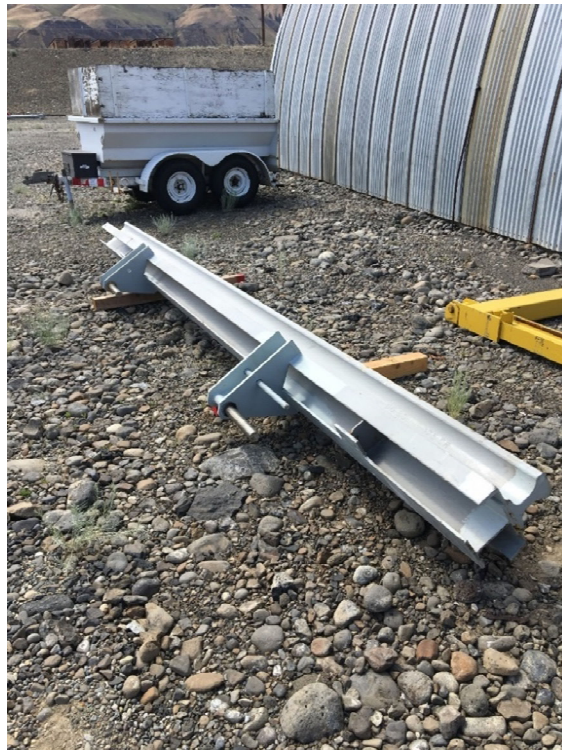
Photo 3: Bay 17 North Swing Rail – Relocated to Storage Yard after Incident

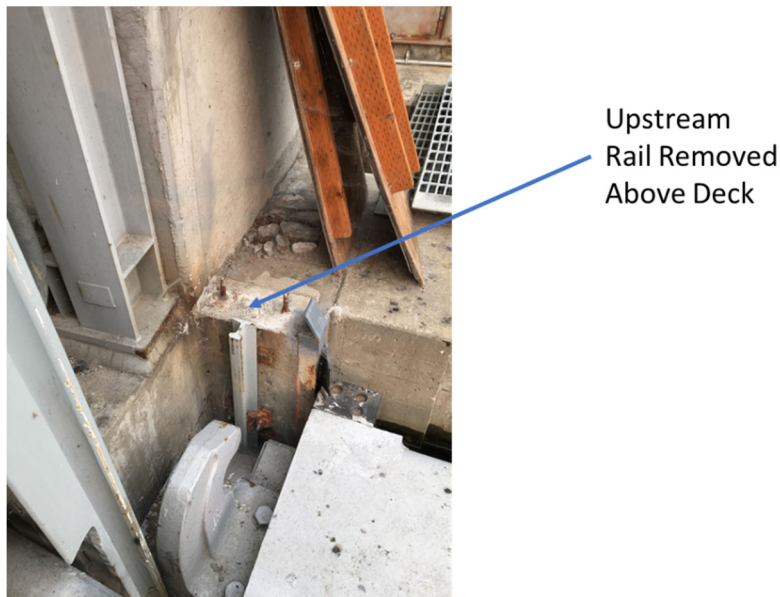
The swing rail modification consists of a swing rail at each stanchion which can be rotated to the side of the stanchion on two hinges located at the top and bottom of the assembly so that the gate can be removed when the assembly is open. The assembly is shown in Photo 3. The swing rail is only installed on the downstream #175 rail at each stanchion. The assembly rotates on a hinge pin held by a tube welded to the stanchion. The hinge also has a locking pin, which, when in place, keeps the swing rail from swinging open. As part of the swing rail retrofit, the upstream rails are removed above the dam deck (roadway) to facilitate connecting to the gate with a gantry crane as shown in Photo 4. In the photo, the top hook for Gate 17 is also shown.

Photo 4; Gate 17 South Stanchion

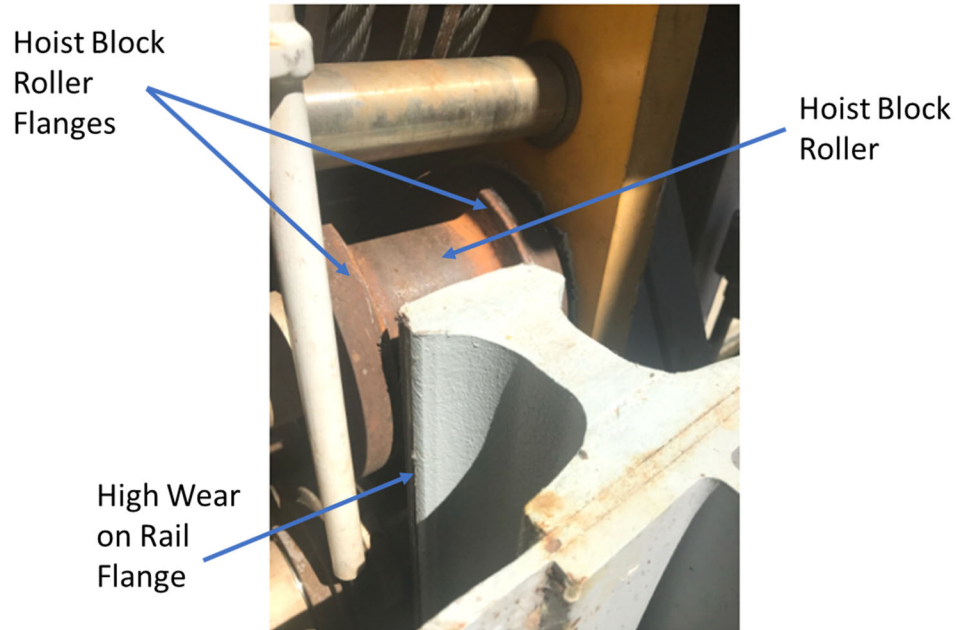
Photo 8: Gate Bay 17 North Stanchion After Incident (Gantry Crane 3 Hoist block Is Not Engaging the Downstream Fixed Rail)

It appears that during the lift, the north hoist block could not follow the north downstream rails over the gap at the junction of the swing rail with the fixed rail. Photo 8 shows the north hoist block upper roller has lost contact with the fixed rail. The hoist block's guide roller flange is riding on the rail flange bearing surface. This might be due to imprecision in the set-up of the crane over the gate, as frequently occurs in such operations, or misalignment of the North and South downstream rails.

The configuration of the hoist block, pushed upstream and off the rails, increases the tendency of the block to rotate. As the hoist block twists, the top of its leaders can catch the bottom edge of the swing rail assembly with either the top of the front leader or the top of the rear leader. Further lifting of the gate eventually unseated the swing rail assembly entirely and it fell to the dam deck ultimately striking and killing a maintenance technician.

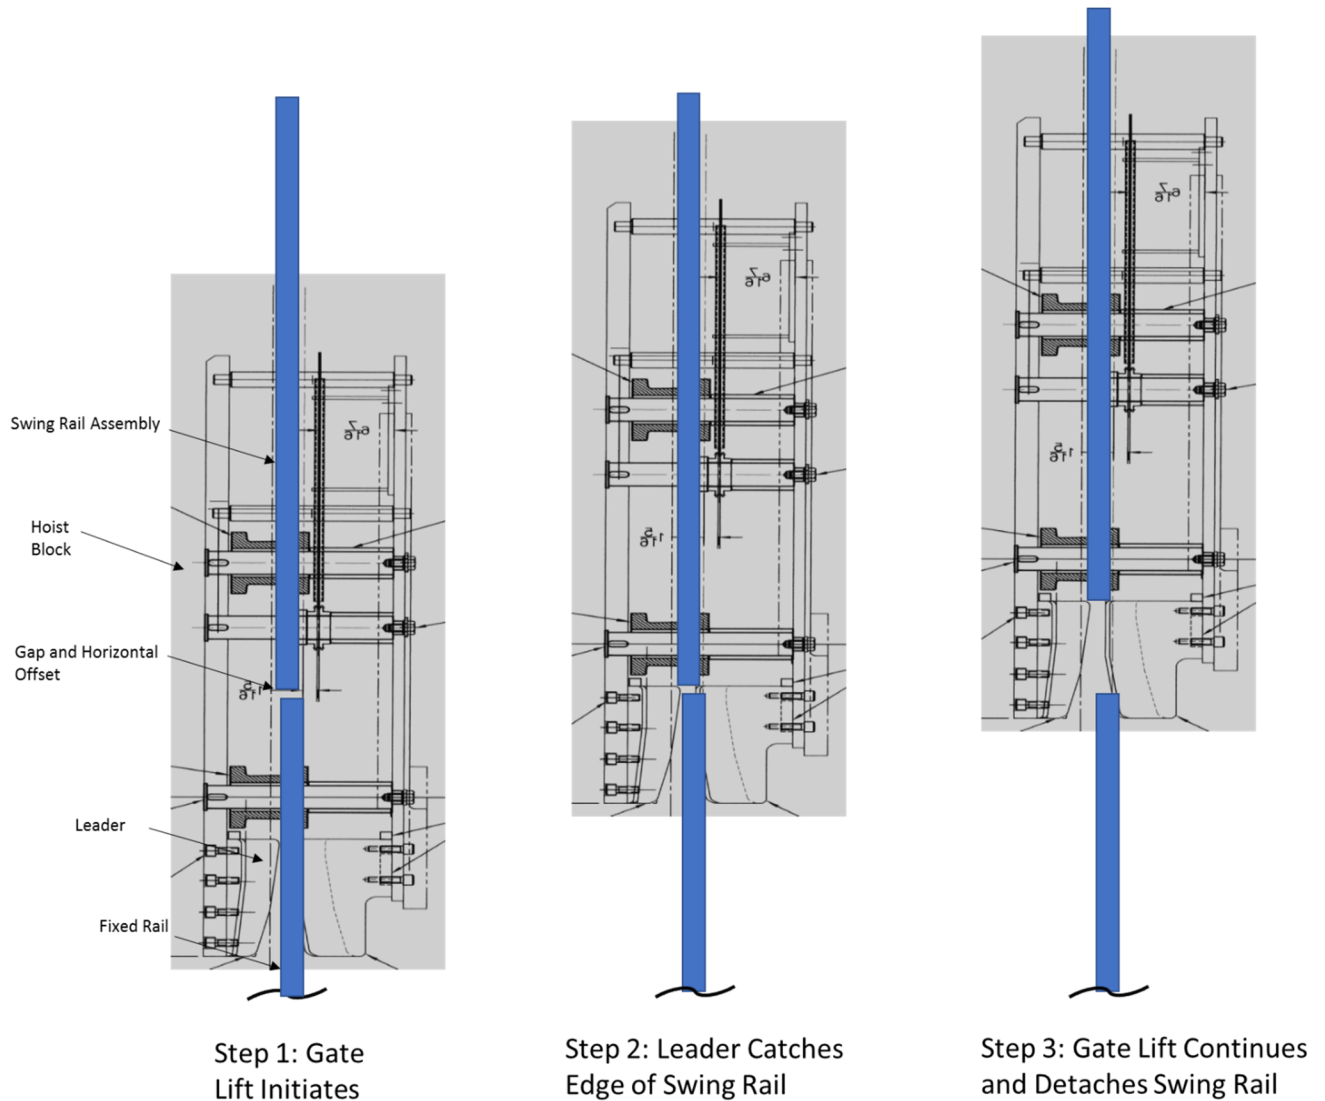
The failure sequence is depicted below in Figure 2. There is a slight horizontal misalignment at the rail gap between the swing rail assembly and the fixed rail at the North stanchion of gate bay 17. Although the hoist block successfully passed the gap on its way down the rail, when the lift operation starts as shown in Step 1, the leaders are pushed to one side due to the set-up of the crane above the gate. This slight offset causes the top on one of the leaders to catch the bottom edge of the swing rail assembly as the leaders, while lifting, pass over the rail gap as shown in Step 2. As the lift continues, the leader starts lifting the swing rail assembly as shown in Step 3.

Figure 2: Root Cause Failure Sequence
