# **Rock Island Spillway Bays 17 & 25 Hoist Replacement**

## **Commission Presentation**

April 15, 2019

Review staff recommendation to revise scope and budget from repair to replace.

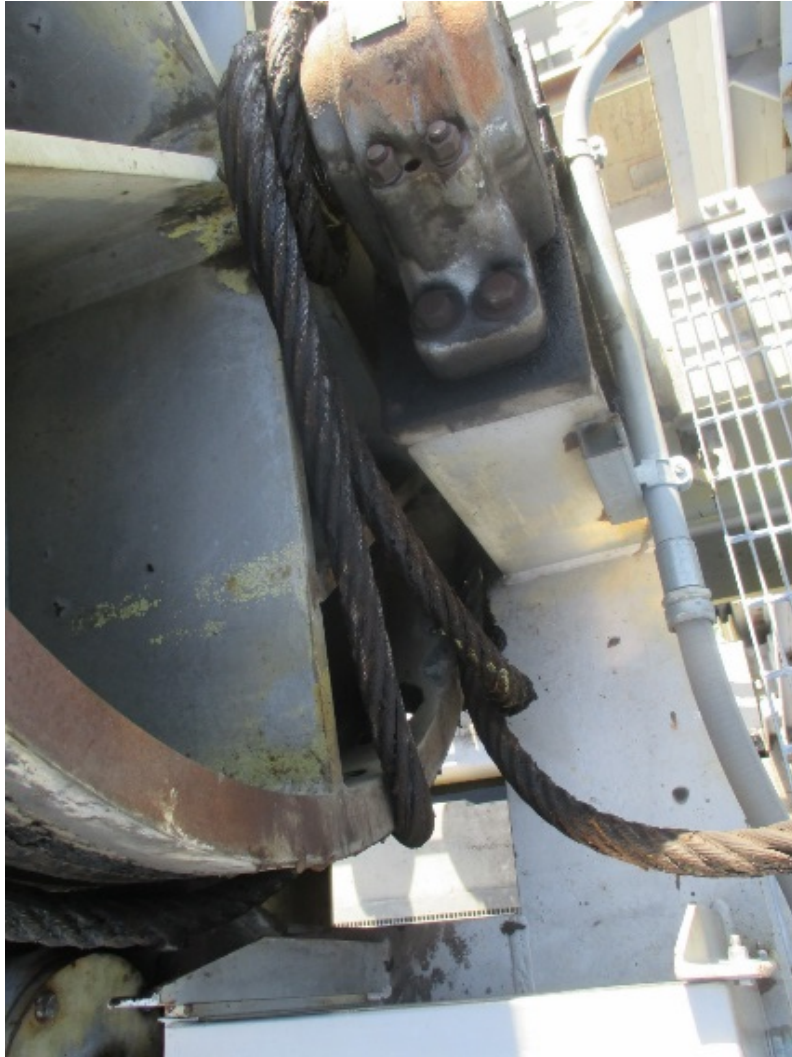
## Bay 17 Hoist Failure

- March 29, 2017
- Gate initially opened to 8 feet
- Failure occurred in a hoist gear box
- Without knowing of failure, gate was lowered to closed position.
- Next operation to open gate caused gate racking and rope failure. (Hoist was trying to lift gate from one side only)

- Hoist removed and spill bay configured for manual gate operation (gantry cranes)
- Spill Bay 25 of similar design inspected
  - Gear shaft had cracks
  - Spill bay 25 equipment removed

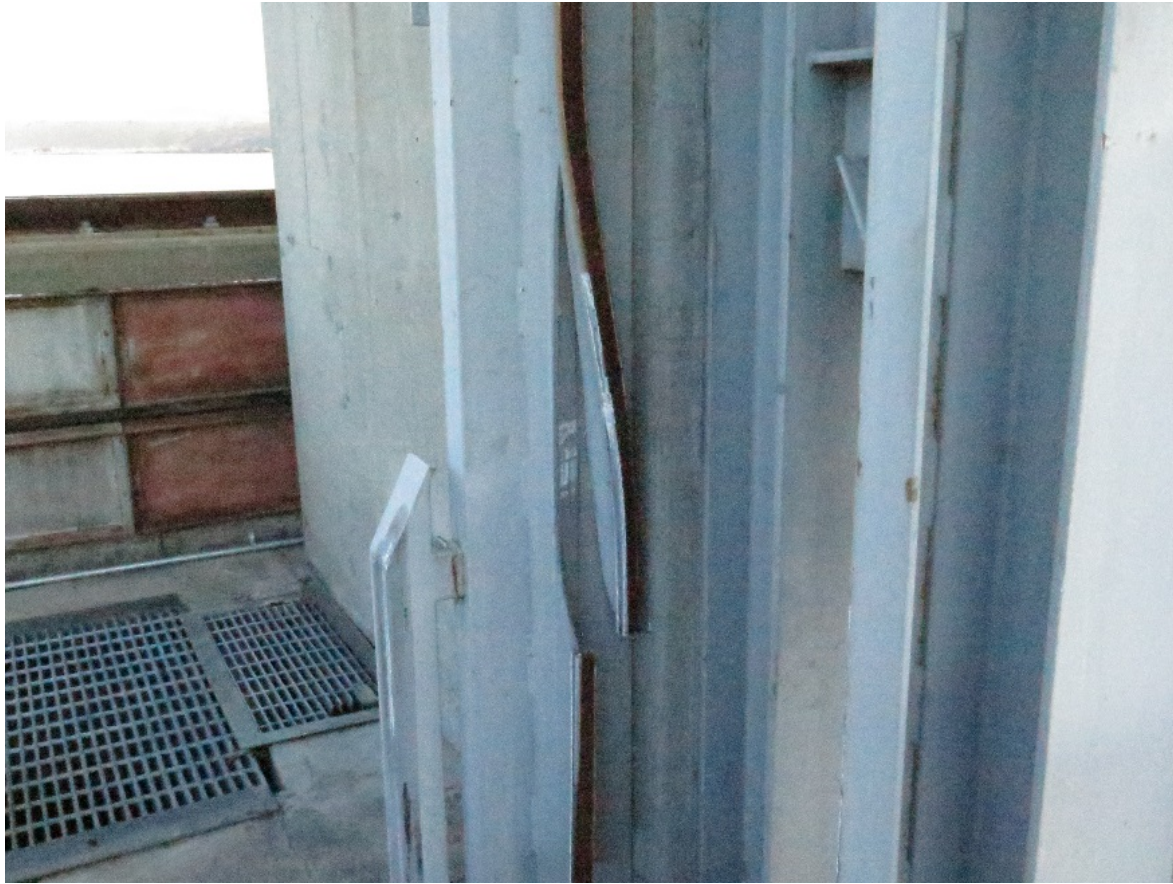
- Wire rope failed
- North guide rail damaged
- 22 foot gate to 11 foot gate linkage damaged
- Broken Shaft on North side gearbox
- Center worm gear teeth damaged

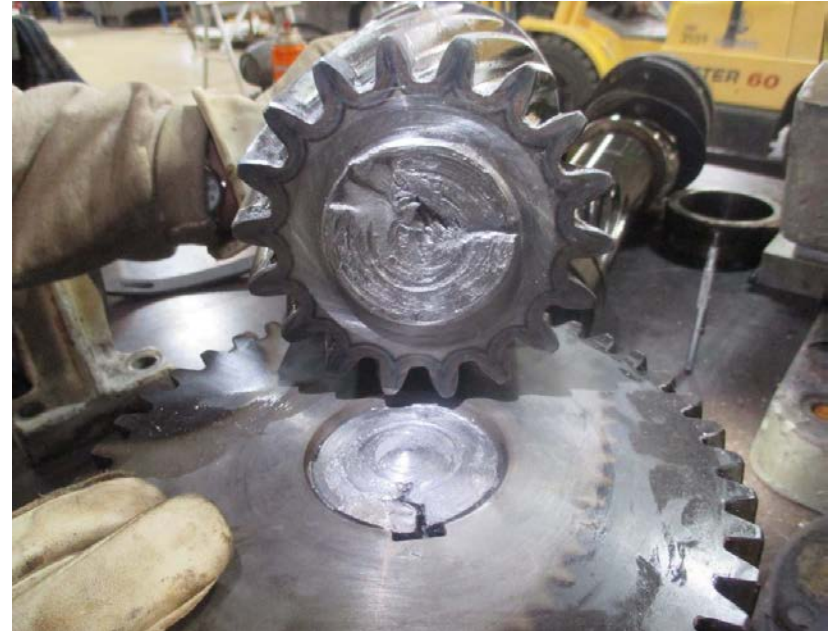
- Broken Gear Shaft

Location of  
sheared shaft
