Emergency Resolution Stehekin Powerhouse

Stehekin Hydro Generator

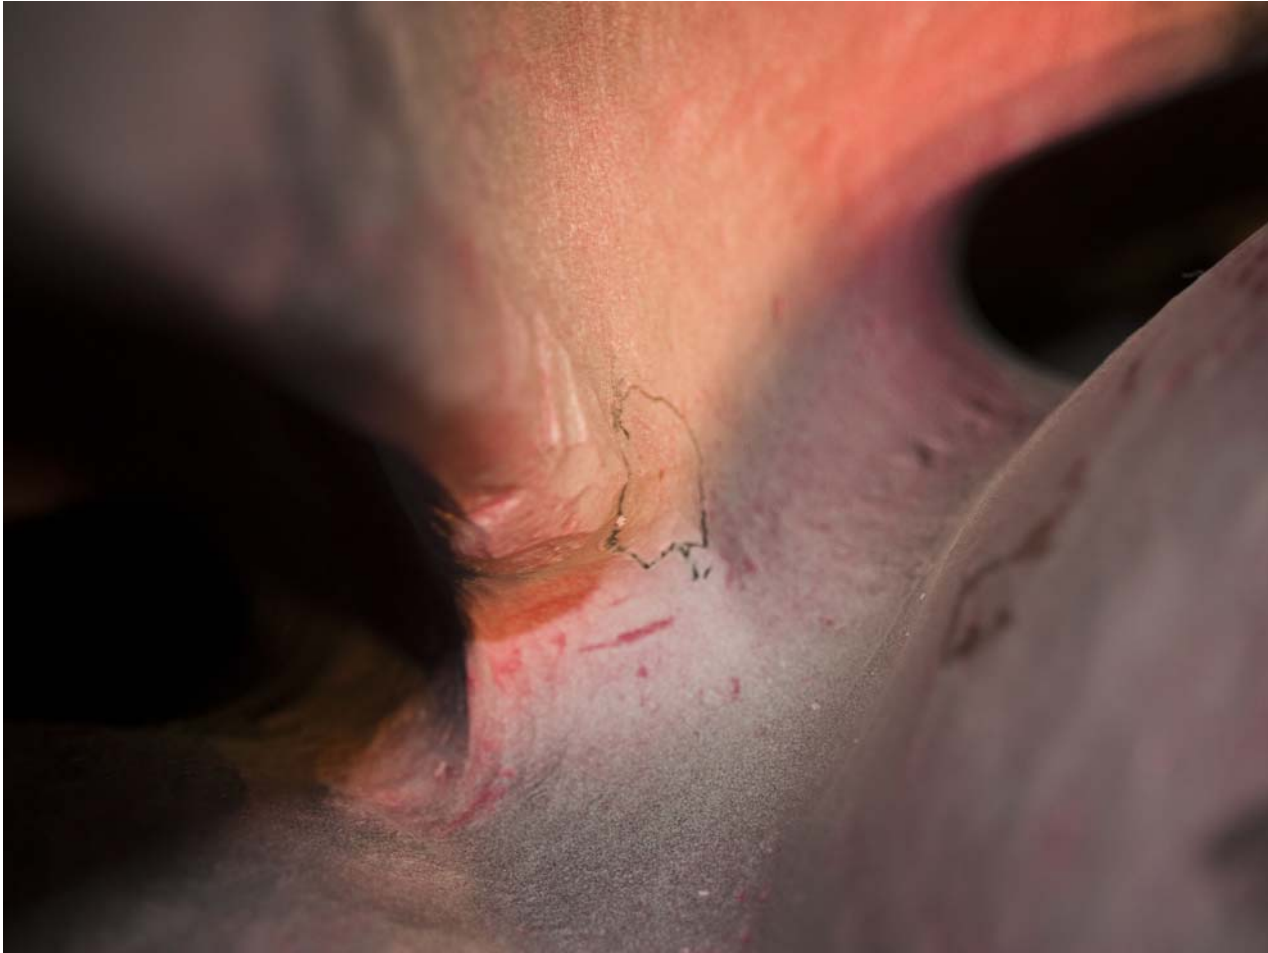
Wheel Crack- 4/24/07

- 2004 - First crack was repaired in place
- 2005 - Second crack was identified. Wheel was removed and brought to Central Maintenance shop for repair
- 2006 – Third crack was discovered. Wheel brought to Central Maintenance for repair. New repair procedure used requiring heat treatment before welding.
- 2007 – A routine inspection discovered three cracks in different runner buckets. Wheel has been removed and is on its way to Central Maintenance for repairs
