Lake Chelan Tributary field trip
April 2, 2009

A site visit to four tributaries to Lake Chelan was made by members of the Lake Chelan Fisheries Forum with Chris Fairbanks, fisheries biologist, Craig Cooper, fluvial geomorphologist, and Pat Powers, fisheries engineer. The objectives of the site visit were to make a qualitative determination if a barrier to upstream fish passage was present at each of the four creeks and to explore alternatives for enhancing or creating upstream fish passage. This site visit was made on April 2, 2009 when the lake surface elevation would be near the annual low operating level and when the streams would have a low discharge. The lake surface elevation was approximately 1,086 feet relative to mean sea level. The four tributaries included:

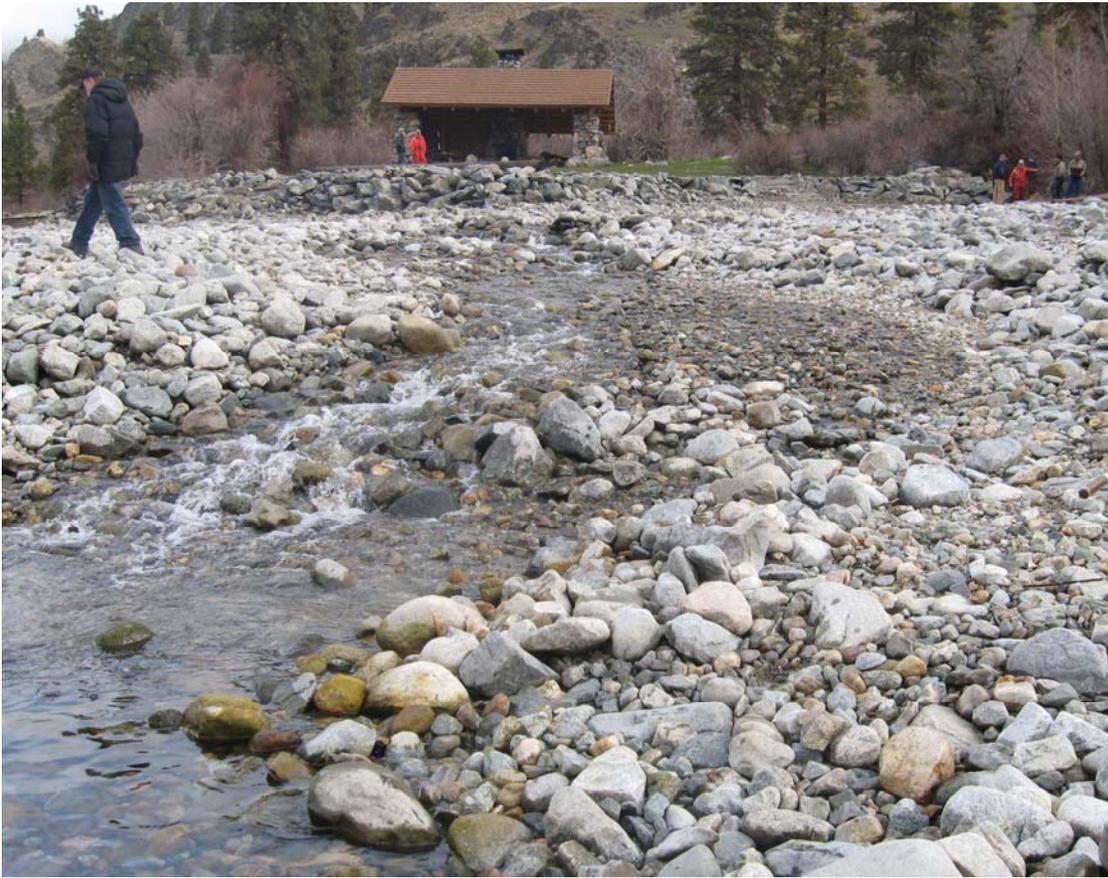
Photo 1.. Mitchell Creek April 2, 2009

The mouth of the creek at full pool elevation (approximately 1,100 feet) is confined and has adequate depth, velocity and grade for upstream passage. Below this elevation, the creek channel become wider across the alluvial fan, water depth decreases and becomes too shallow for fish passage (Photos 1 and 2). The field team consensus was that upstream fish passage was impeded primarily by shallow water depth.

A solution to improve upstream passage was to confine the stream flow to a narrower channel that would provide depth with some step-pools to allow resting stations. Large angular rocks would be the most appropriate materials that would least likely to be moved by high stream flows or by campground guests. Large woody material would not be an appropriate material; the wood may be used for firewood.

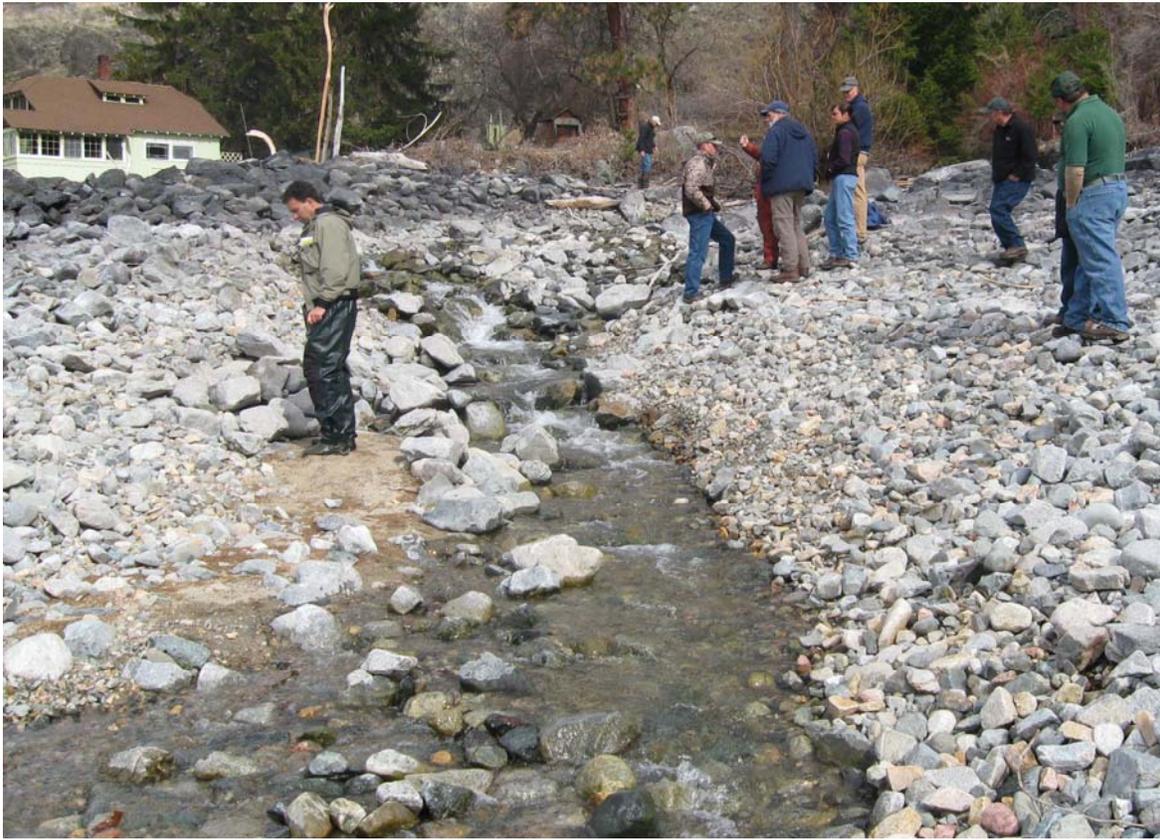
Photo 3. Gold Creek April 2, 2009

The Gold Creek channel has been very stable since the 2000 field season. The creek has remained confined to a channel that extends from the full pool level through the alluvial fan to the lake surface. Large rocks along the right bank (looking downstream) keeps the stream channel confined (Photo 3). The overall grade of the stream channel in the alluvial fan was 10% with a short cascade of 16.7% (Photo 4). The staff gage from the 2000 field season has been removed and the stream discharge was not estimated.

The group consensus was that fish passage was impeded by grade and water velocity that could be improved with rock weirs. Rock weirs would create step pools which would reduce the overall grade and water velocity. The step pools would also provide resting stations for upstream migrating fish. Addition parameters that were discussed were:

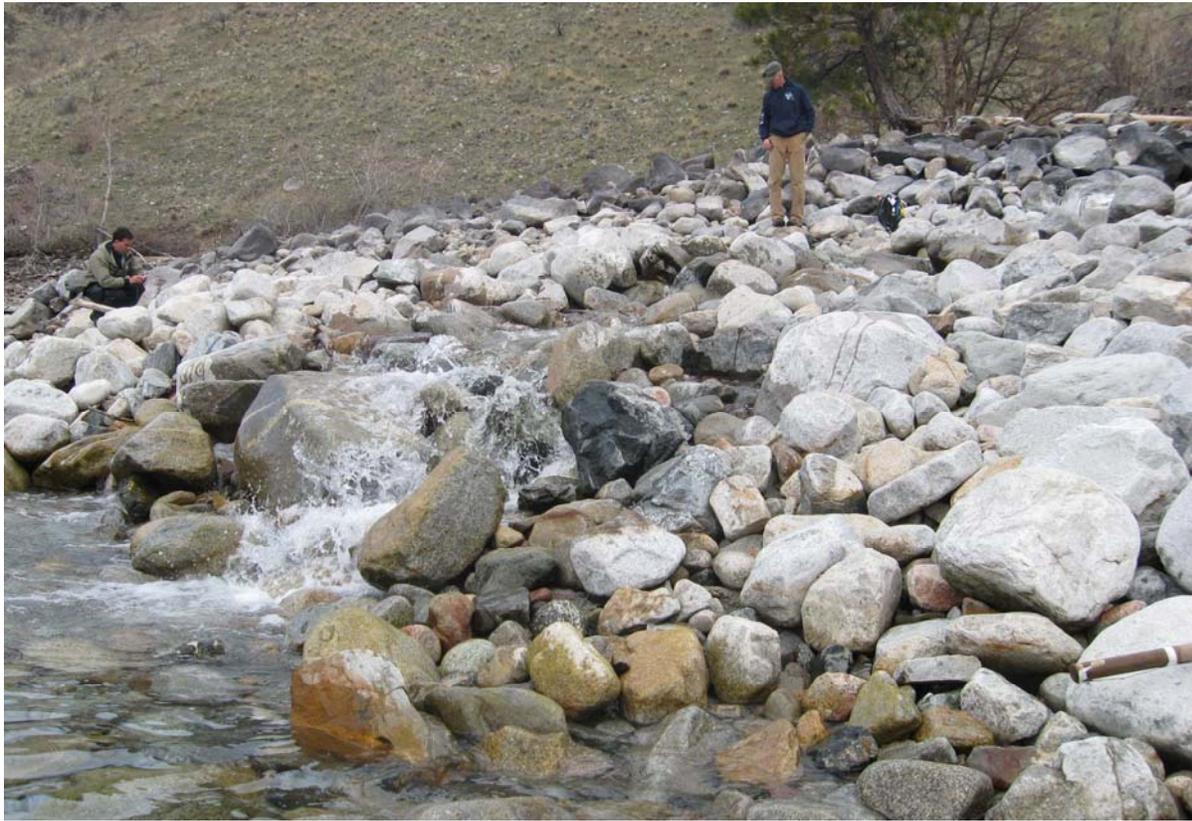
Photo 5. Grade Creek April 2, 2009

Grade Creek is a challenging site. The overall grade of the stream channel in the alluvial fan was 19% with few step pools for resting stations for upstream migrating fish. The stream gage was intact and the channel appears to be fairly similar to the 2000 field season; stream discharge was approximately 7.1 cfs.

The team consensus was that fish passage was impeded by the steep slope and by high water velocity with few resting stations for upstream migrating fish (Photos 5 and 6). Several ideas to lengthen the stream channel were discussed, however; physical constraints of the site's geology and stream energy make alterations of the stream channel unfeasible. Placement of pre-fabricated concrete fishways was accepted as a method to provide upstream passage. Fishways would be placed in the two steepest section of the alluvial fan. These areas would be excavated with a barge-mounted back hoe and fishways placed in the trench and then backfilled with native material. The fishways would need monitoring and servicing to ensure that rock and woody material is not blocking fish passage.

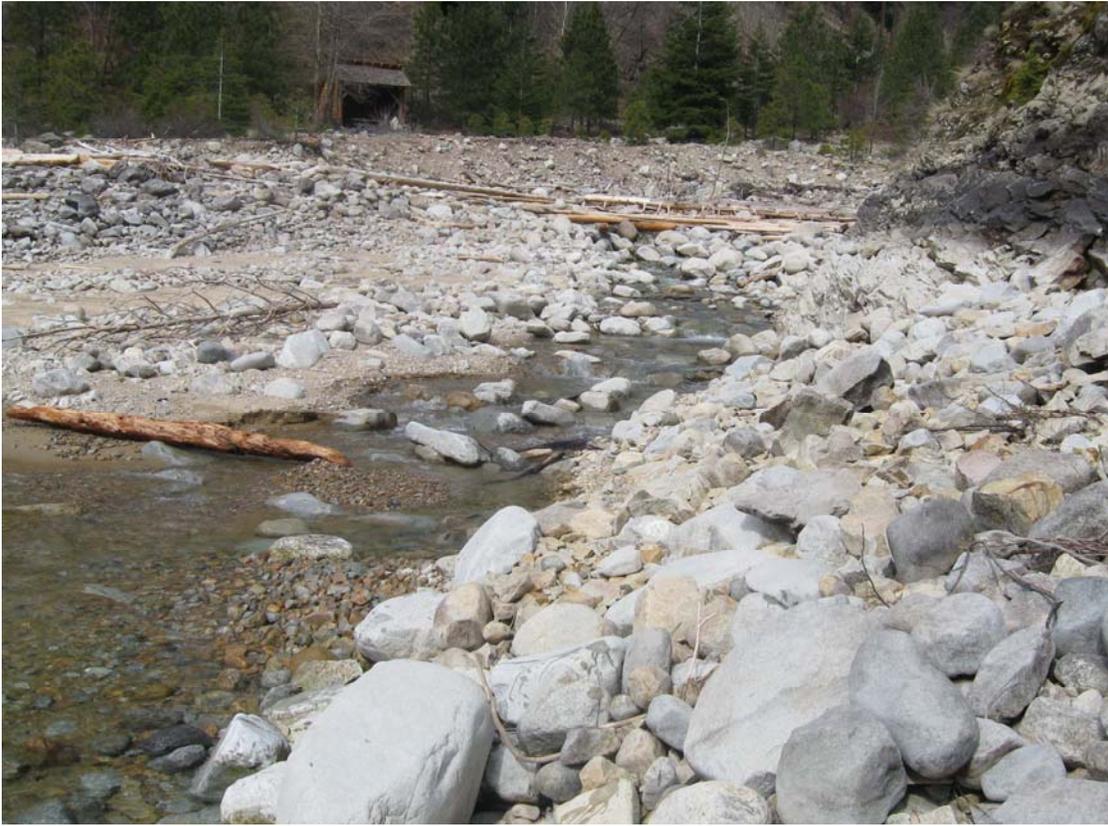
Photo 7. Safety Harbor Creek April 2, 2009

The stream channel of Safety Harbor Creek has been greatly down cut compared to the 1999 and 2000 field seasons. The grade, water velocity, and water depth appear to be appropriate for upstream fish passage (Photo 7). Fish passage may however have been impeded by woody material that has accumulated near the full pool level and group members removed key pieces to allow natural processes to keep a section of the channel clear of debris and with adequate water depth and velocity for fish passage (photo 8).
