Draft for 1st Quarter Report Example 4/8/09

Chelan Ranger District
Mitchell Creek Campground
Erosion Control Treatment Site 59
2009

Site 59 is the first erosion site treated under the Lake Chelan Hydroelectric Project No.637-022, under Article 401. The treatment followed the site specific plans for this site filed November 7, 2007 by Chelan PUD with the Federal Energy Regulatory Commission's (FERC) for approval of the Erosion Control Implementation and Erosion Monitoring and Maintenance Plan (Erosion Control treatment Plans) and the Site-Specific Erosion Control Plan (Site-Specific plan for site 59). On December 14, 2007, FERC issued the Order approving these plans.

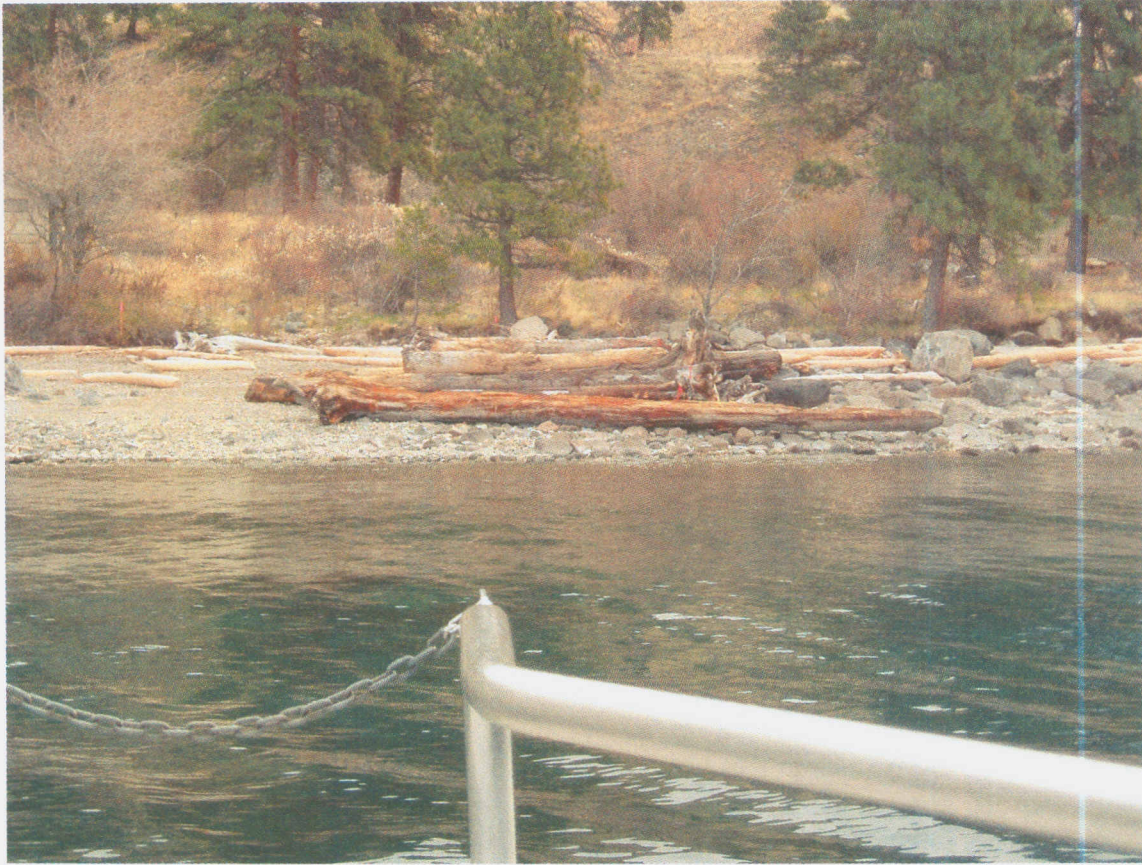
LWD was pre-stage at the uplake portion of the treatment site 568 tons of rock were pre-stage at this site during early December 2008. Approximately 356 linear feet of shoreline were treated on the up lake side of site 59 with 241 linear feet treated on the down lake portion of the site.

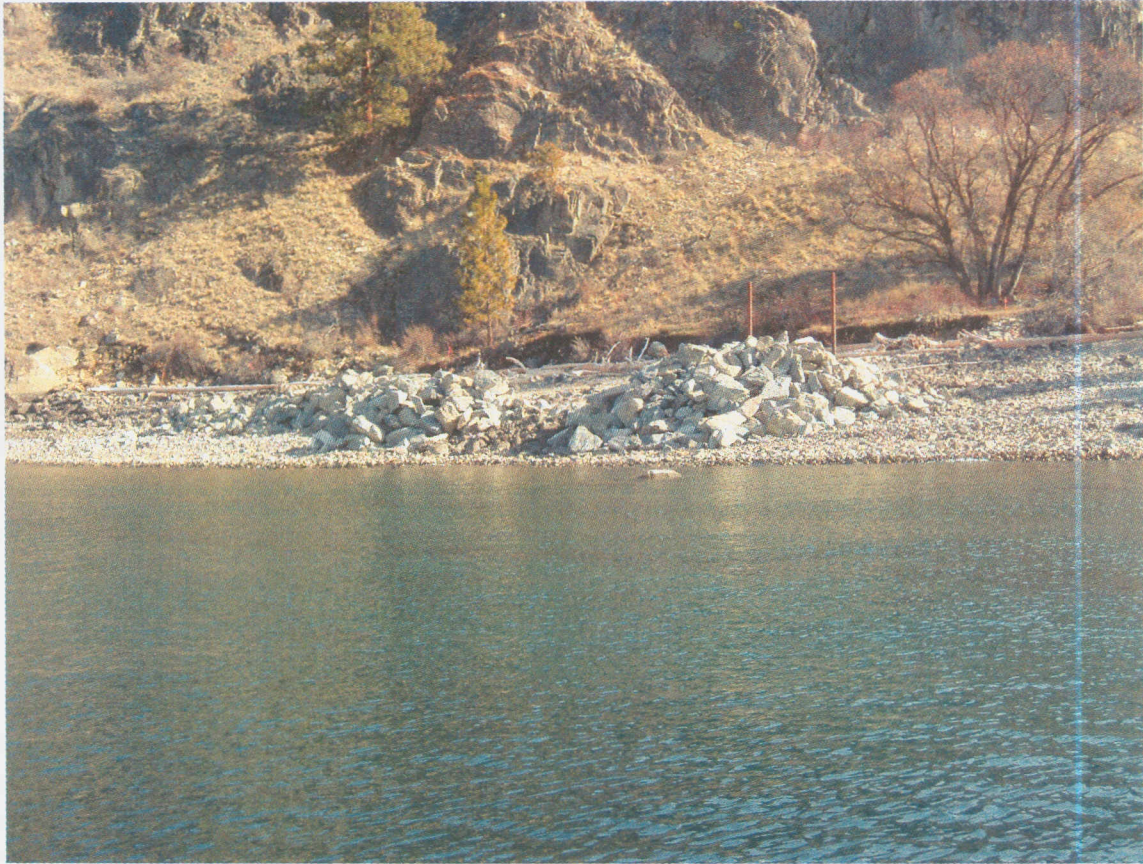
Placement of rock started and was completed in March of 2009. A Komat'su 220 excavator was the primary rock moving machine. All full treatment areas used Geotex 801 fabric cloth 12 feet wide was placed over coir wattles that were placed at 1100 and 1104 elevations, fabric was placed near the top of the treatment and into the toe trench. A small toe trench was excavated below 1100 feet with approximately $\frac{1}{2}$ of the excavated material going upslope to create a softer slope and some be pulled in front of the toe of the trench.

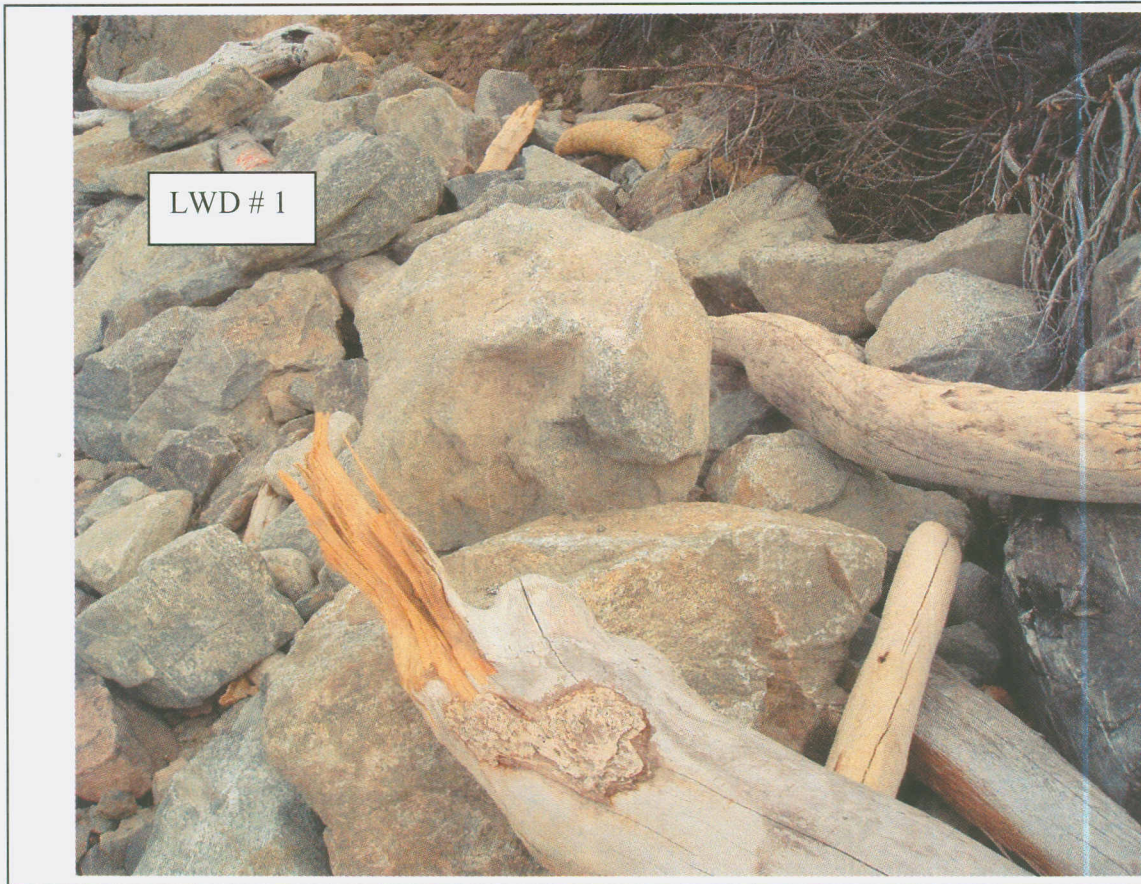
LWD # 1

The photograph shows (LWD# 1) our first rock anchored piece of LWD it has 3 large rock on top of the log and is side pinned by rock. This is treatment area "A" which called for single large rock. We had additional rock and beefed up the treatment.

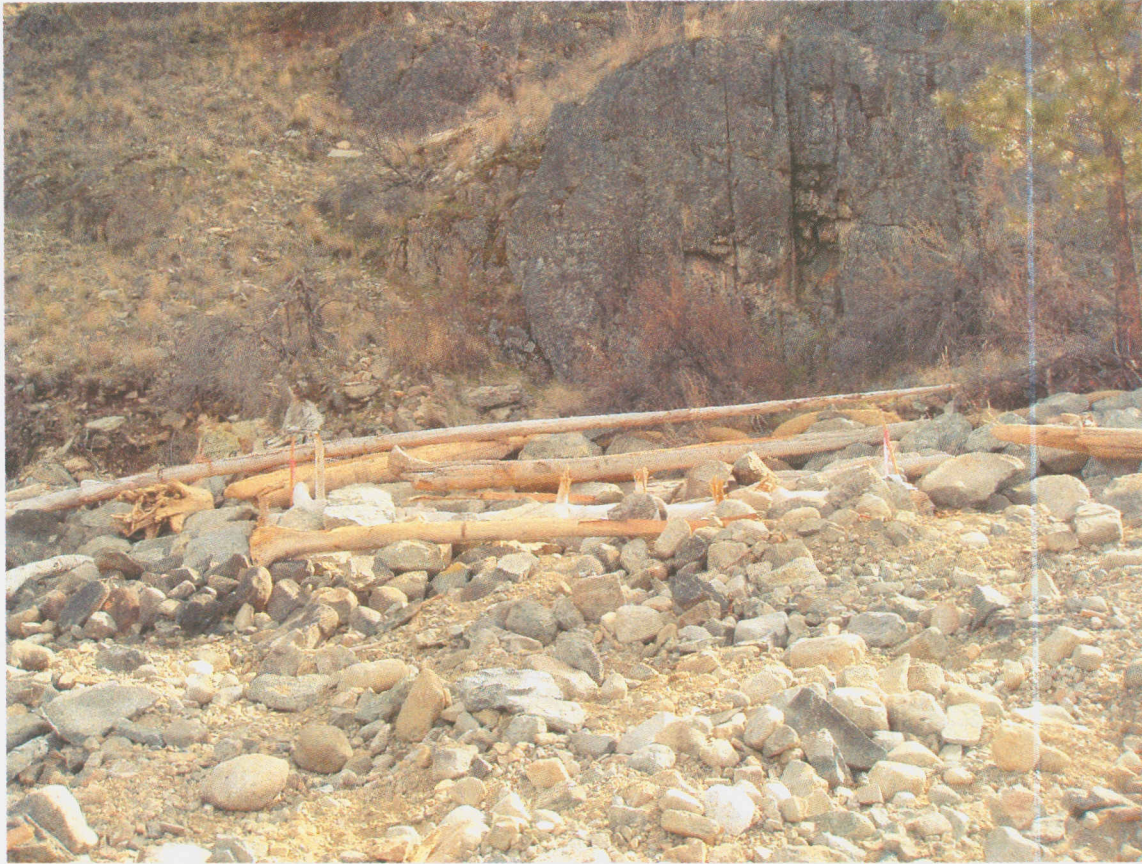
(LWD #2)

This shows a shoreline view of LWD # 2 (ends are at orange stakes) the piece is down at 1099 feet of elevation and pinned under large rocks. Smaller woody debris that was not of suitable size but naturally washed up in this bay is re-distributed behind and in front of treatment with no attempt to anchor it.

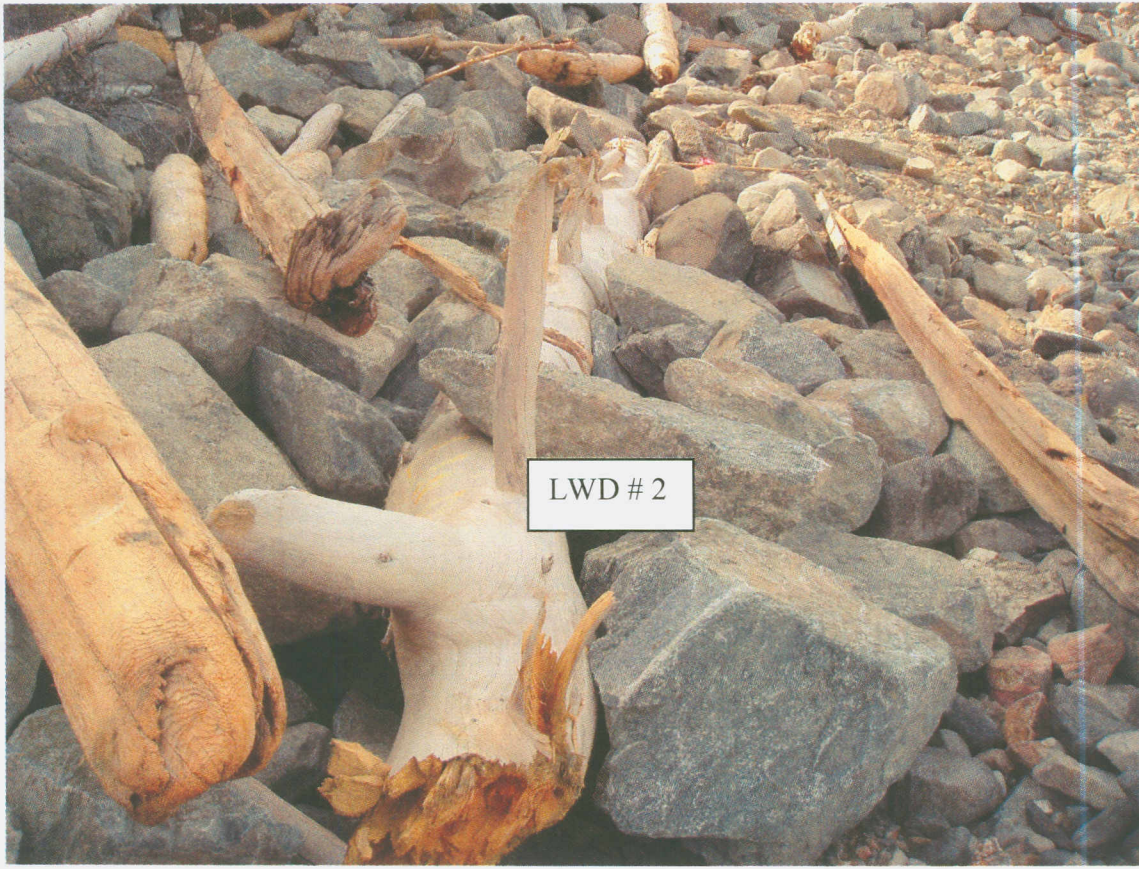
(Top view of LWD #2 pinned with rock)

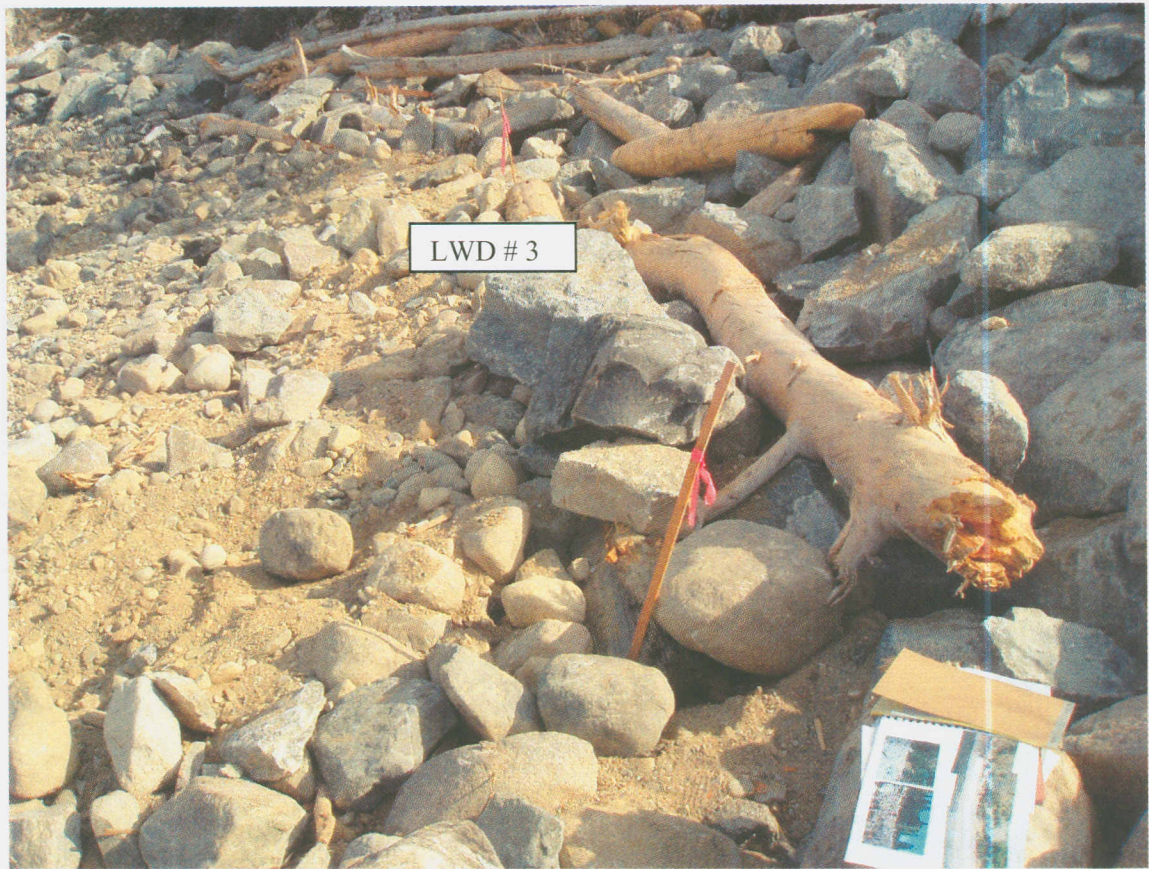
(LWD # 3 half buried at 1099 feet elevation (note close flagged lathe), 2 large and 2 med rocks pin the log, medium piece “trapped” with one pin point behind anchored LWD. This top log is not a counted mitigation piece of LWD, but still pinned. This is the beginning of treatment C a full T1 type of treatment with fabric cloth and waddles.

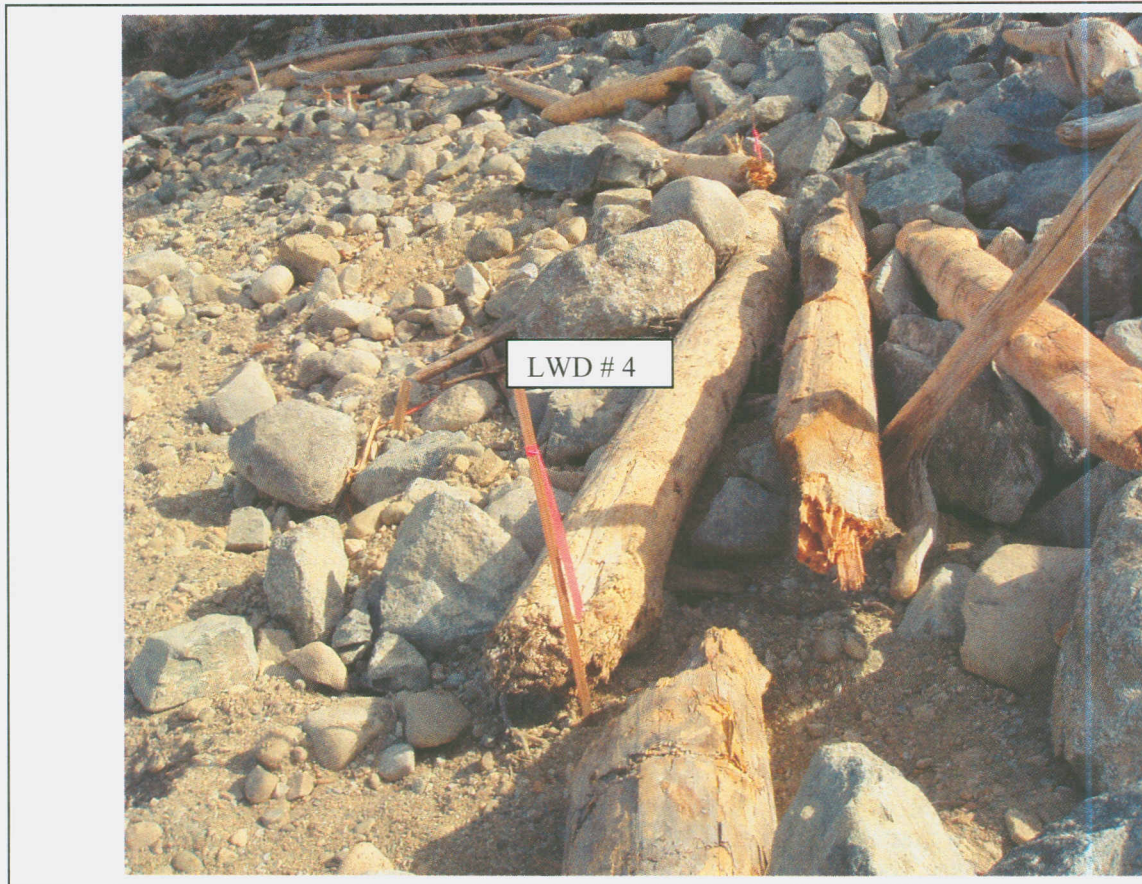
(LWD # 4) LWD #4 is between flagged stakes and pinned with 2 large rock with minor LWD placed behind anchored log. The intent here is that # 4 is anchored at 1099 feet elevation and will be under water, anchoring rock should keep minor LWD behind it but allow some movement.

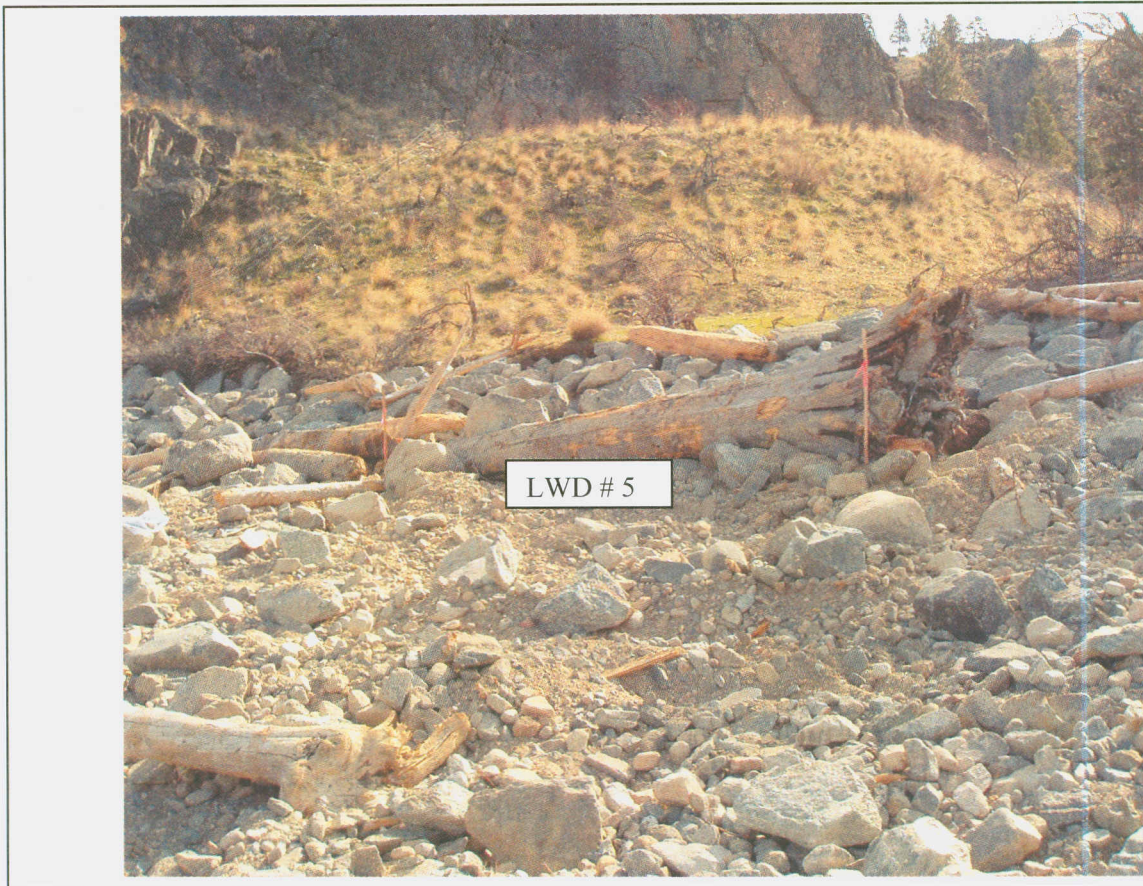
(LWD # 5) LWD #5 is one of the larger pieces of LWD it is double cabled to large rock with ½ inch stainless steel cable and epoxy cemented into rock with Hilti HY 150 adhesive. Shoreline texture of this area was deliberately left rough to mimic original conditions recorded in the 1999 survey photographs CD31 FR 13 and CD 31 FR14.

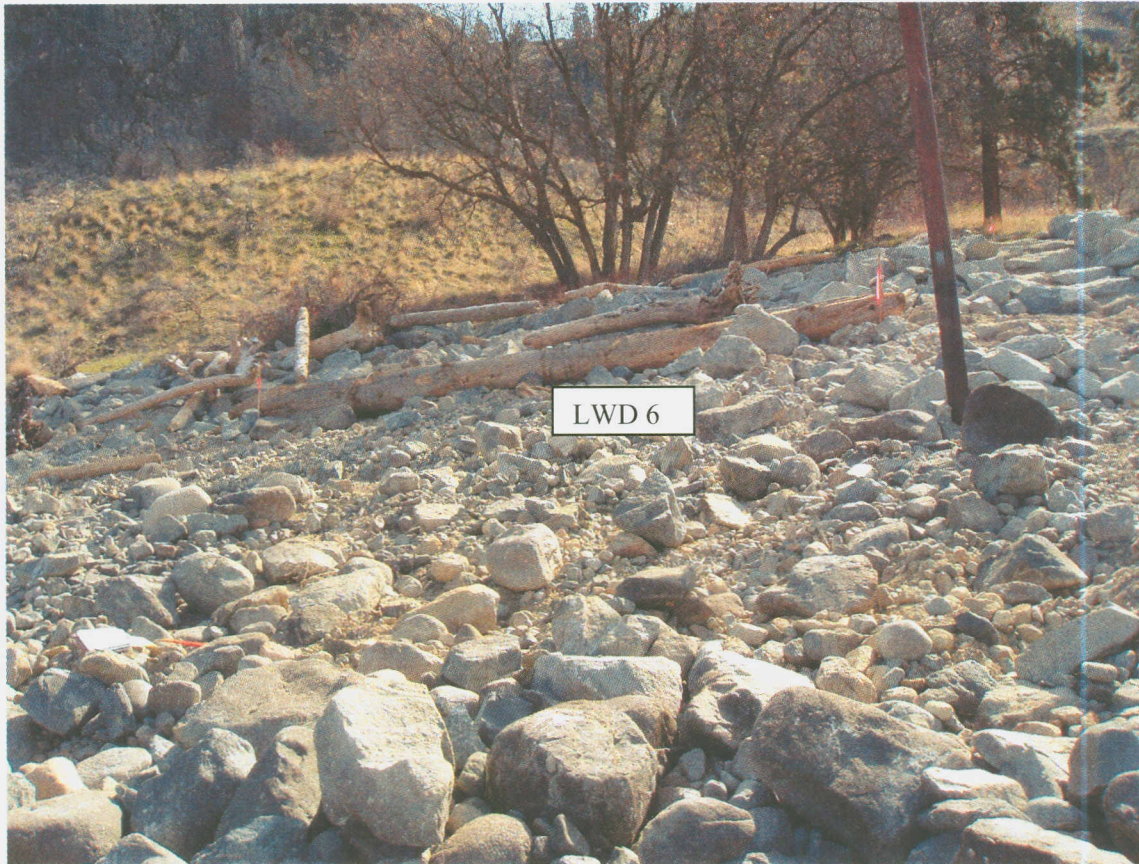
(LWD # 6) LWD # 6 (between flagged stakes) is a large 30 foot x 18 inch diameter tree bole that is double rocked and double cabled to rocks it is at the very toe of the treatment approximately 1098.5 -1099. Feet of elevation. Smaller woody debris has been placed on top of treated area to help naturalize the site with scattered pieces of “beached” wood. Recreational rock steps (B1) from the upland campsite are right of the old historic steel piling in the photograph.

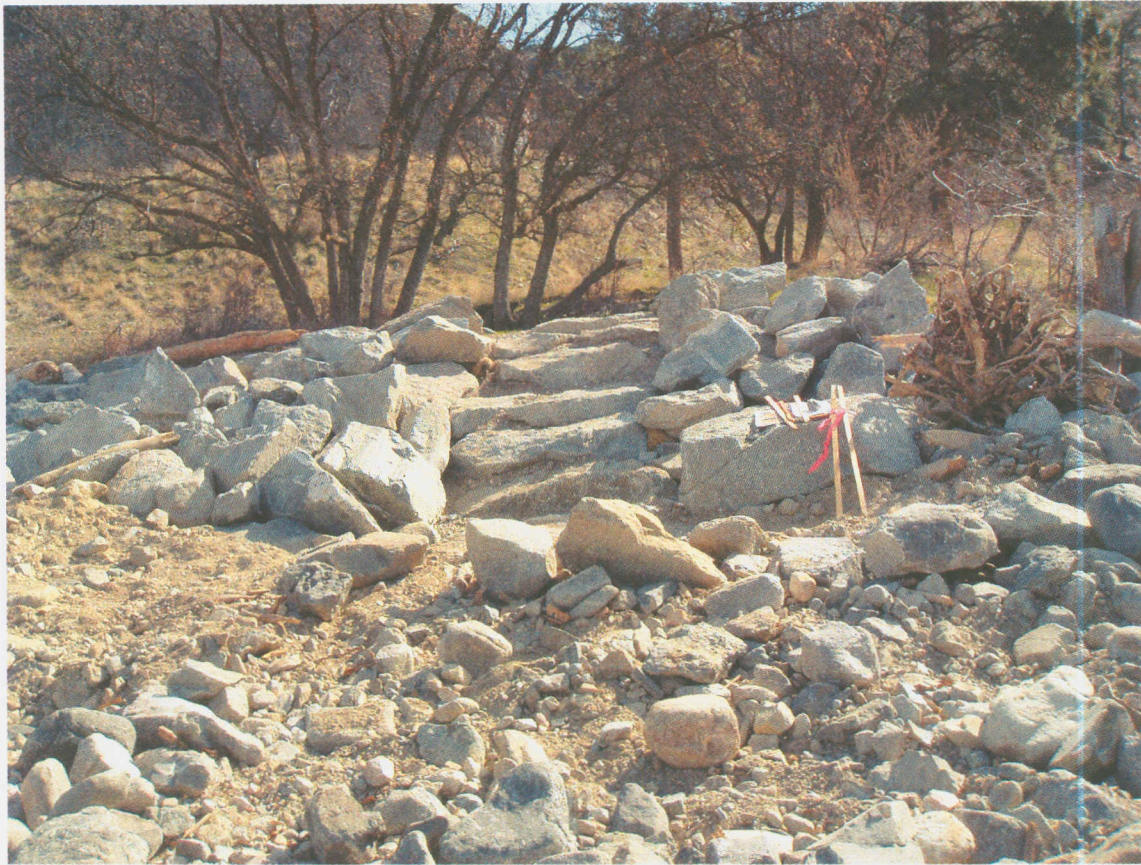
(Treatment B1) Rock steps for recreational access to water, treatment zone C1 ends at root wad right of the lathe and flagging. Large 4-5 foot relatively flat rock was used to create recreational access path.

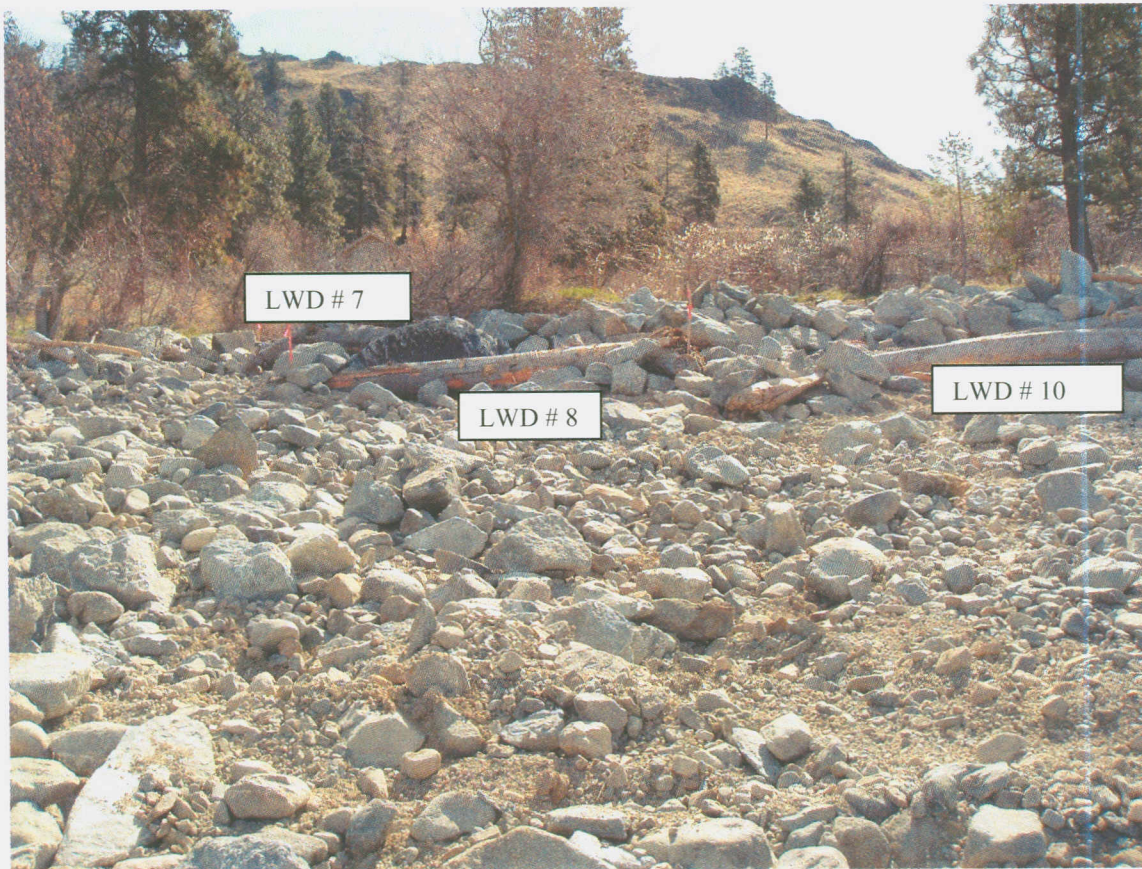
(LWD # 8 front with pink flagged lathe, and LWD # 7 behind, beach view)
Both LWD pieces are cabled with LWD # 7 partially buried below 1100 Feet elevation.
LWD # 8 is at 1099 approximately top of log. This is treatment zone D1 planned as a
single large rock with LWD treatment, however due to having additional rock available

we choose to improve and beef up this treatment area. Note large blackish rock behind LWD # 8.

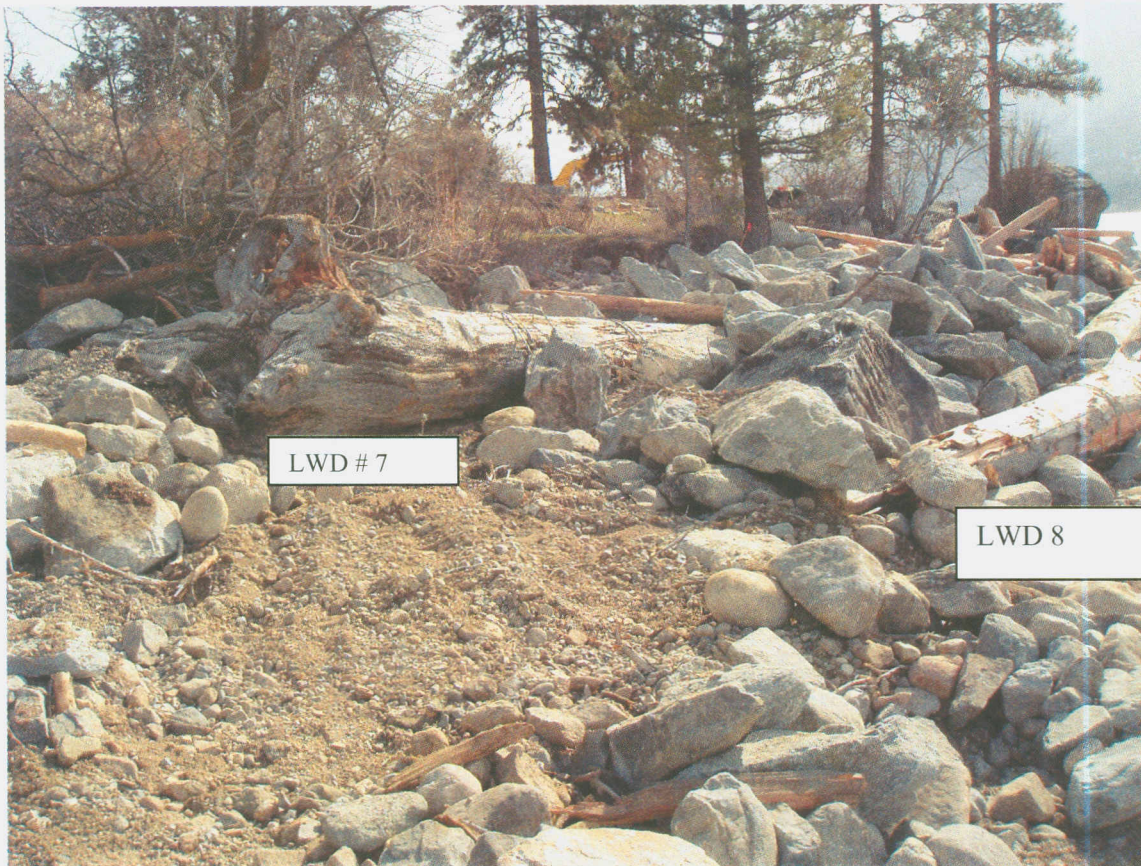
(LWD #7 and #8 side view)

This picture shows double cables on piece #7 (behind large black rock) and rock pinning downlake end. LWD piece # 8 is partially buried with rock on the buried end, with cable on the downlake end.

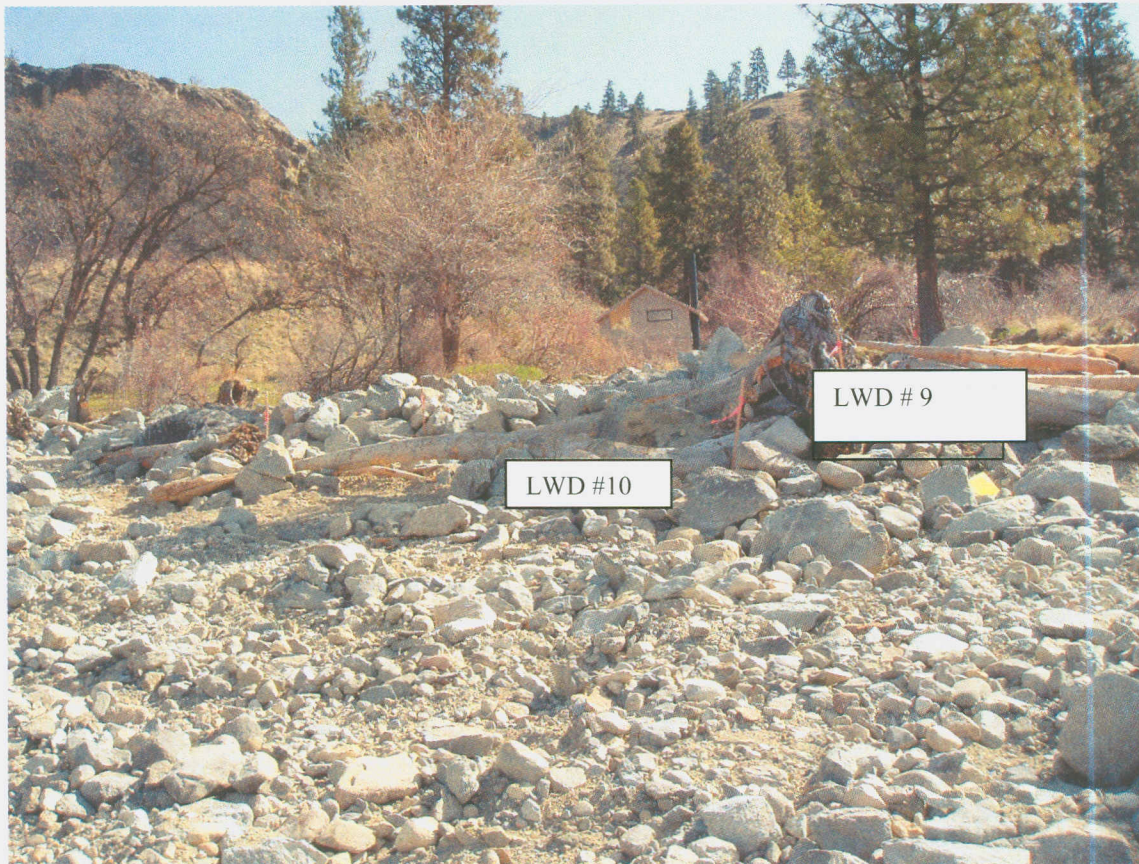
(LWD #10 foreground and LWD # 9 with large root wad)

Both left ends of these logs are partially buried LWD #10 is buried under the root wad of # 8. Rocks on top of and cables are used on both pieces of LWD. This is still treatment zone D1. LWD pieces # 11 and 12 are located behind # 9's large root wad.

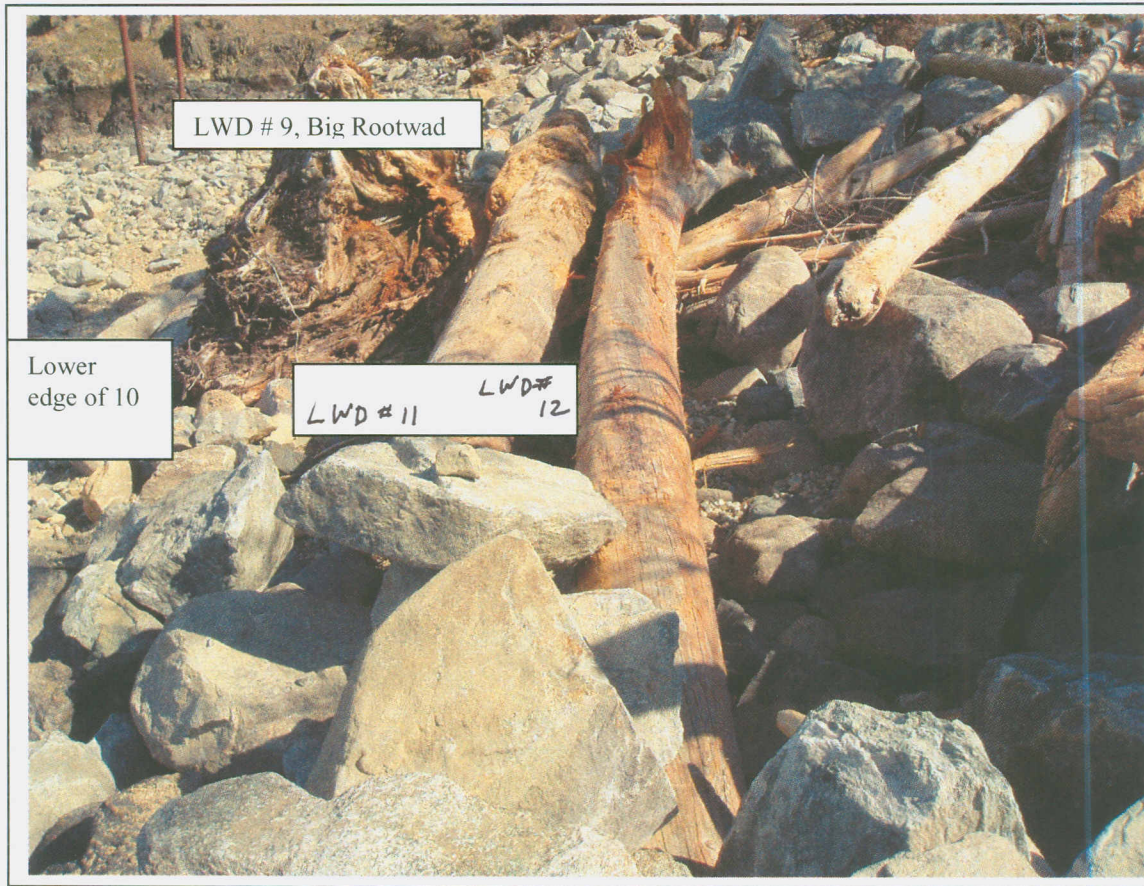
(LWD # 11 and 12)

These pieces of LWD have rock placed on top of the down lake end and are trapped behind the large root wad of LWD # 9.

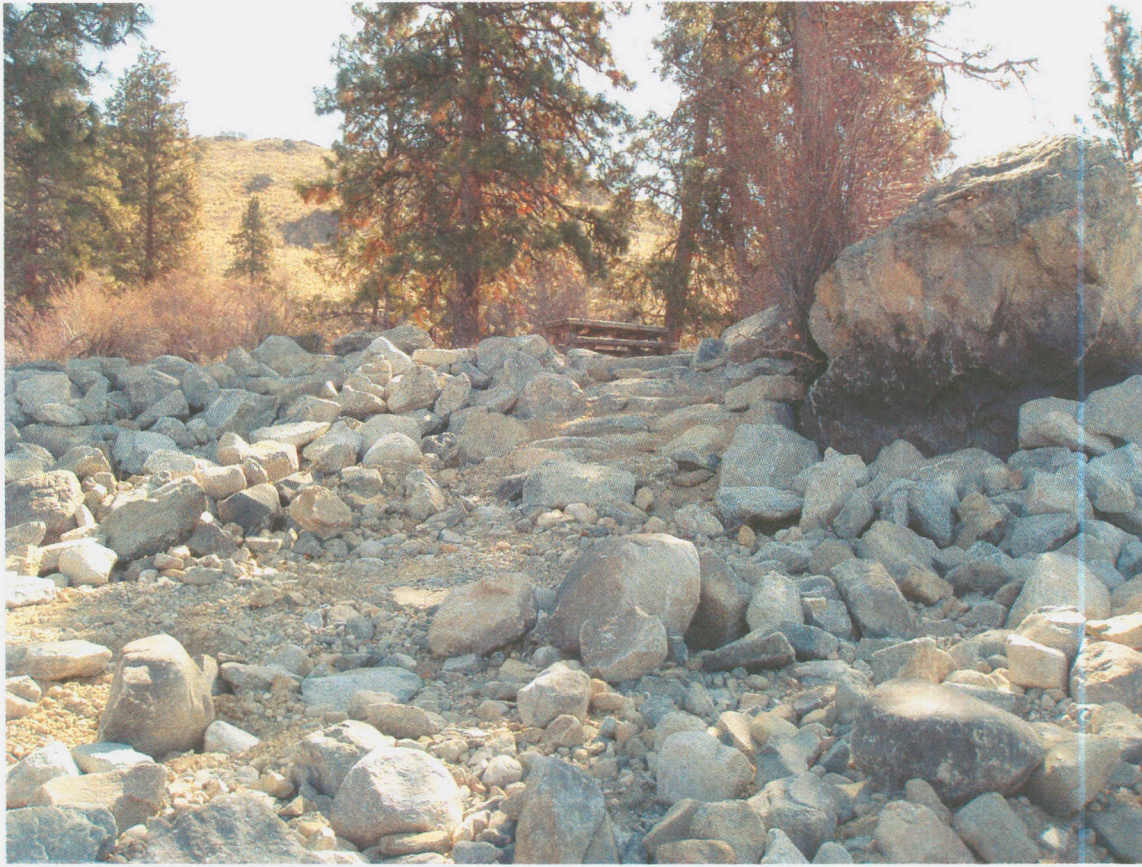
(B2 Recreational Rock Steps)

This photograph shows treatment zones C2 and B2, C2 is the full treatment left of the steps. At the base of the large point rock is approximately 40 yards of surplus rock for additional repairs should they be needed.

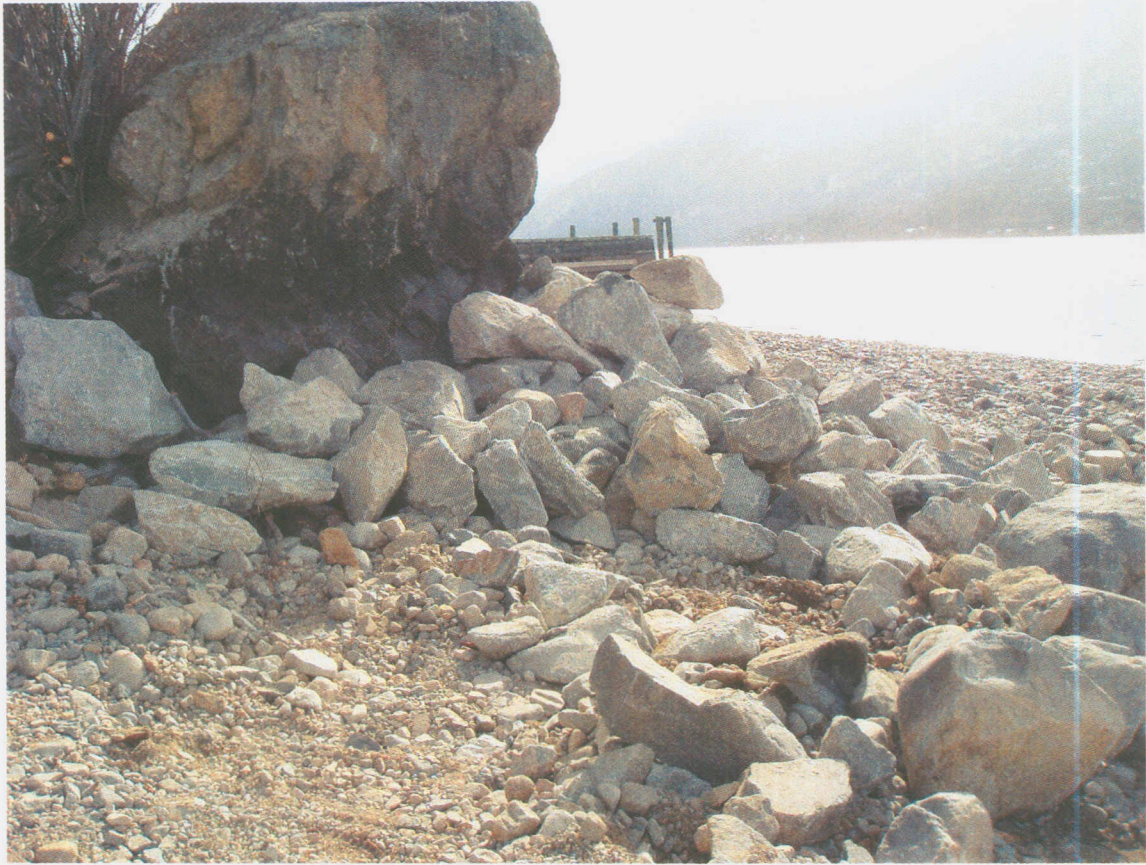
(Side view of surplus rock)

Site C3 full treatment continued on the other side of the rock for 17 feet.

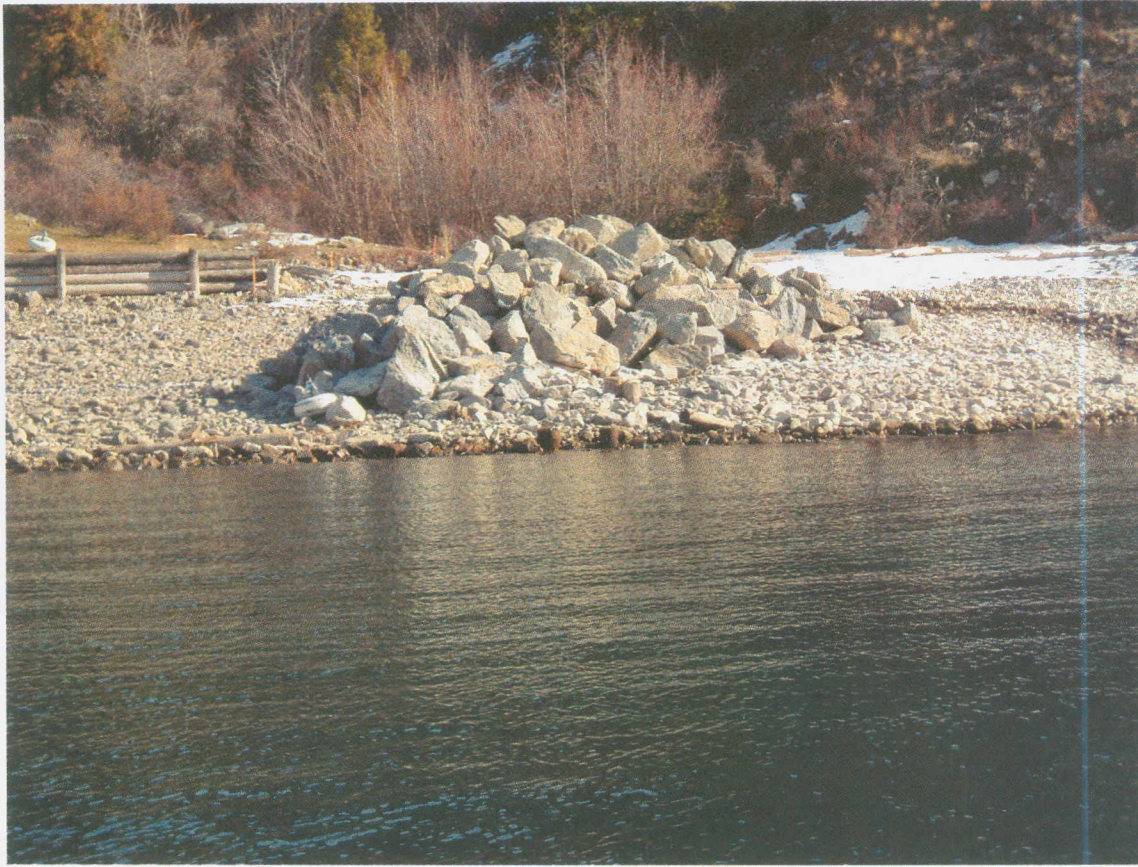
Approximately 190 tons of pre-placed rock for treatments D2 – E2, for treating 148 feet of erosion control repair.

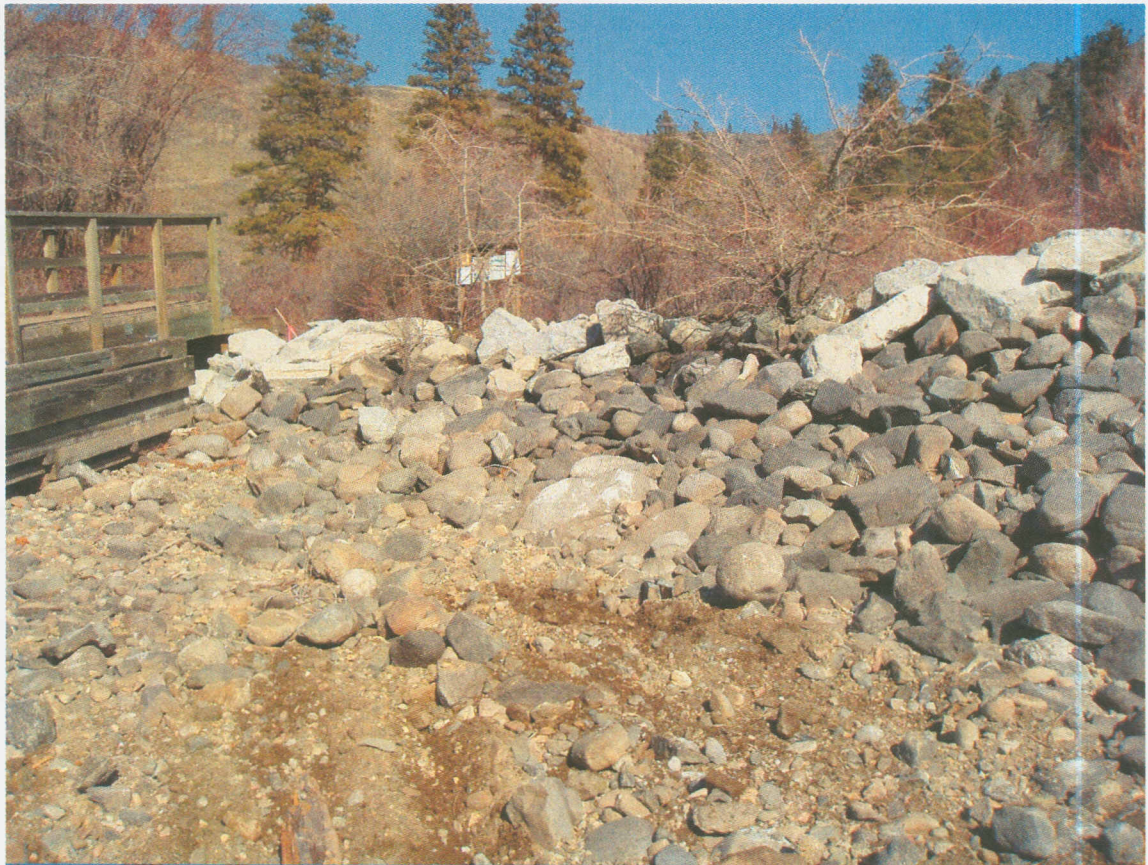
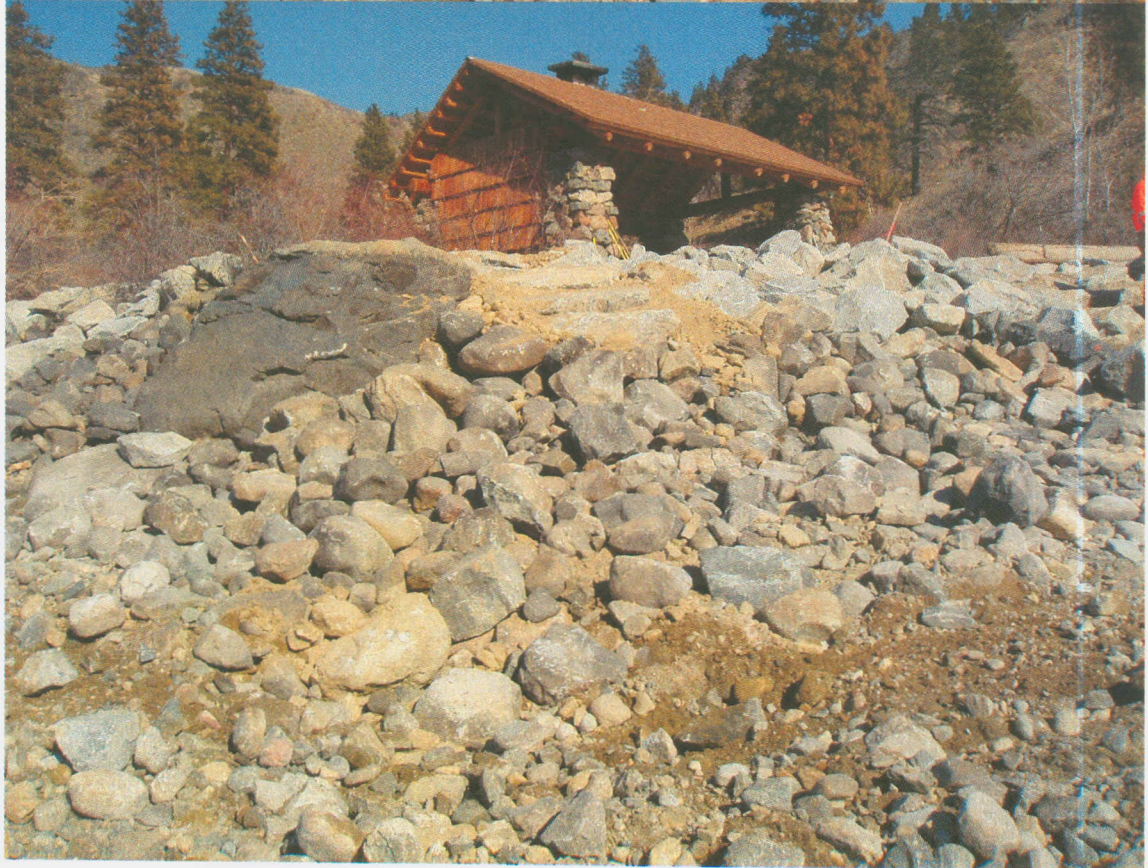
Top photo is approximately 20 feet of spot rock treatment in area D2.

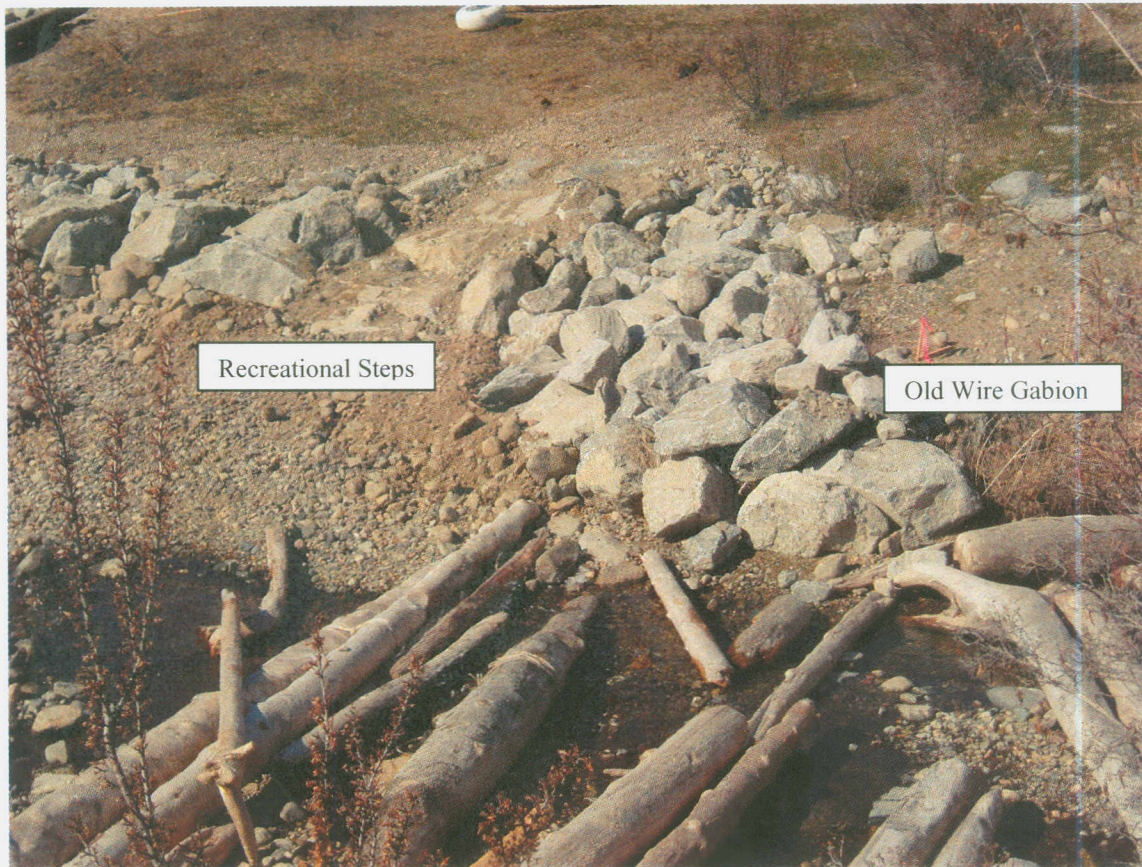
B5 recreational steps leading from Mitchell Shelter area to Lake Chelan and Mitchell Creek. Rock next to creek to pink flagged lathe is rock over exposed wire basket gabion from 1980's

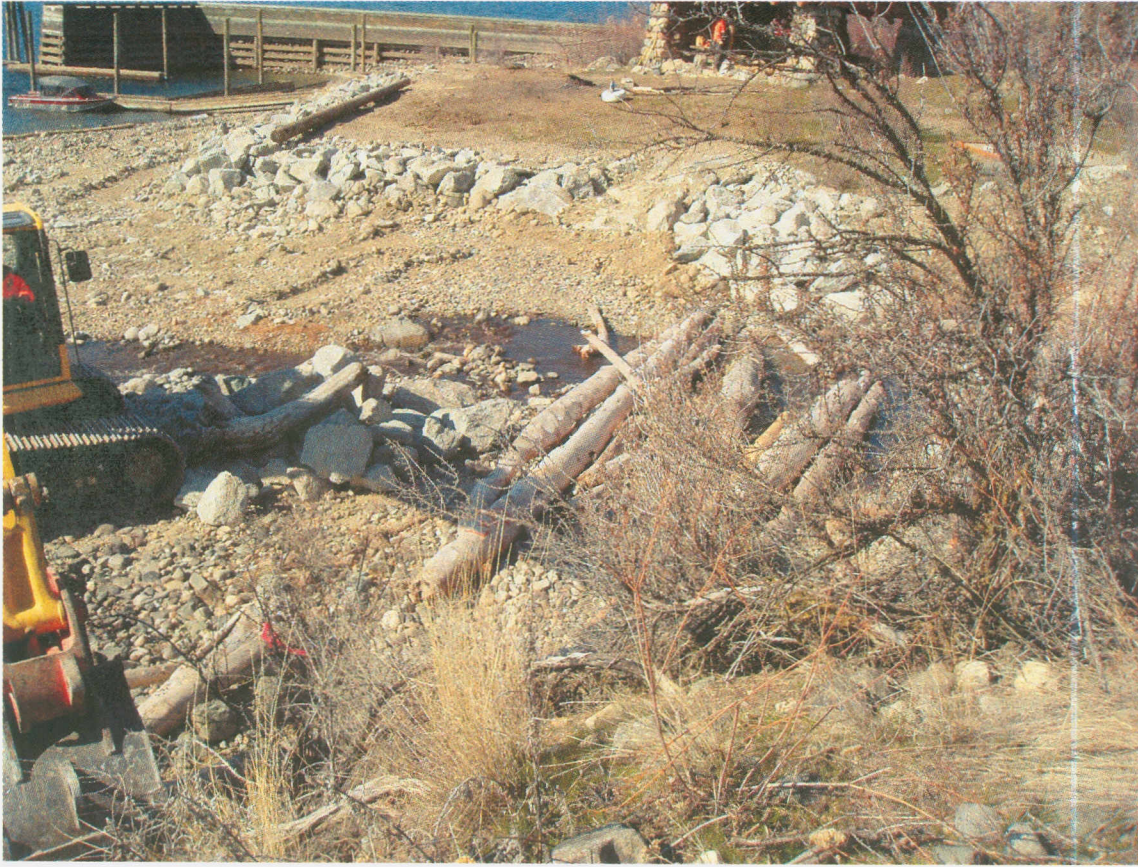
Top view of treated area around Mitchell Creek Shelter.
