Draft for 1st Quarter Report Example 4/8/09

Chelan Ranger District
Mitchell Creek Campground
Erosion Control Treatment Site 59
2009

Site 59 is the first erosion site treated under the Lake Chelan Hydroelectric Project No.637-022, under Article 401. The treatment followed the site specific plans for this site filed November 7, 2007 by Chelan PUD with the Federal Energy Regulatory Commission's (FERC) for approval of the Erosion Control Implementation and Erosion Monitoring and Maintenance Plan (Erosion Control treatment Plans) and the Site-Specific Erosion Control Plan (Site-Specific plan for site 59). On December 14, 2007, FERC issued the Order approving these plans.

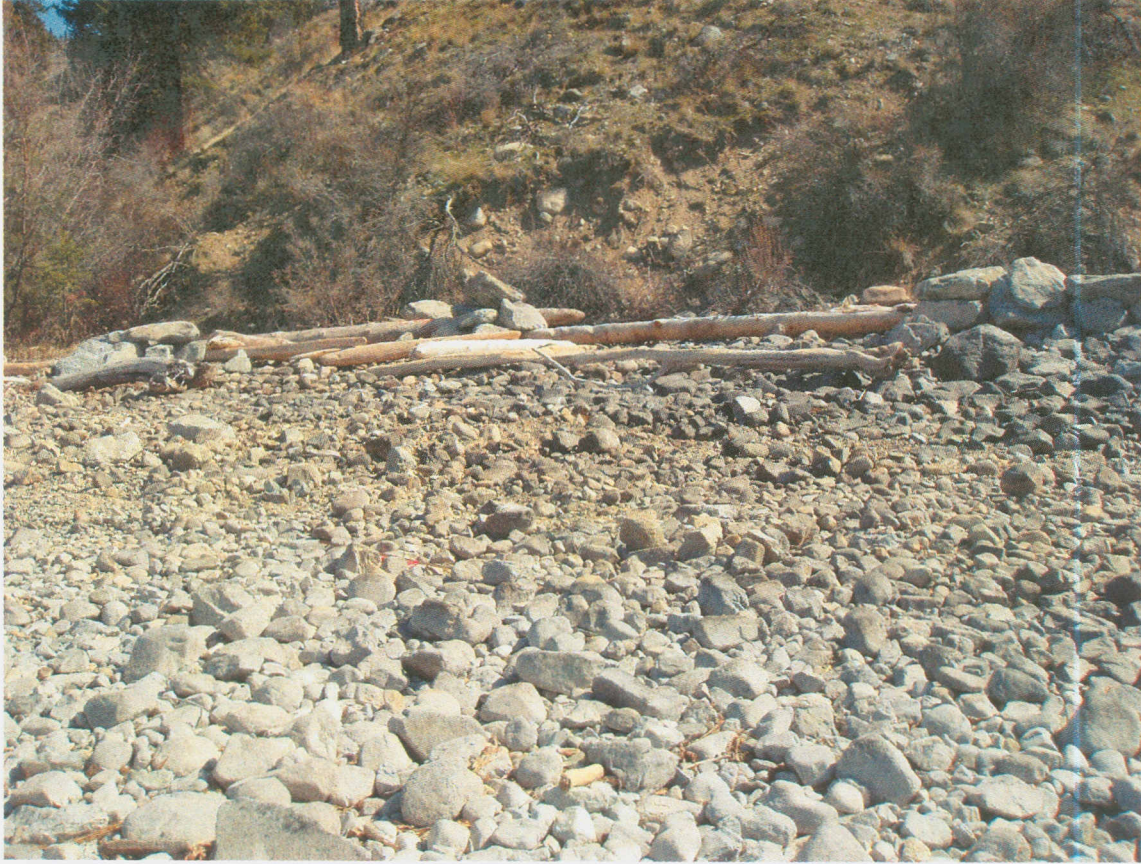
(LWD # 13 and # 14)

These pieces of LWD are down lake of Mitchell Creek. They are anchored by rock piles over the LWD.

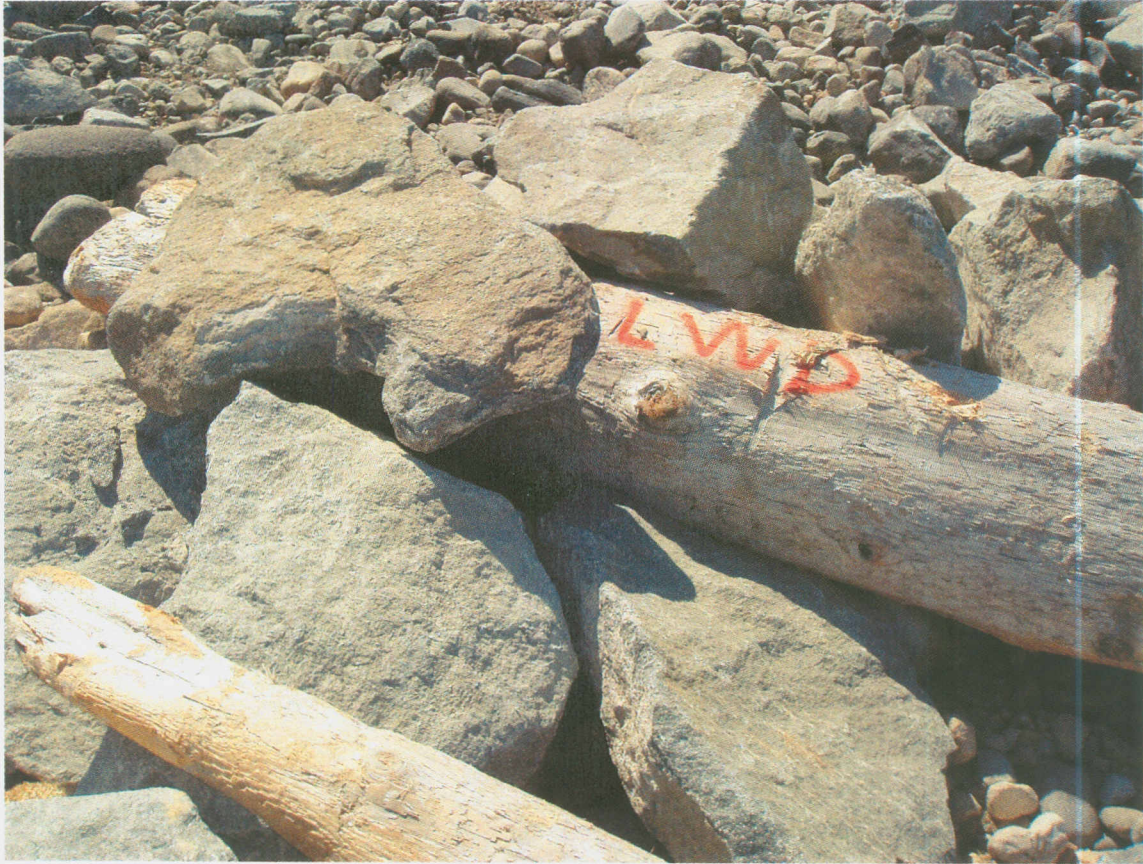
Upper end of LWD # 13 anchored with large single rock on top of LWD.

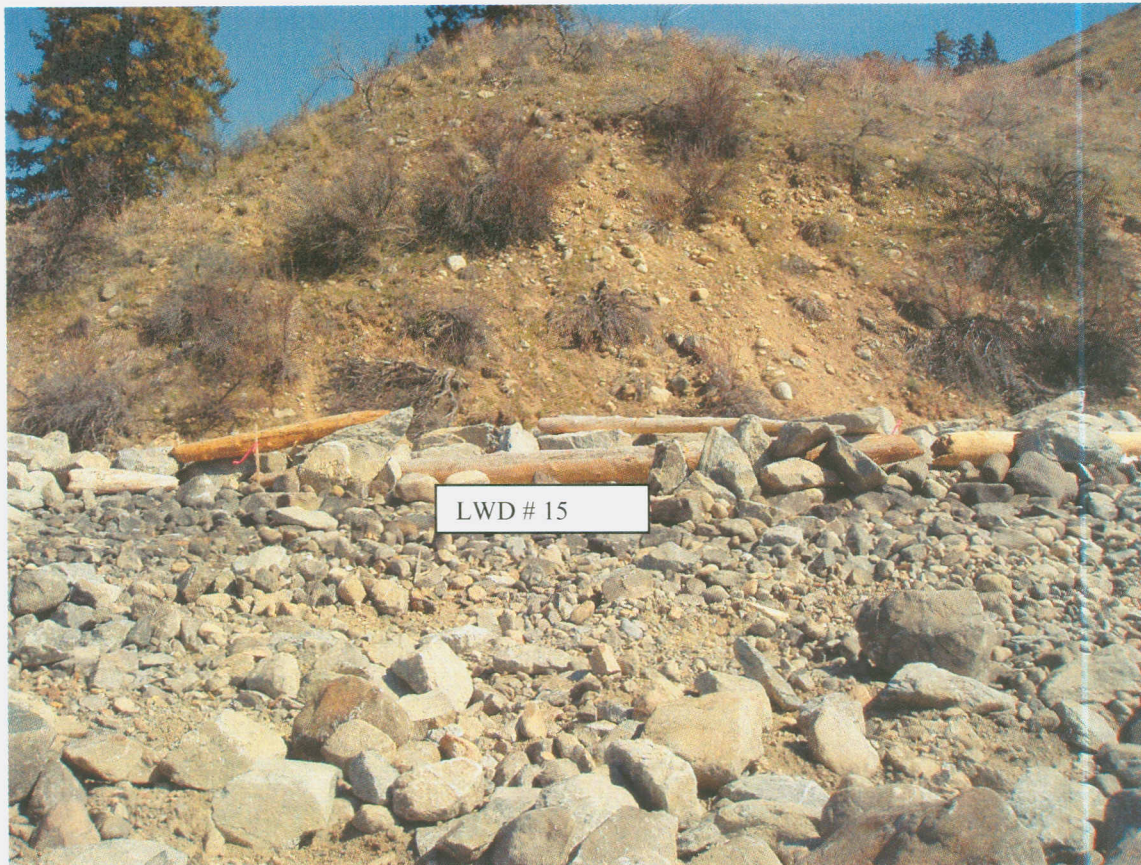
(LWD # 15)

LWD # 15 is anchored by two large piles of rock. Treatment areas F and G approximately 66 feet are treated with a double row of rock and this one large anchored piece of LWD. Despite having extra rock the decision was made to stay with the two forms of proposed treatments.

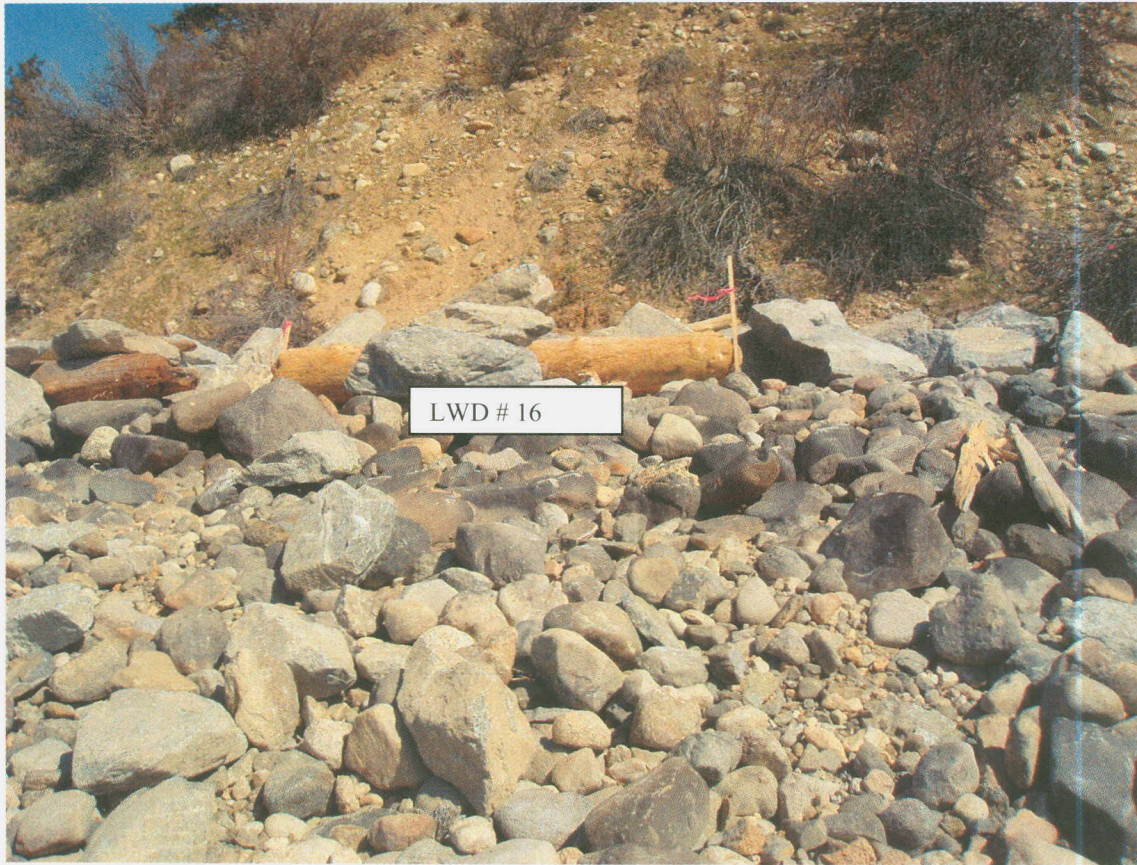
(LWD # 16)

LWD # 16 is anchored by a large single rock centered on top of the log between two other large rocks.

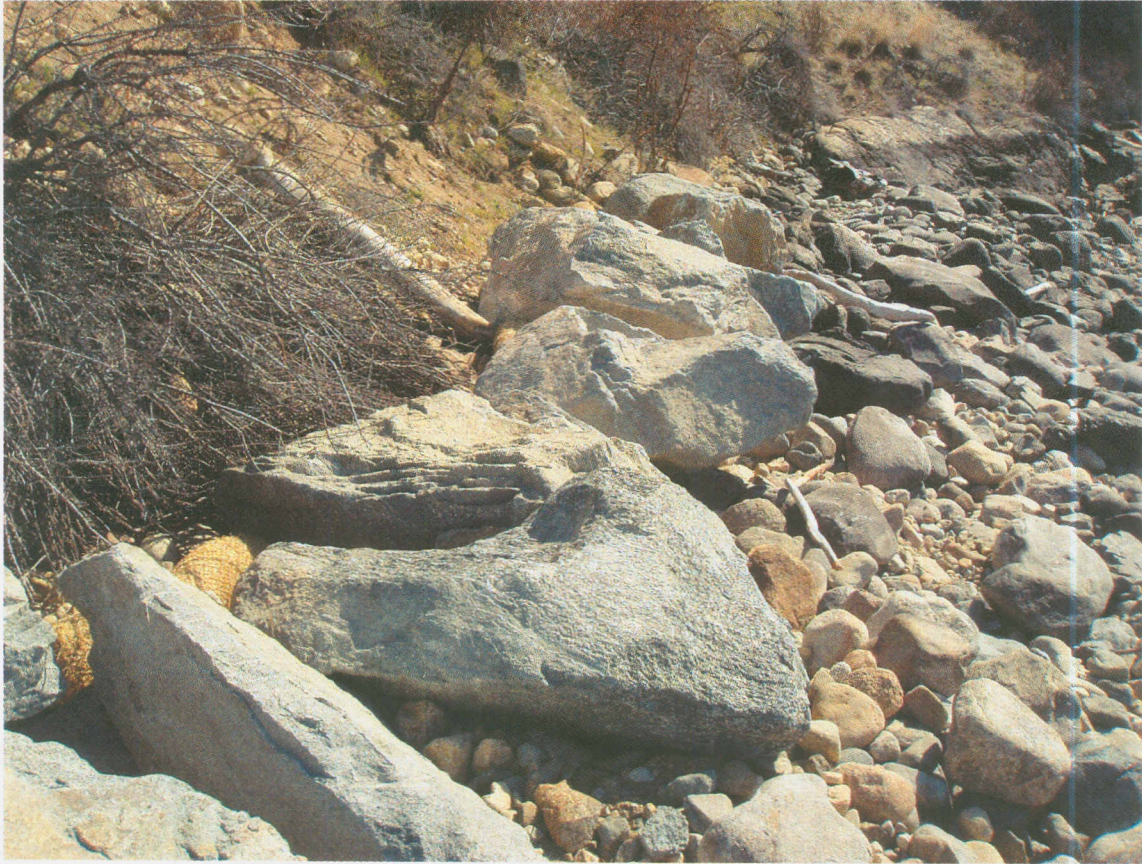
Mitchell Creek site 59 end of treatment, F1 single rock treatment.

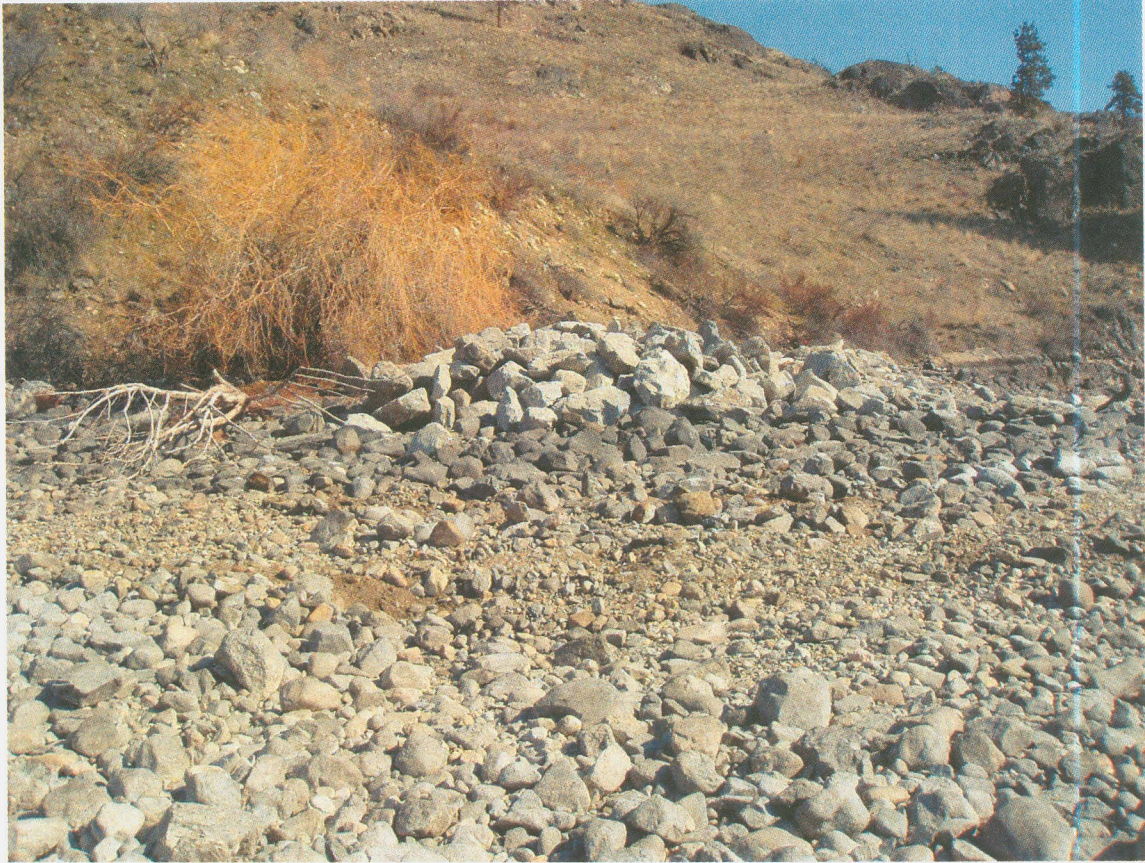
Storage location of rock to beef up future treatments approximately 45 yds.
