Enclosed are two reports for the 2008-2009 erosion control work done on Lake Chelan under US Army Corps of Engineers (USACE) permit number NWS 2007 1652 CRC by the Forest Service. A certificate of compliance has been mailed to the USACE and copies of the report validating all required Large Woody Debris anchored and placed per WDFW agreement.

Chelan Ranger District
Deer Point Campground
Erosion Control Treatment Site 58 Report
2009

Site 58 is the second erosion site treated under the Lake Chelan Hydroelectric Project No.637-022, under Article 401. The treatment followed the site specific plans for this site filed November 7, 2007 by Chelan PUD with the Federal Energy Regulatory Commission's (FERC) for approval of the Erosion Control Implementation and Erosion Monitoring and Maintenance Plan (Erosion Control treatment Plans) and the Site-Specific Erosion Control Plan (Site-Specific plan for site 58). On December 14, 2007, FERC issued the Order approving these plans.

Chelan Ranger District
Mitchell Creek Campground
Erosion Control Treatment Site 59 Report
2009

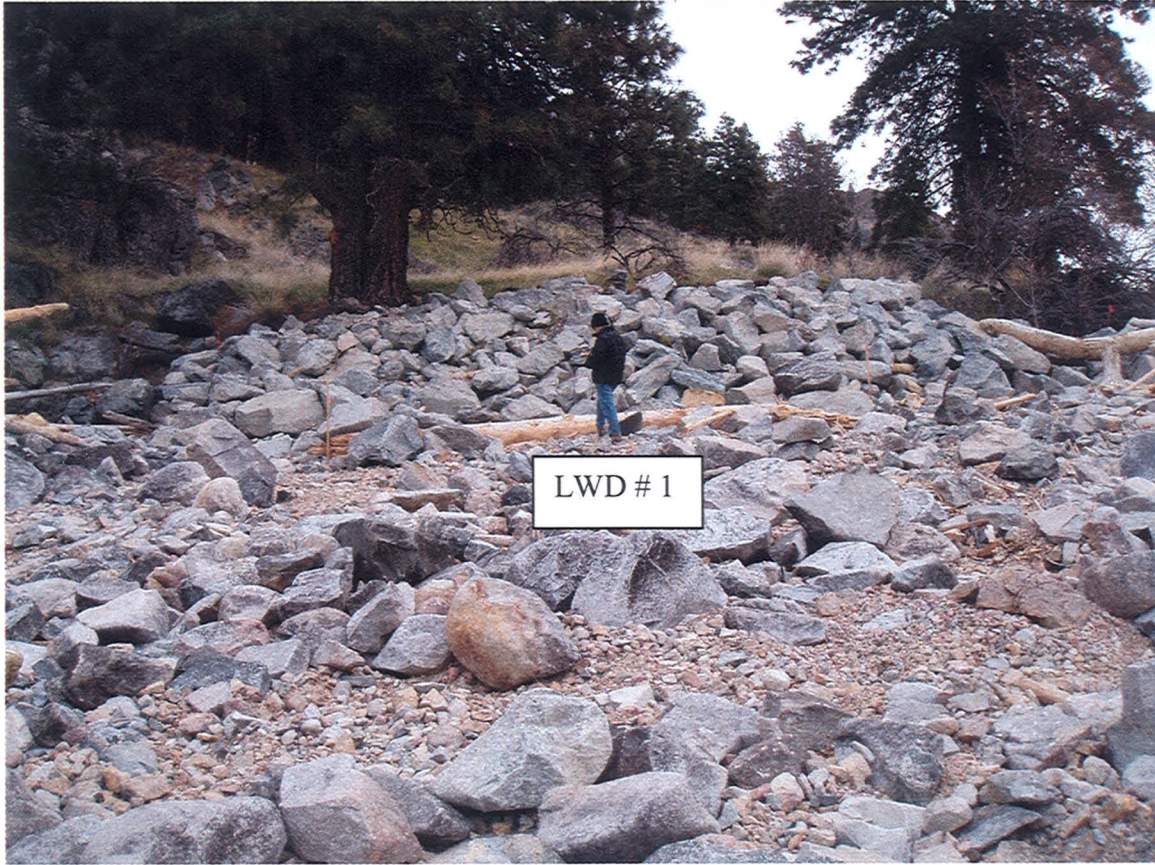
Start of treatment area A1a (50 feet) enhanced placed rock with LWD in foreground anchored with rock piles.

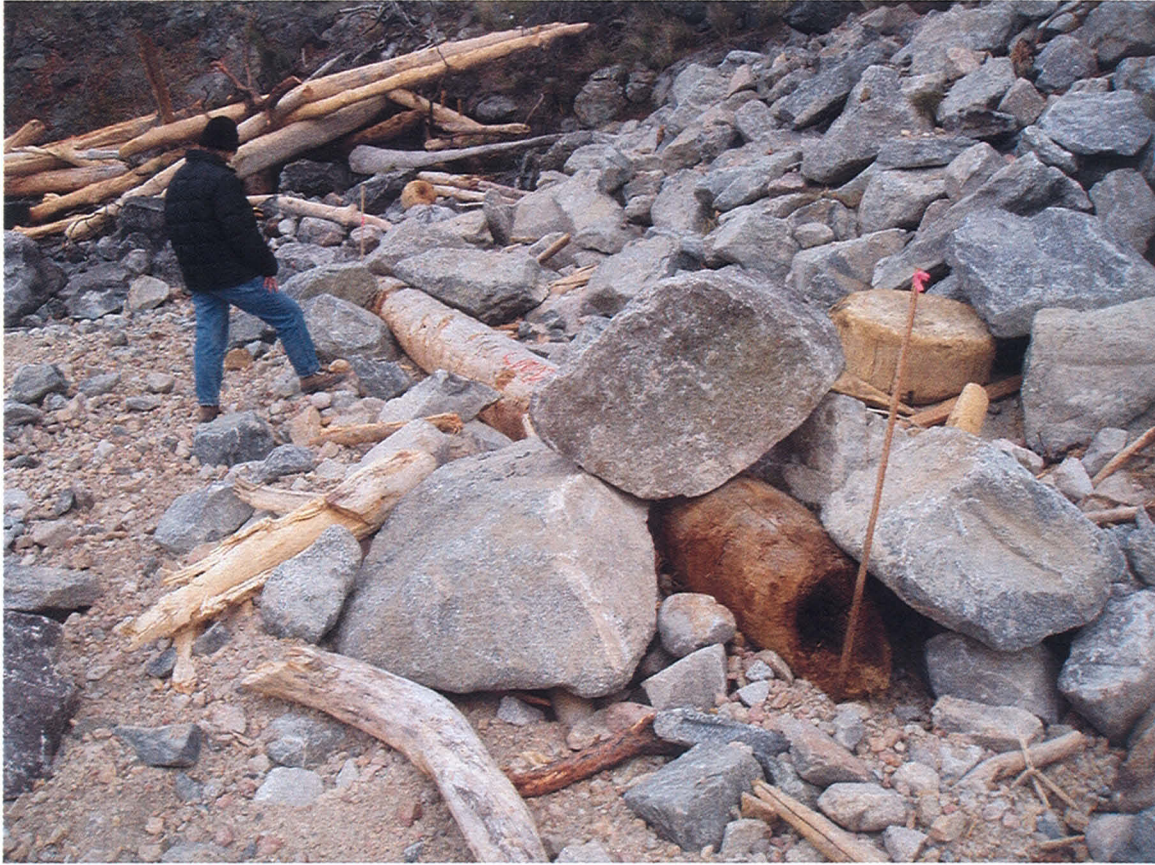
LWD #1 side view showing large rock piles used to anchor LWD. Natural smaller woody debris randomly piled left of treatment.

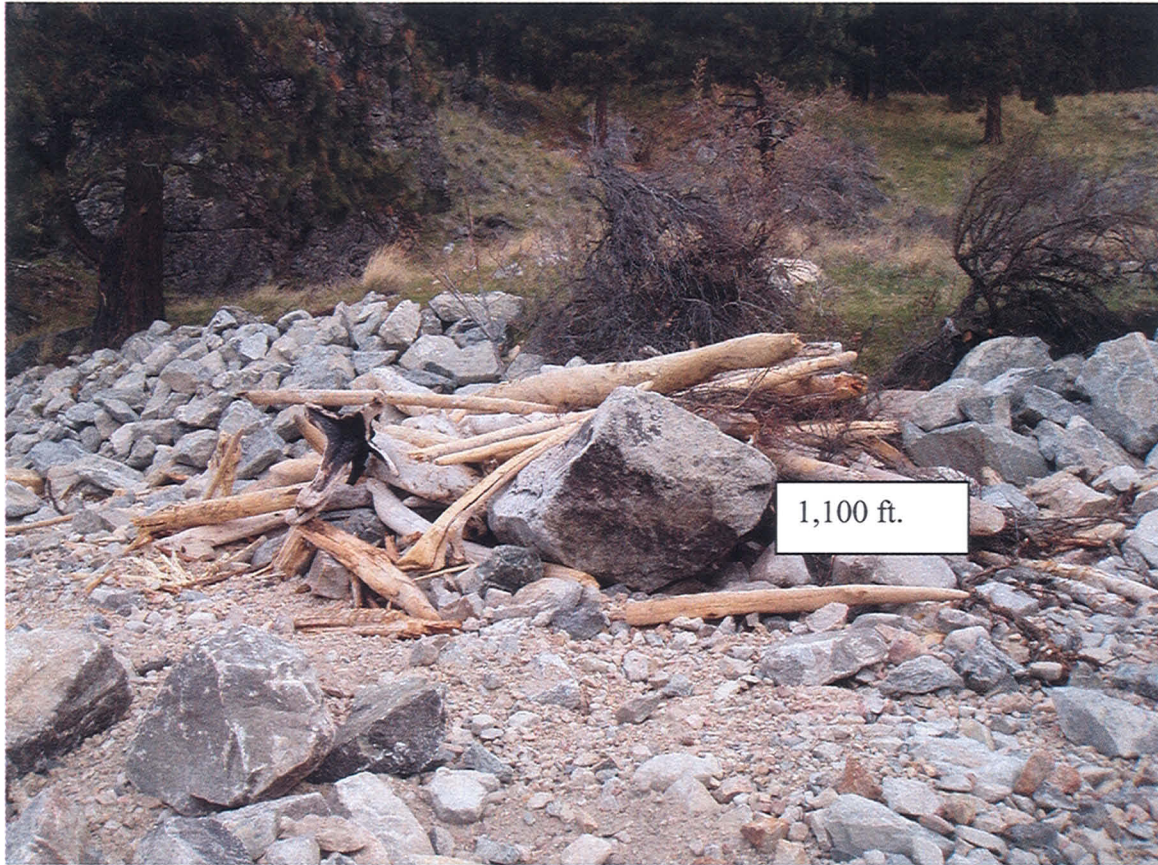
Minor area between treatments A1a and A1b approximately 12 feet of existing larger rock filled with minor woody debris from shoreline. Existing large rock shows approximate level of 1100 feet lake elevation.

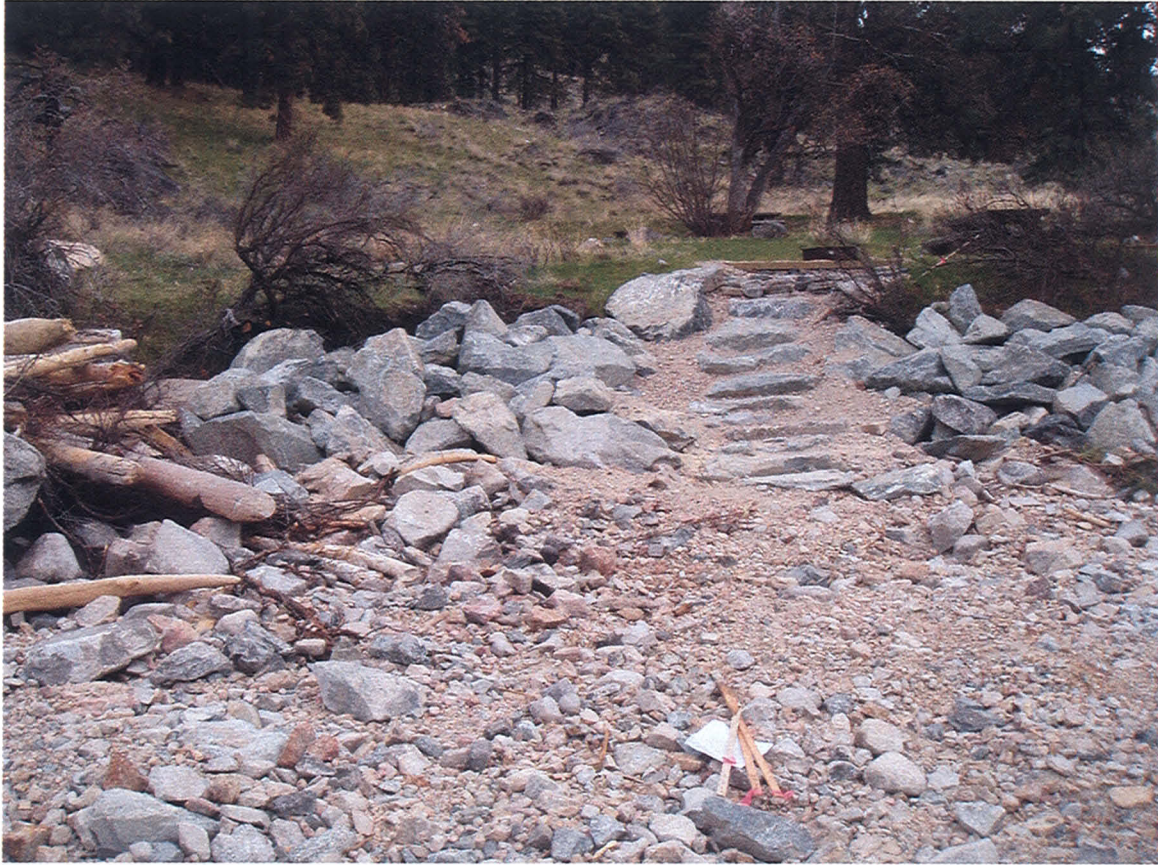
Deer Point recreational steps (B1 contract reference) with treatments A1b left of steps and treatment A1c right. Natural smaller woody debris left on site behind large existing rock (far left of picture).

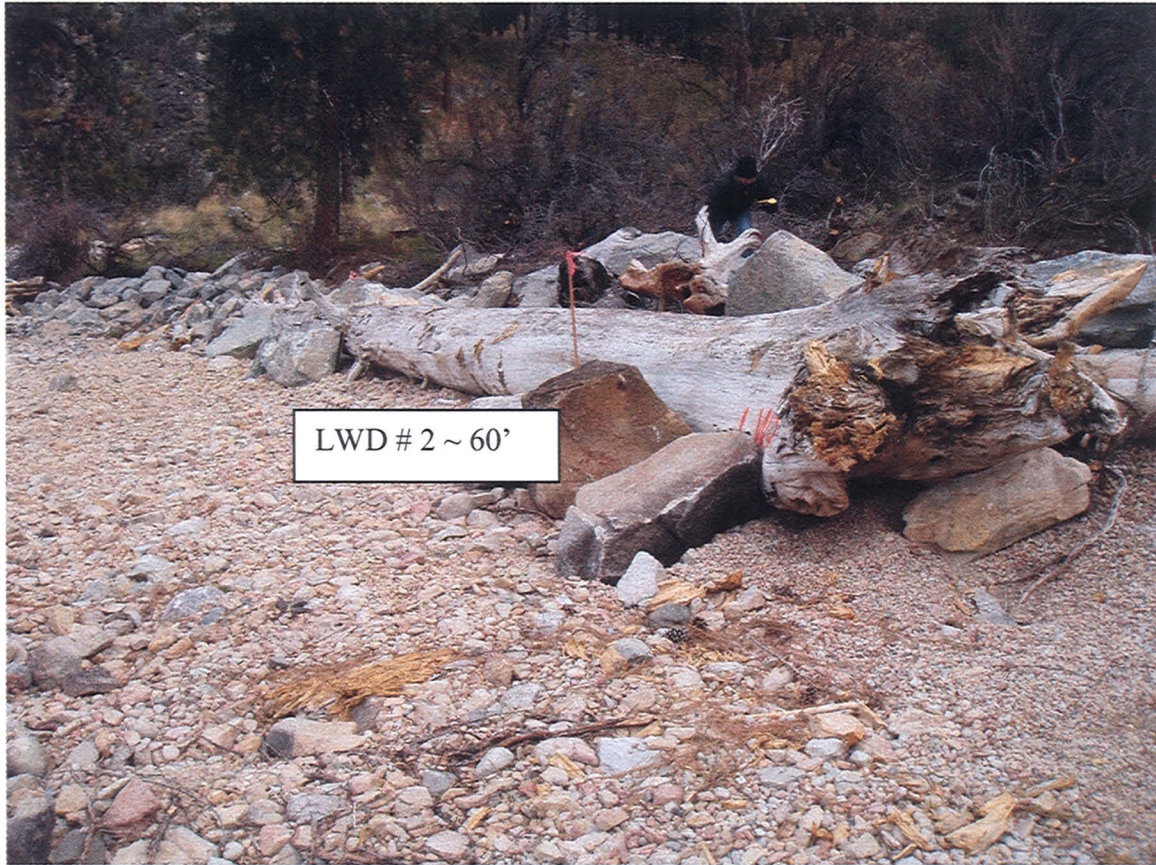
This is a north looking view of LWD #2 in the foreground from the down-lake butt end of the log. The person in the picture is collecting GPS point # 3 on top of LWD # 3.

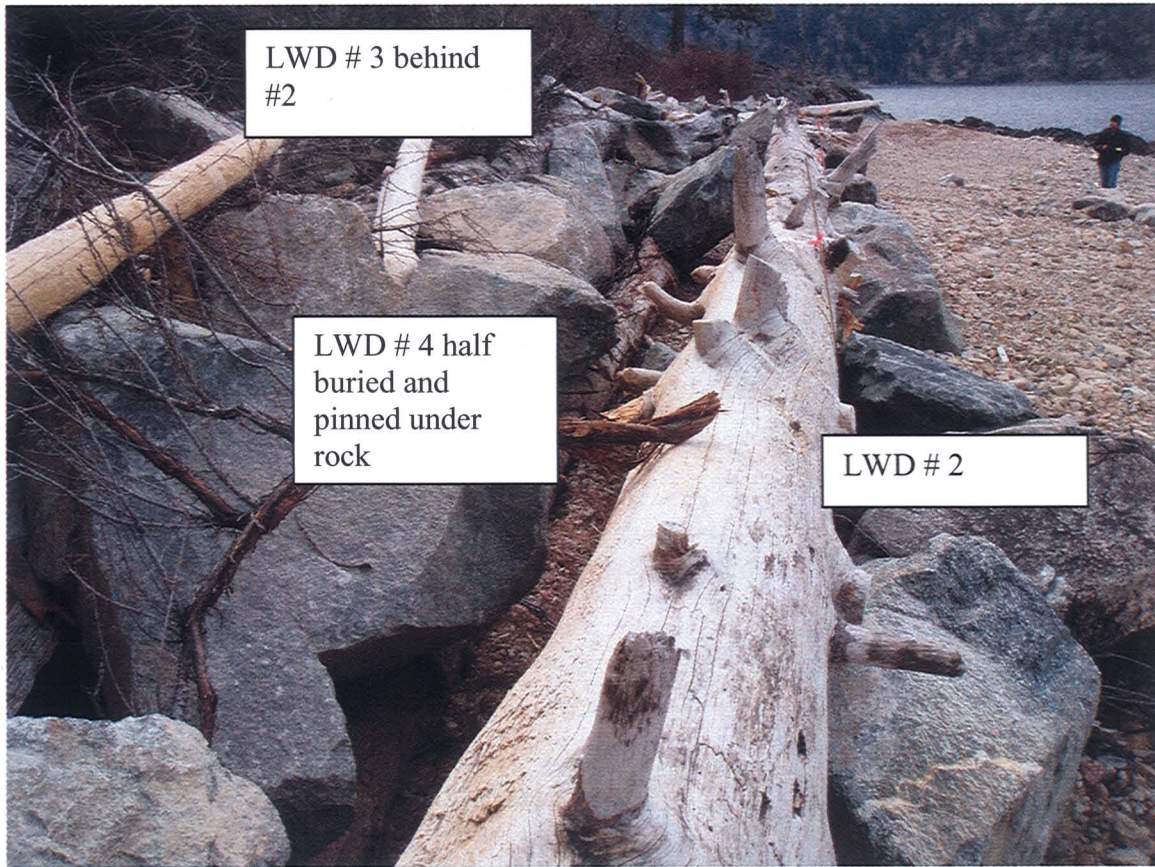
This view looking south shows the uplake end of LWD #2 pinned with multiple rocks. Treatment is double row of placed rock with LWD for approximately 80 feet.

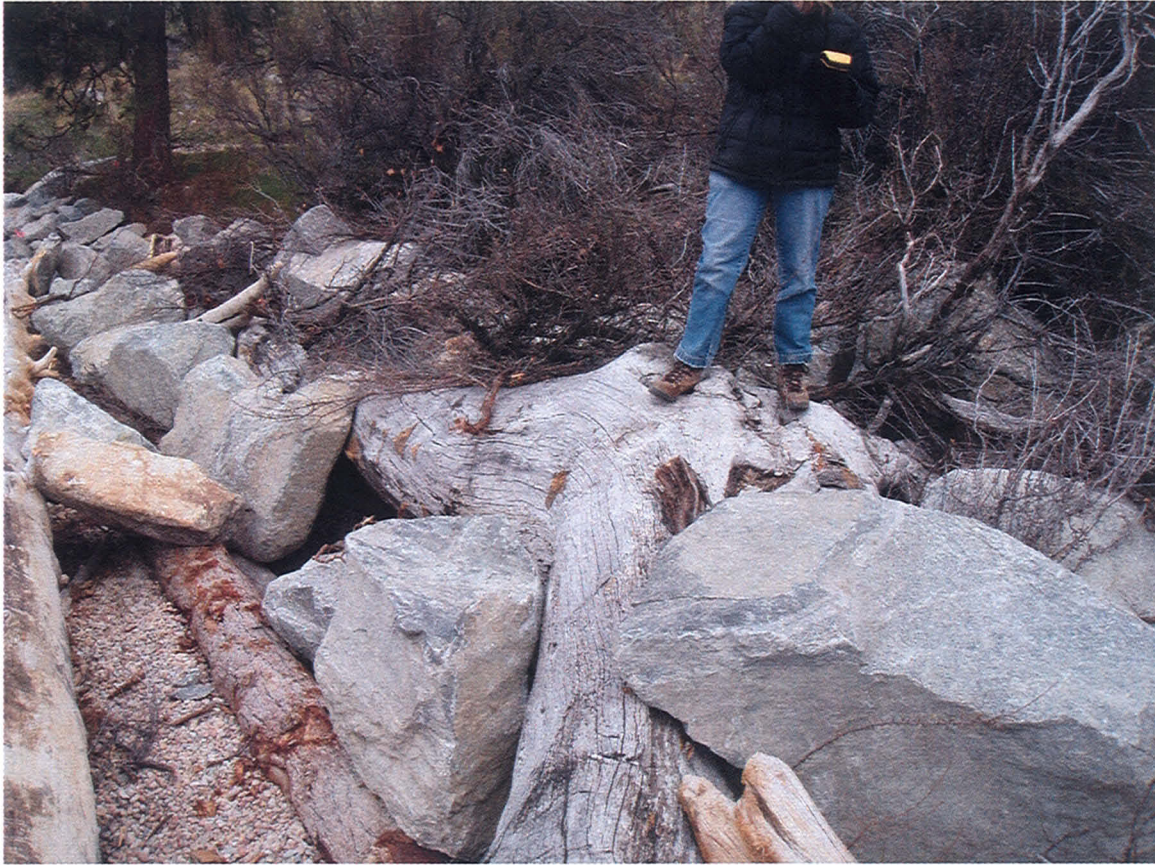
Person standing on LWD #3 while taking GPS point, photograph shows half buried LWD # 4 behind LWD # 2. This treatment blended barged in rock and existing LWD to treat a (1- 1.5 foot) under cut raw bank. Hanging bitter brush and vegetation was trimmed to allow tighter rock placement.

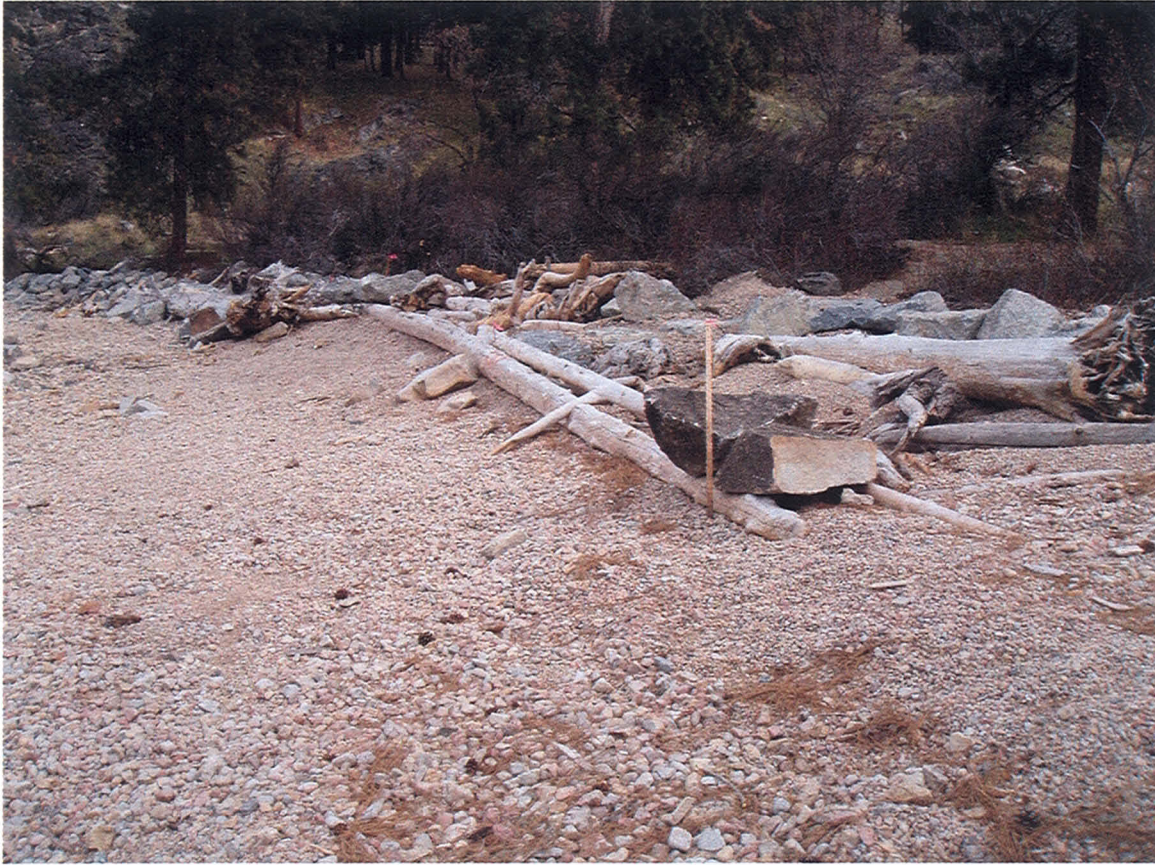
This shows LWD # 5 foreground with rock piles by end stakes, minor natural woody debris placed behind rock anchored pieces. Treatment B3 recreational steps are shown at the top of the stake.

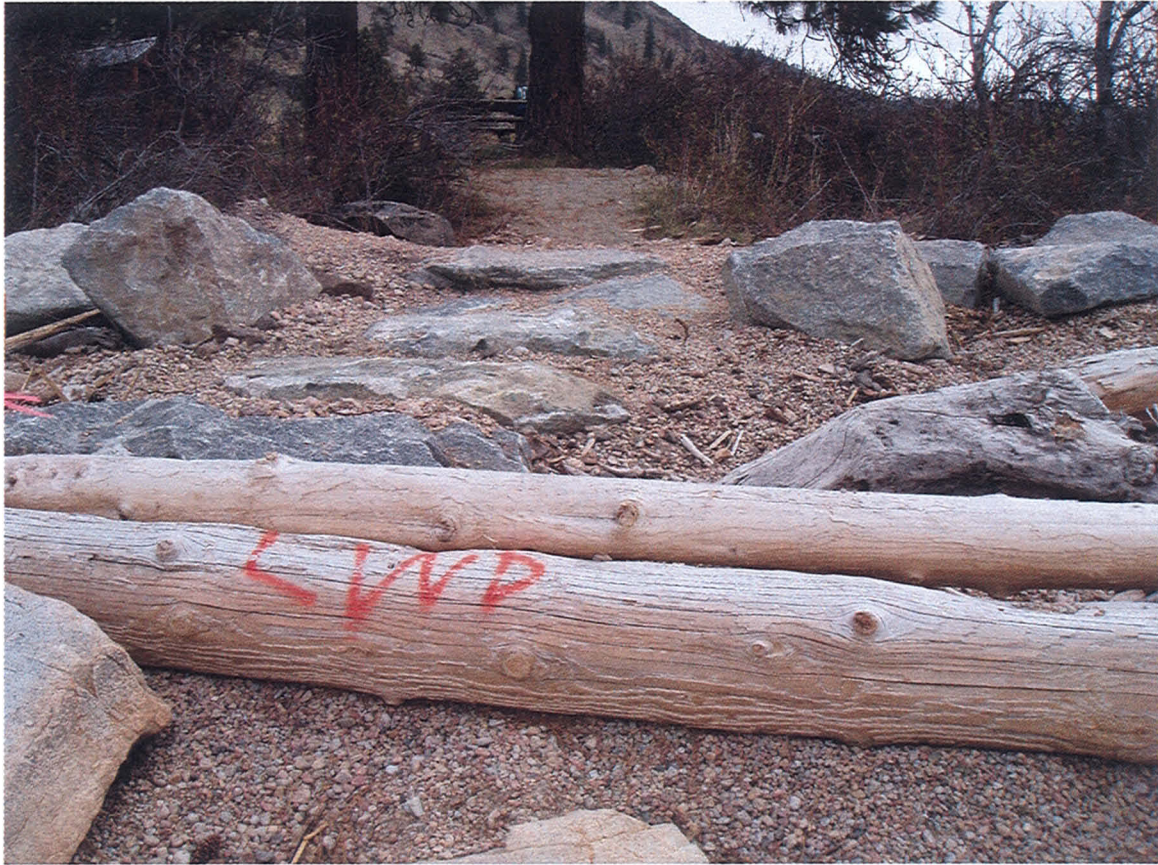
B3 recreational steps frontal view with LWD # 5, treatment right of steps changes to single rock placement with minor woody debris.

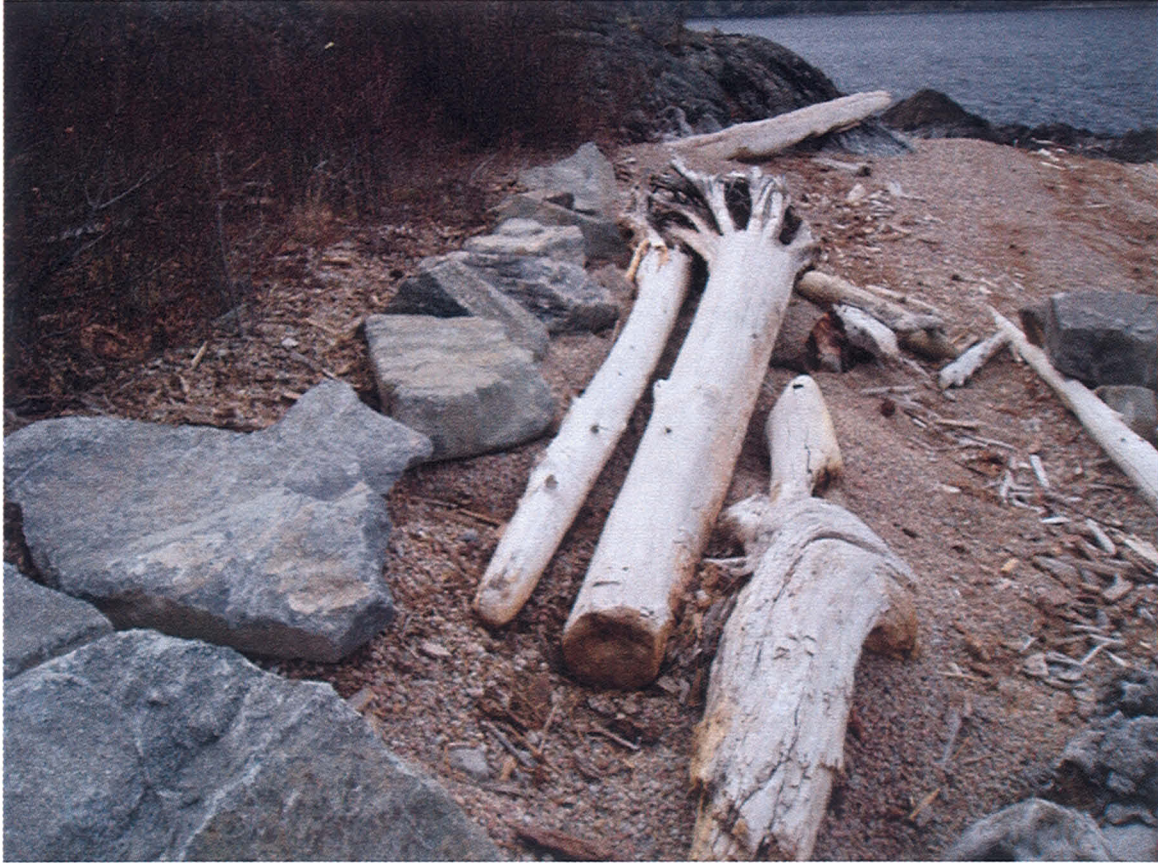
End of uplake treatment section single rock with natural woody debris. Lower end of LWD #5 has rock on top of it. Double root-wad cedar is placed at approximately 1099.7 to 1100 feet elevation. This was a borderline natural piece that did not truly meet our standard for LWD to be anchored, its placement is done so that it will naturally stay embedded in washed up gravels. This piece was not counted in our calculations.

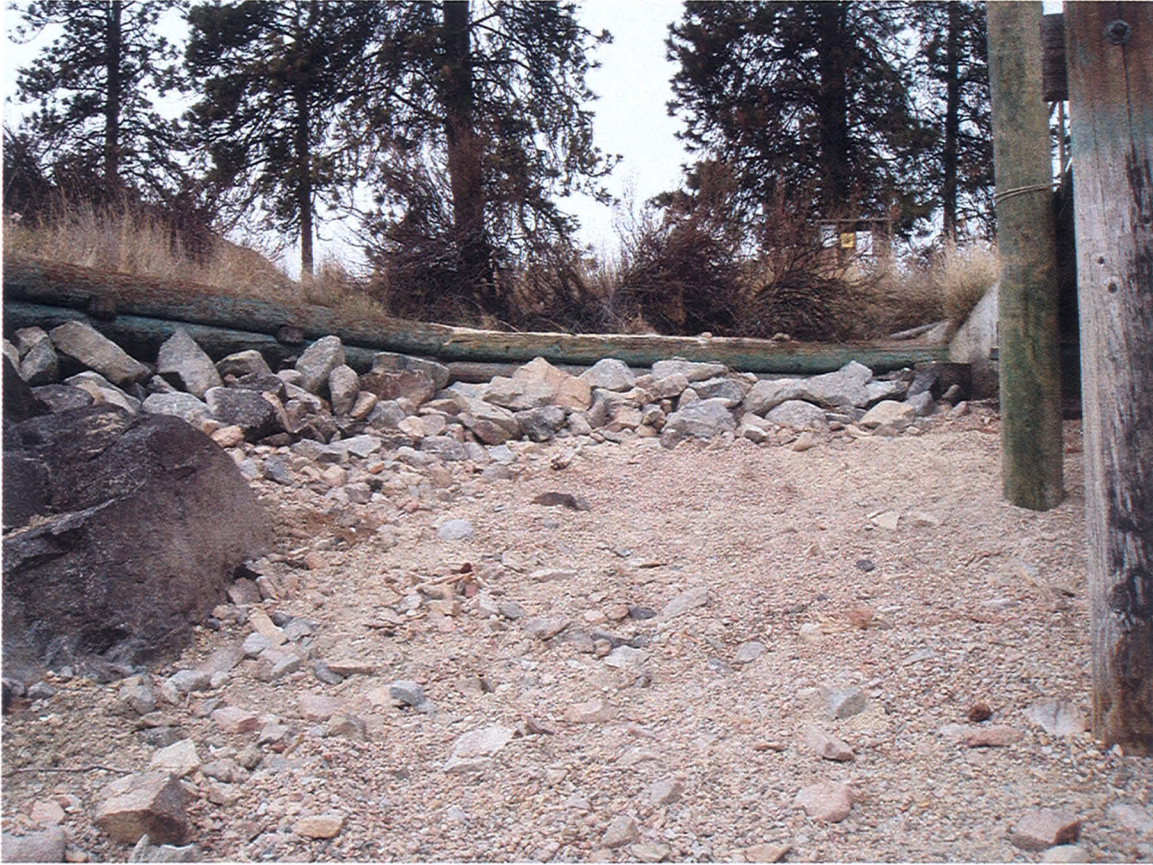
The southern section of the existing log crib had some undercutting of gravels. This was single and smaller rock placed at the toe of the existing logs. This is treatment zone F (contract) approximately 25 lineal feet.

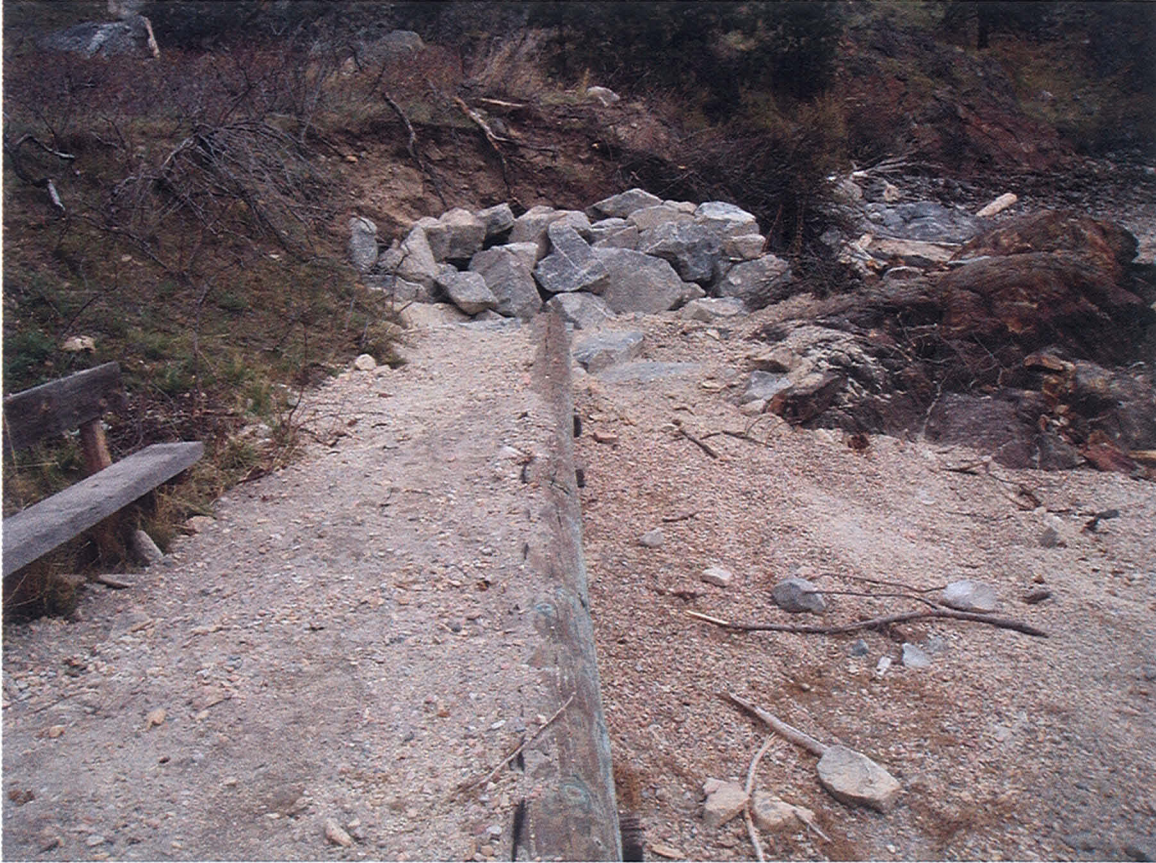
This shows the right side of the existing log cribbing at the Deer Point Dock. A large tree died and blew over causing spaces to develop in the cribbing. Cribbing was pushed back in place, with a new fabric cloth liner and re-leveled. The top of the photograph shows the first section of A2 treatment behind the recreational steps. The top layer of soil was slightly disturbed to do a trial planting of native blue bunch wheatgrass and yarrow (*Agropyron spicatum* and *Achillea millefolium*, respectively).

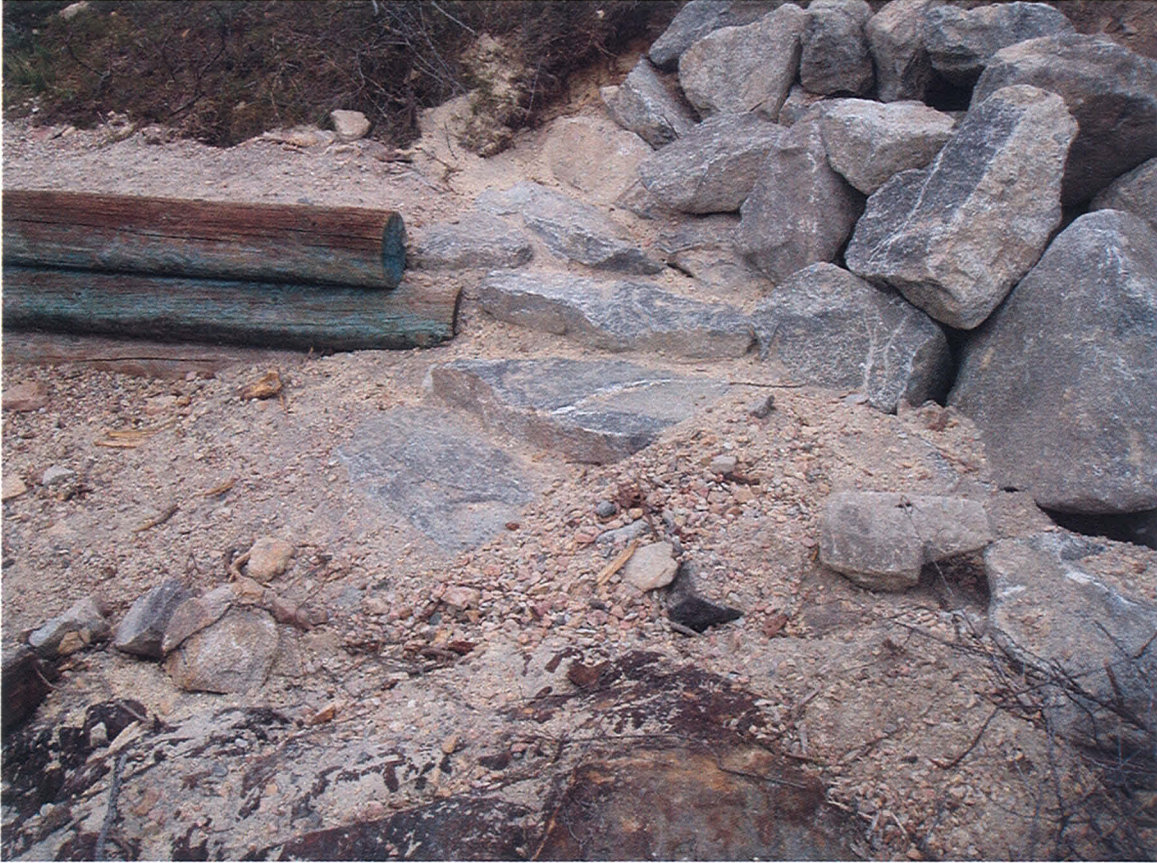
This is a frontal view of the recreational step access at the end of the existing wood cribbing.

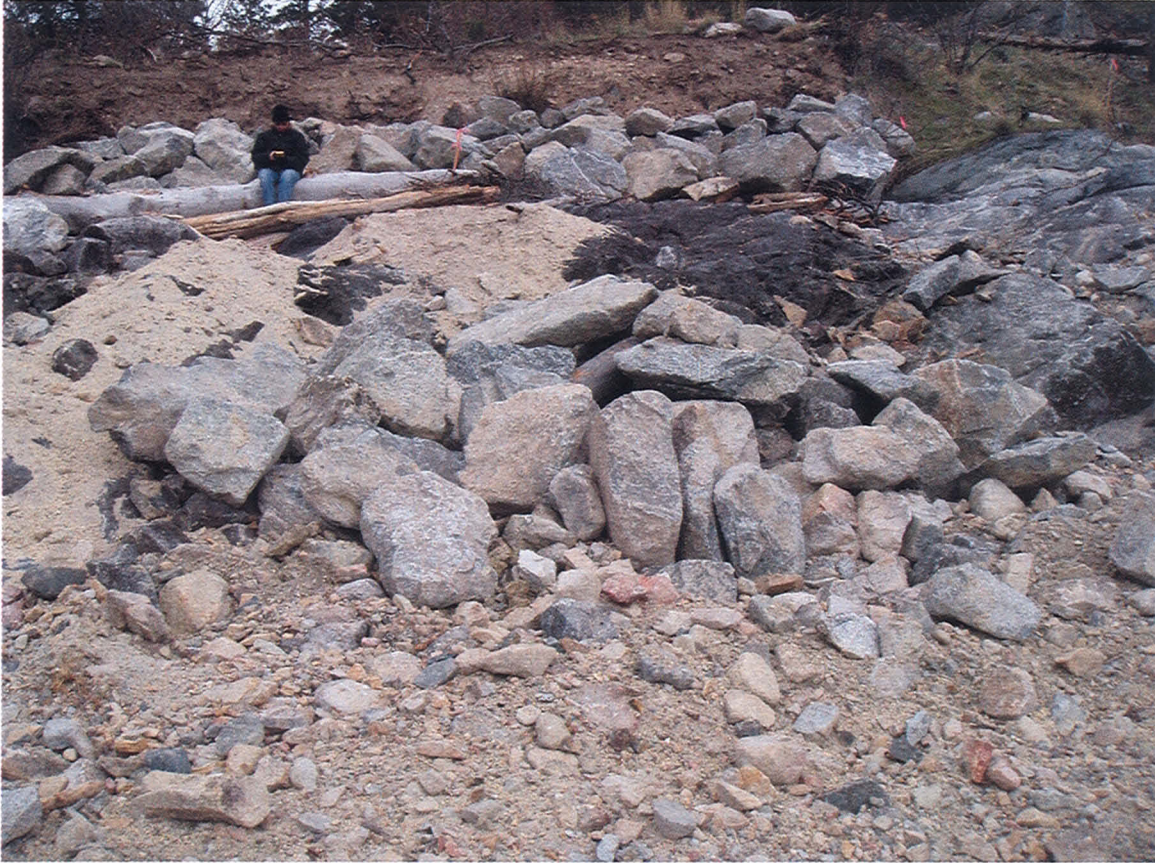
This photograph shows a person sitting on LWD # 6 while taking a GPS point. These are pinned with rock on the high end. This is a T2 treatment with a fabric cloth pocket behind the upper layer of rock. This A2 area was also seed with a native grass mixture of Blue bunch wheatgrass and yarrow. A small amount of additional rock approximately 10 cubic yards was left in front of the natural rock outcrop for maintenance or additional anchoring of new LWD pieces.

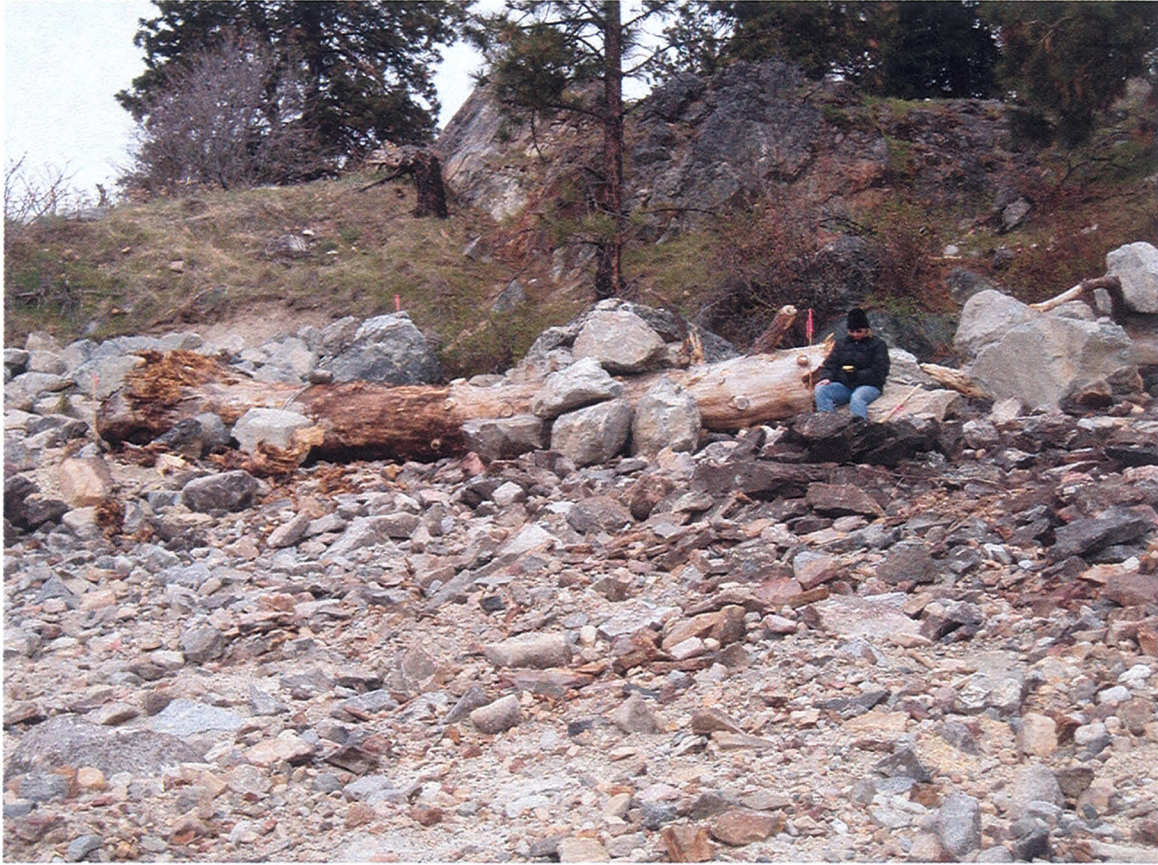
This is LWD # 7 in the foreground it is anchored with large rock and cabled wrapped. The left one-third of the picture shows the end of treatment zone A2. GPS point #7 is being collect by the person in the photograph.

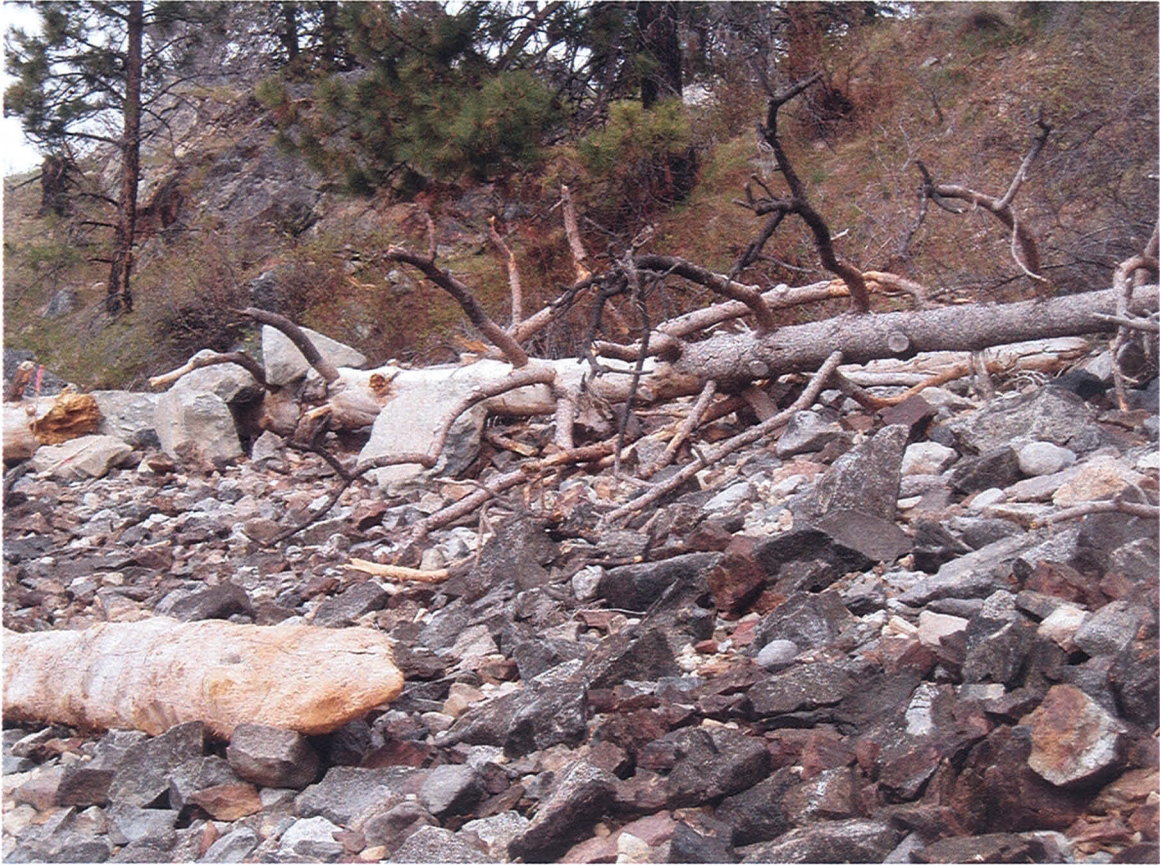
This is LWD # 8 it is anchored by cable and a large rock pile.

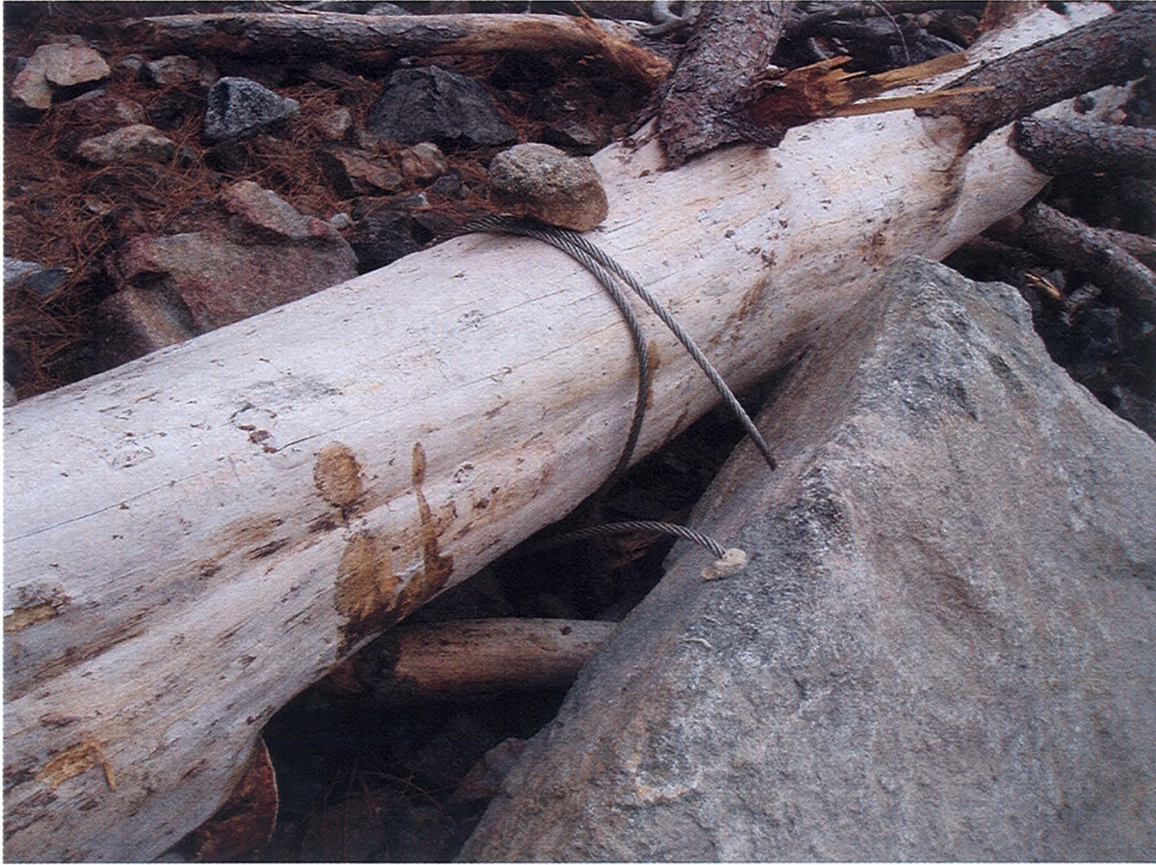
This is a close up photograph of LWD # 8 cabled with 1/2 inch stainless steel cable and glued with Hilti HY150 epoxy adhesive into drilled holes 8-9 inches deep.

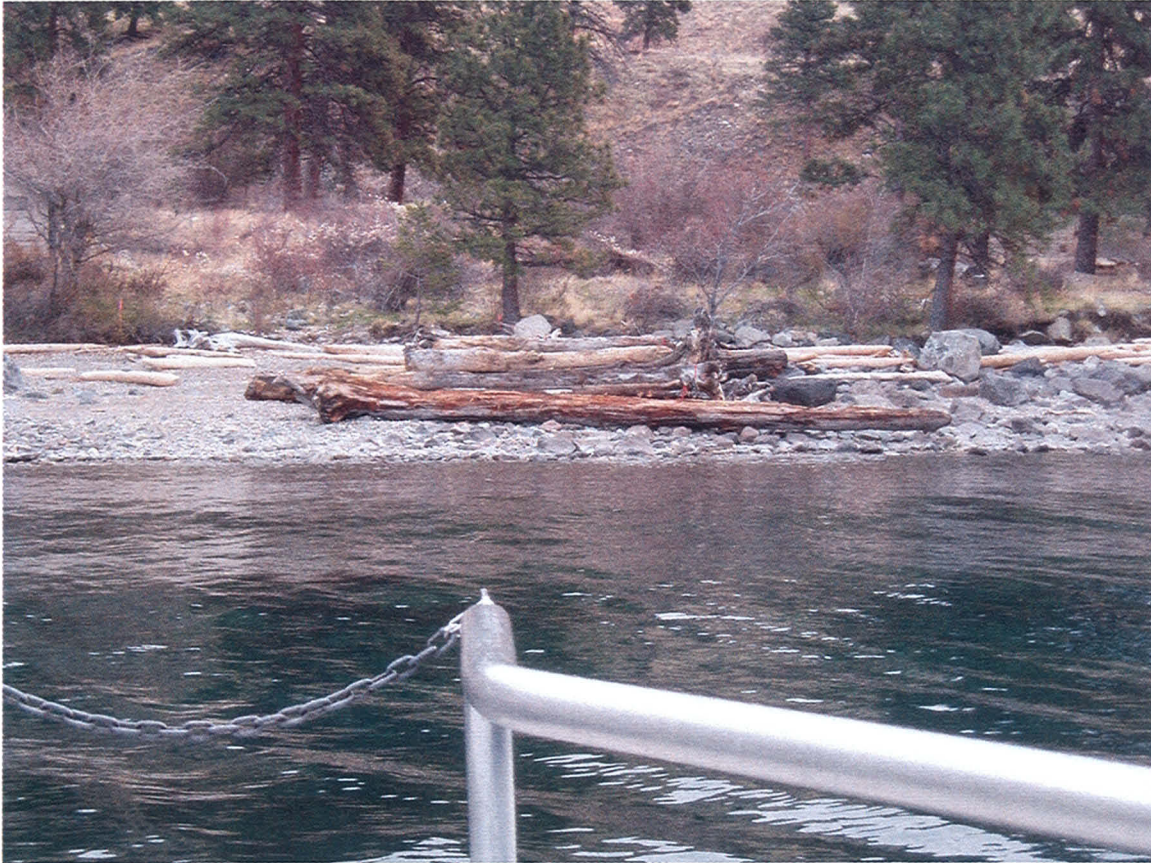
LWD was pre-stage at the uplake portion of the treatment site 568 tons of rock were pre-stage at this site during early December 2008. Approximately 356 linear feet of shoreline were treated on the up lake side of site 59 with 241 linear feet treated on the down lake portion of the site.

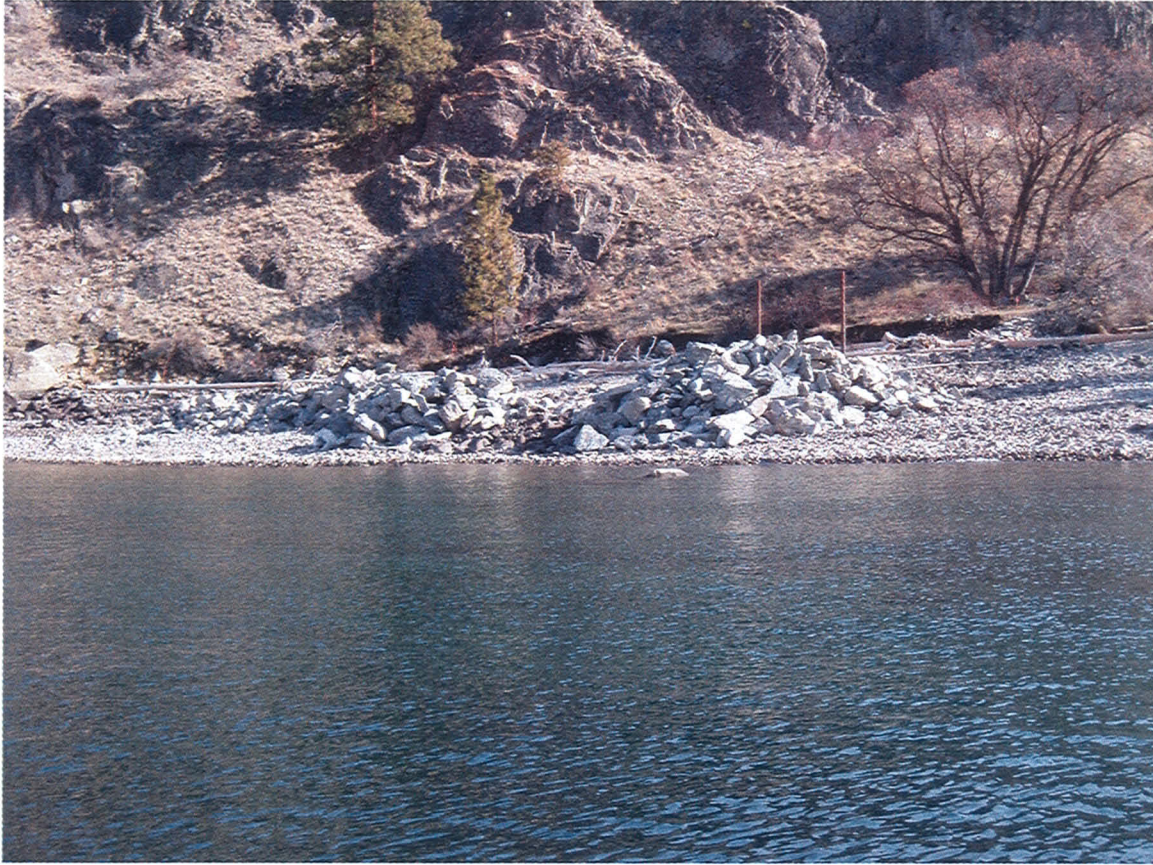
Placement of rock started and was completed in March of 2009. A Komat'su 220 excavator was the primary rock moving machine. All full treatment areas use a Geotex 801 fabric cloth 12 feet wide that is placed over coir wattles which are placed at 1100 and 1104 elevations, fabric was placed near the top of the treatment and into the toe trench. A small toe trench was excavated below 1100 feet with approximately $\frac{1}{2}$ of the excavated material going upslope to create a softer slope and some be pulled in front of the toe of the trench.

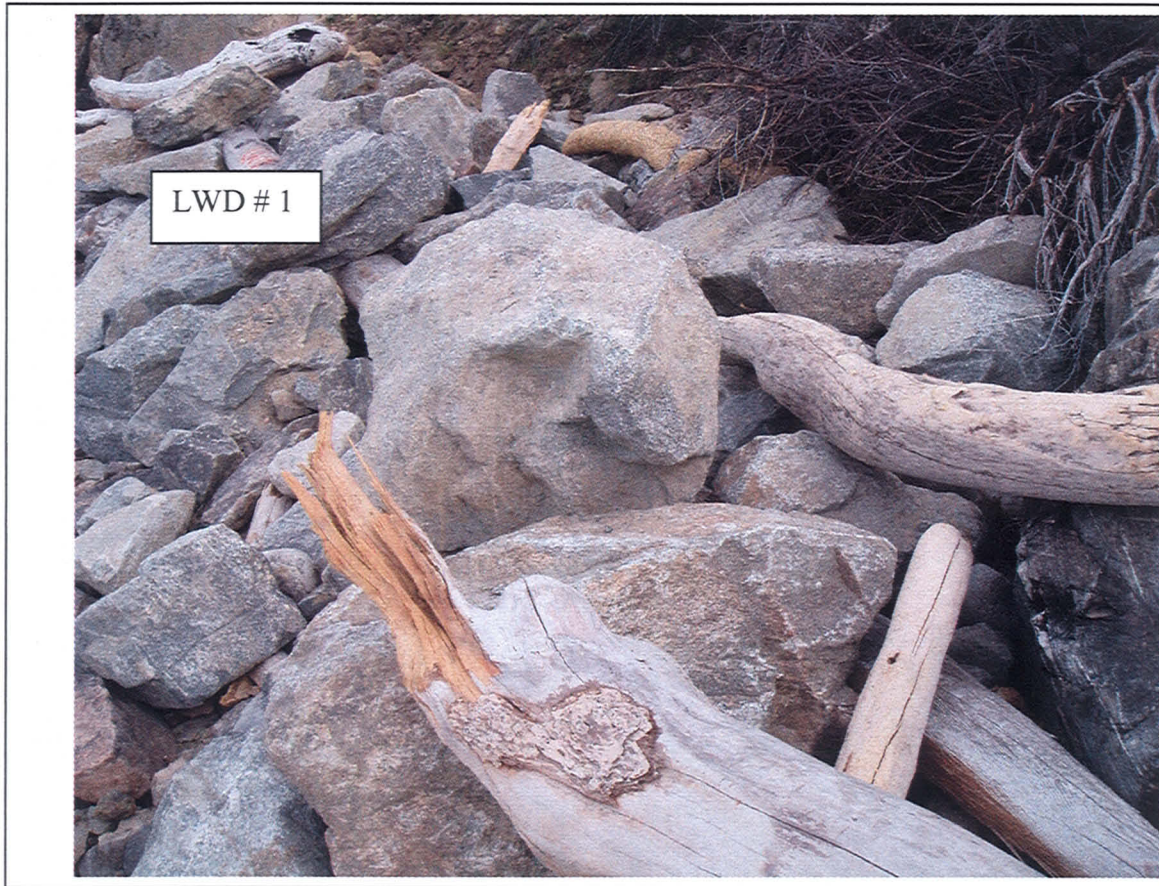
LWD # 1

The photograph shows (LWD# 1) our first rock anchored piece of LWD it has 3 large rock on top of the log and is side pinned by rock. This is treatment area "A" which called for single large rock. We had additional rock and beefed up the treatment.

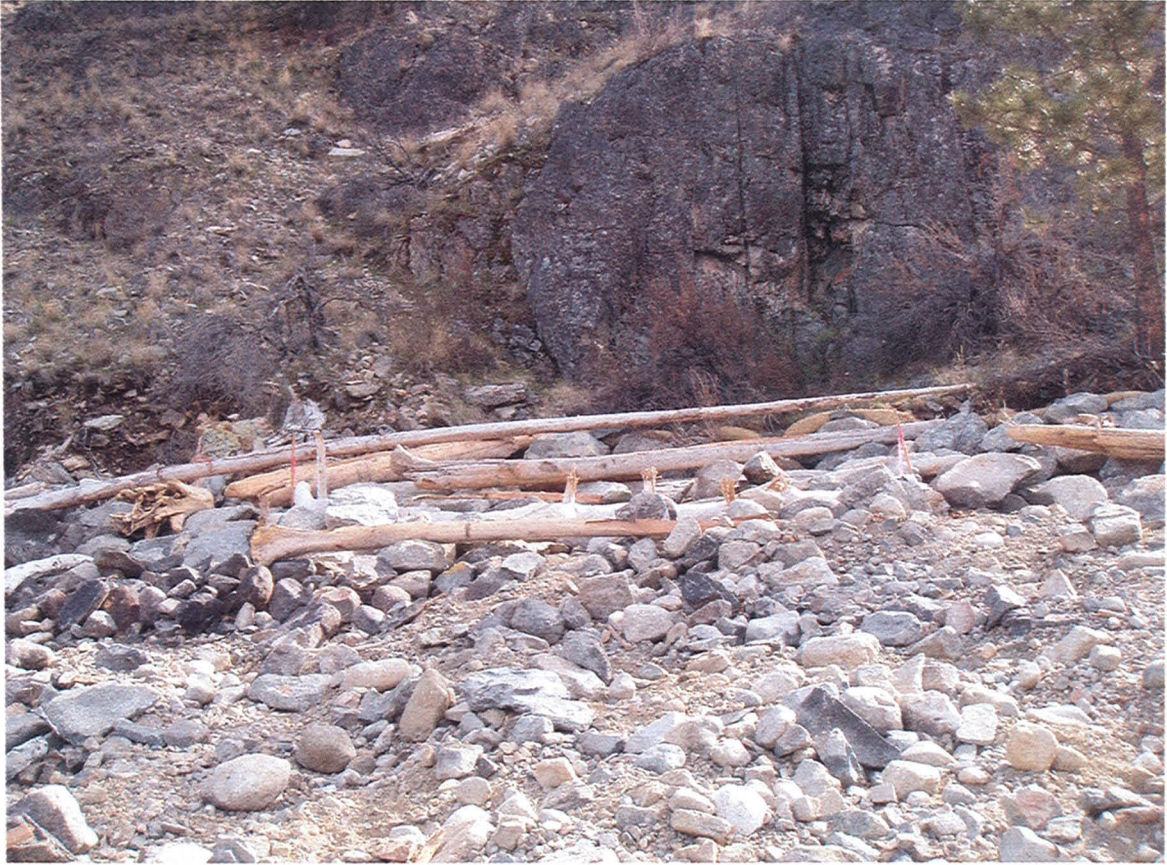
(LWD #2)

This shows a shoreline view of LWD # 2 (ends are at orange stakes) the piece is down at 1099 feet of elevation and pinned under large rocks. Smaller woody debris that was not of suitable size but naturally washed up in this bay is re-distributed behind and in front of treatment with no attempt to anchor it.
