Enclosed are two reports for the 2008-2009 erosion control work done on Lake Chelan under US Army Corps of Engineers (USACE) permit number NWS 2007 1652 CRC by the Forest Service. A certificate of compliance has been mailed to the USACE and copies of the report validating all required Large Woody Debris anchored and placed per WDFW agreement.

Chelan Ranger District
Deer Point Campground
Erosion Control Treatment Site 58 Report
2009

Site 58 is the second erosion site treated under the Lake Chelan Hydroelectric Project No.637-022, under Article 401. The treatment followed the site specific plans for this site filed November 7, 2007 by Chelan PUD with the Federal Energy Regulatory Commission's (FERC) for approval of the Erosion Control Implementation and Erosion Monitoring and Maintenance Plan (Erosion Control treatment Plans) and the Site-Specific Erosion Control Plan (Site-Specific plan for site 58). On December 14, 2007, FERC issued the Order approving these plans.

Chelan Ranger District
Mitchell Creek Campground
Erosion Control Treatment Site 59 Report
2009

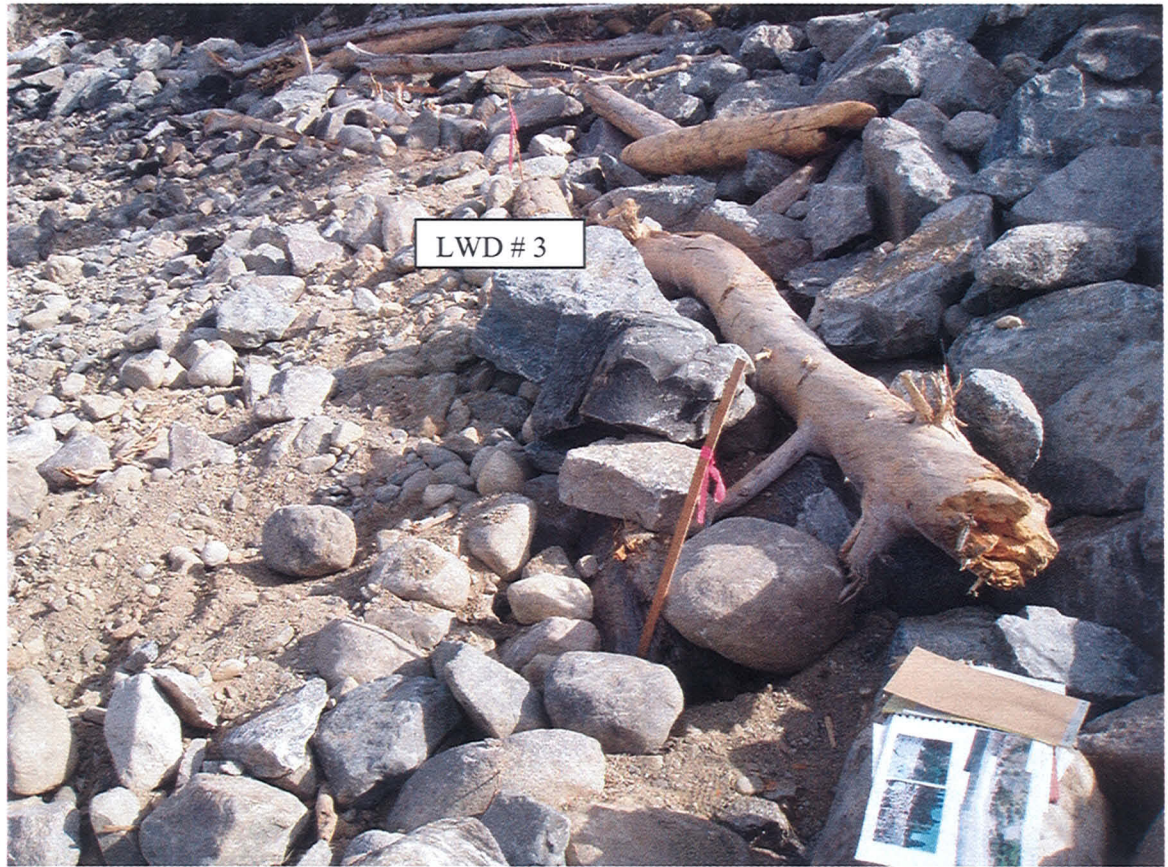
(LWD # 3 half buried at 1099 feet elevation between pink flagged lathe), 2 large and 2 med rocks pin the log, medium piece “trapped” with one pin point behind anchored LWD. This top log is not a counted mitigation piece of LWD, but still pinned. This is the beginning of treatment C a full T1 type of treatment with fabric cloth and waddles.

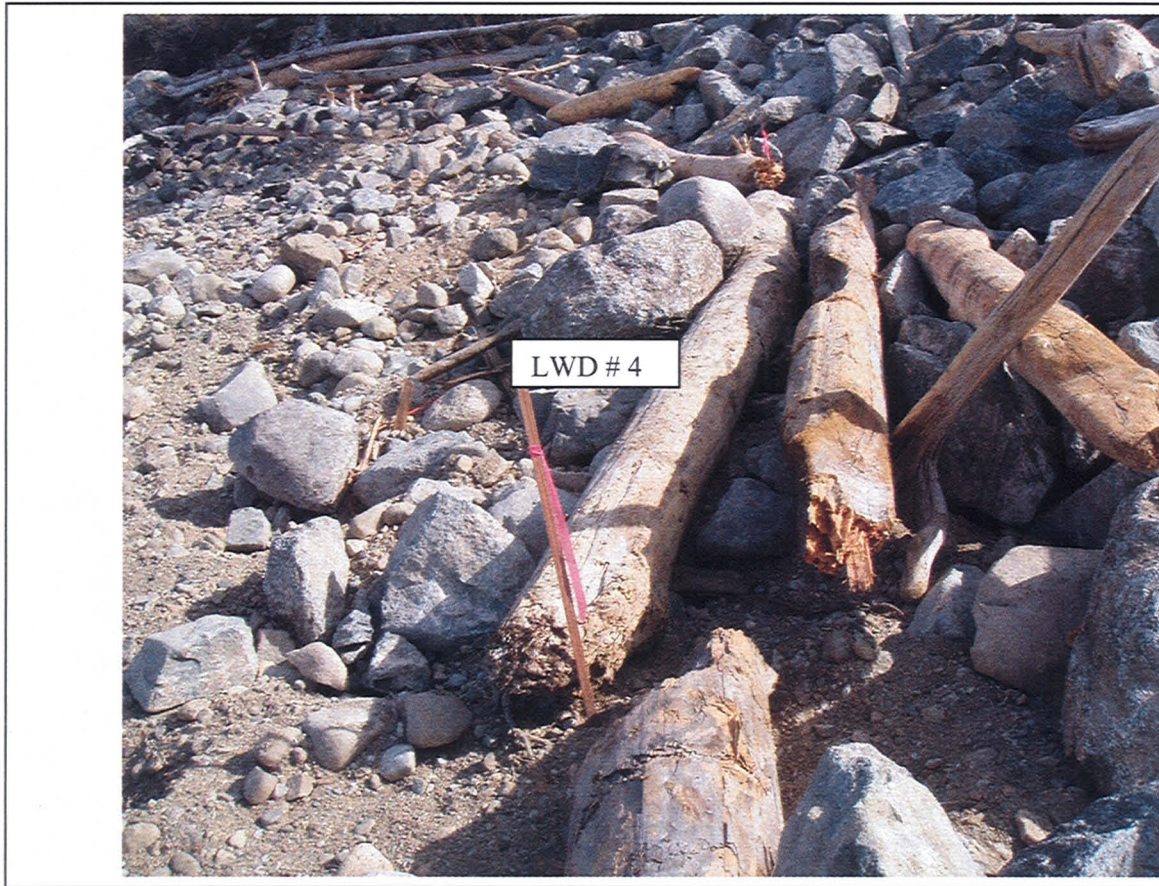
(LWD # 4) LWD #4 is between flagged stakes and pinned with 2 large rock with minor LWD placed behind anchored log. The intent here is that # 4 is anchored at 1099 feet elevation and will be under water, anchoring rock should keep minor LWD behind it but allow some movement.

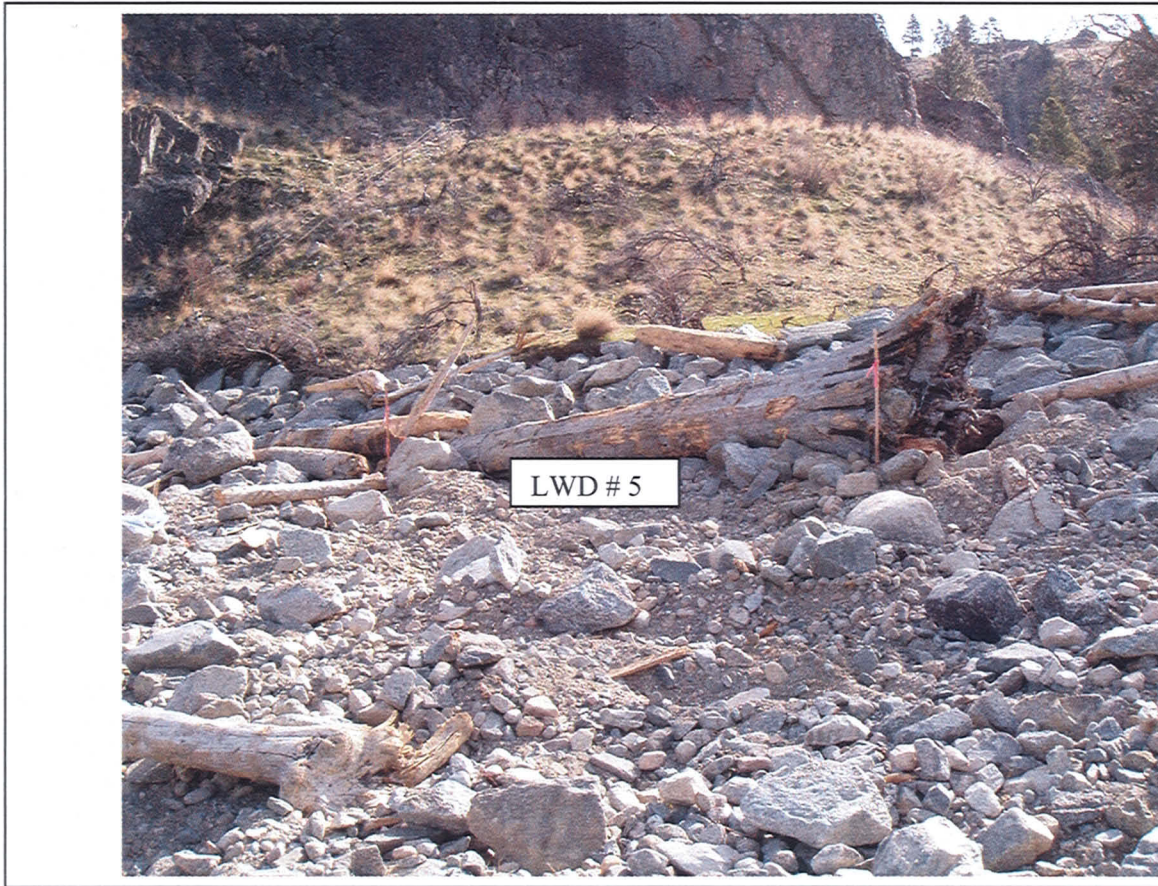
(LWD # 5) LWD #5 is one of the larger pieces of LWD it is double cabled to large rock with ½ inch stainless steel cable and epoxy cemented into rock with Hilti HY 150 adhesive. Shoreline texture of this area was deliberately left rough to mimic original conditions recorded in the 1999 survey photographs CD31 FR 13 and CD 31 FR14.

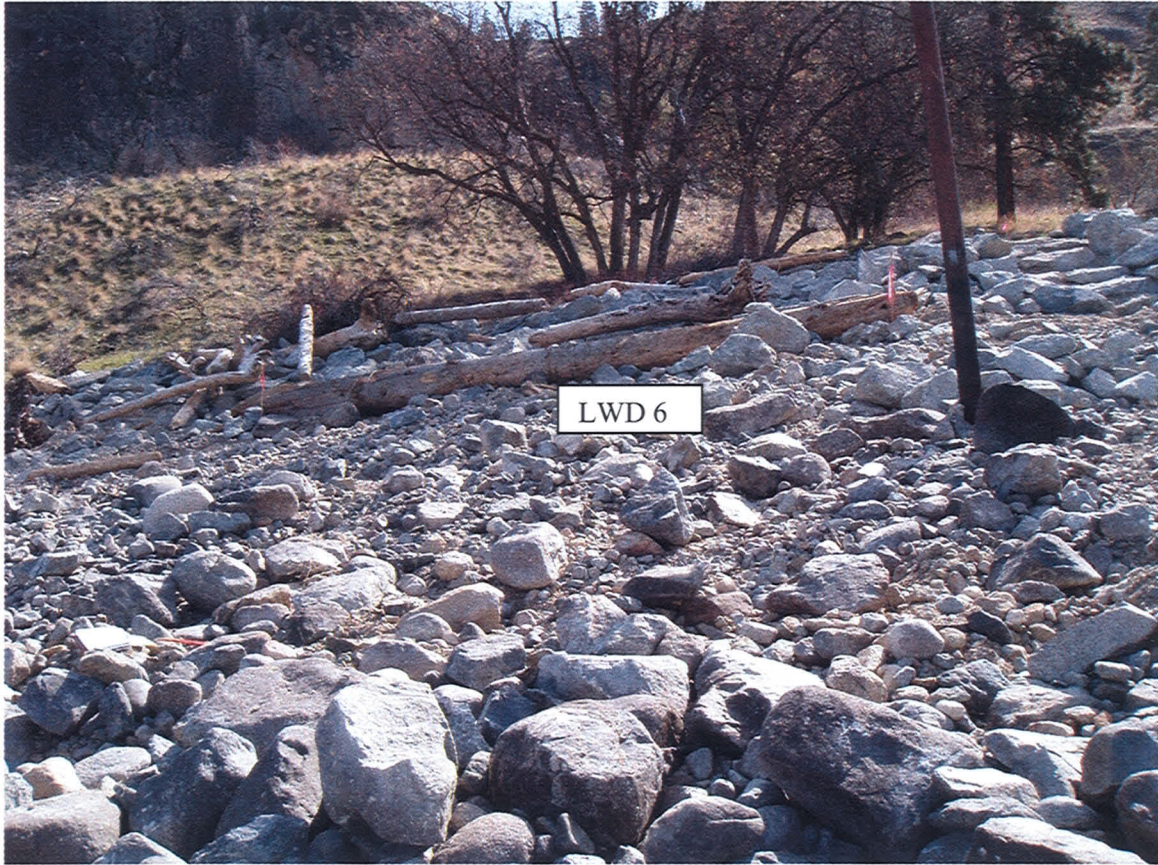
(LWD # 6) LWD # 6 (between flagged stakes) is a large 30 foot x 18 inch diameter tree bole that is double rocked and double cabled to rocks it is at the very toe of the treatment approximately 1098.5 -1099. Feet of elevation. Smaller woody debris has been placed on top of treated area to help naturalize the site with scattered pieces of "beached" wood. Recreational rock steps (B1) from the upland campsite are right of the old historic steel piling in the photograph.

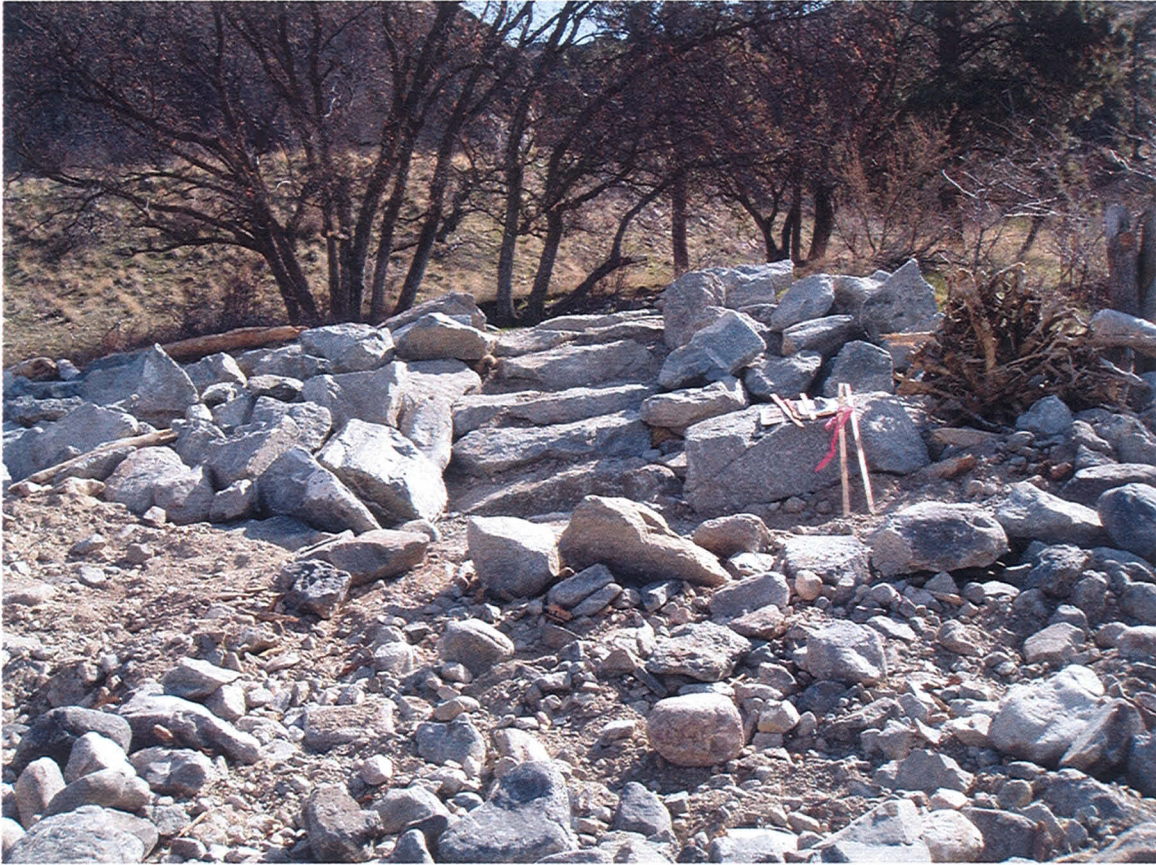
(Treatment B1) Rock steps for recreational access from shoreline camp site to water, treatment zone C1 ends at root wad right of the lathe and flagging. Large 4-5 foot relatively flat rock was used to create recreational access path.

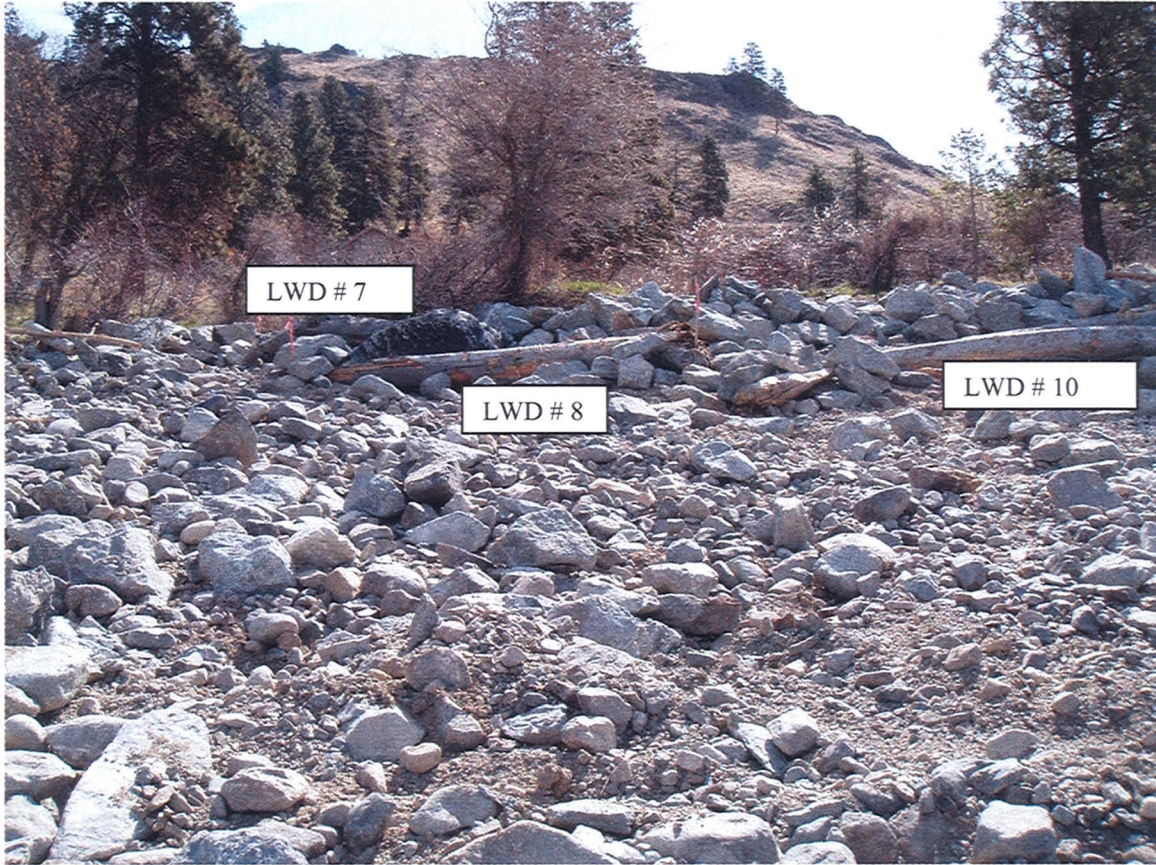
(LWD # 8 front with pink flagged lathe, and LWD # 7 behind, beach view)
Both LWD pieces are cabled with LWD # 7 partially buried below 1100 Feet elevation. LWD # 8 is at 1099 approximately top of log. This is treatment zone D1 planned as a single large rock with LWD treatment, however due to having additional rock available we choose to improve and beef up this treatment area. Note large blackish rock behind LWD # 8.

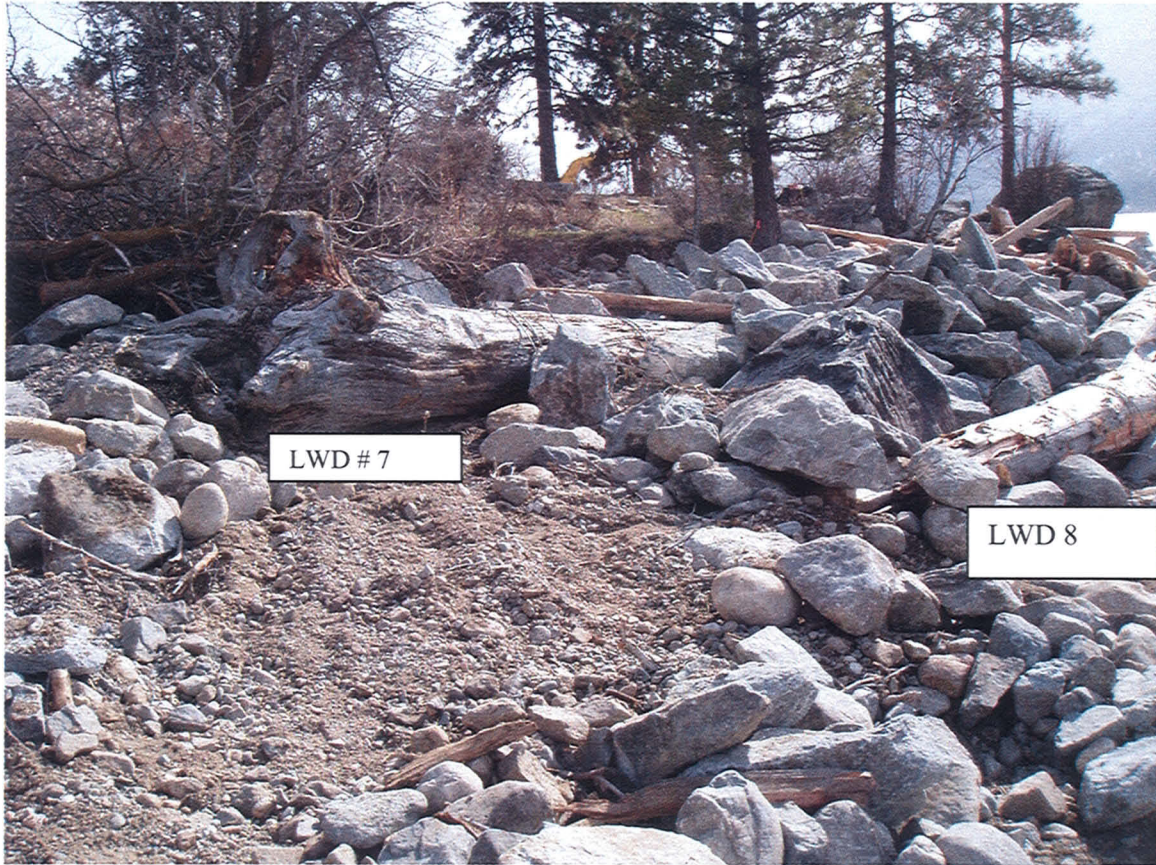
(LWD #7 and #8 side view)

This picture shows double cables on piece #7 (behind large black rock) and rock pinning downlake end. LWD piece # 8 is partially buried with rock on the buried end, with cable on the downlake end.

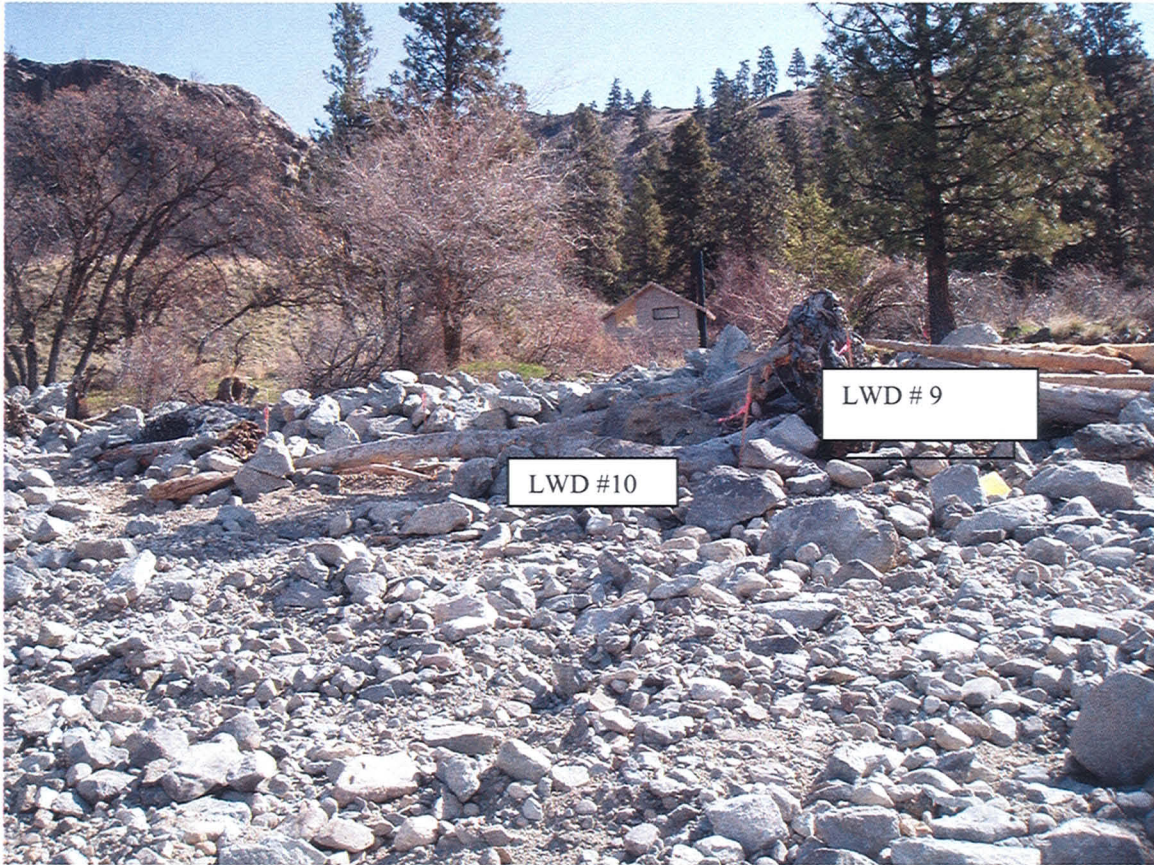
(LWD #10 foreground and LWD # 9 with large root wad)

Both left ends of these logs are partially buried LWD #10 is buried under the root wad of # 8. Rocks on top of and cables are used on both pieces of LWD. This is still treatment zone D1. LWD pieces # 11 and 12 are located behind # 9's large root wad.

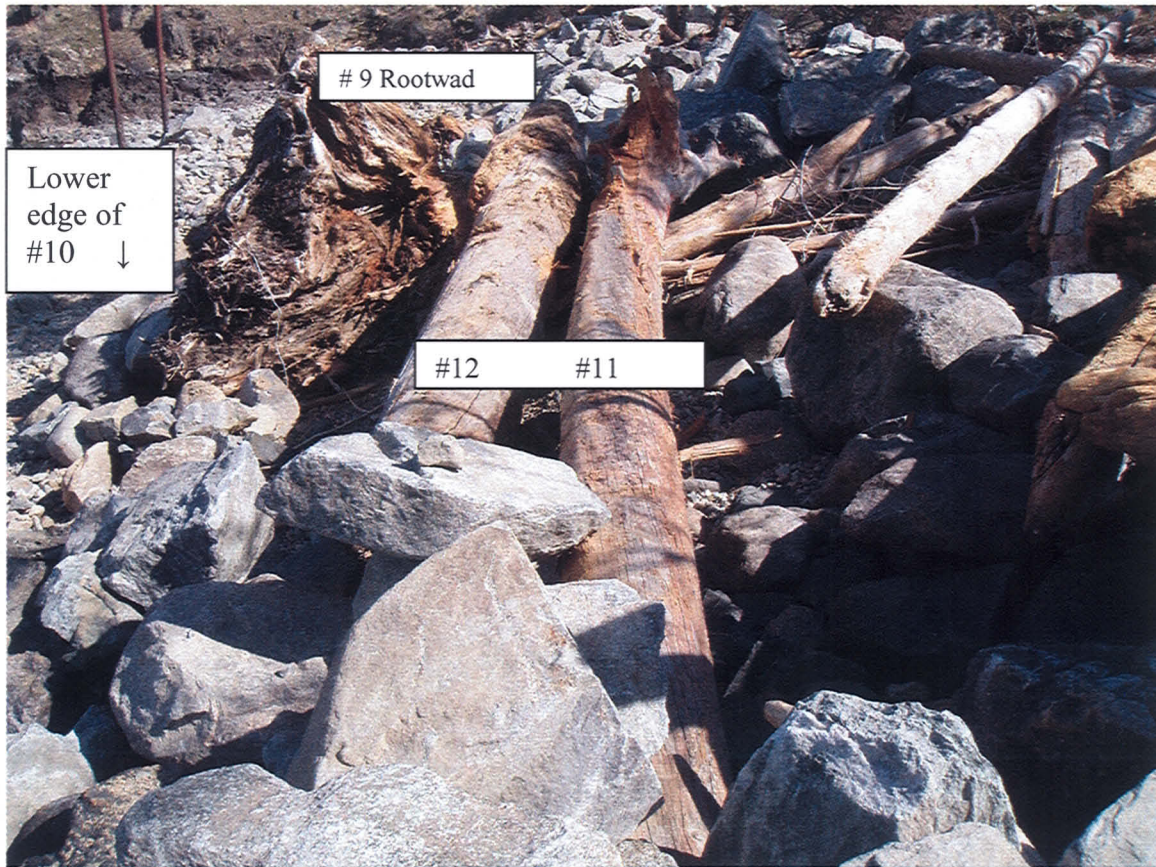
(LWD # 11 and 12)

These pieces of LWD have rock placed on top of the down lake end and are trapped behind the large root wad of LWD # 9.

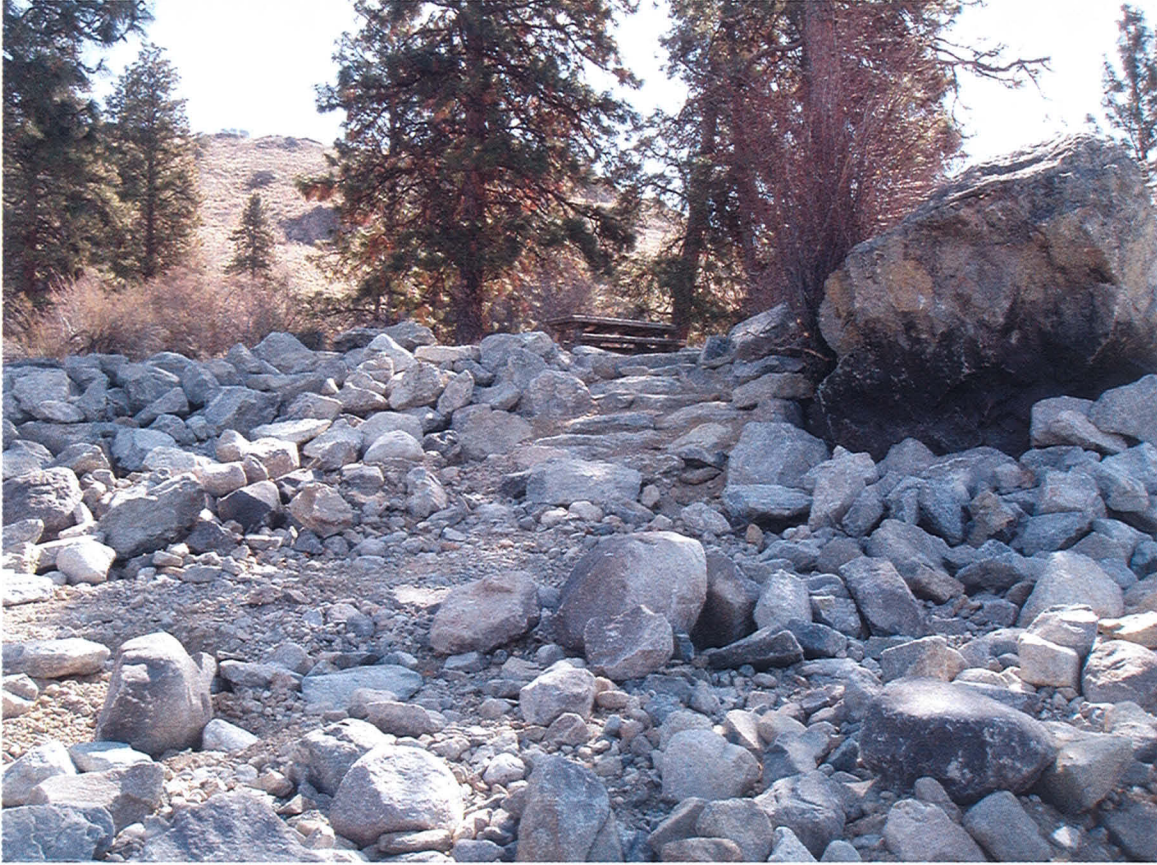
(B2 Recreational Rock Steps)

This photograph shows treatment zones C2 and B2, C2 is the full treatment left of the steps. At the base of the large point rock is approximately 40 yards of surplus rock for additional repairs should they be needed.

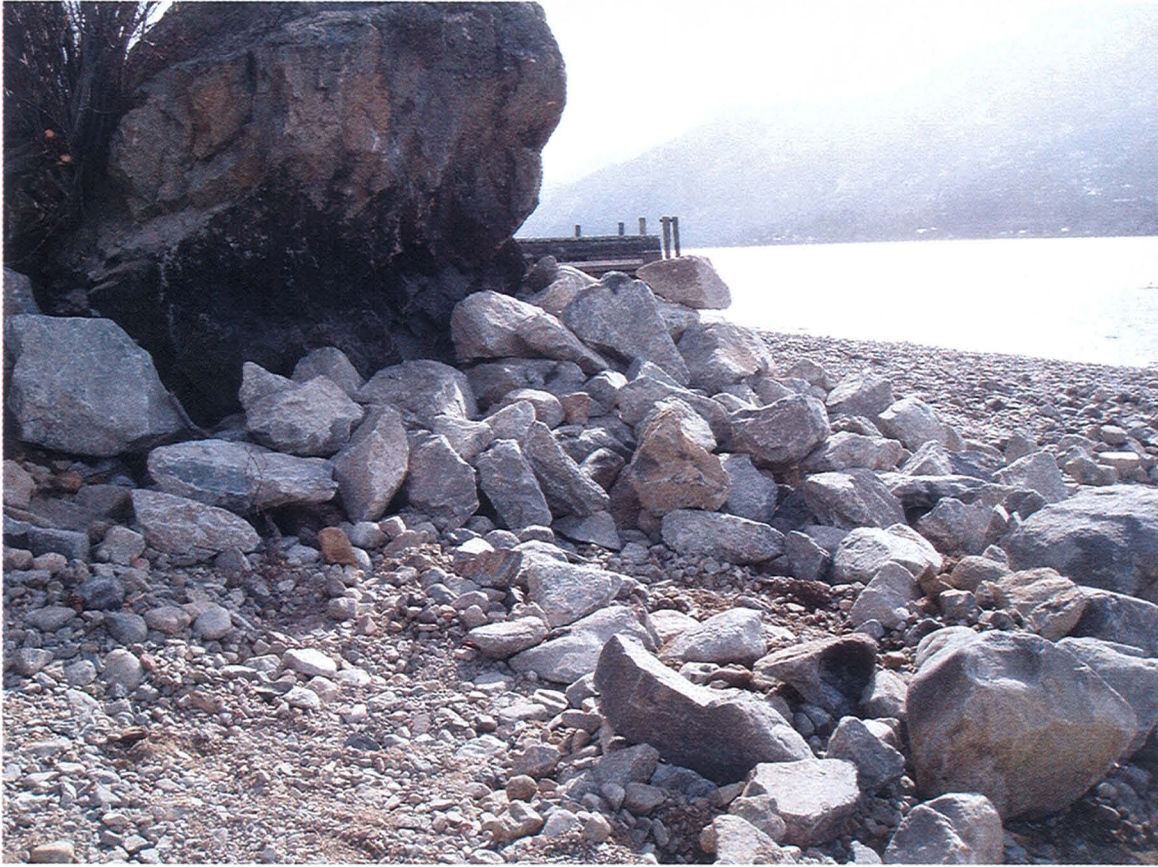
Side view of surplus rock uplake side of Mitchell Creek site.

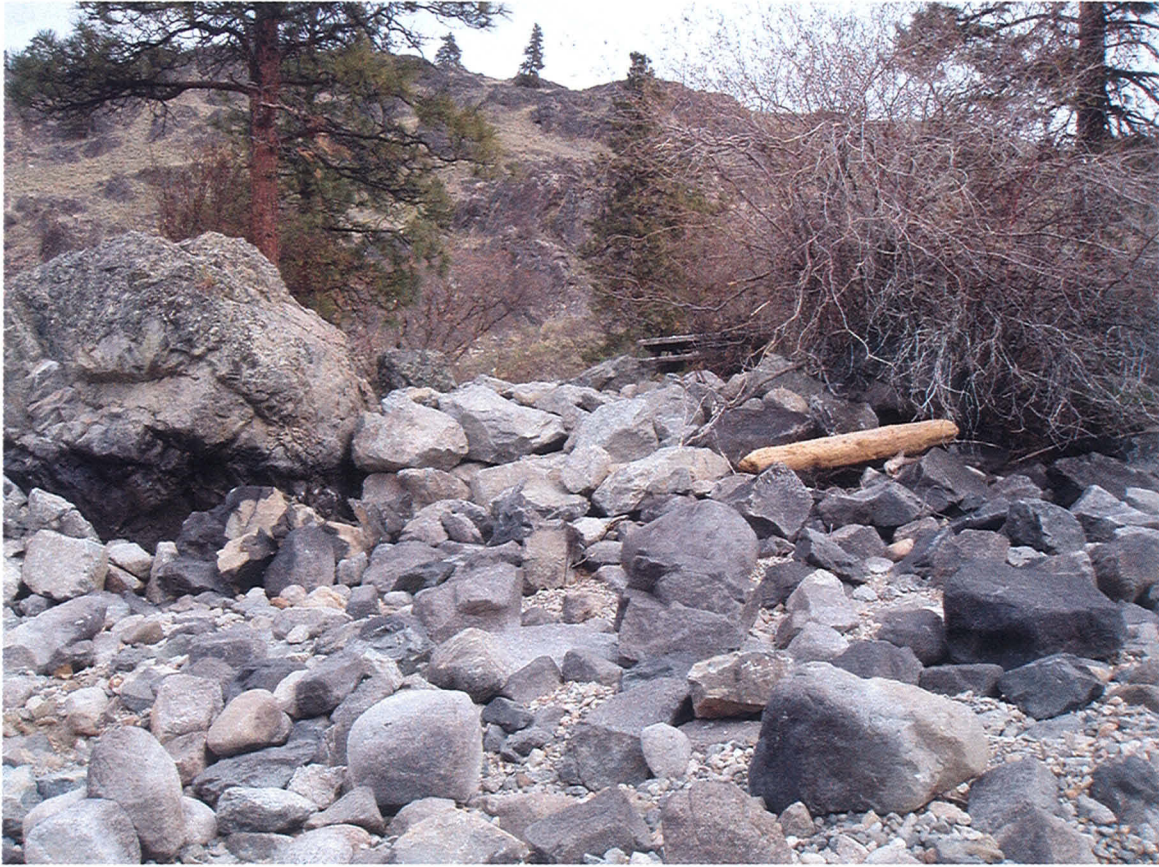
Site C3 full treatment continued on the other side of the rock for 17 feet. End of uplake treatment of site 59.

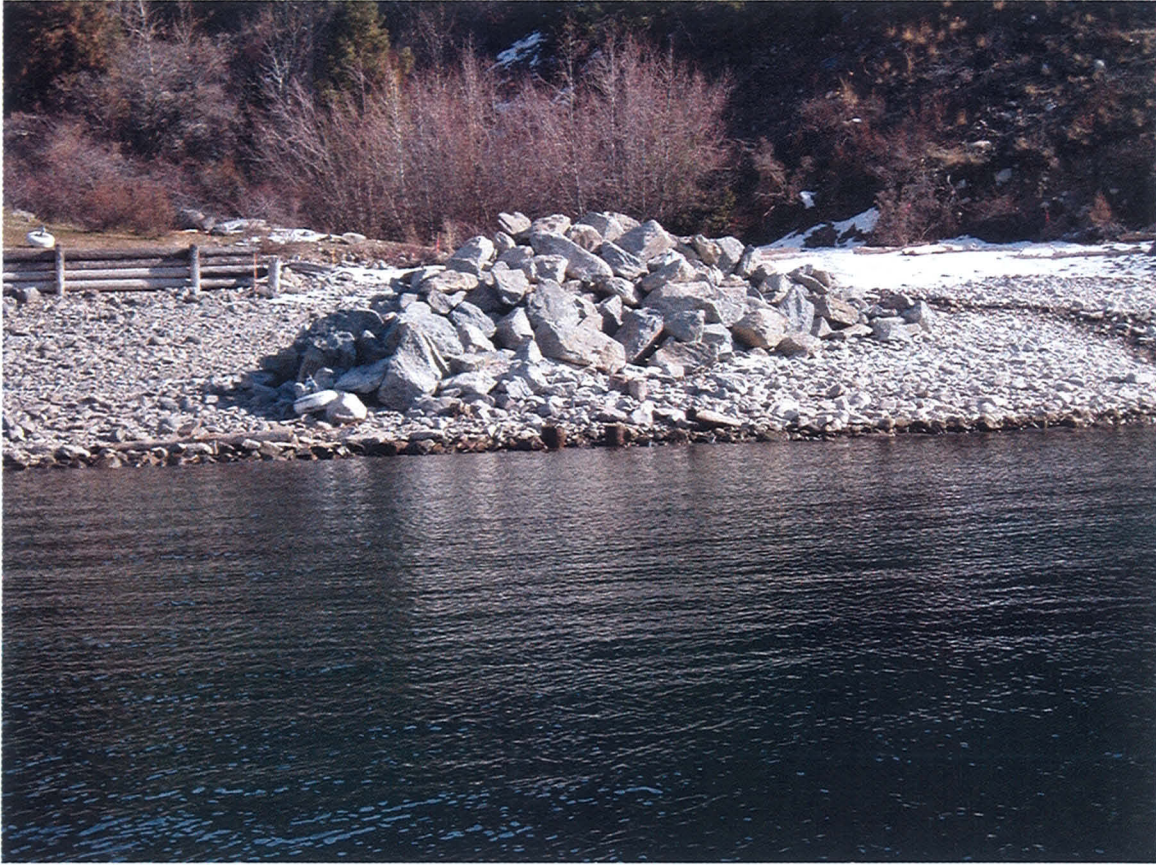
Approximately 190 tons of pre-placed rock for treatments D2 – E2, for treating 148 feet of erosion control repair. Note old crib wall and failed stream side section that has washed out.

Photo is approximately 20 feet of spot rock treatment in area D2.

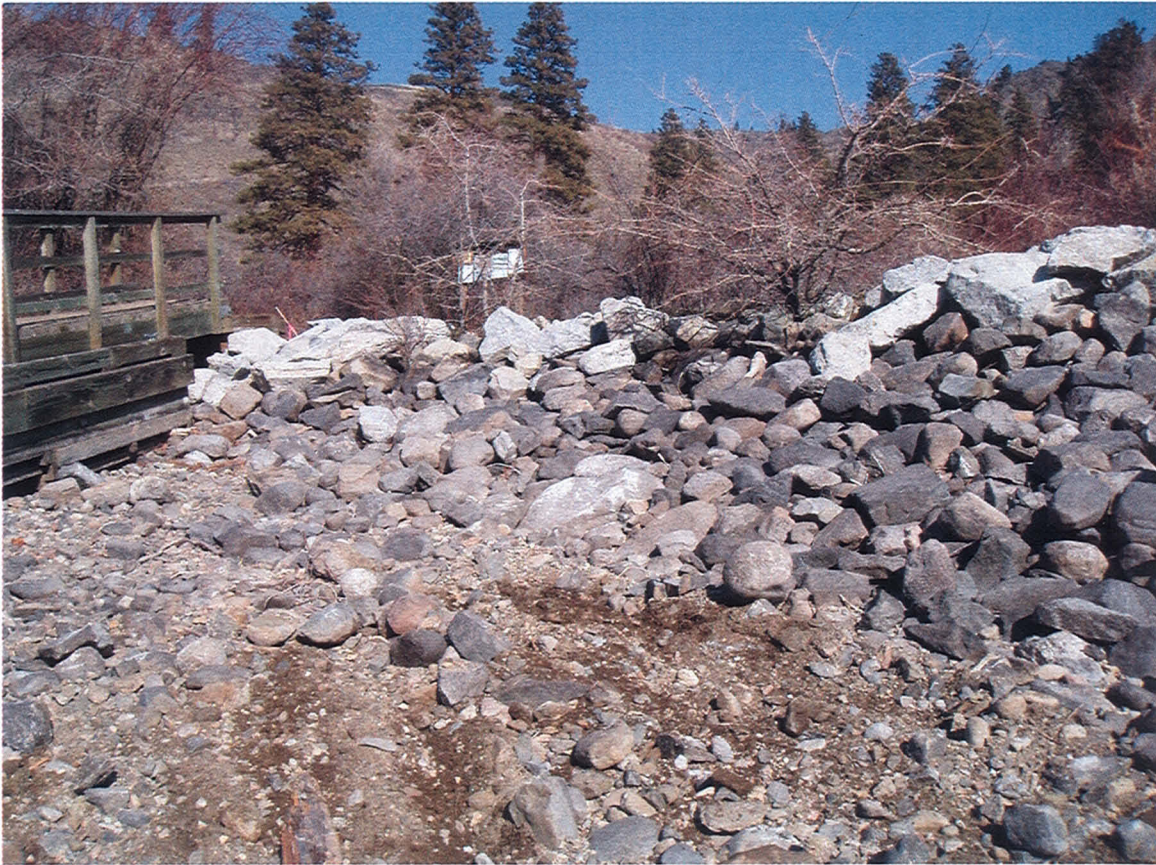
Lighter white rock is newly placed beefing up failed section of previous 1980 treatment.

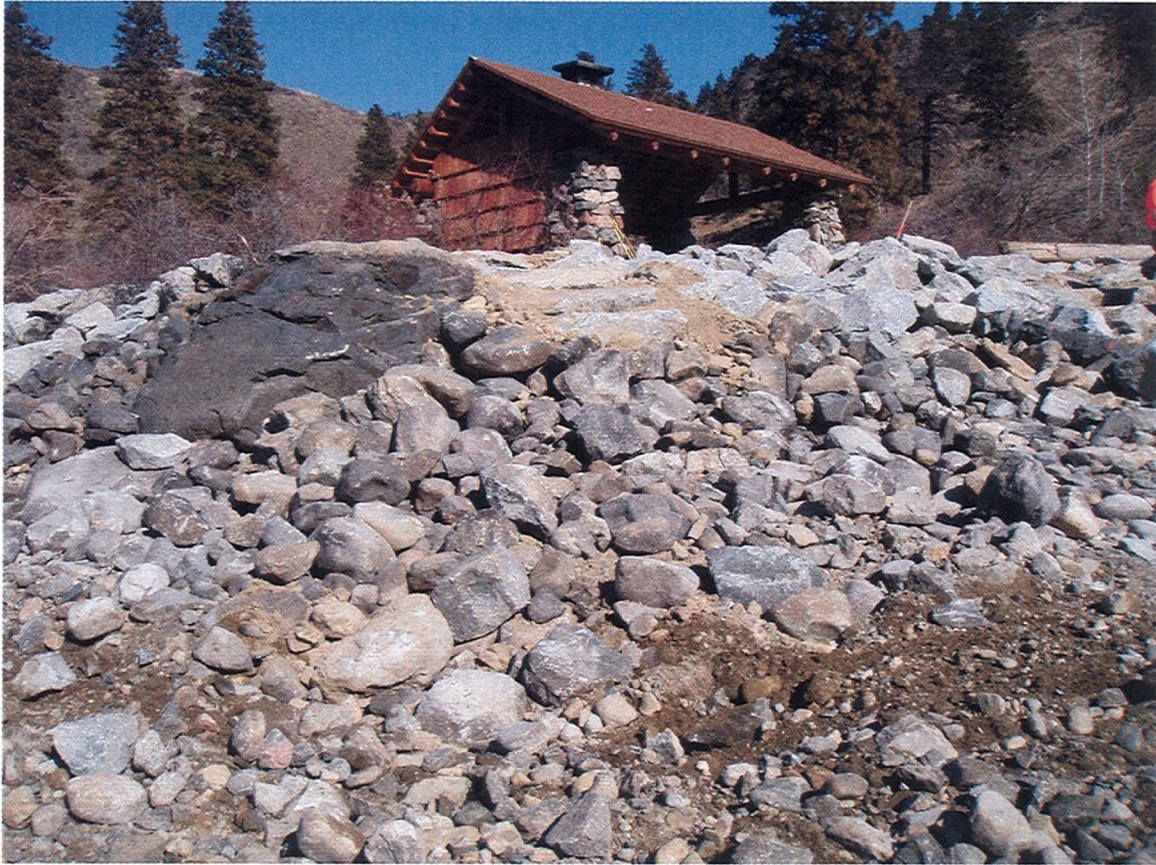
B3 recreational steps are right of the large black rock followed by treatment area E1 a fully treated area with fabric cloth and waddles.

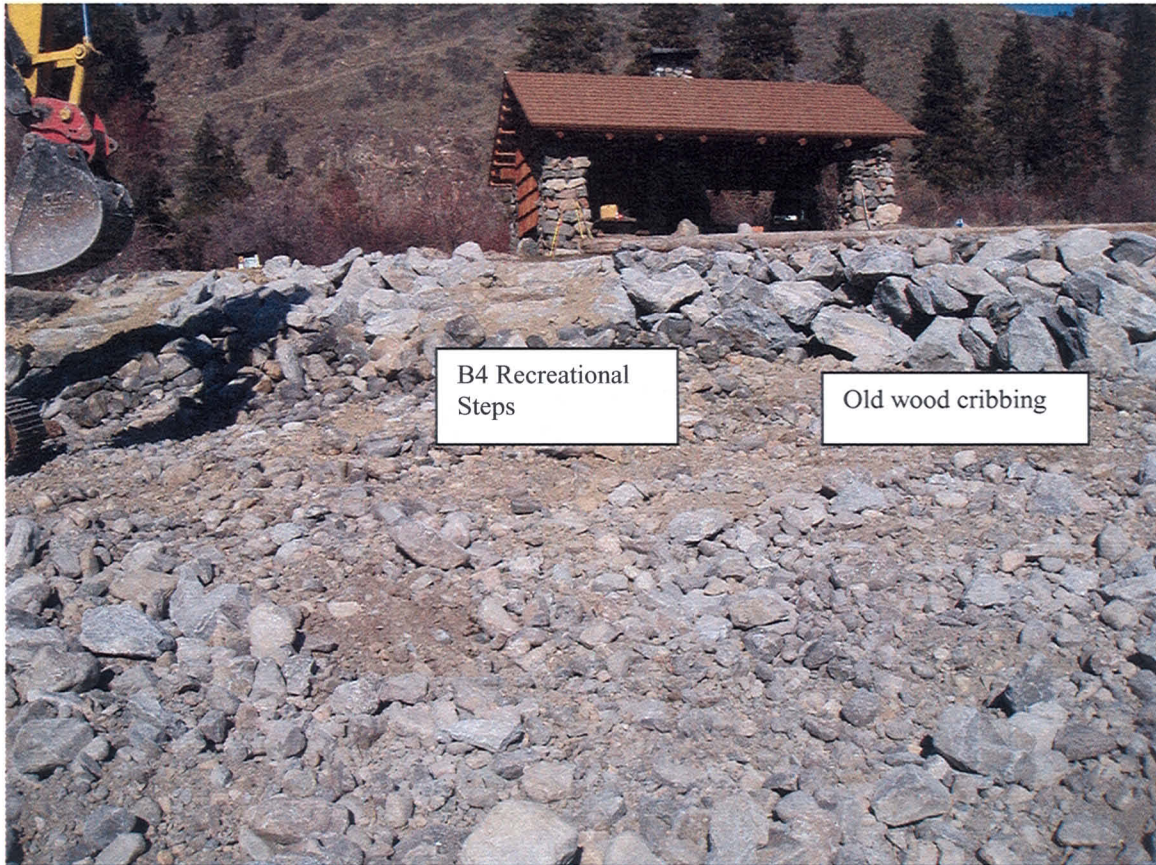
Since Mitchell Creek Shelter is the hub all shoreline water activities 3 different sets of rock steps were planned to facilitate user access to the Lake via the constructed steps; two in front and one along side of Mitchell Creek.

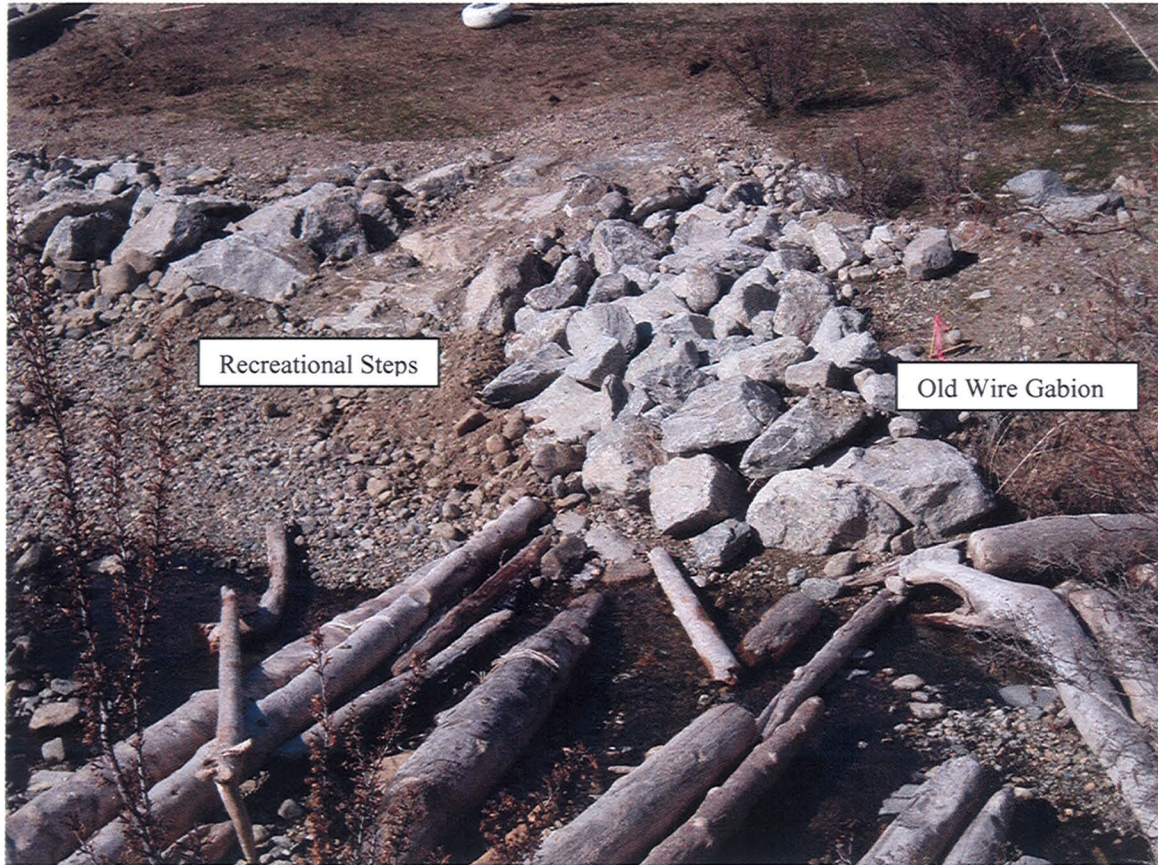
B5 are the recreational steps leading from Mitchell Shelter area to Lake and Mitchell Creek. Rock next to creek to pink flagged lathe is rock over the old exposed wire basket gabion from 1980's or 1970's repair when Mitchell Creek over flowed it channel.

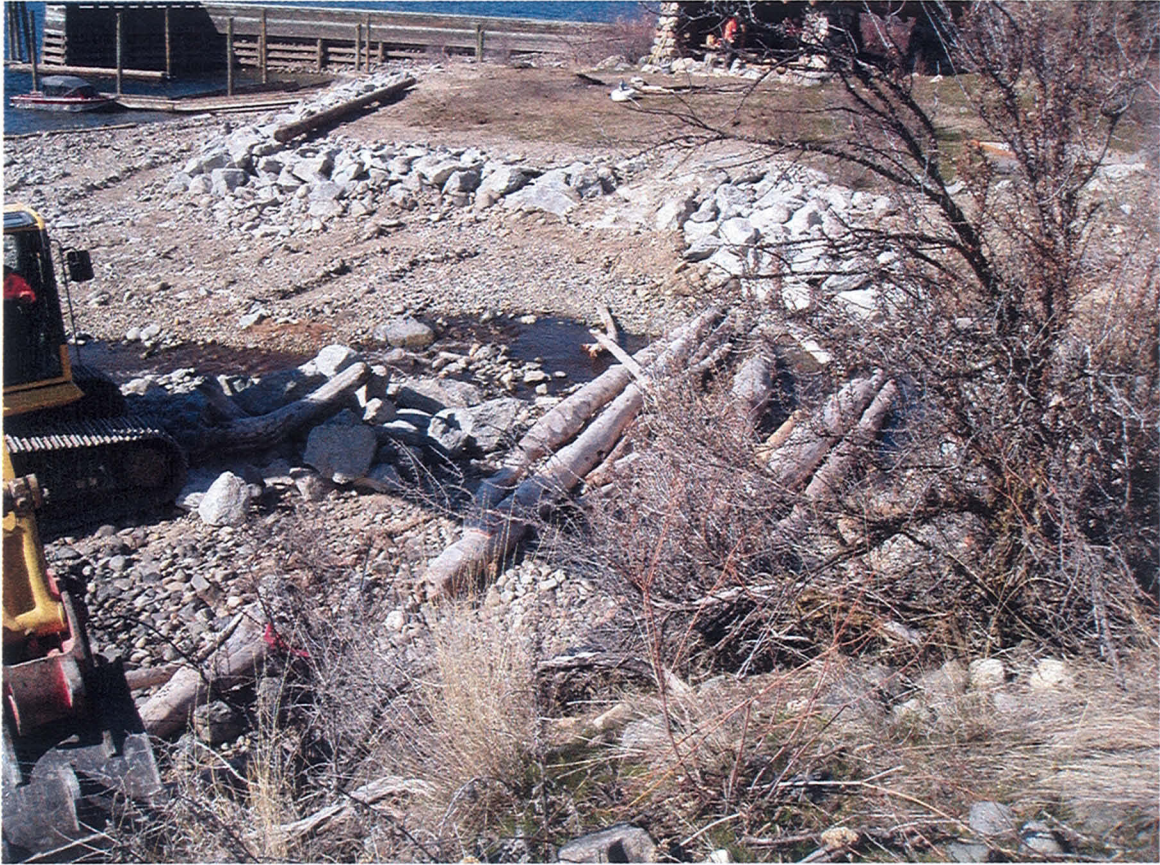
This is an overhead view of the treated area around Mitchell Creek Shelter.

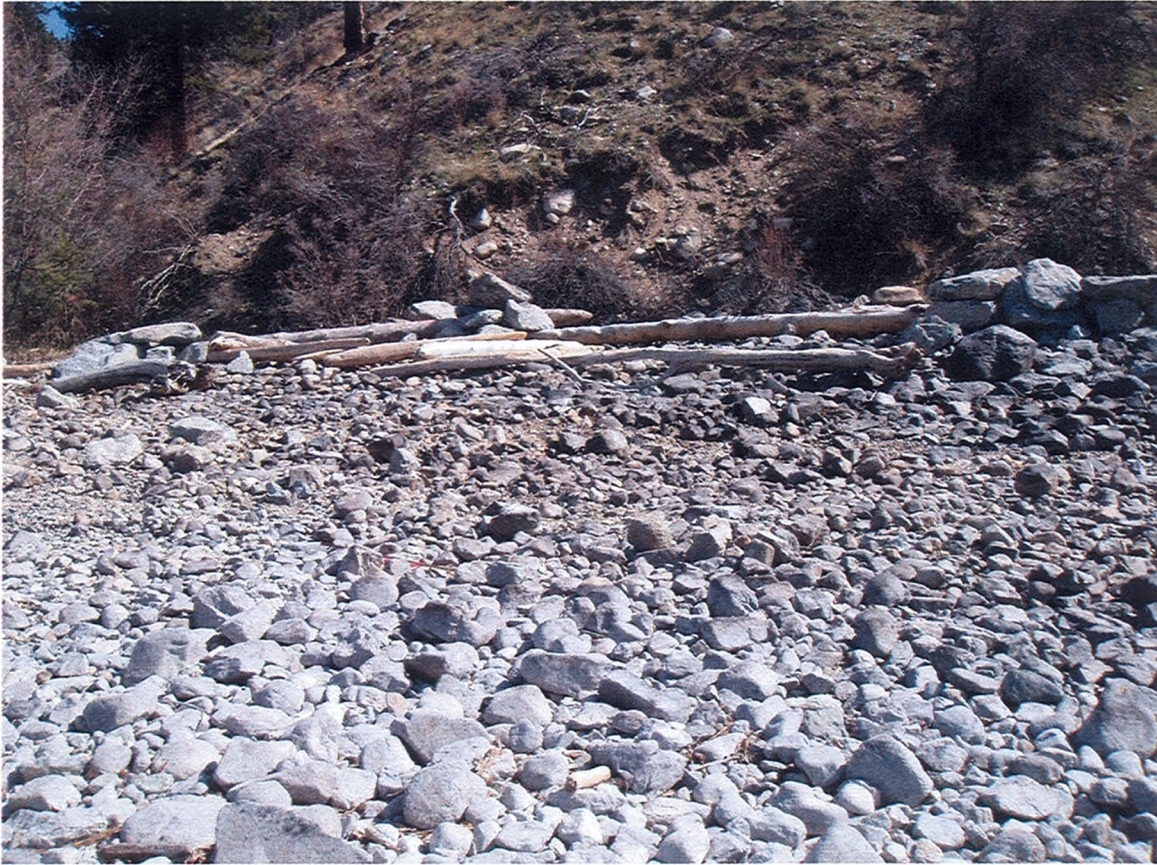
LWD # 13 and # 14

These pieces of LWD are down lake of Mitchell Creek. They are anchored by rock piles over the LWD.

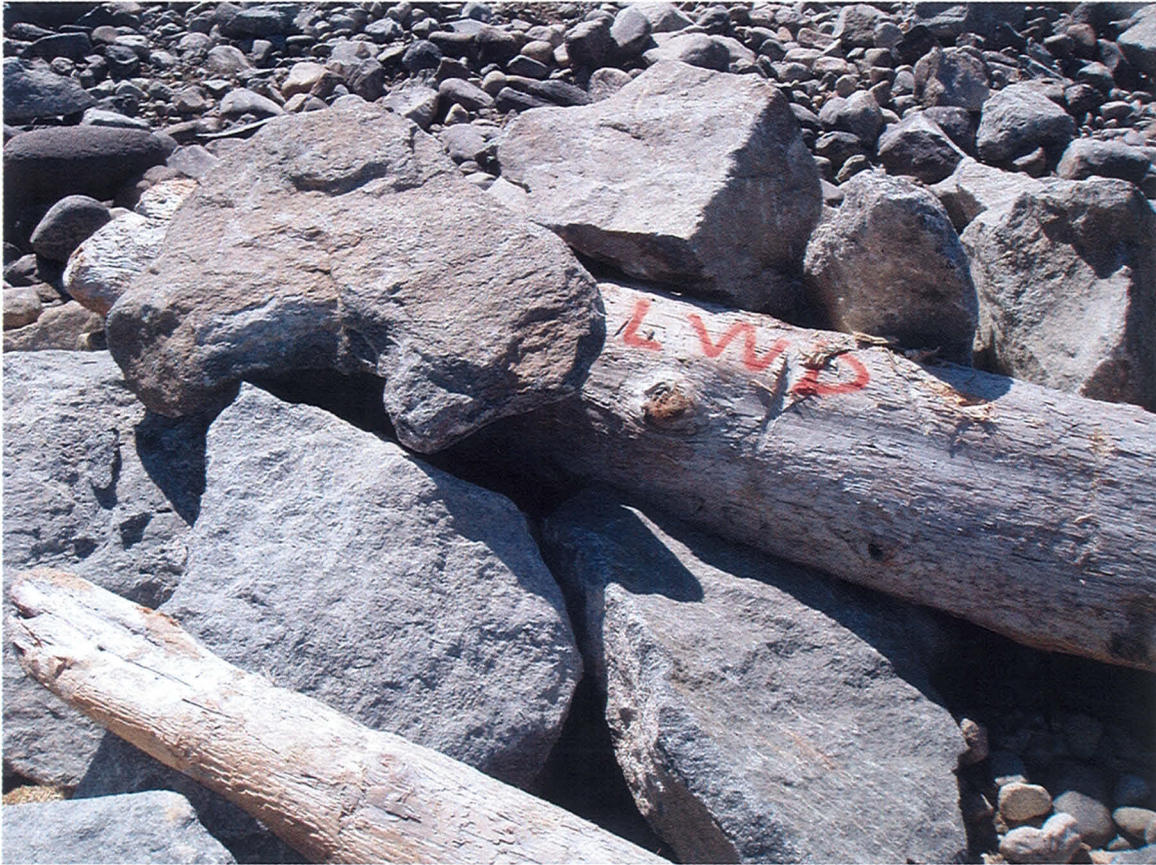
Upper end of LWD # 13 anchored with large single rock on top of LWD.

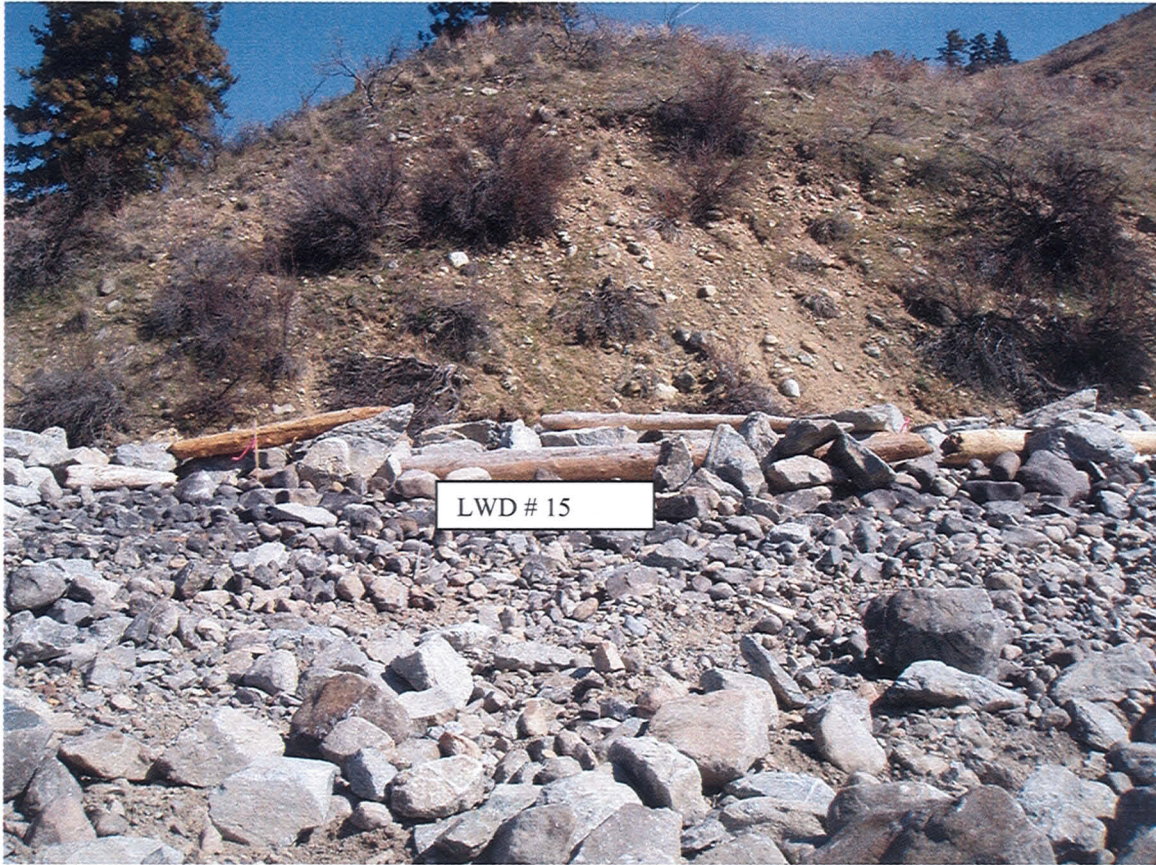
(LWD # 15)

LWD # 15 is anchored by two large piles of rock. Treatment areas F and G approximately 66 feet are treated with a double row of rock and this one large anchored piece of LWD. Despite having extra rock the decision was made to stay with the two forms of proposed treatments.
