Enclosed are two reports for the 2008-2009 erosion control work done on Lake Chelan under US Army Corps of Engineers (USACE) permit number NWS 2007 1652 CRC by the Forest Service. A certificate of compliance has been mailed to the USACE and copies of the report validating all required Large Woody Debris anchored and placed per WDFW agreement.

Chelan Ranger District
Deer Point Campground
Erosion Control Treatment Site 58 Report
2009

Site 58 is the second erosion site treated under the Lake Chelan Hydroelectric Project No.637-022, under Article 401. The treatment followed the site specific plans for this site filed November 7, 2007 by Chelan PUD with the Federal Energy Regulatory Commission's (FERC) for approval of the Erosion Control Implementation and Erosion Monitoring and Maintenance Plan (Erosion Control treatment Plans) and the Site-Specific Erosion Control Plan (Site-Specific plan for site 58). On December 14, 2007, FERC issued the Order approving these plans.

Chelan Ranger District
Mitchell Creek Campground
Erosion Control Treatment Site 59 Report
2009

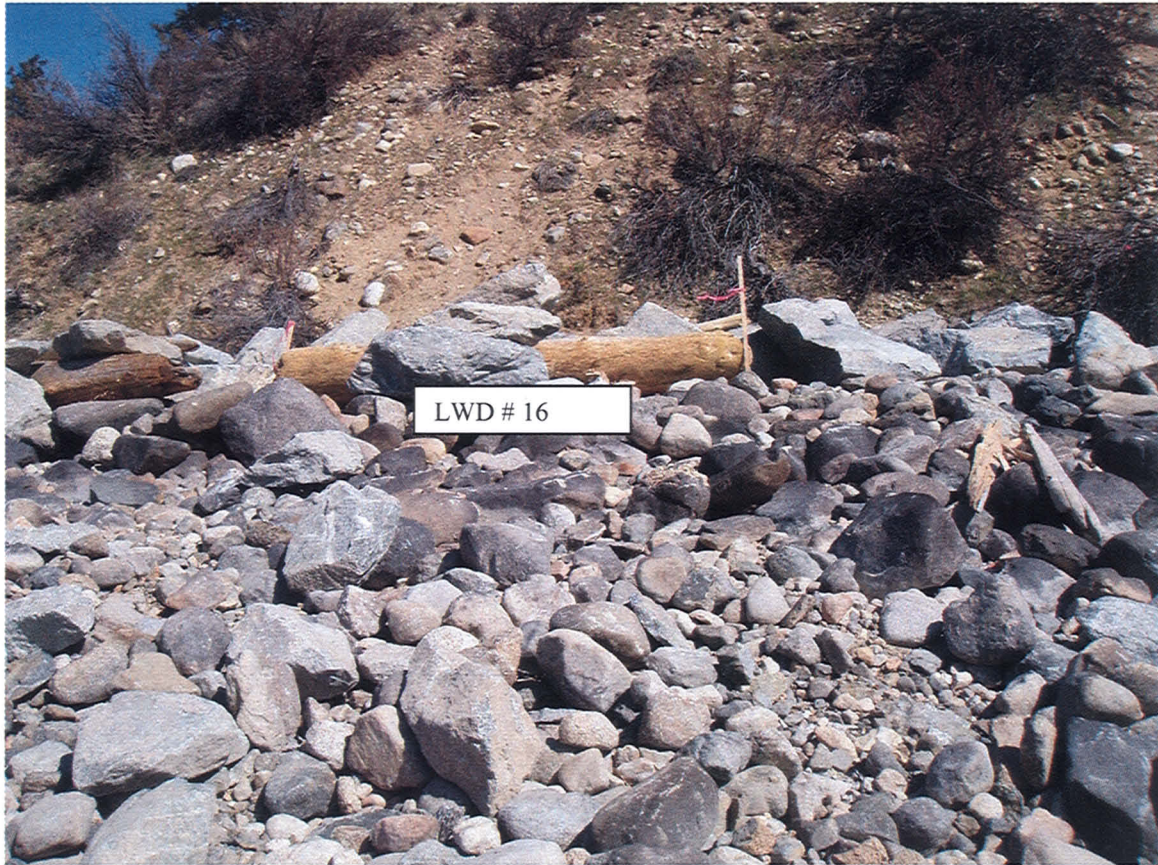
(LWD # 16)

LWD # 16 is anchored by a large single rock centered on top of the log between two other large rocks.

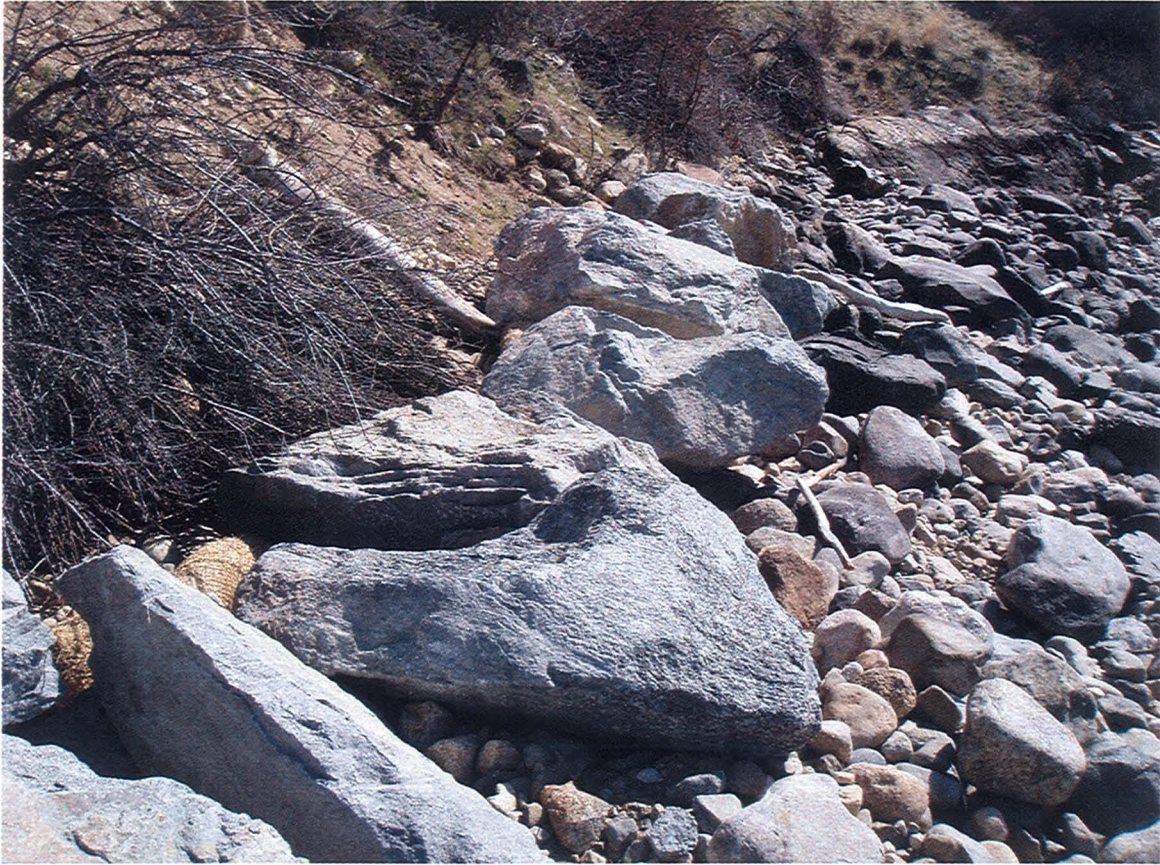
Mitchell Creek site 59 end of treatment, F1 single rock treatment.

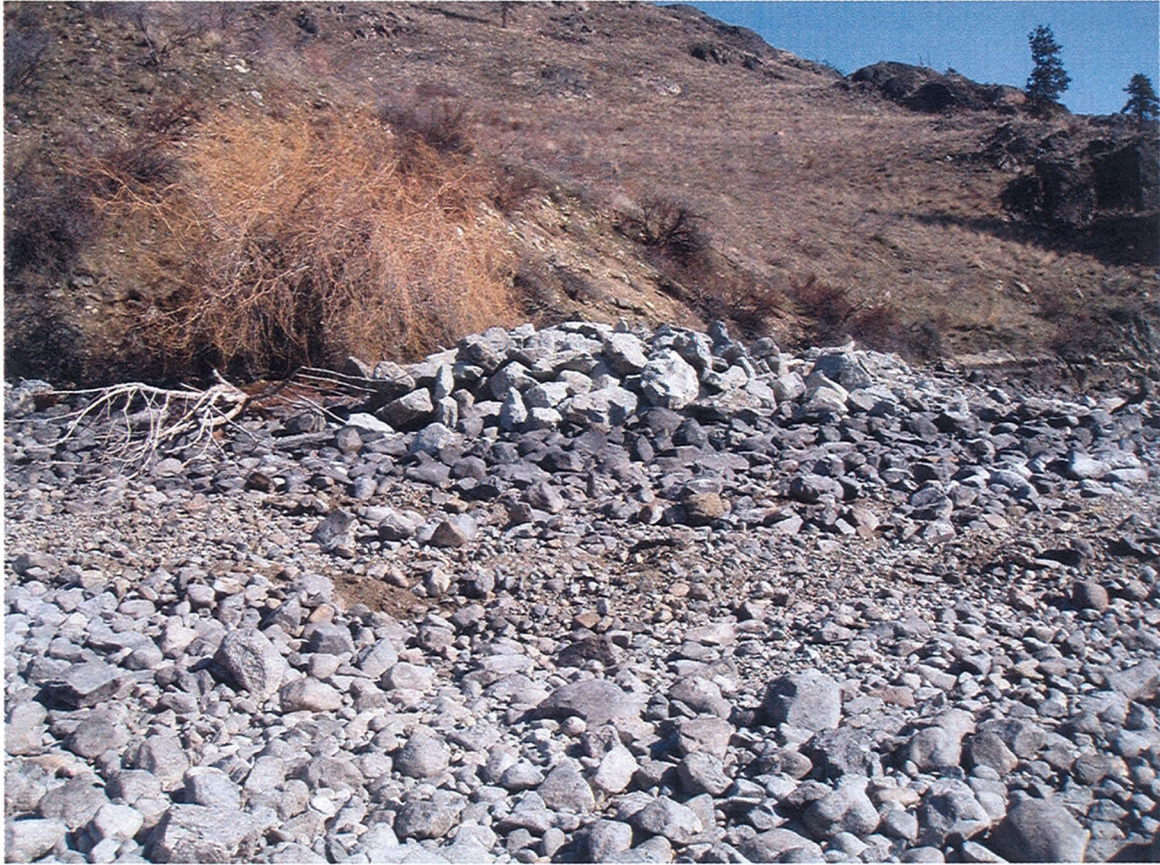
Mitchell Creek storage location of rock to beef up future treatments for LWD, or stream work; approximately 45 yards of material.
