Re: Chelan River Project Monthly Report

Chelan River Project – Monthly Report
Lake Chelan Hydroelectric Project – FERC No. 637
Public Utility District No. 1 of Chelan County

December 15th, 2008

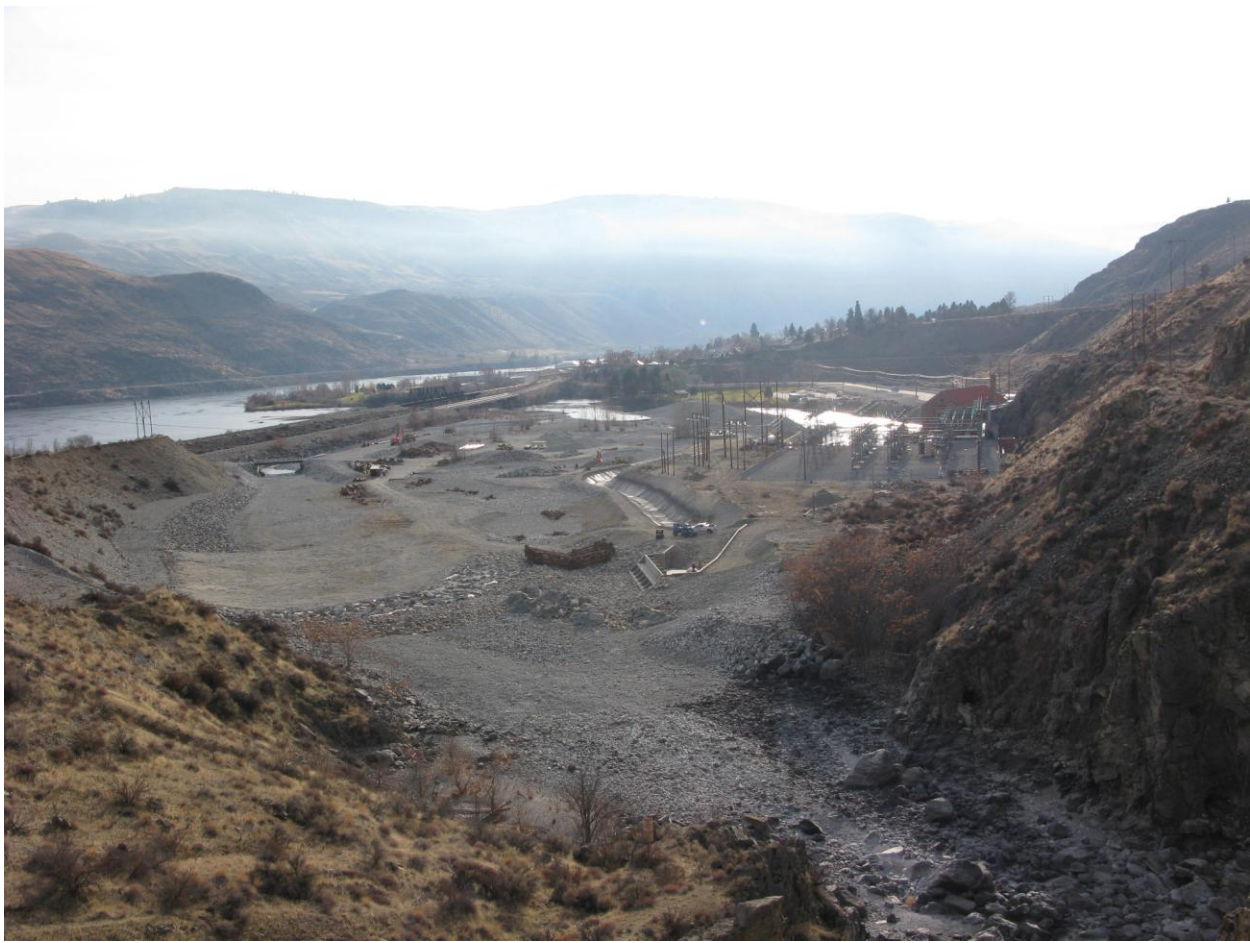
This shows Reach 4 looking south, on December 11th, 2008. The pumped water conveyance canal temporary embankment has not yet been removed to meet the outlet structure. Concrete work on the outlet structure is complete. The Hydraulic Control Structure is complete, and so is the entrance log jam. Reach 4 (spill channel) is complete except for access road removal, and temporary bridge removal. Grading and gravel (fish mix & riffle mix) installation in the Habitat Channel is complete.

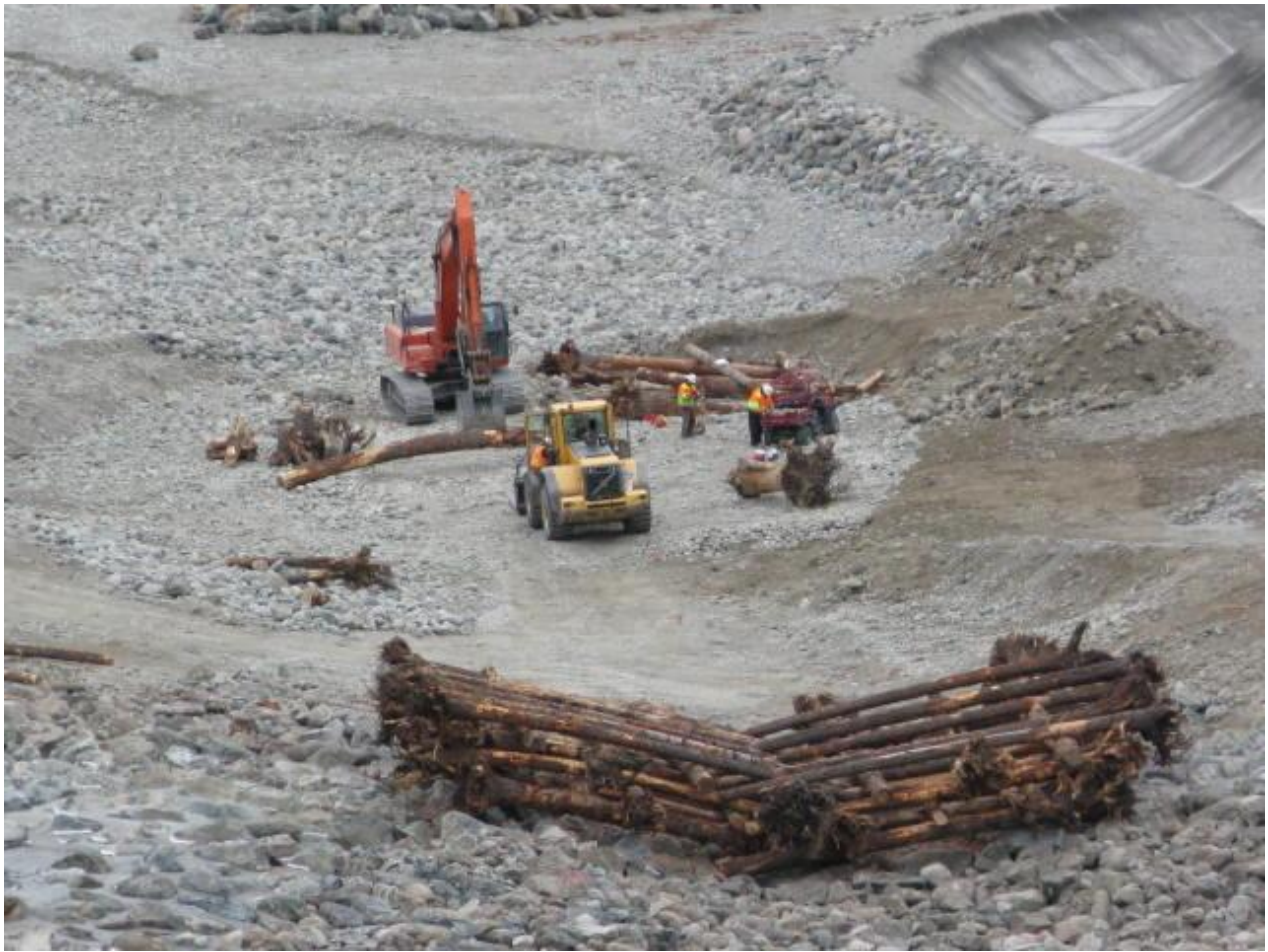
Picture taken on 12/1/08 looking south, showing the log jam at the entrance to the Habitat Channel. Forty-six trees, approximately 30 ft. long with root balls, make up this structure.

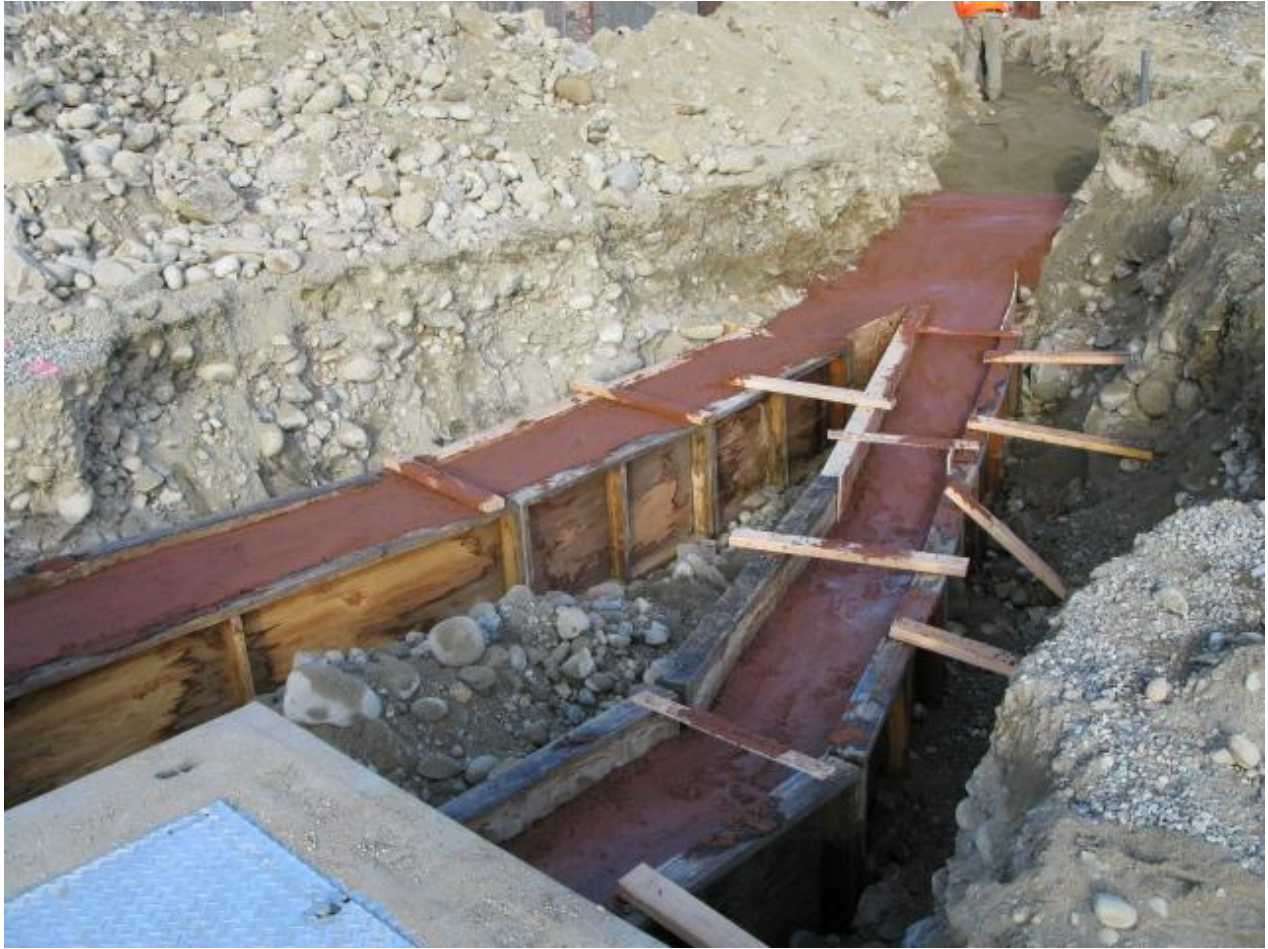
Conduit road crossings, formed up and red-dyed concrete placed. Picture taken on 12/11/08.

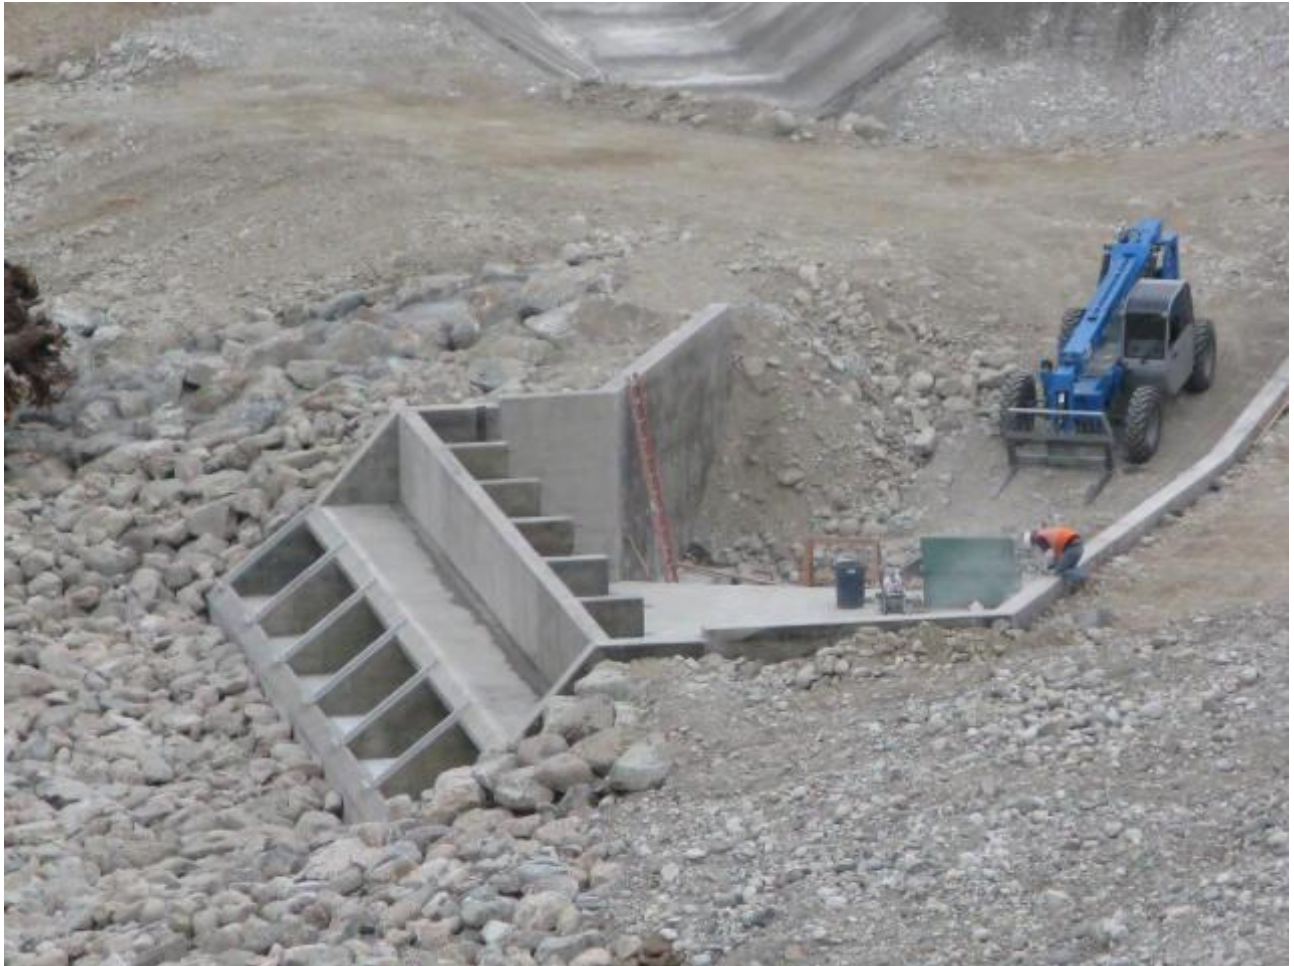
The last concrete placement for the Pumped Water Outlet Structure was on 10/27/08. Form removal, sacking and patching has now been completed, with final inspection on 12/12/08. Installation of gates, screens and walkway components remain.

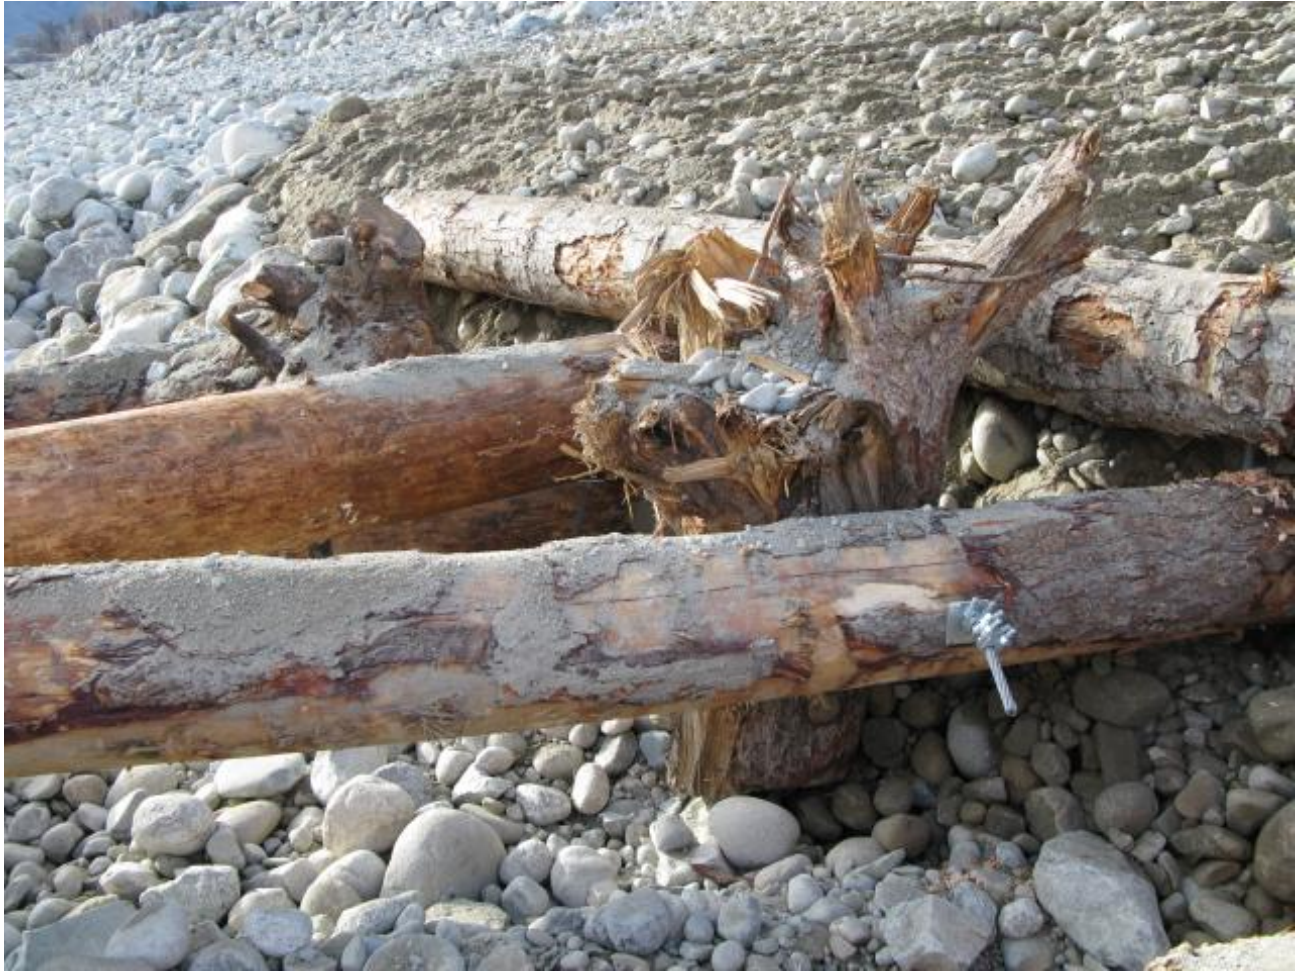
This picture is of a completed V-Log Jam in the habitat channel. Picture was taken on 12/2/08.

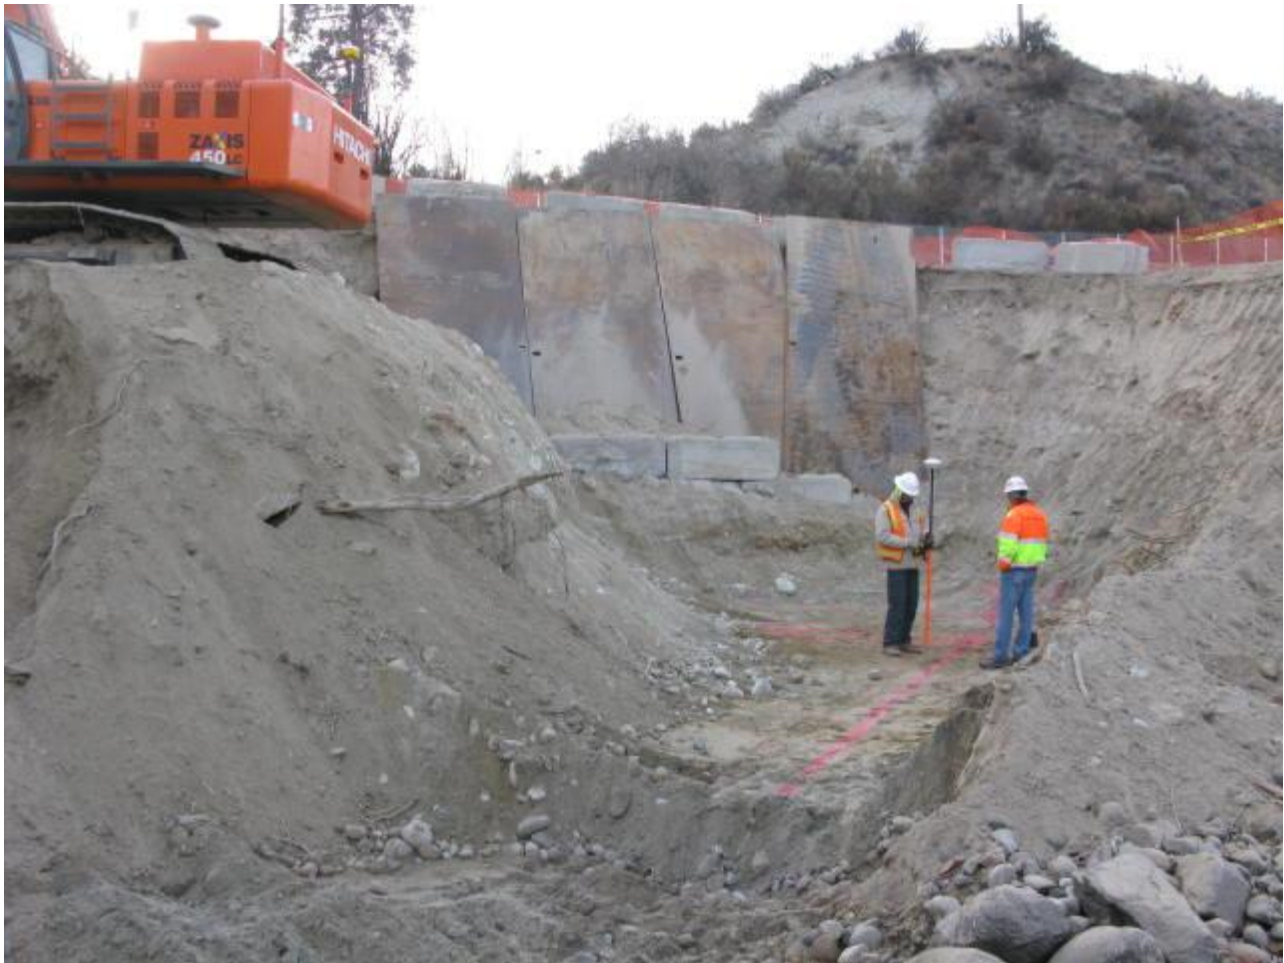
Excavation work is underway at Lake Chelan Dam, for the outlet structure for the Low Level Outlet. Picture was taken on 12/9/08.
