B1 to B4 Rehab

Assessment of Reused Components

Commission Presentation

August 7, 2017

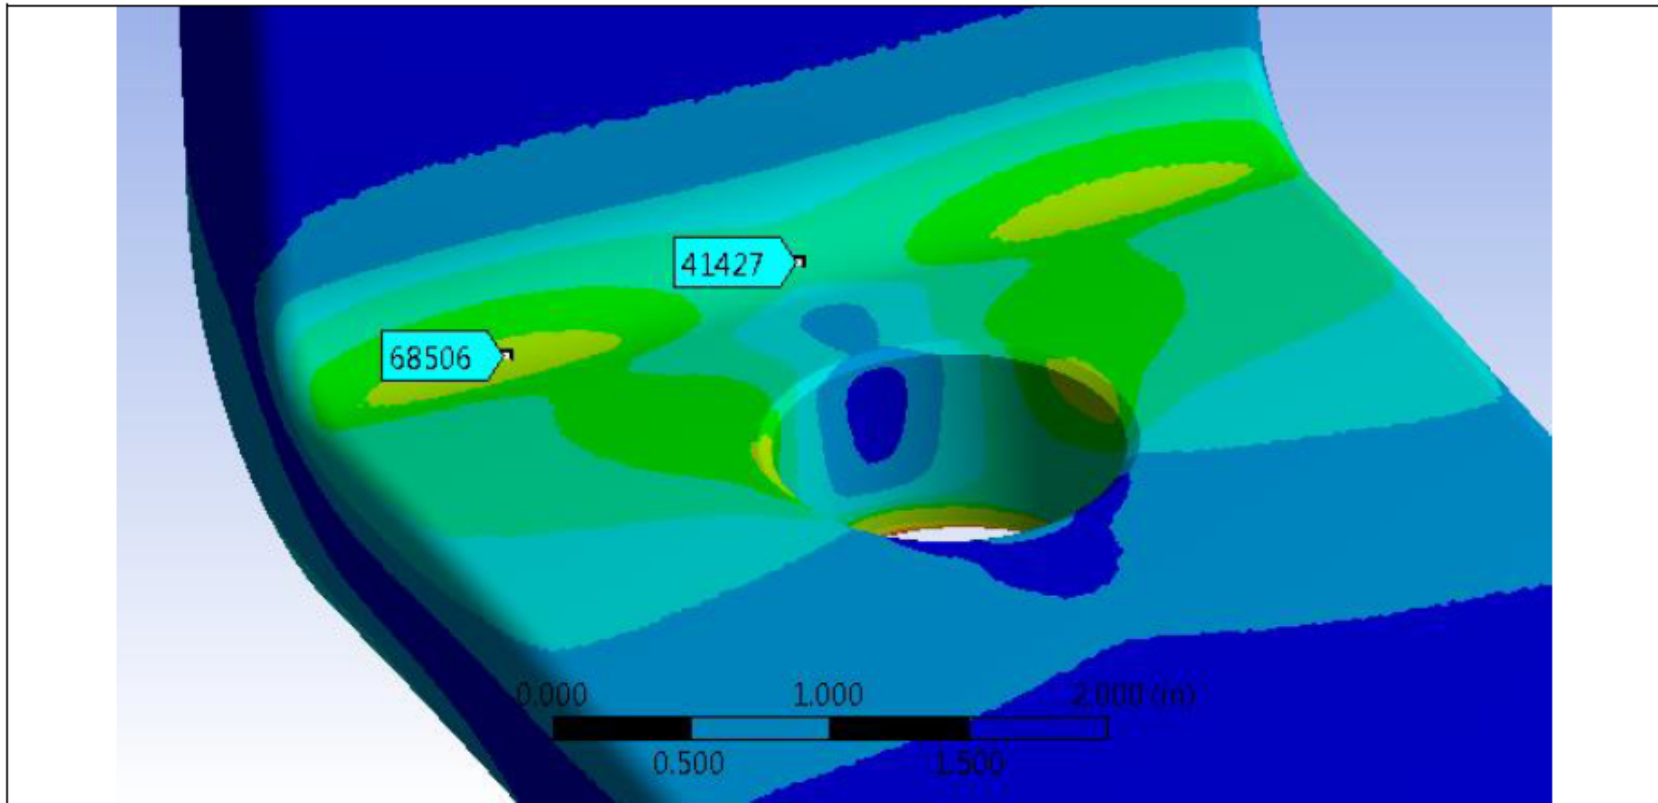
Pole L Bracket FEA

Von Mises stress in top side of endplate radius at runaway.

Bulk: $P_L + P_b \in (41.4\text{ksi}, \dots 68.5\text{ksi}) \gg 1.155 \times 0.667 \times S_y = 31.6 \therefore$ not acceptable per contract

This region is under serious risk of plastic collapse during runaway speed.

Local: $P_L + P_b + Q + F = 68.5\text{ksi} \rightarrow$ fatigue analysis conducted for completeness

- Contract has option for new poles at \$1.15 million per unit additional cost (\$1.65M).
- Recommendation – Because of cracks in material and overstress at runaway, propose to replace pole body and reinsulate winding all 4 units.
- Cost estimated at \$750k per unit additional cost (\$1.25M).

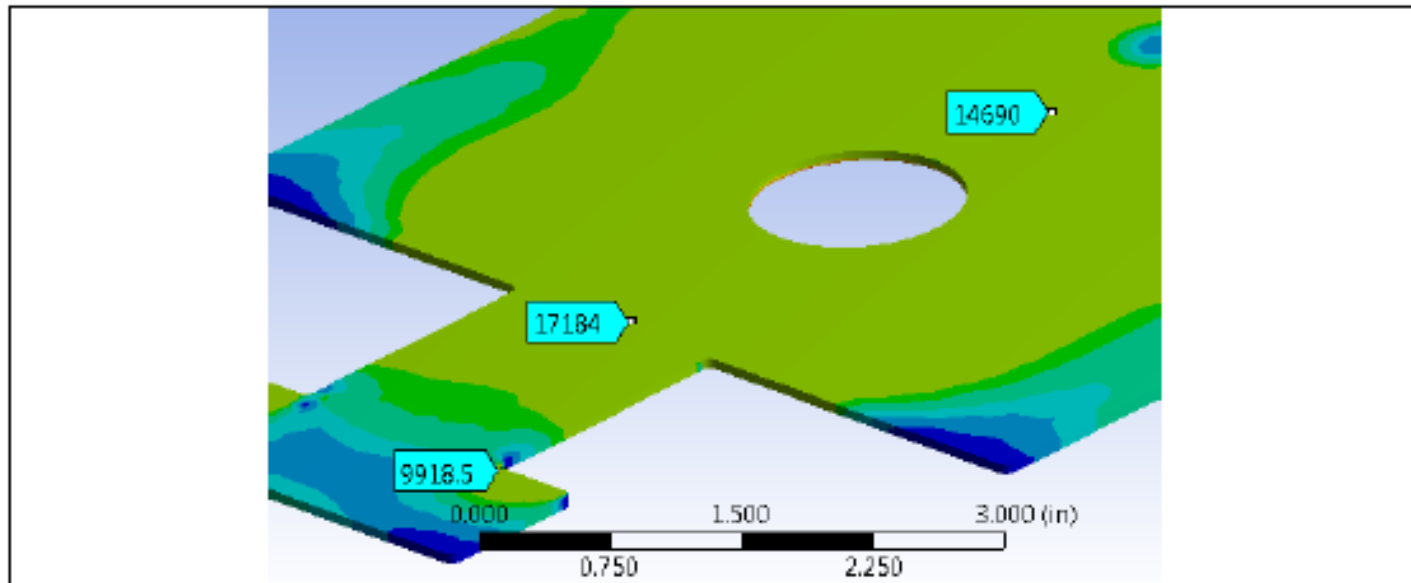
Pole Body Lamination FEA

Von Mises stress at dovetail radius and dovetail neck at runaway speed.

Local: $P_L + P_b + Q + F = 9.9\text{ksi}$ → fatigue analysis required

Bulk: $P_L + P_b = 17.1 < 1.155 \times 0.667 \times S_y = 27\text{ksi}$ ∴ acceptable per contract

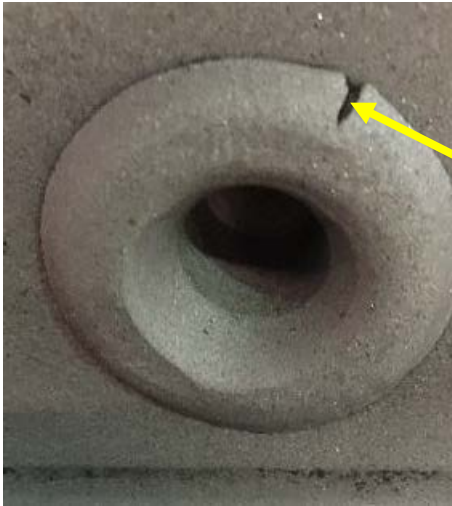
- Condition assessment performed for rotor poles. 6 poles removed for evaluation.
- Problems (similar in all 6 of 72 inspected)
 - Rivets: some cracked and loose
 - Dovetail: cracks in welds
 - 90% probability pole body will not last 50 years
 - Winding: copper looks to be reusable if reinsulated.

RIVET CRACKS

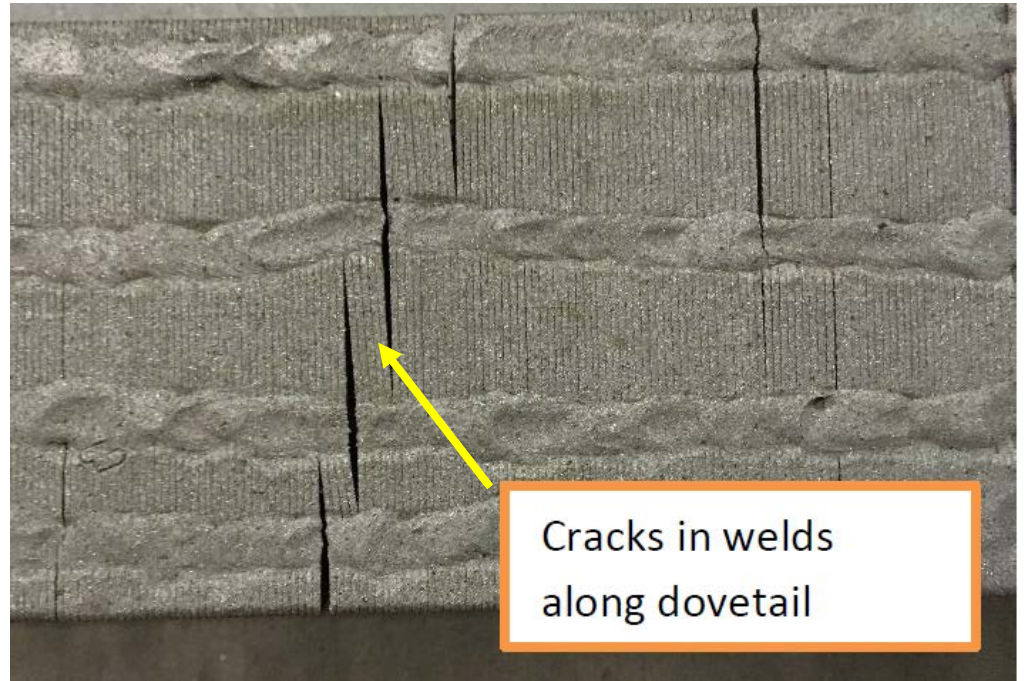
Cracks in welds
along dovetail

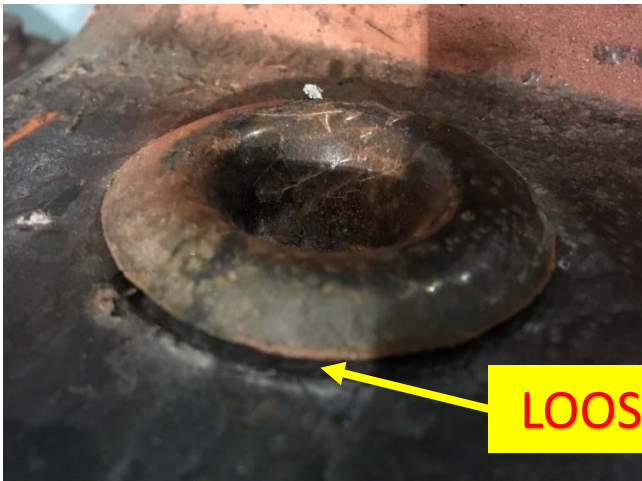
LOOSE RIVETS

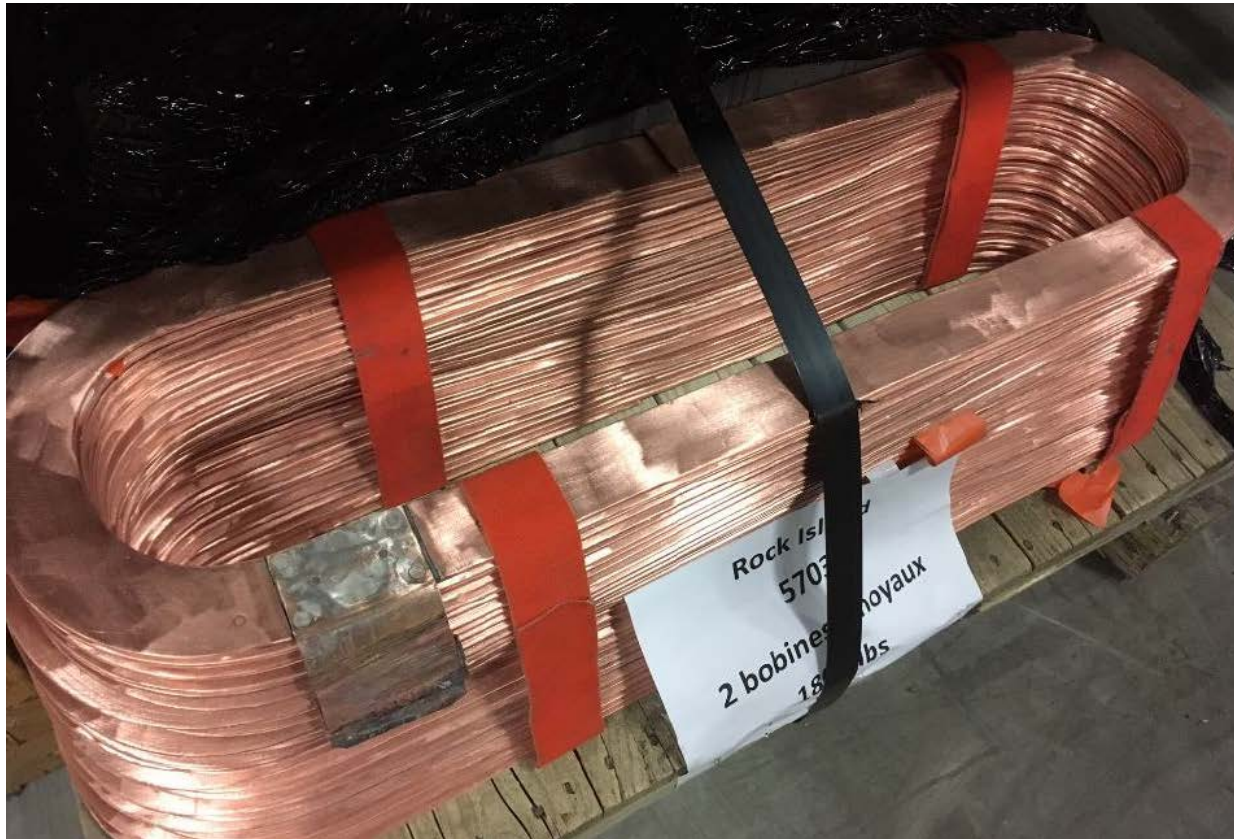
B4 copper winding after insulation removal

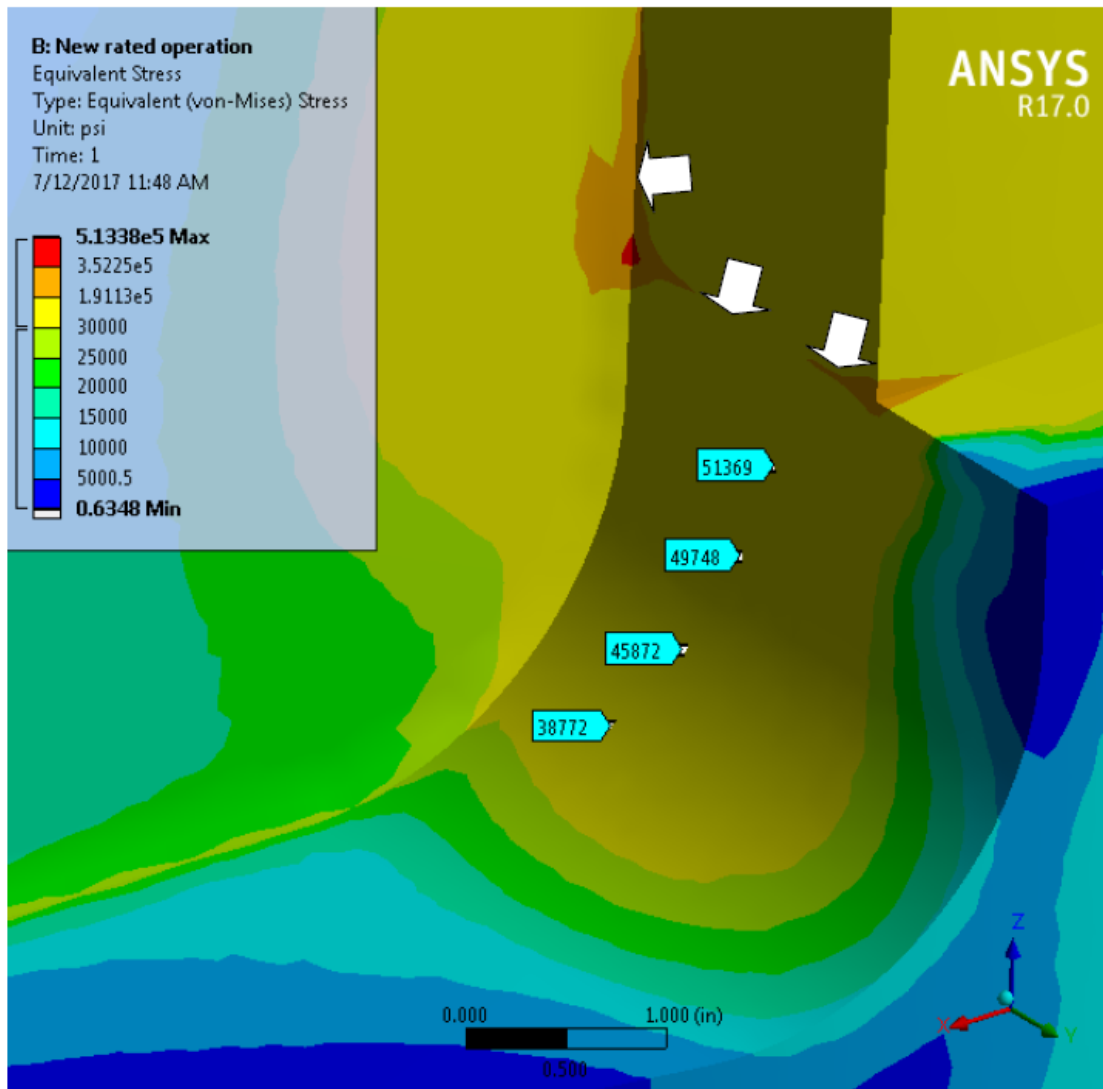
Gen shaft FEA at rotor keyway

Figure 15: Von Mises stress in bottom of torque keyway at new rated operation.

Local: $\sigma_L + \sigma_b + \sigma_Q = 51\text{ksi} > 0.8 * 1.5 \sigma_{all} = 24\text{ksi}$: static stress not acceptable

Note: The as-measured main radius in this area is generously sized, so the presence and role of σ_F and fatigue are debatable. Nevertheless, a fatigue check using a principal stress made up largely of $\sigma_L + \sigma_b$ is done for completeness.

- Recommendation – Purchase new gen shaft all 4 units
 - Benefits are that \$100k goes to new purchase with full 50-yr life and no schedule impacts.

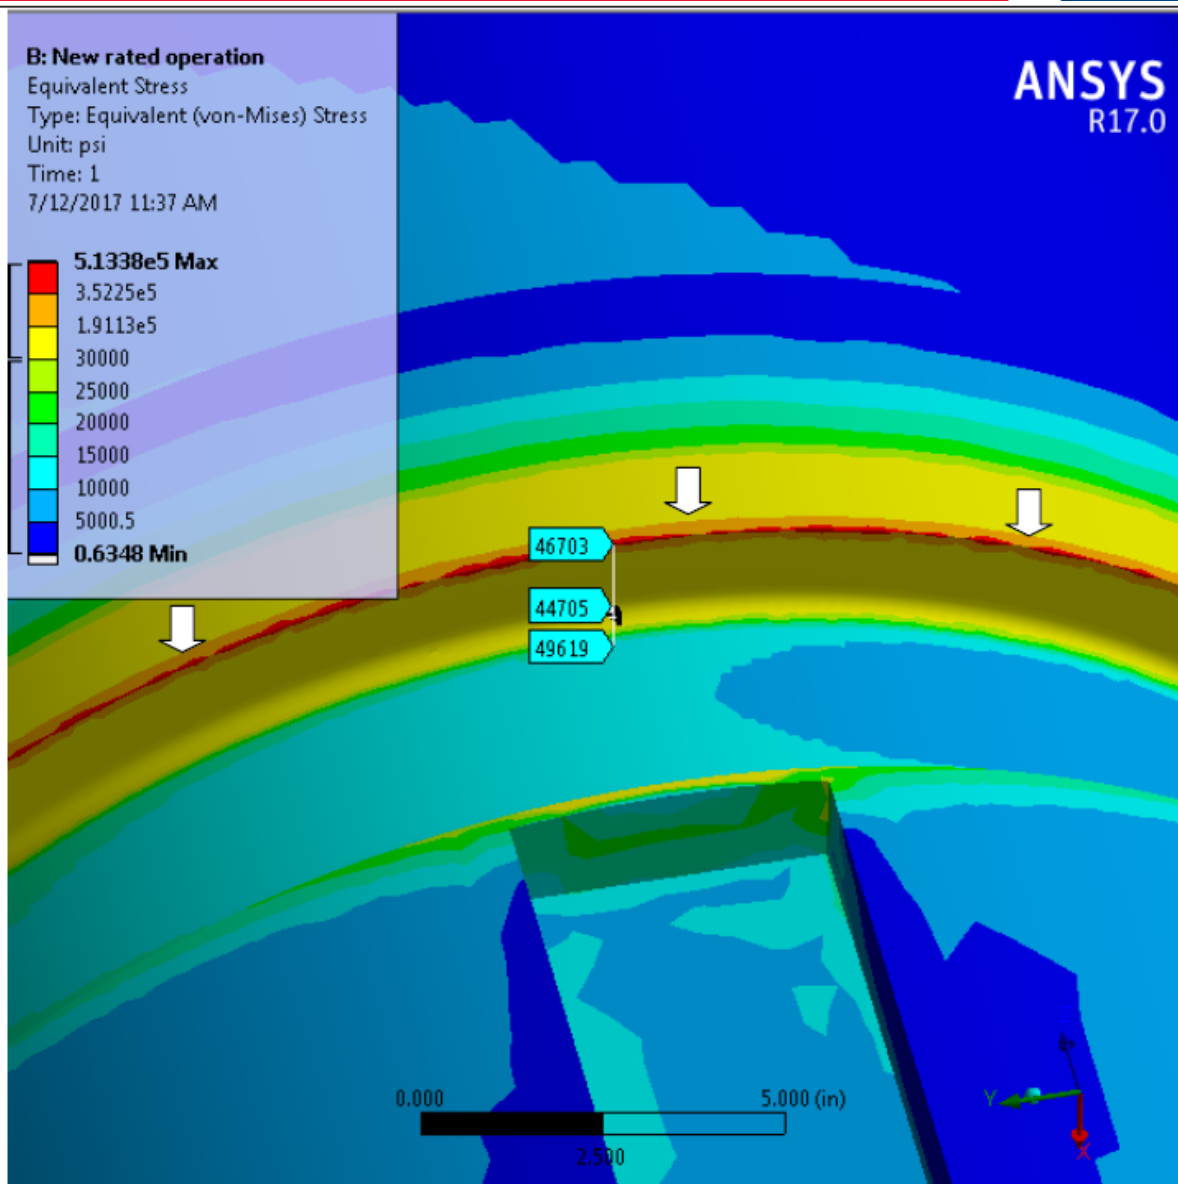
Gen shaft FEA at axial thrust keyway

Figure 14: Von Mises stress in top radius of axial thrust keyway at new rated operation.

Local: $\sigma_L + \sigma_b + \sigma_Q + \sigma_F = 50 \text{ ksi} > 0.8 * 1.5 \sigma_{all} = 24 \text{ ksi}$: static stress not acceptable
 → fatigue analysis required

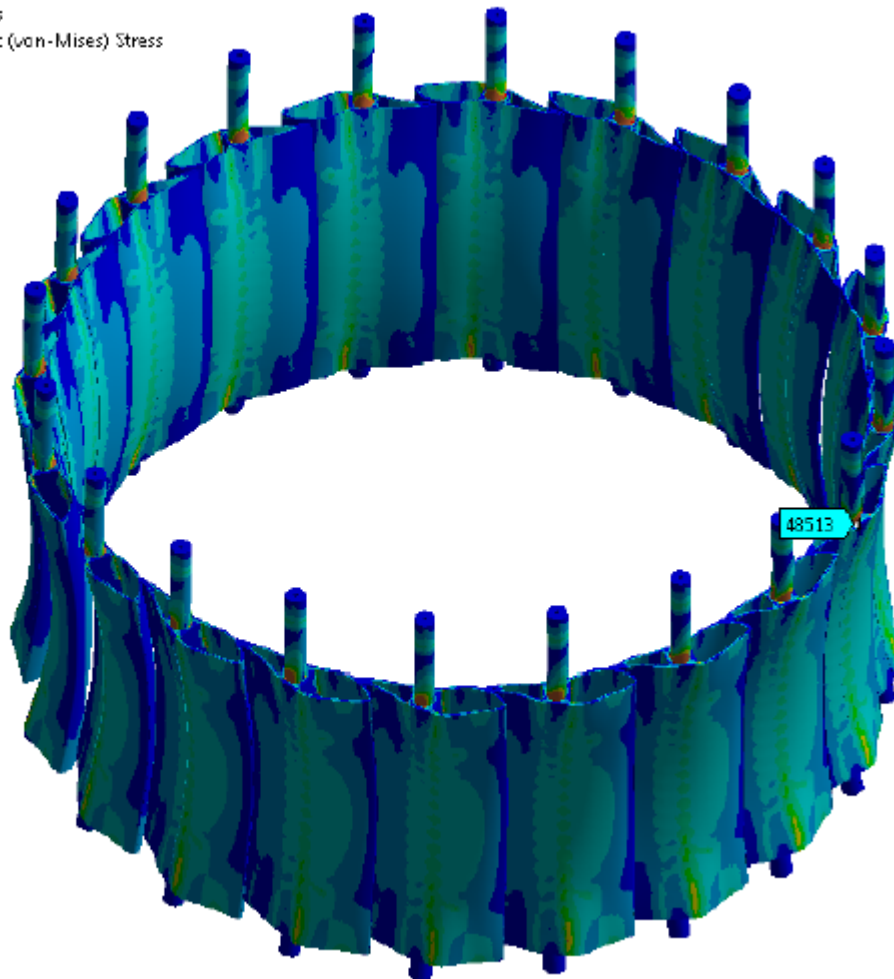
Wicket Gate Stress Analysis

9.1.6 LC1 Wicket Gates Von Mises Stress

Equivalent Stress
Type: Equivalent (von-Mises) Stress
Unit: psi
Time: L
Max: 51599
Min: 17.751

- Contract has option for new wicket gates at \$575k per unit additional cost.
 - FEA recommends stem machining est. at \$100k per set, which is extra work.
 - Extra work also would include crack repair, stem straightening, additional sleeves.
 - 50% chance repairs similar to B2 found on the other 3 units (\$175k).
 - 90% probability gates won't last 50 years.
 - 50% chance gates last 20 years.
 - Undefined risk – if corrosion fatigue of wicket gates is similar to blades, then all gates may be very near end of life.
- Recommendation – Purchase 3 sets of new wicket gates. Reuse B2 wicket gates.
- Benefits are that \$275k goes to new purchase with full 50-yr life and no schedule impacts

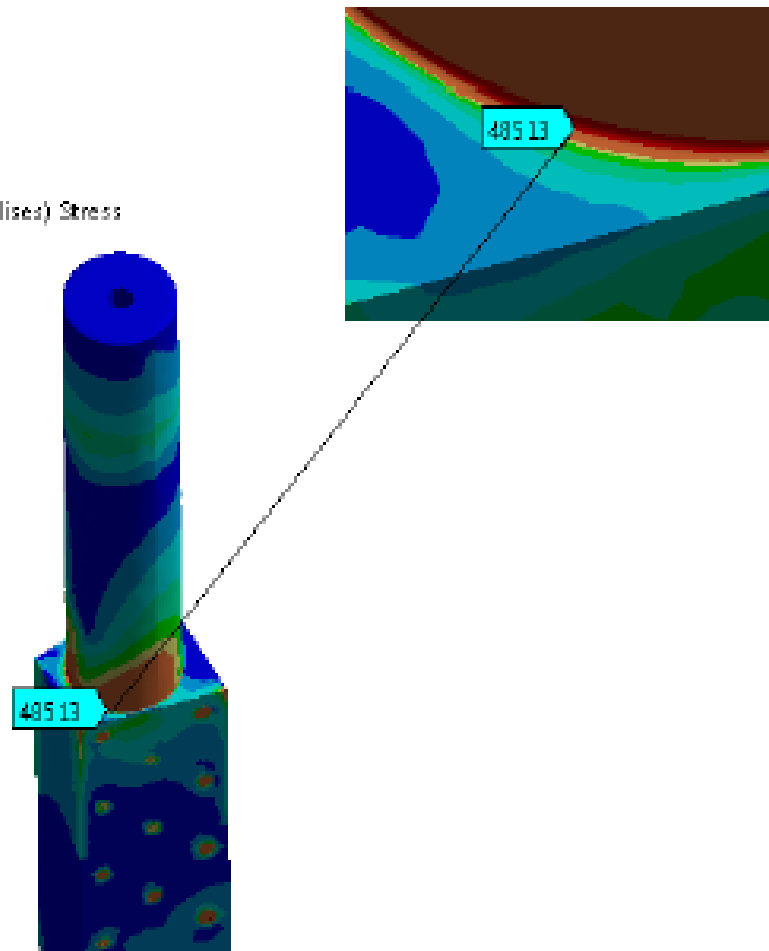
Wicket Gate Stem Stresses

9.1.7 Wicket Gate Upper Stem Von Mises Stress

Equivalent Stress Stem
Type: Equivalent (von-Mises) Stress
Units: psi
Time: 1
Max: 51599
Min: 37.622
