# Long Range Facilities Plan

## COMMISSION BRIEFING State of Facilities Conditions

January 9, 2017

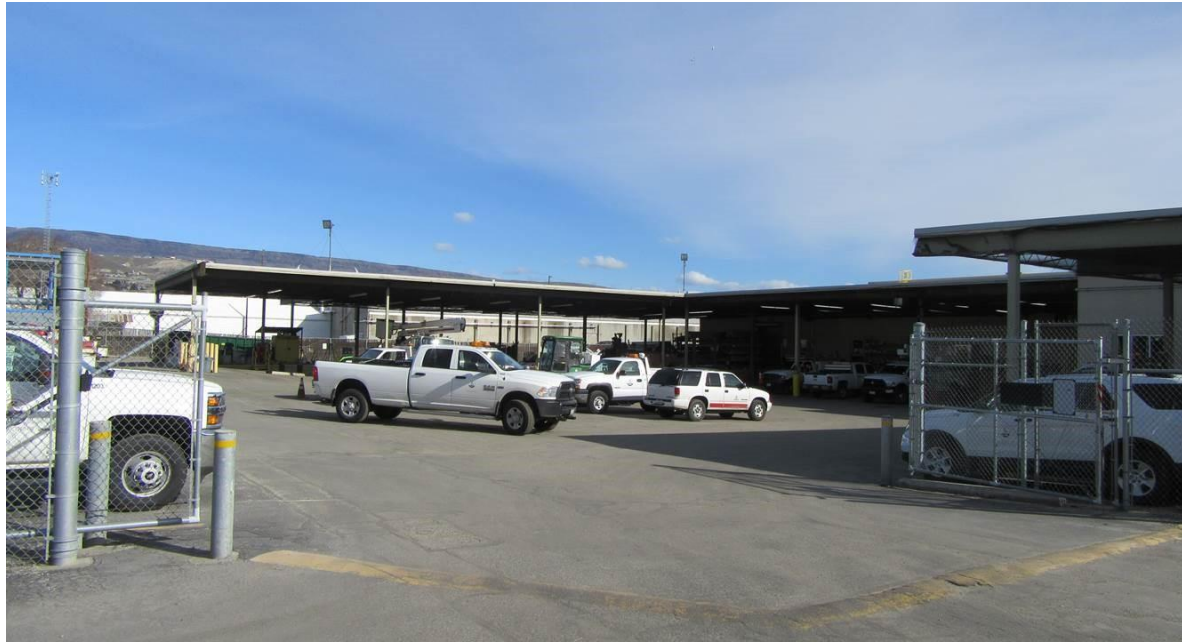
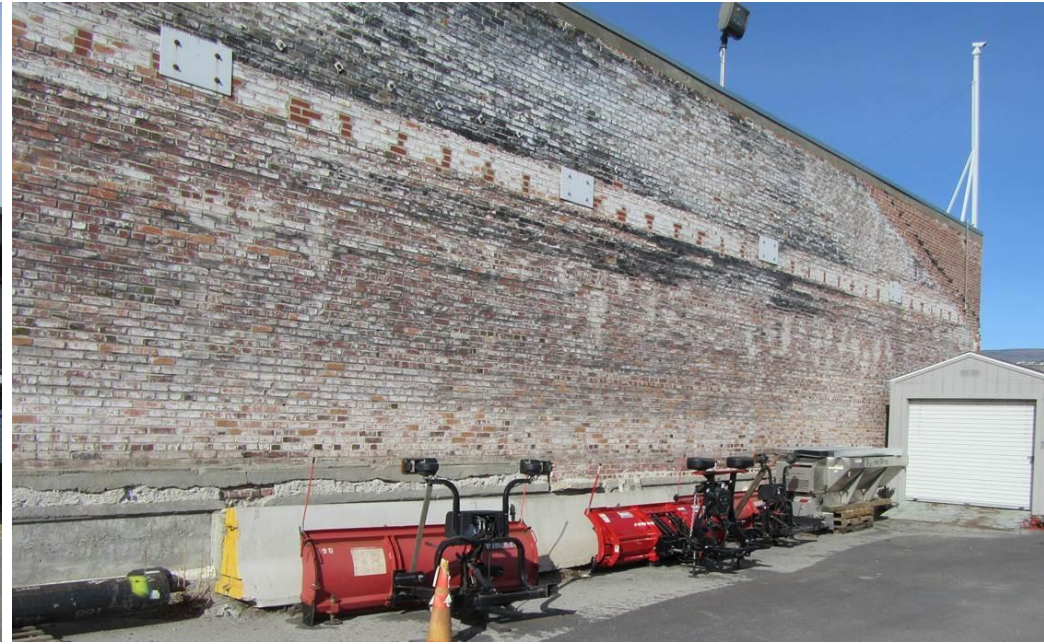
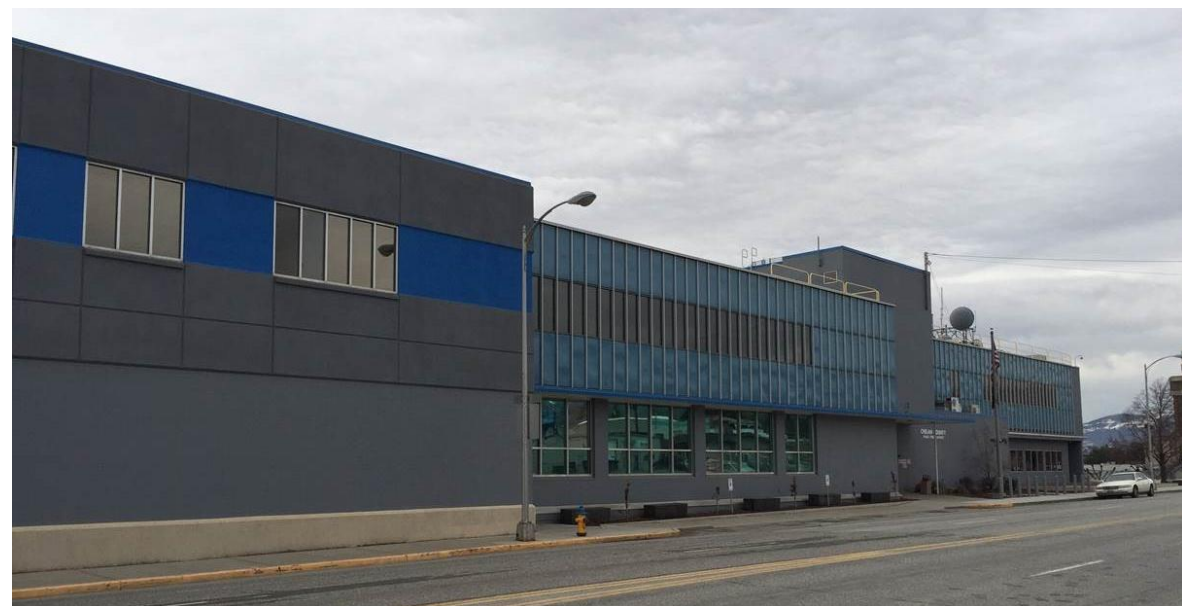
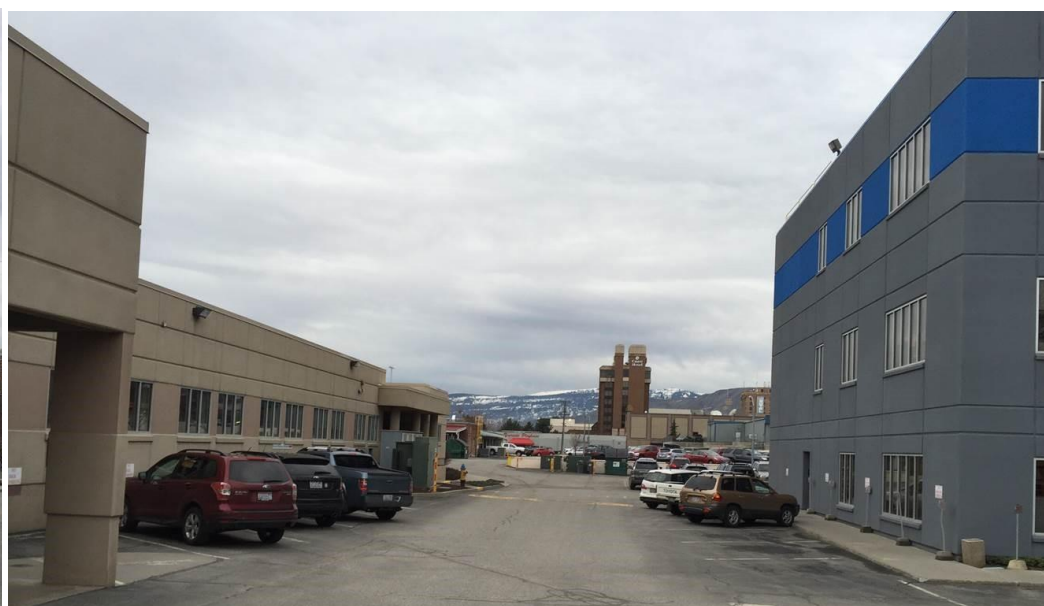
- Site configuration creates congestion, inefficiencies and unsafe conditions.
- Main building requires significant annual maintenance costs and is at capacity.
- Tech Shop is at the end of its useful life.
- Facility environments do not promote operational excellence.

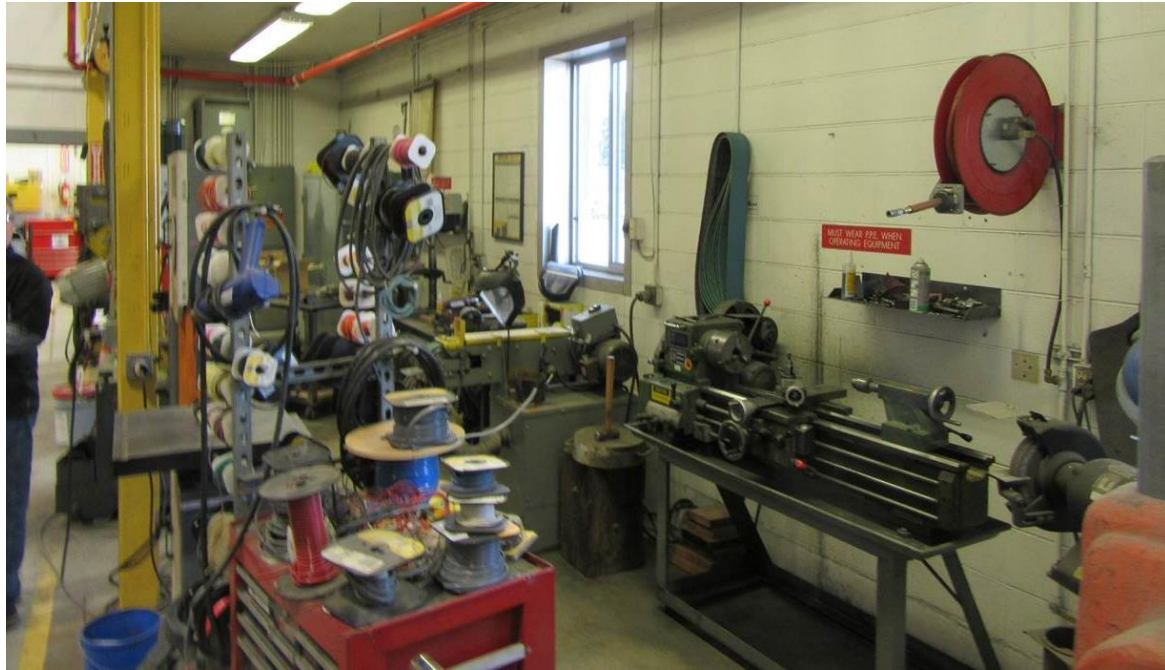
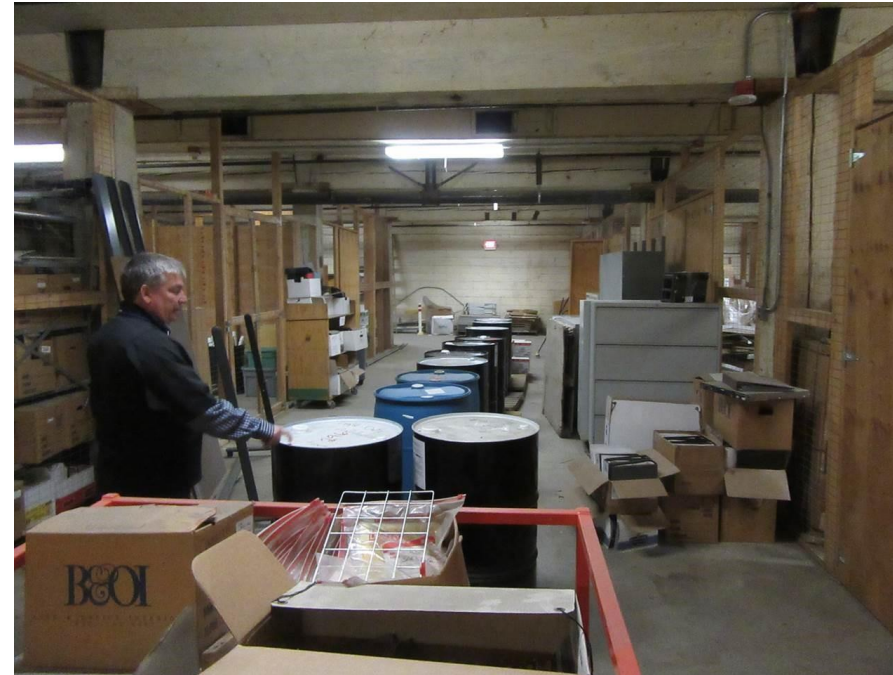
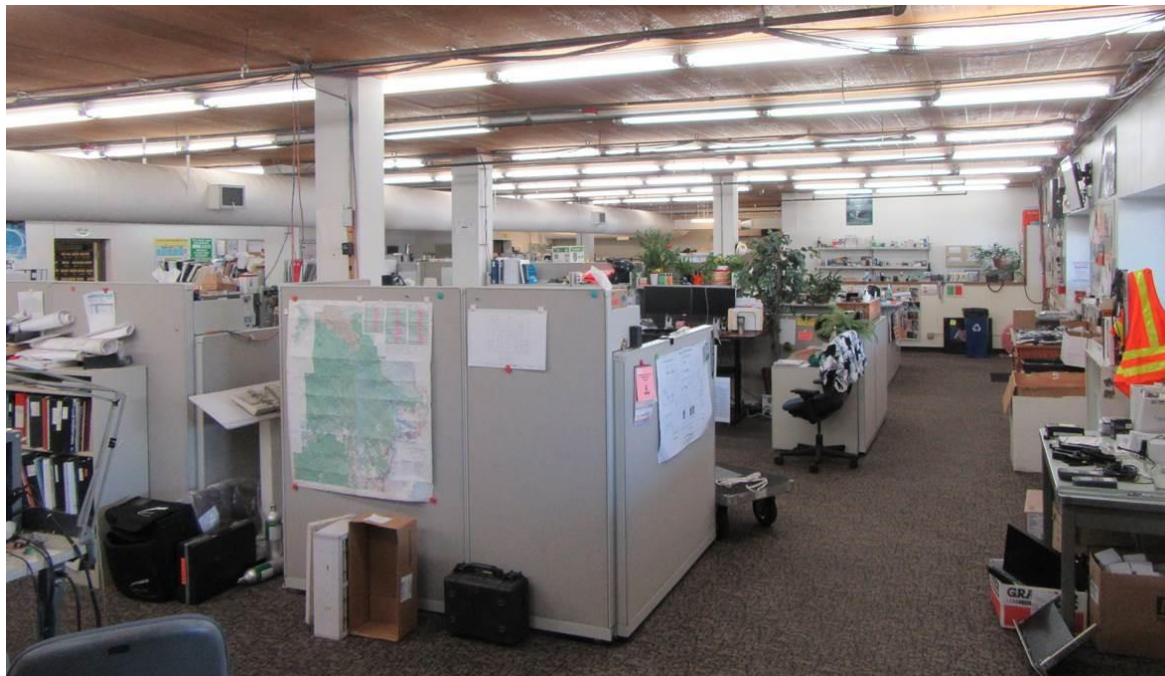
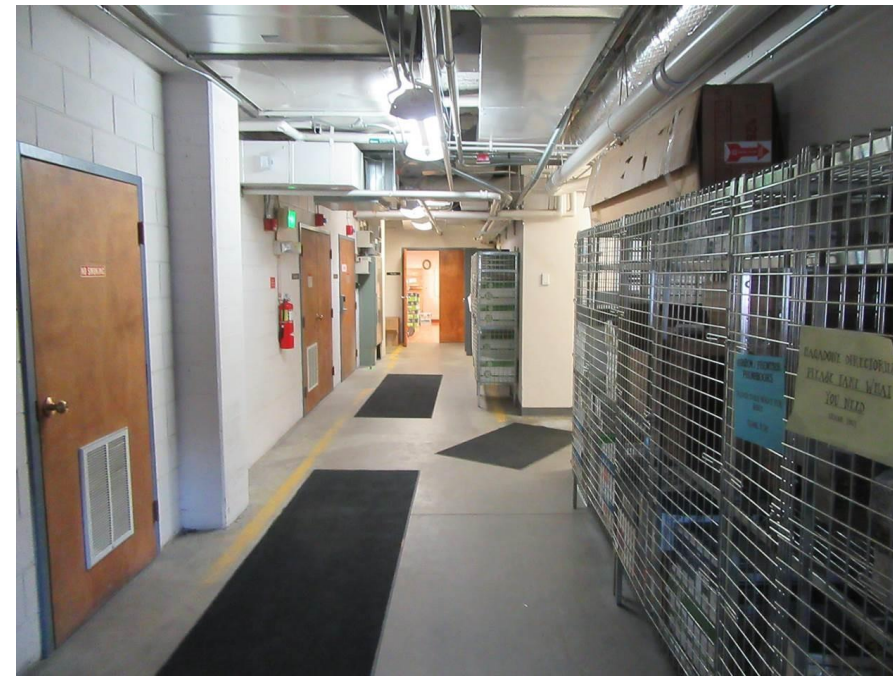
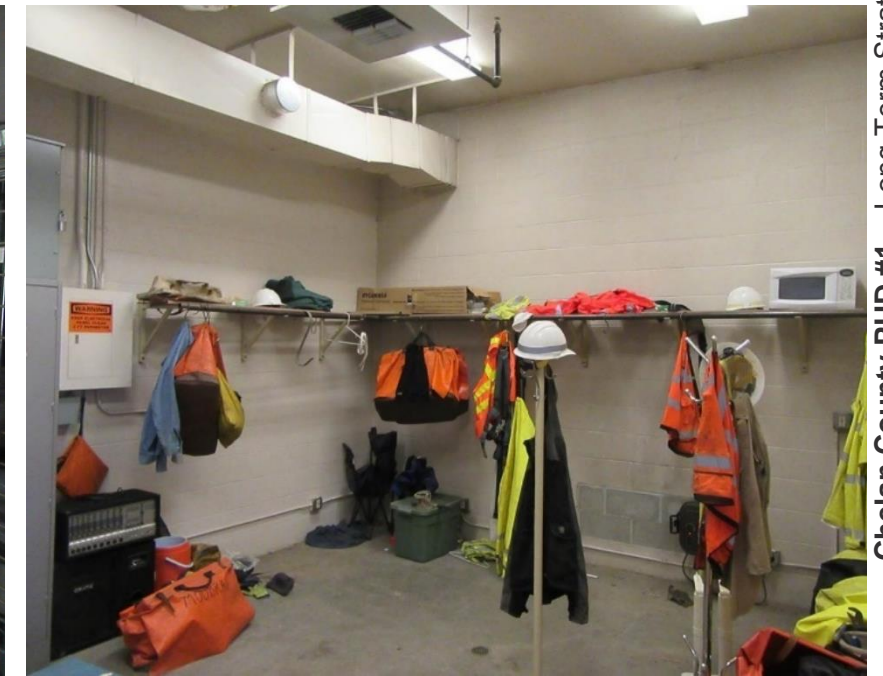
- Fleet Shop spaces are undersized and inefficient.
- Office spaces are at capacity, requiring leased space off site.
- Crew spaces are cramped and inadequate

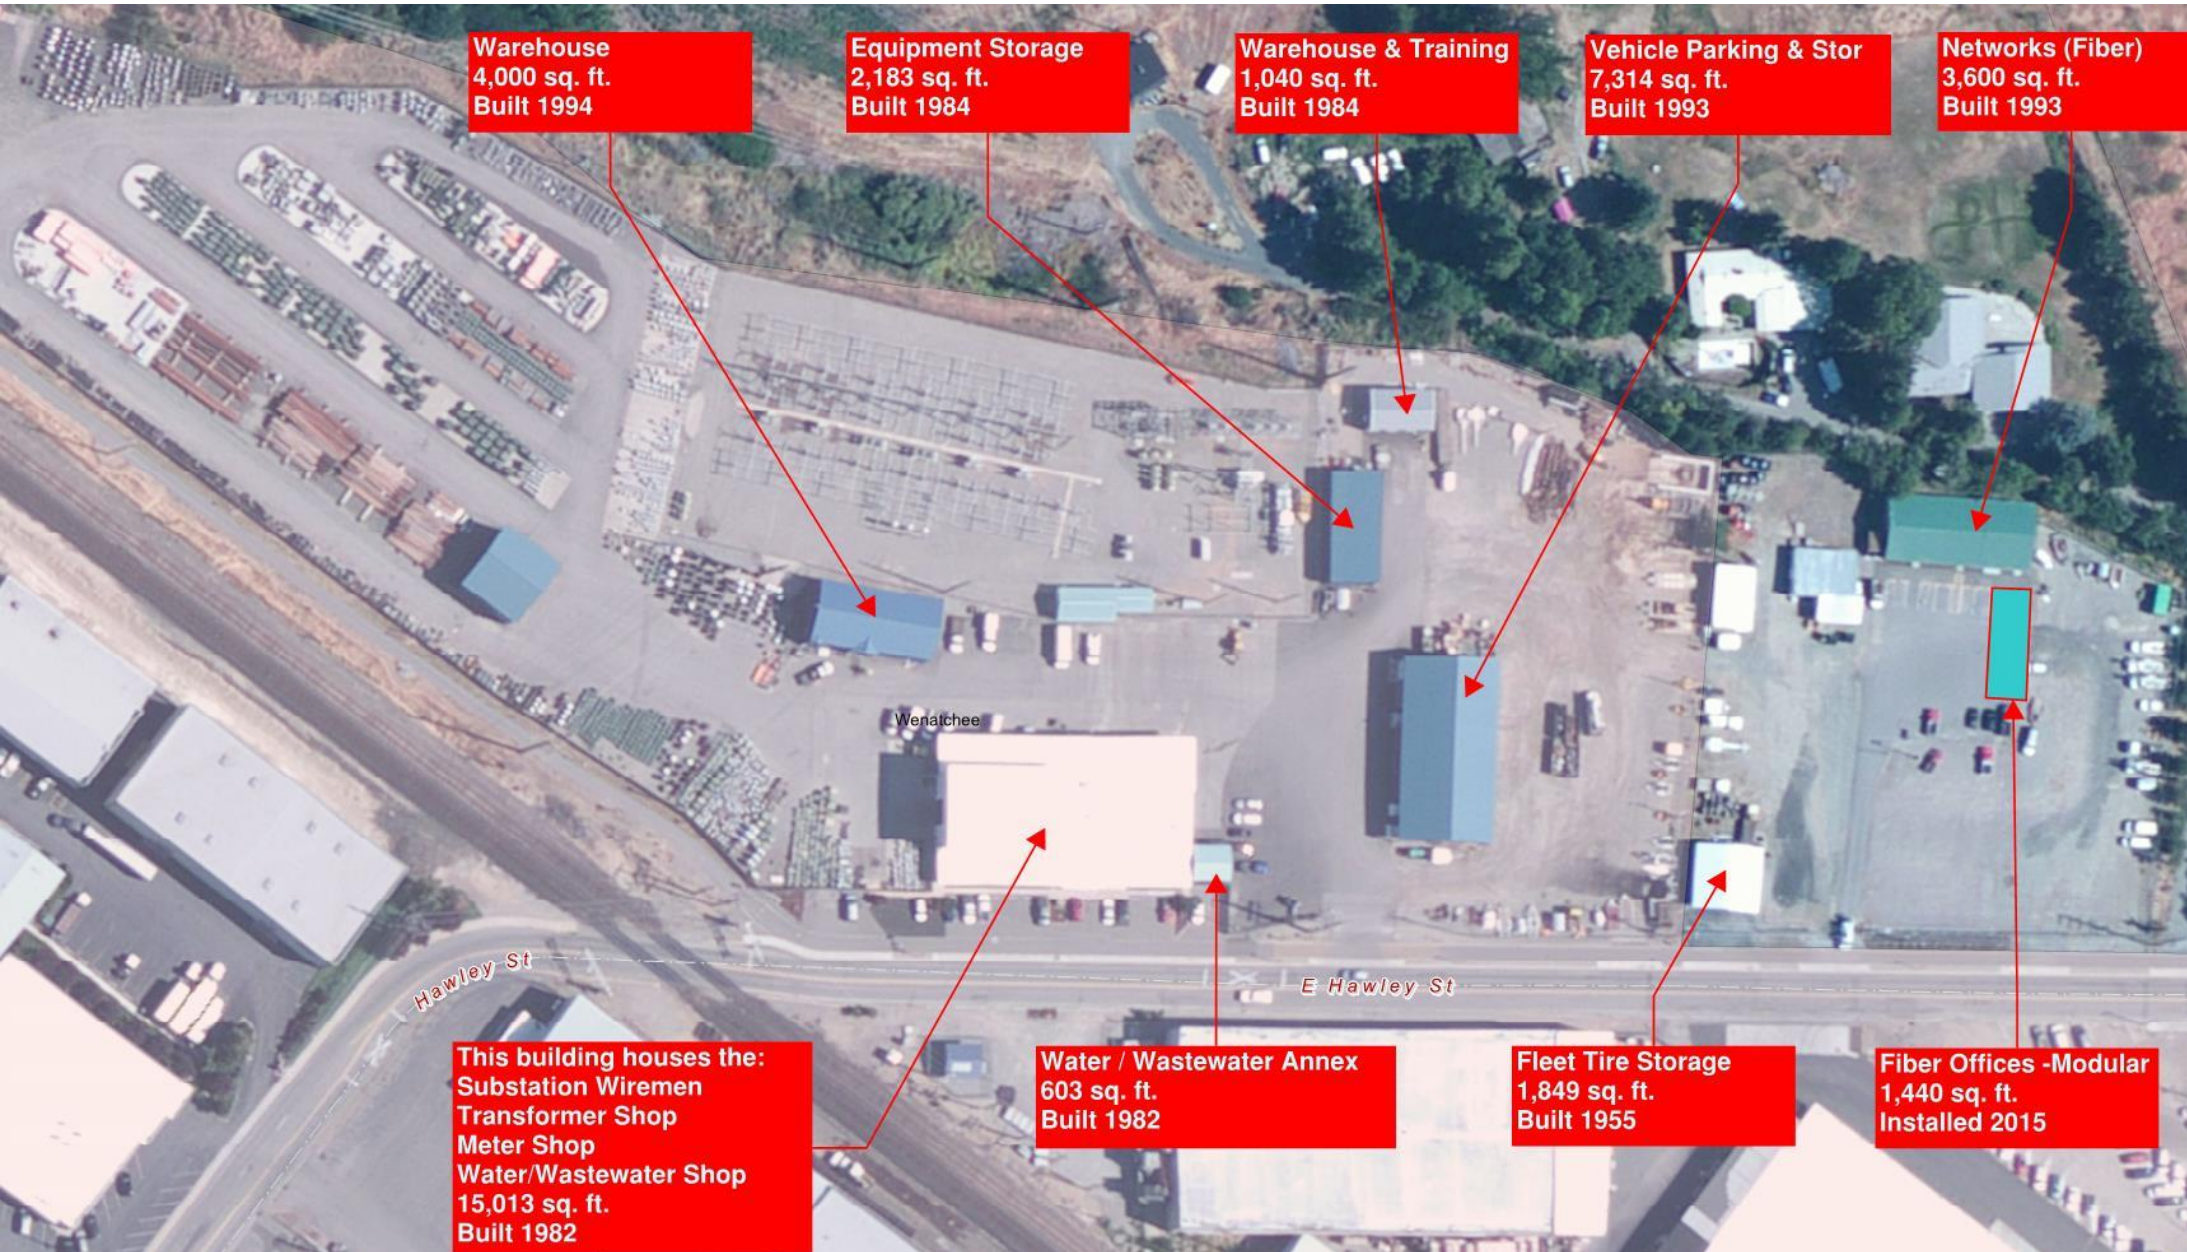
- Site conditions create inefficient work flow.
- General building quality is low. Some buildings are at or beyond useful life.
- Decisions regarding future facilities investments at Hawley Street should be tied to long term District goals.

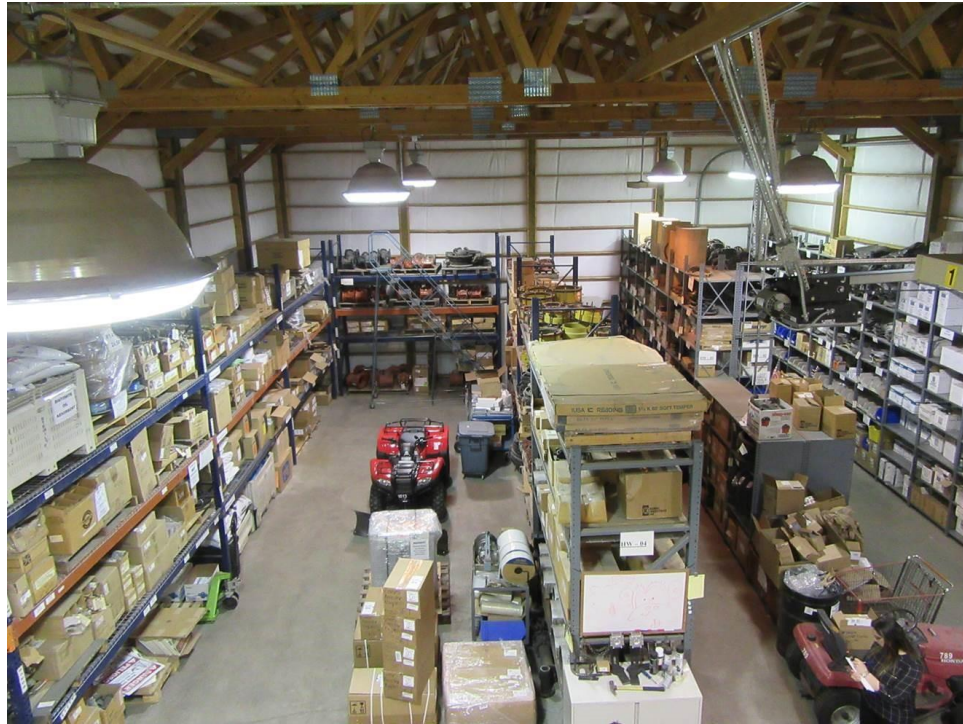
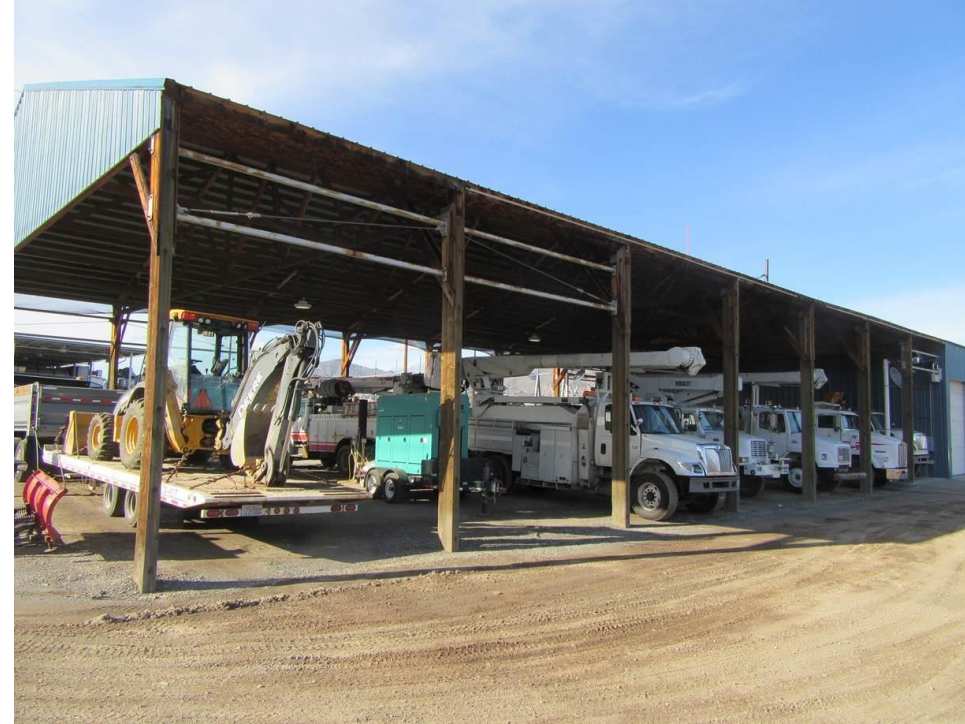
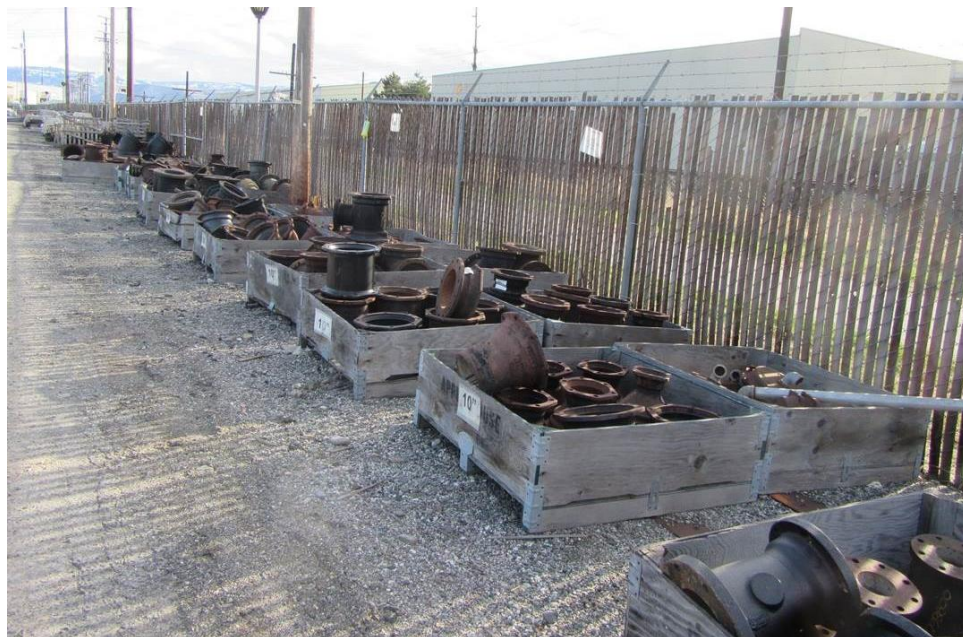
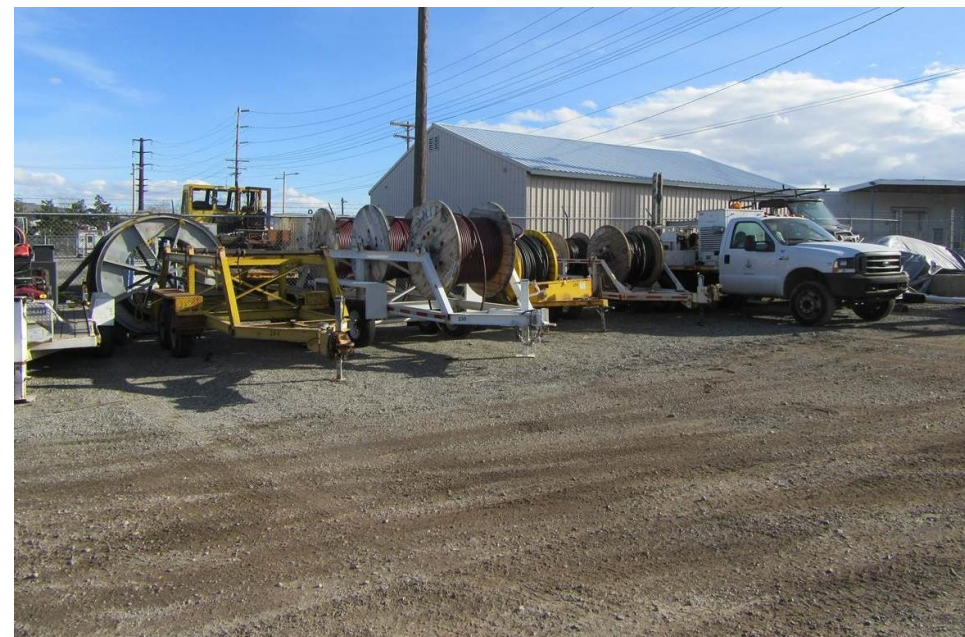
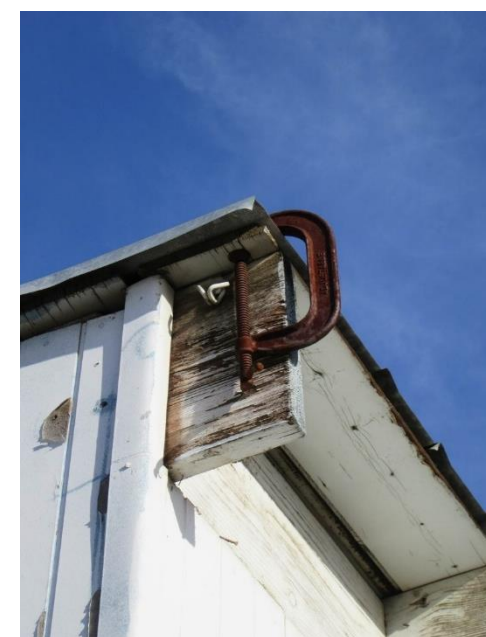
- Structure quality is questionable for value of inventory and equipment.
- Site has limited hard surfacing, creating undesirable conditions
- Yard storage

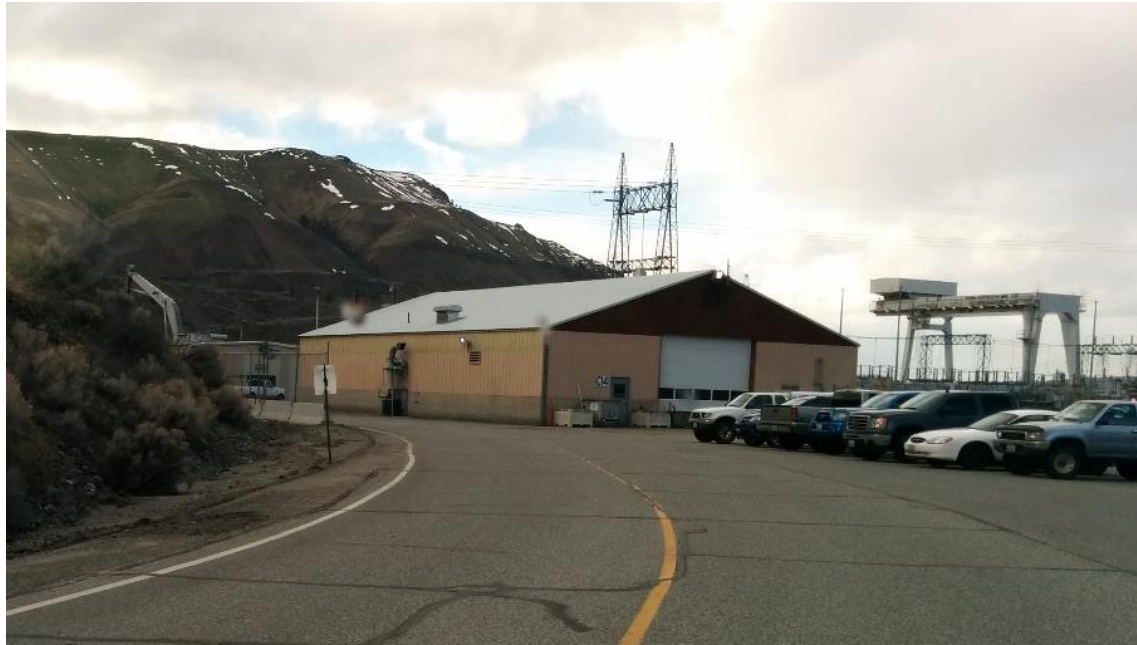
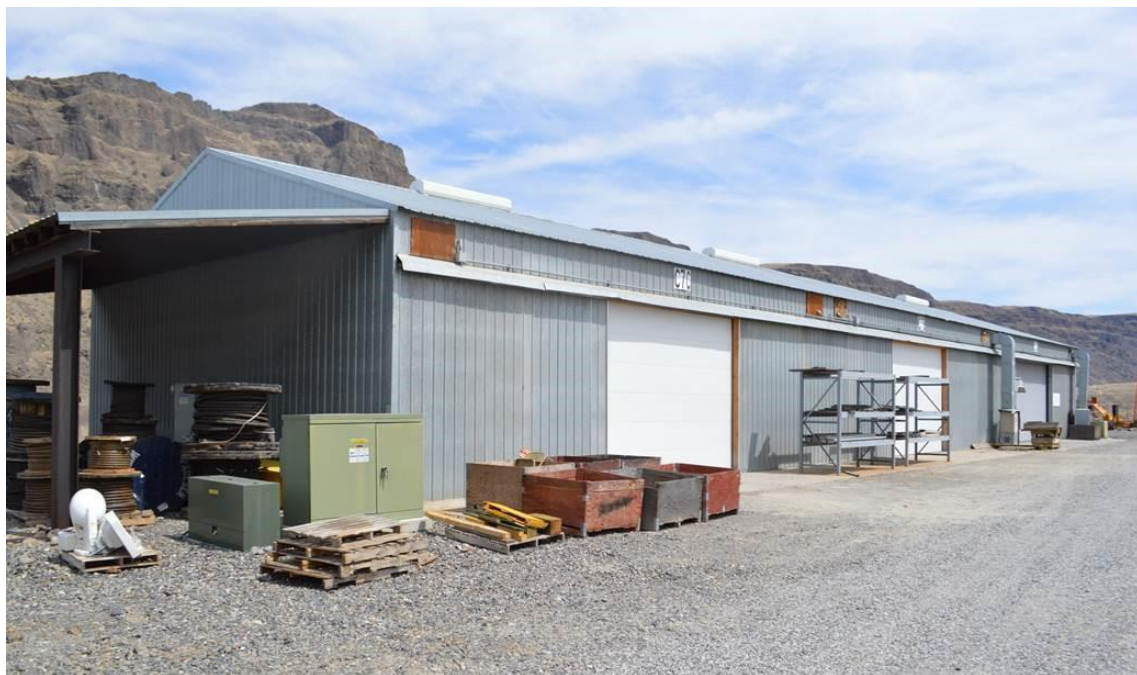
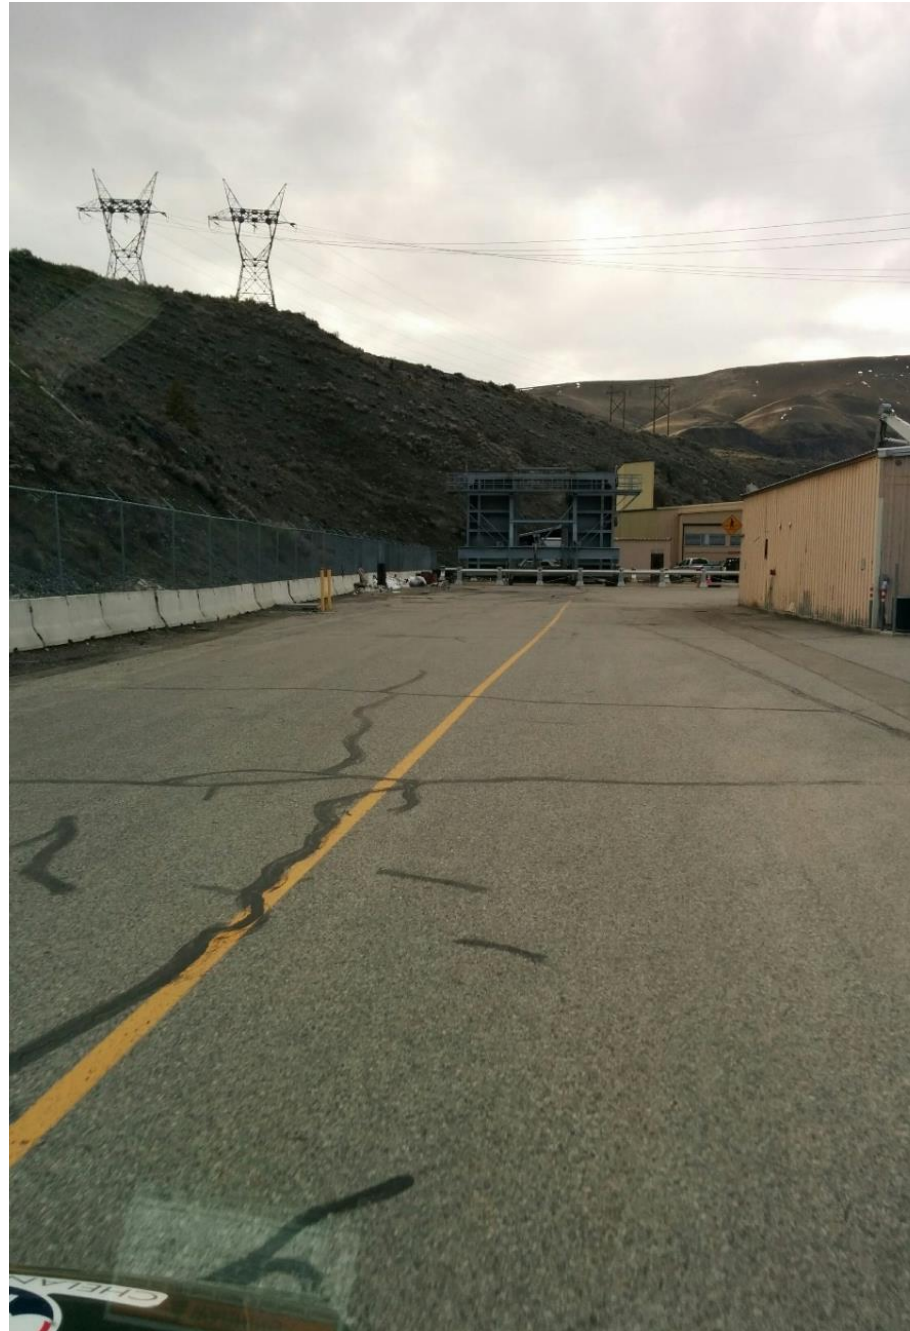
- Bridge Deck Congestion & “wind-shield time” creates significant work inefficiencies
- Severe lack of adequate shop and storage facilities creating additional inefficiencies
- Many buildings are at or near the end of their useful life.
- Limited available land at lower site level.

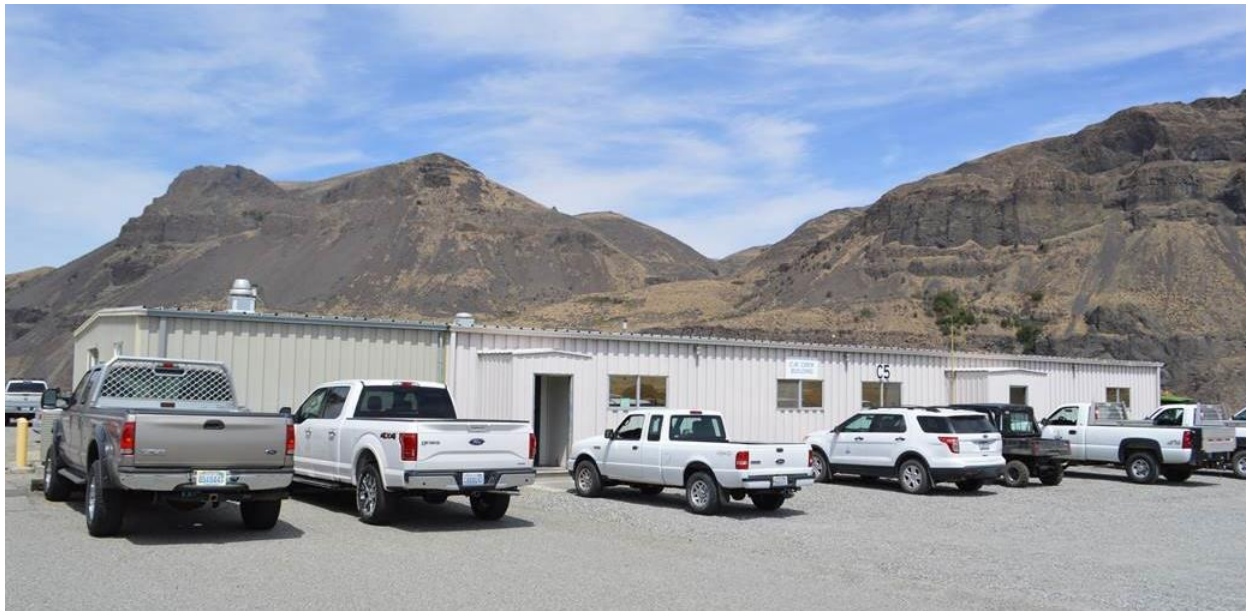
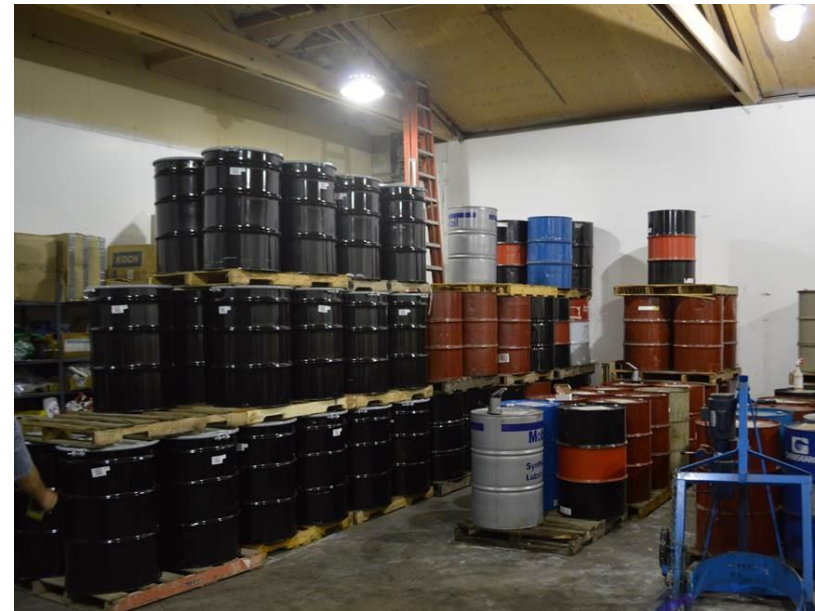
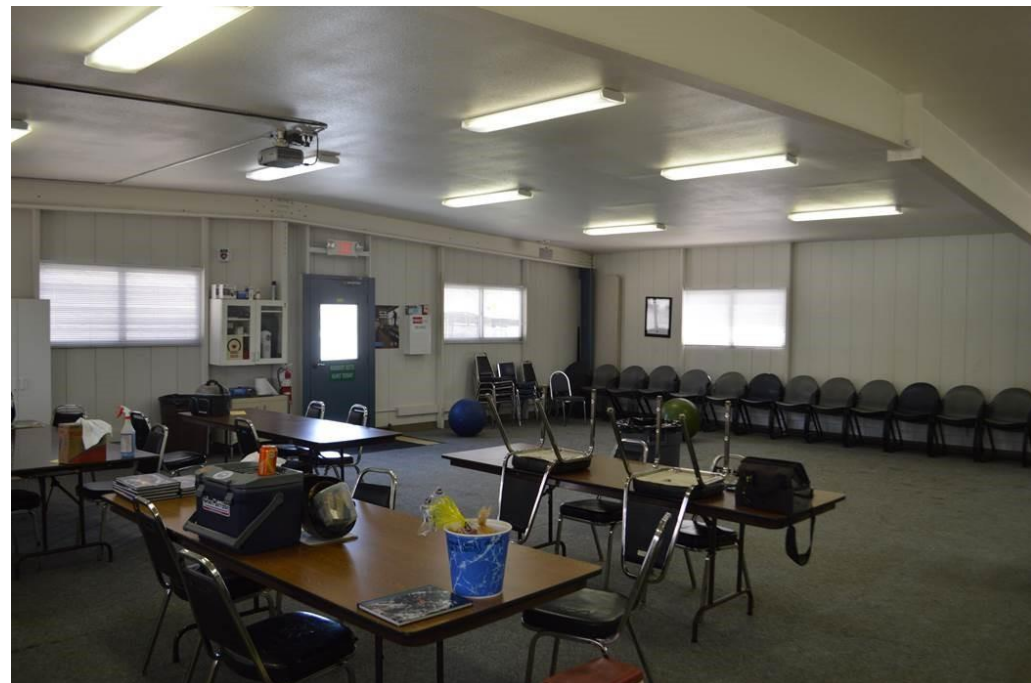
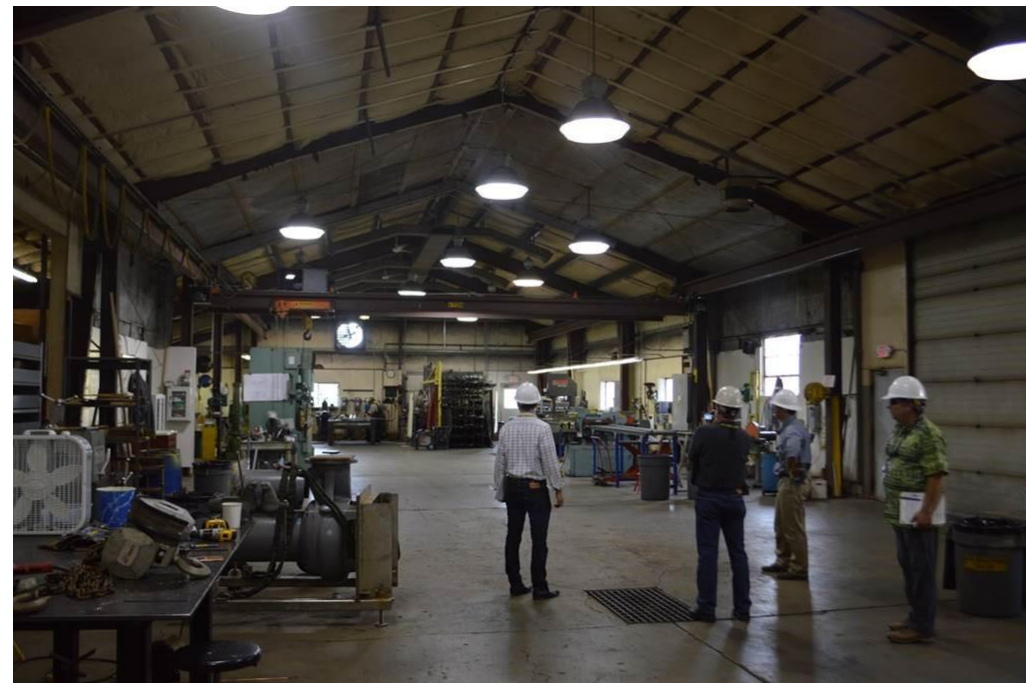
- Main Crew Building is a repurposed contractor building from mid 1970's.
- Hazardous Materials containment facilities should be improved
- Machine shop facilities are deficient in size, location, and configuration
- Facility environments do not promote a culture of operational excellence.

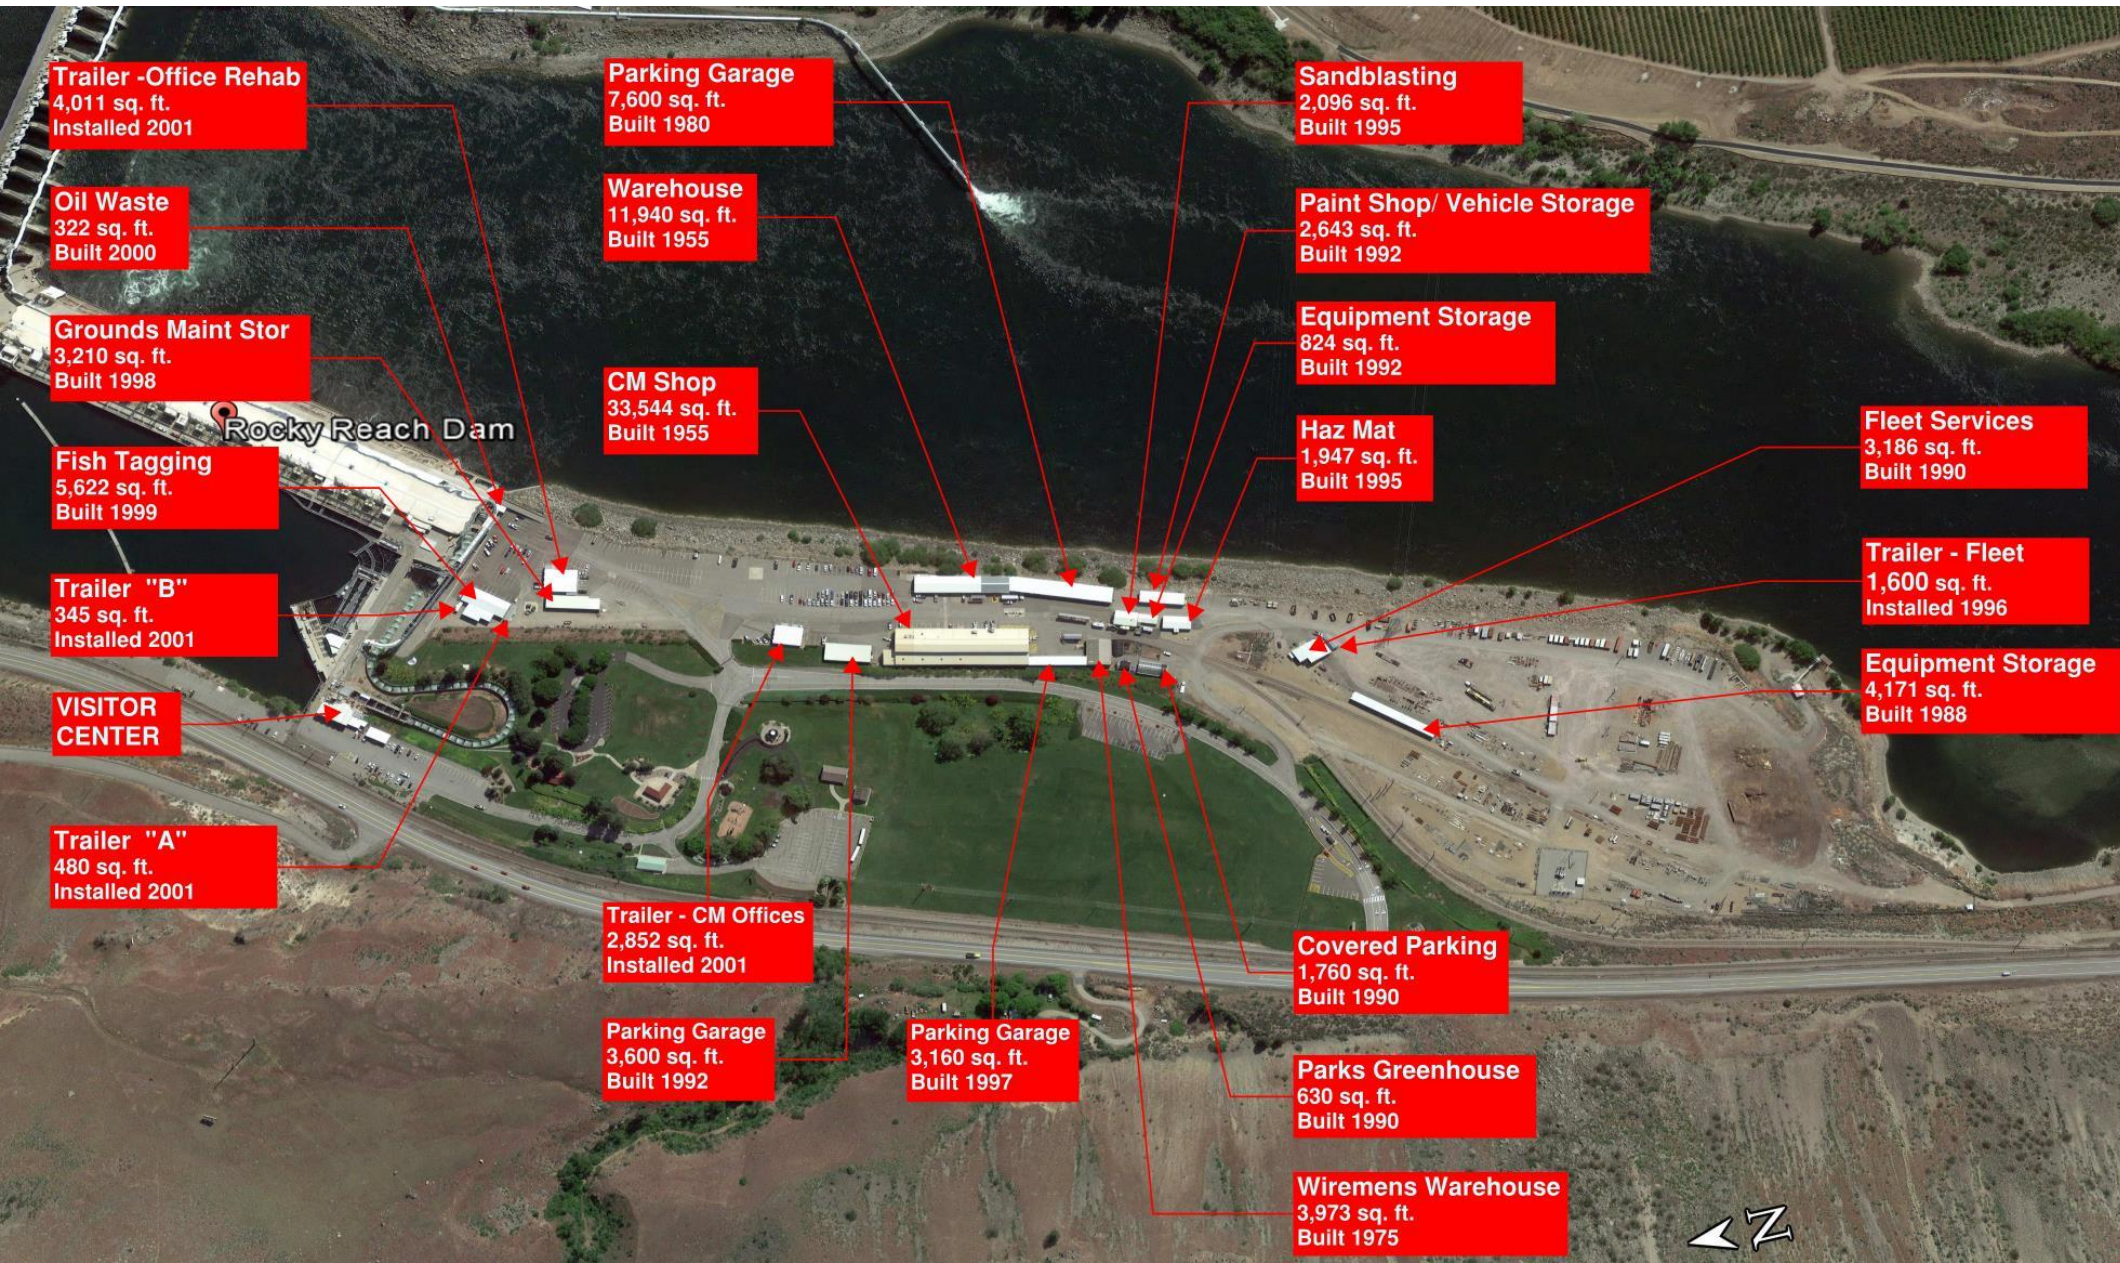
- Most buildings are at or near the end of useful life for systems and functionality
- Site congestion due to building layouts is problematic and creates unsafe conditions

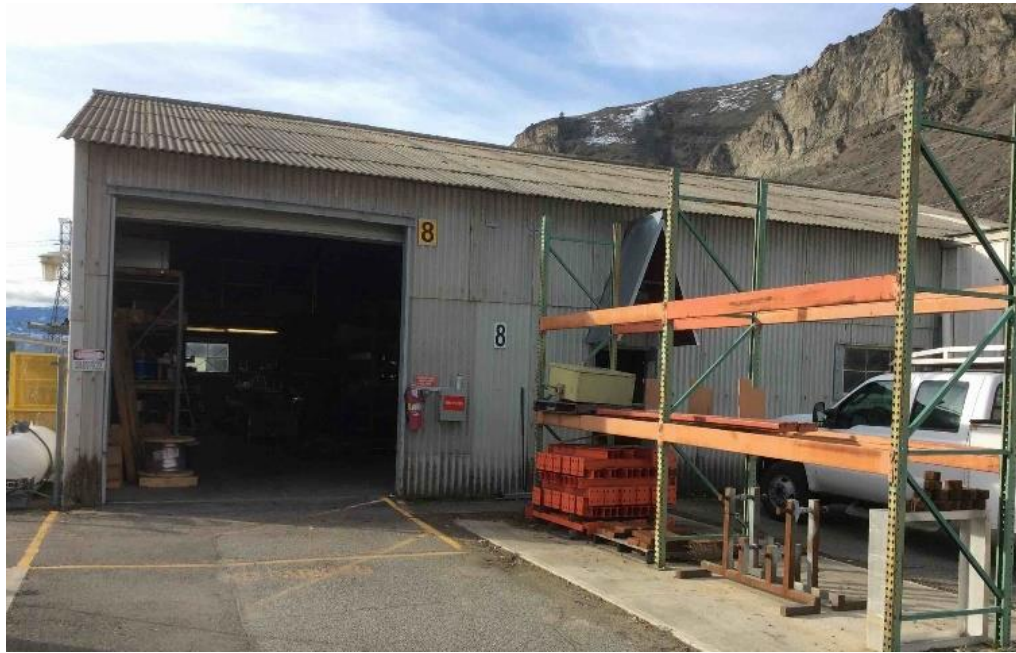
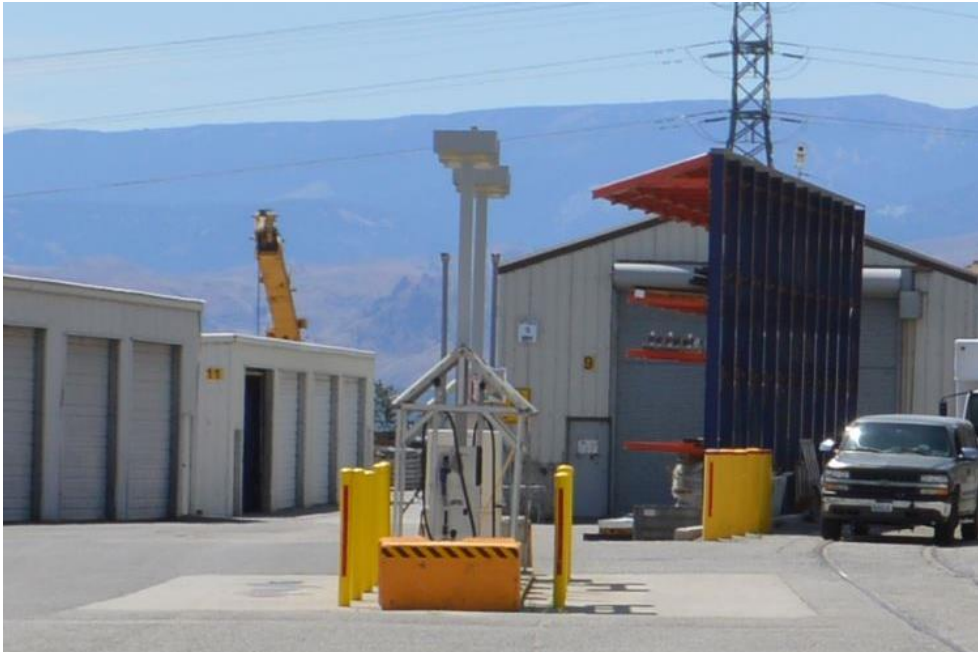
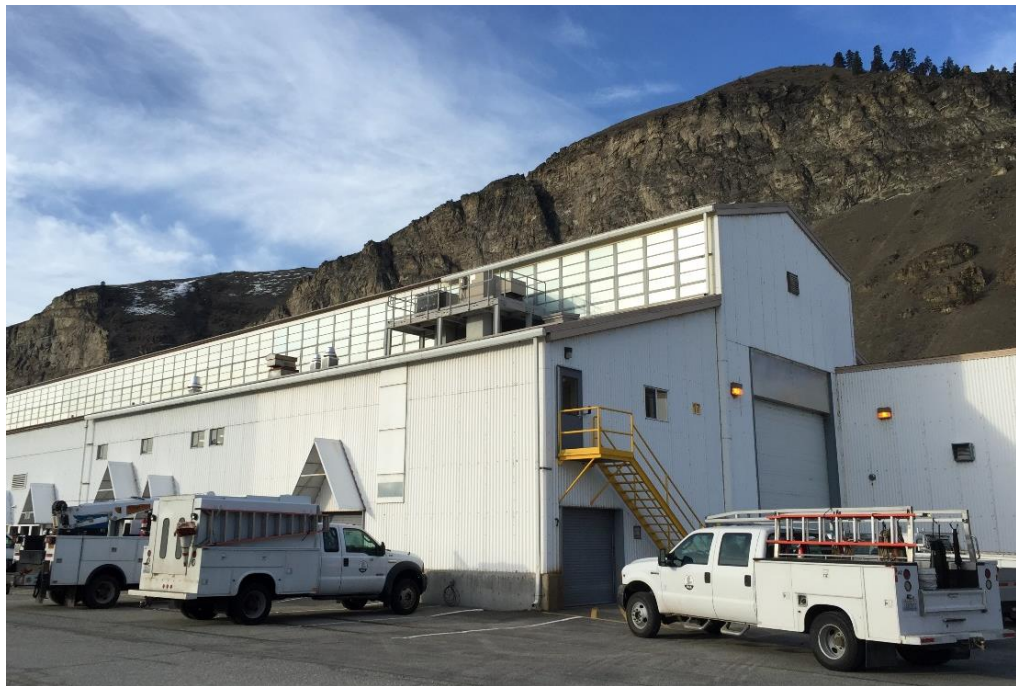
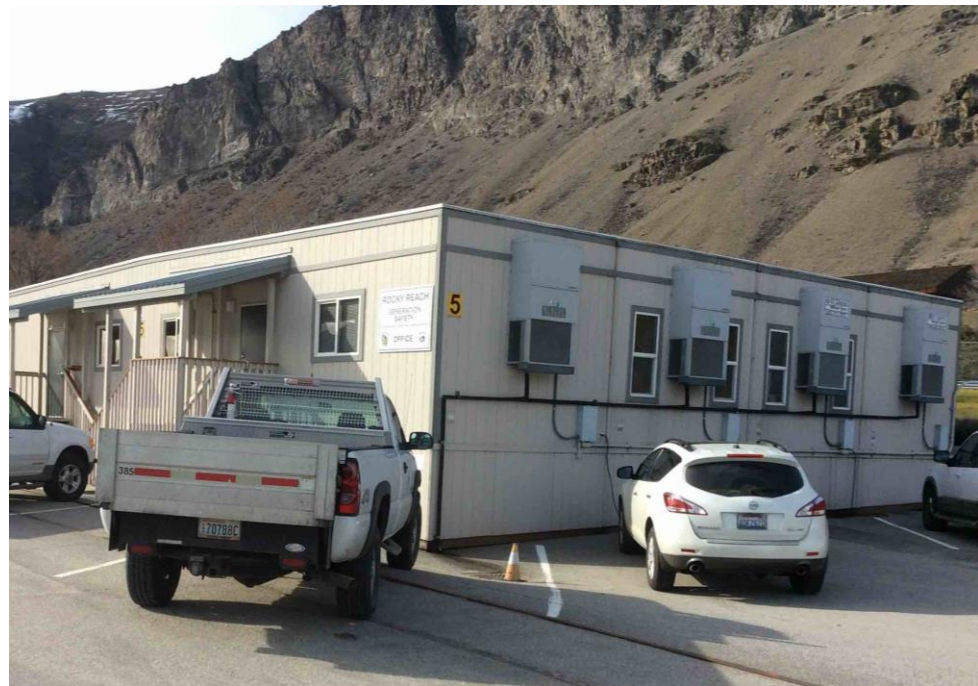
- Exterior Envelope of CM 17 should be replaced, also requiring asbestos abatement
- CM 5 Office Modular is beyond its useful life
- Building placement creates daily inefficiencies, congestion, and safety concerns
