# Long Range Facilities Plan

## COMMISSION BRIEFING State of Facilities Conditions

January 9, 2017

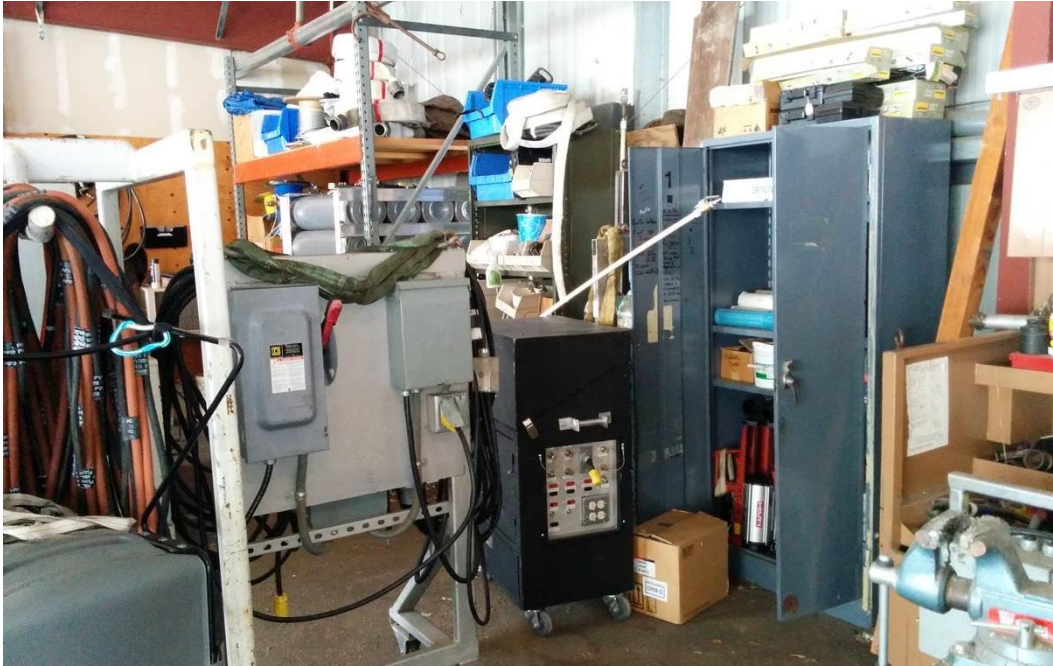
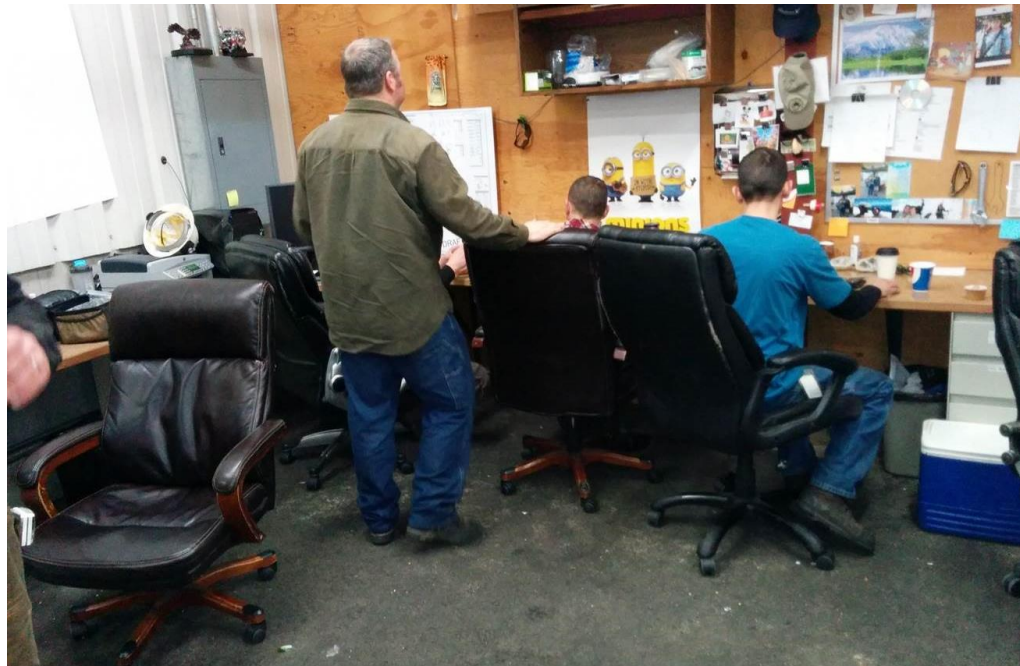
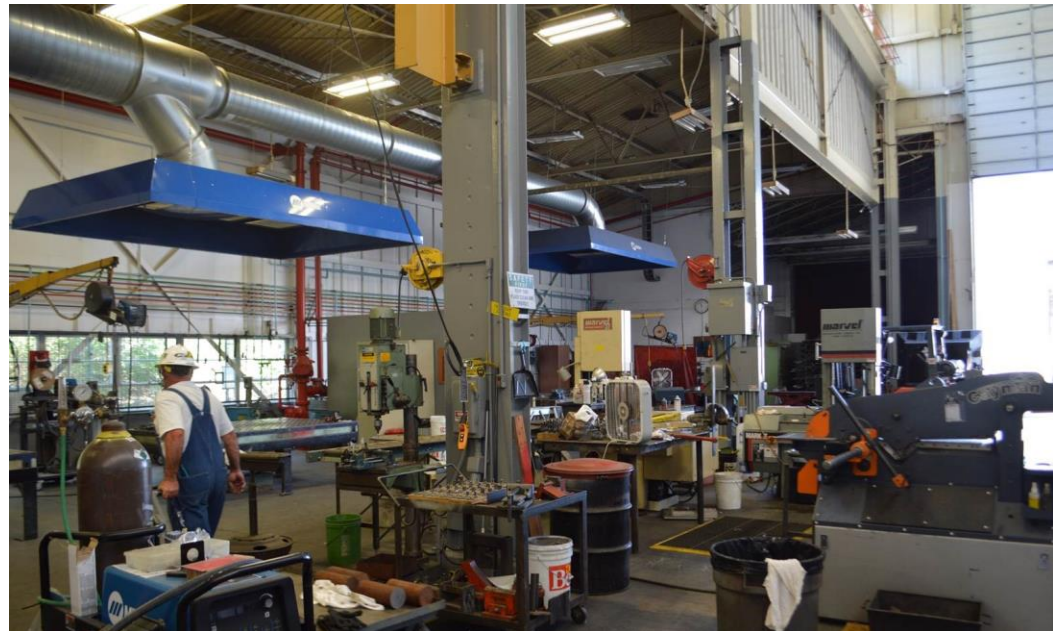
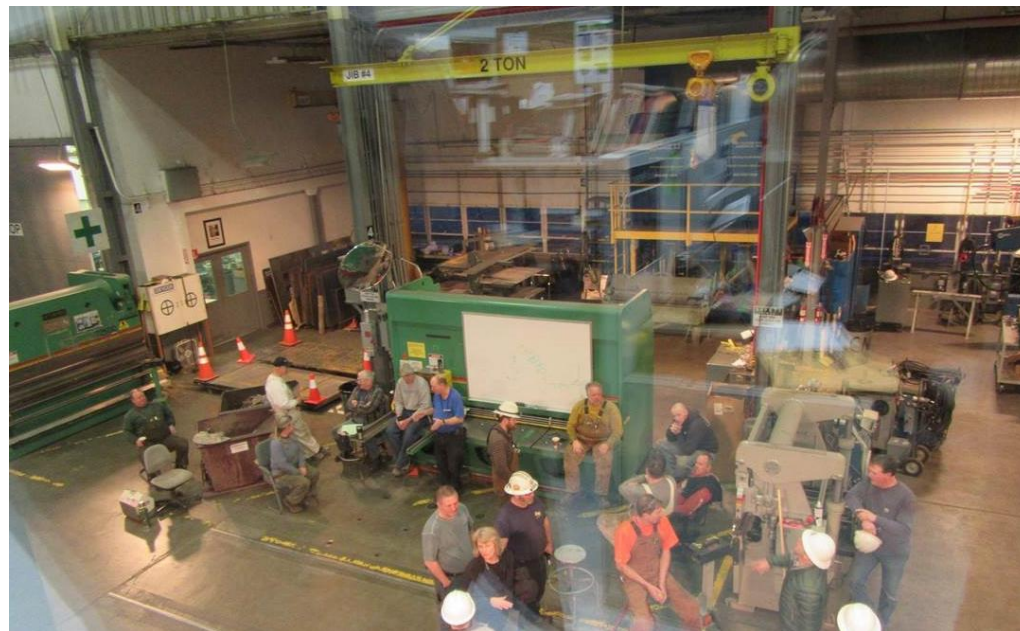
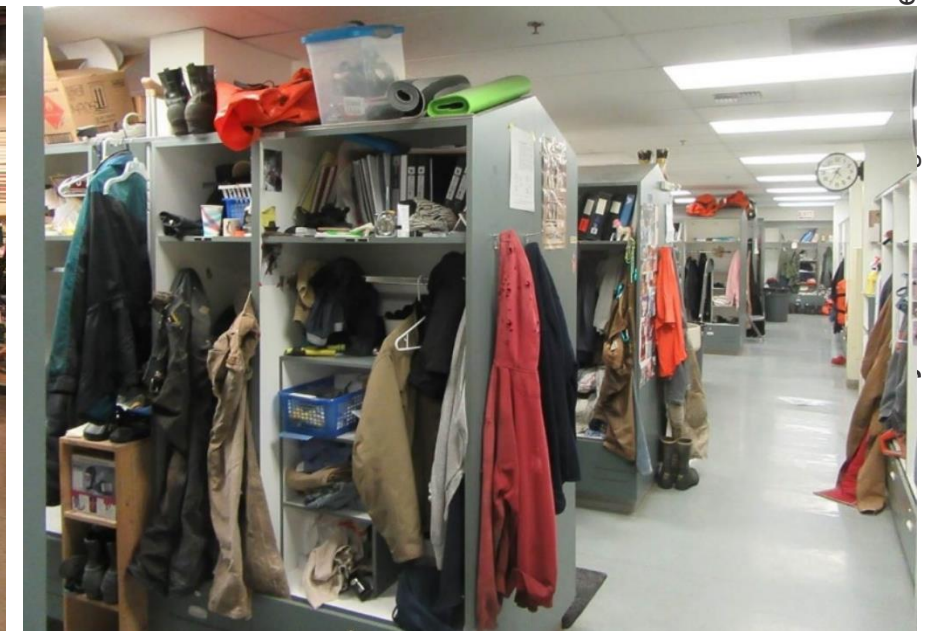
- Most crew and shop related spaces are deficient in size and configuration, and require significant systems upgrades
- Facility environments do not promote a culture of operational excellence.
