C9 Runner

Sample of
Runner Hub
Cavitation Areas
needing Repair

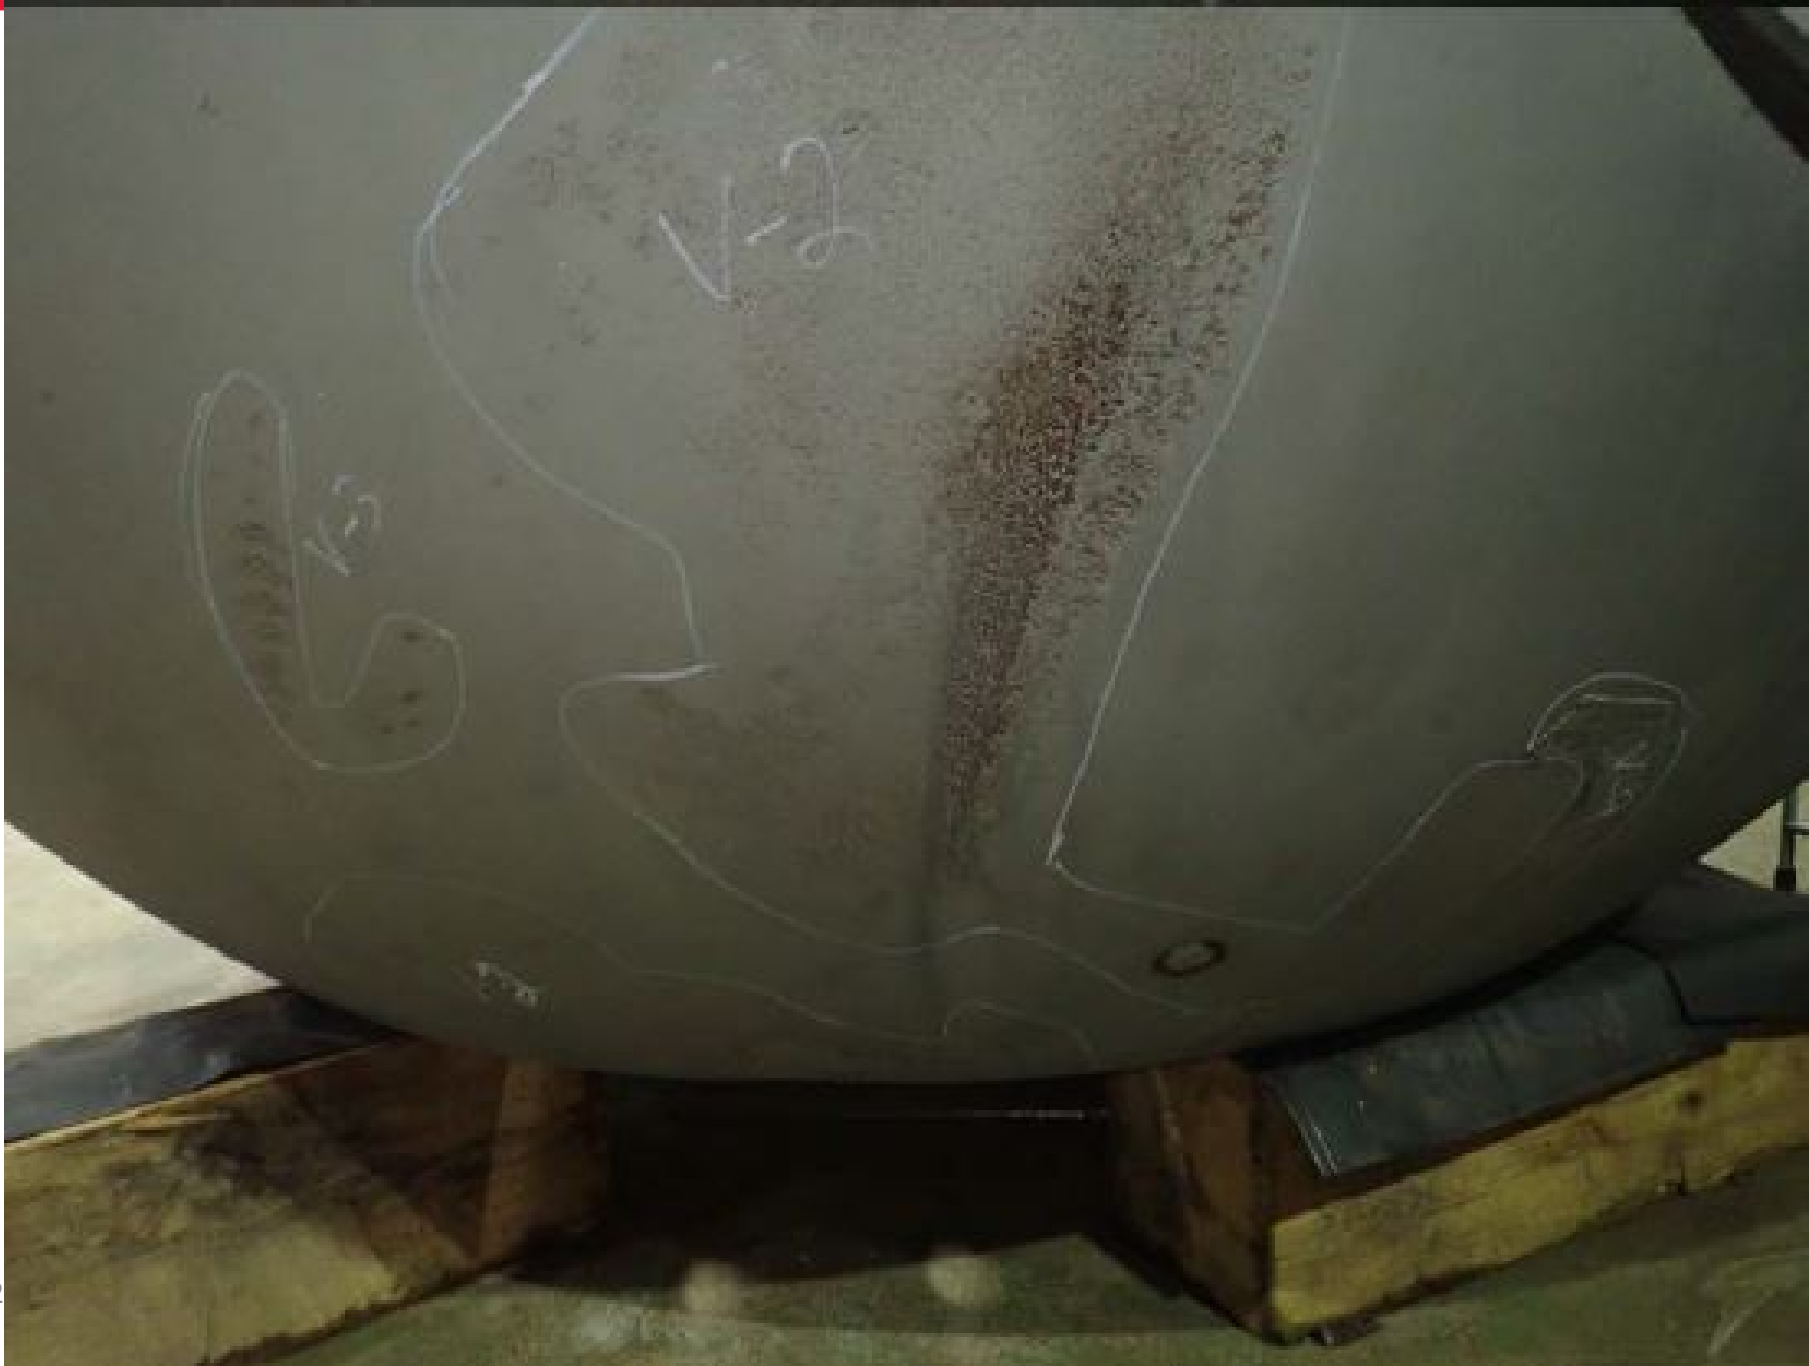
C9 Cavitation Damage on Hub
