30 PERCENT DESIGN REPORT

HABITAT RESTORATION OF THE CHELAN RIVER REACH 4 AND TAILRACE

March 2007

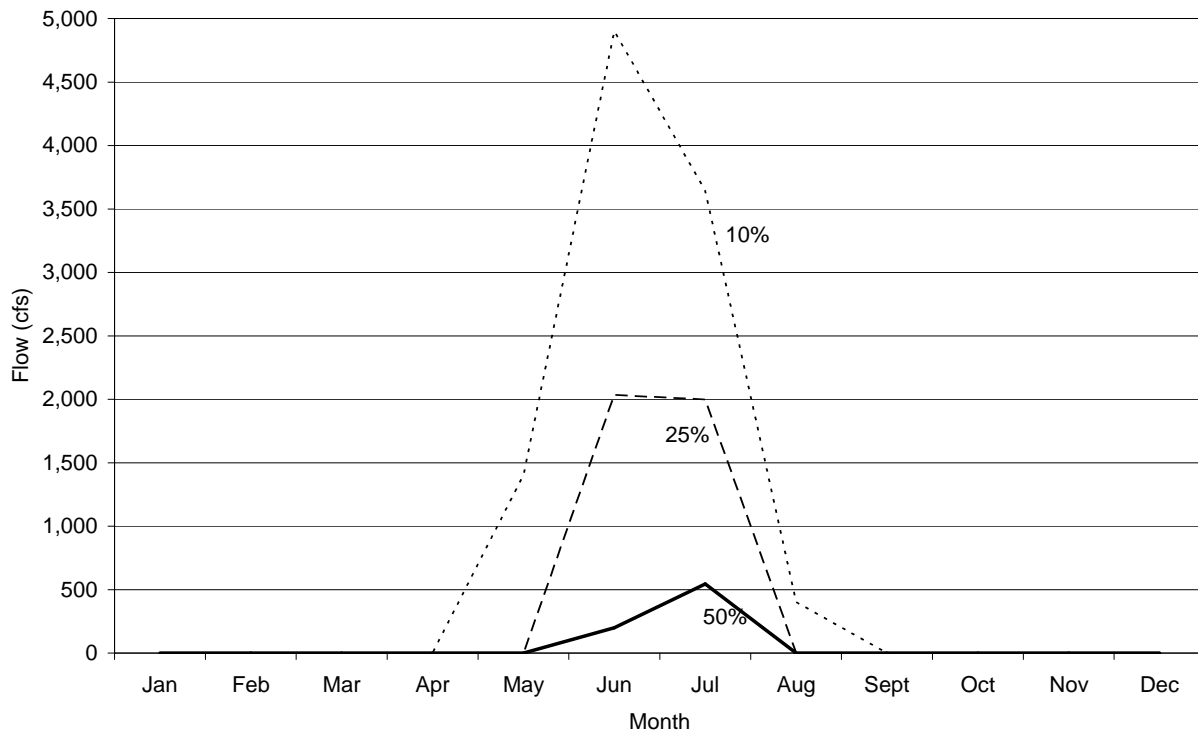
Figure 2
Historic Chelan River Spill Exceedence – 1974 to 2003

Spill into the Chelan River downstream of the dam occurs most years during the spring runoff season and occasionally during large fall/winter rain or rain-on-snow events. The 10 percent, 25 percent, and 50 percent mean daily reported spill exceedences for each month were plotted with month on the x-axis and flow on the y-axis (Figure 1). Flow exceedence refers to the percentage of days during each month that a particular flow is exceeded. For example, a 10 percent flow exceedence of 1,402 cfs during May means that for a 30-year analysis period on 10 percent of the days during May, or on average 3 days in May, the mean daily flow was over 1,402 cfs (conversely, 90 percent of the days' flows were less than 1,402 cfs). Flow exceedence values for mean daily recorded spills shows a monthly 50 percent exceedence value of 200 cfs in June and 544 cfs in July (Figure 2 and Appendix B). Note that this analysis groups all days of each month together (e.g., all June days for the 30 years of record are treated as a population, a total of 900 days).

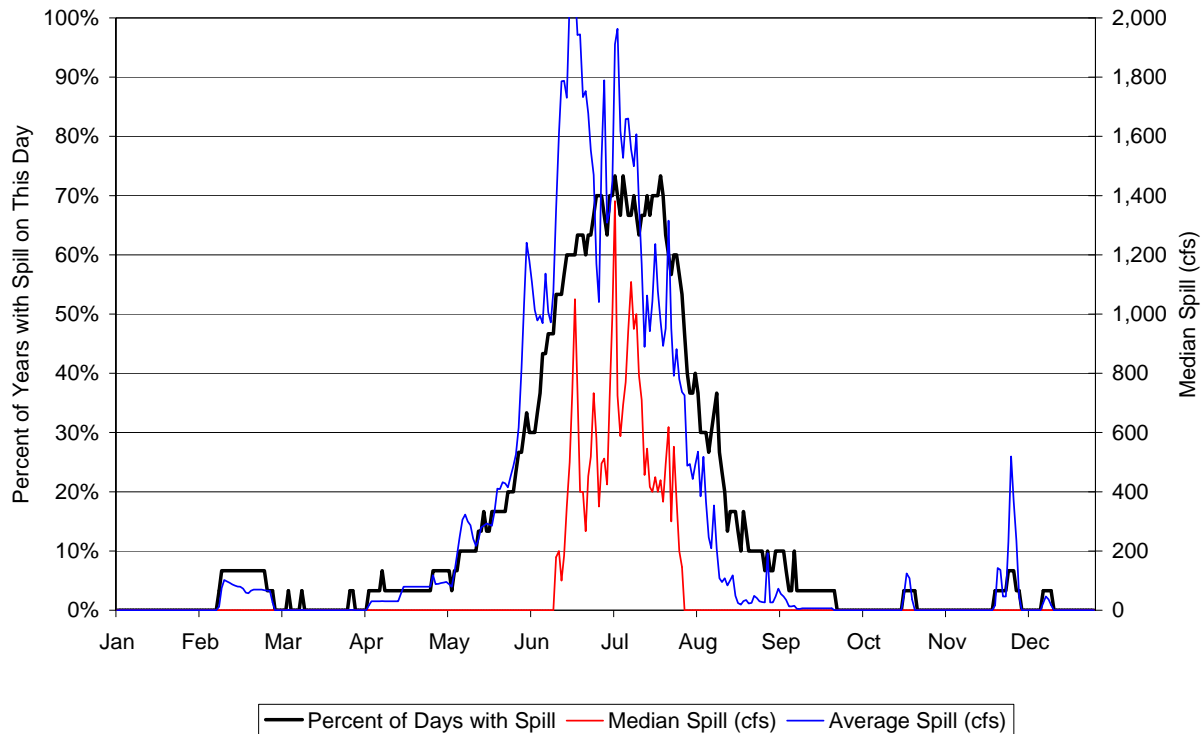
Figure 3
Historic Chelan River Days with Average and Median Spill Magnitude – 1974 to 2003

To provide additional detail on the likelihood and magnitude of spill during any given year, the percent of days over the period of spill records (30 years) that actually had spill was calculated for each day of the year (Figure 3). This analysis is not grouped by month, but by each day of the year (e.g., the population for June 1 is the flow on June 1st during each of the 30 years, a total of 30 days). Likelihood of spill is low during the fall, winter, and early spring. On over 10 percent of years, the days between mid-May and mid-August had spill. On over 60 percent of the years, days between mid-June and mid-July had spill, with median (50 percent exceedence) spill magnitudes between 250 to 1,400 cfs, and an average spill of 1,000 to 2,000 cfs. There was some spill during 26 of the 30 years of spill record.

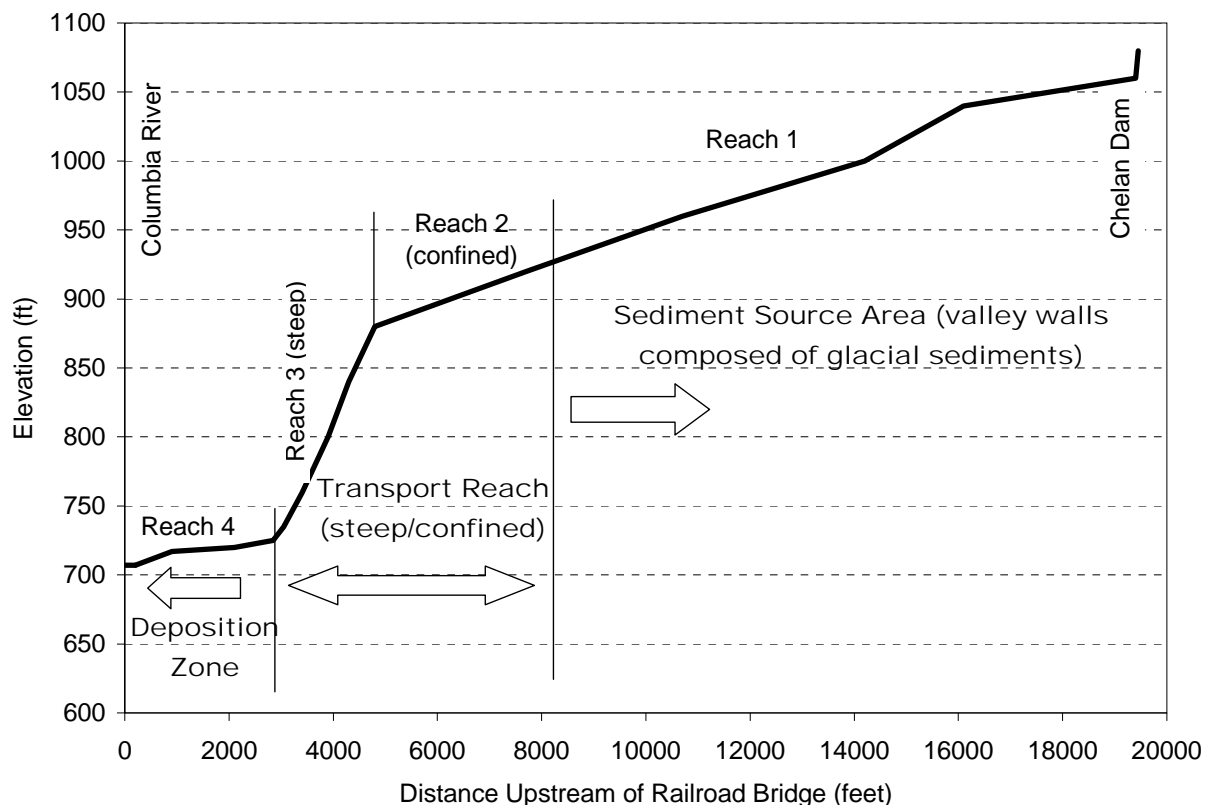
Figure 4
Chelan River Profile and Geomorphic Zones

Figure 4 shows the profile of the Chelan River from the Chelan Dam to the confluence with the Columbia River. This stretch of the river can be divided into four geomorphic zones on the basis of channel slope (gradient) and confinement.

Reach 1 extends from Chelan Dam downstream for 2.3 miles. This section is relatively low gradient (1 percent) and moderately confined by steep slopes of glacial moraine deposits. The glacial deposits are easily eroded, providing the river with a large source of boulders, cobbles, gravel, and sand when flows are high enough to erode the valley walls. Reach 2 has a similar low gradient but is within the upper portion of the narrow bedrock canyon. Reach 3 is the high gradient portion of the bedrock canyon. This reach is very steep (9 percent) and confined; sediment supplied from upstream reaches is transported quickly through this reach. Reach 4 is a very low gradient (0.4 percent), relatively unconfined reach. As a result of the extreme transition in gradient from Reach 3 to Reach 4, all the boulders, cobbles, and gravel from upstream reaches are deposited in Reach 4.

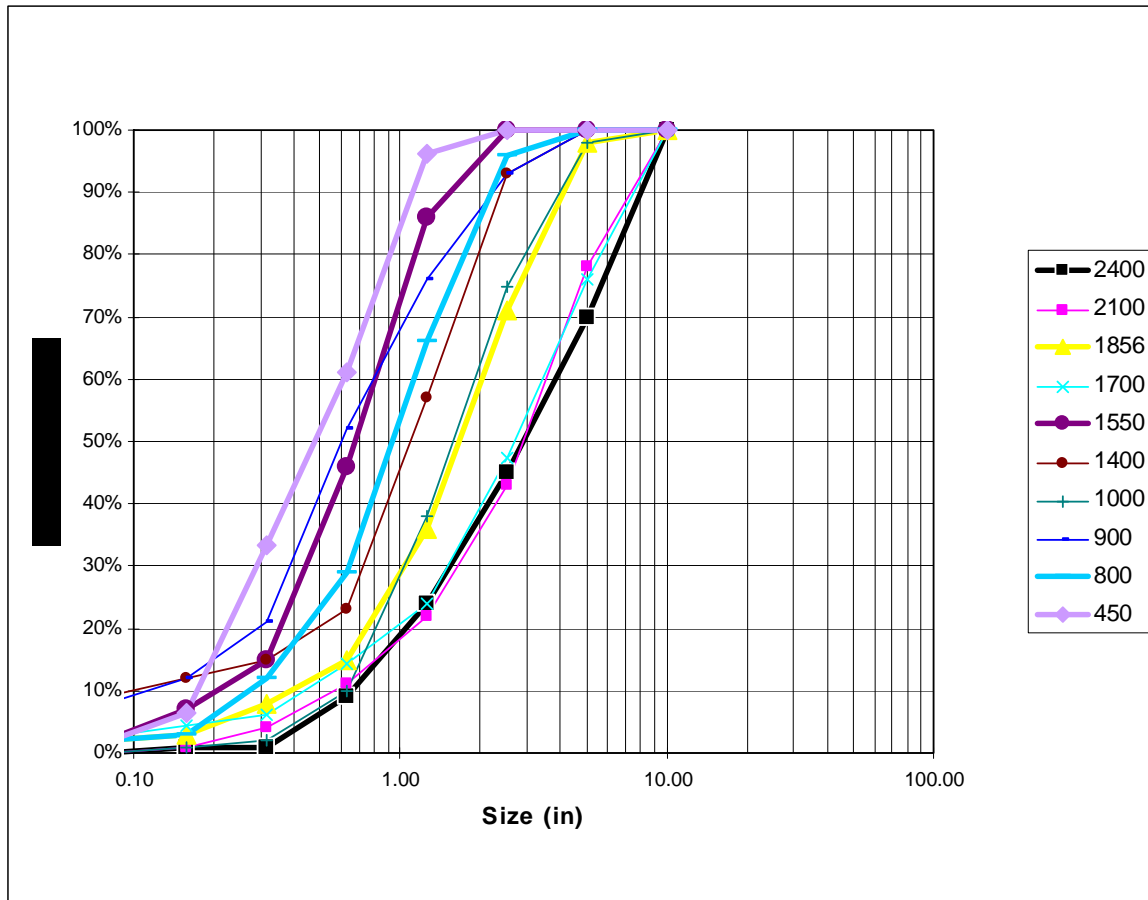
Figure 5
Armor Layer Pebble Count Grain Size Distribution

Surface pebble count grain size distributions are summarized in Figure 5. Note that the information in Figure 5 is converted to grain size in inches. Graphs and data in Appendix 1 are in mm, the standard unit used for pebble counts and sieving. Median particle size of armor layer samples ranged from 77 mm (3 inches) near the top of Reach 4 to 12 mm (0.5 inches) near STA 4+50. Median particle size of the sub-armor samples (shown in Appendix C) ranged from 15 mm (0.6 inches) to 40 mm (1.5 inches). Sub-armor layers did not include particles larger than cobbles due to sampling constraints.

Note: The station locations described here do not correspond to station locations used in the hydraulic modeling. The hydraulic modeling of the proposed channel design adjusted the station positioning by approximately 232 feet. As a result, STA 4+00 in the test pit analysis corresponds to location 6+32 in the hydraulic modeling analysis.

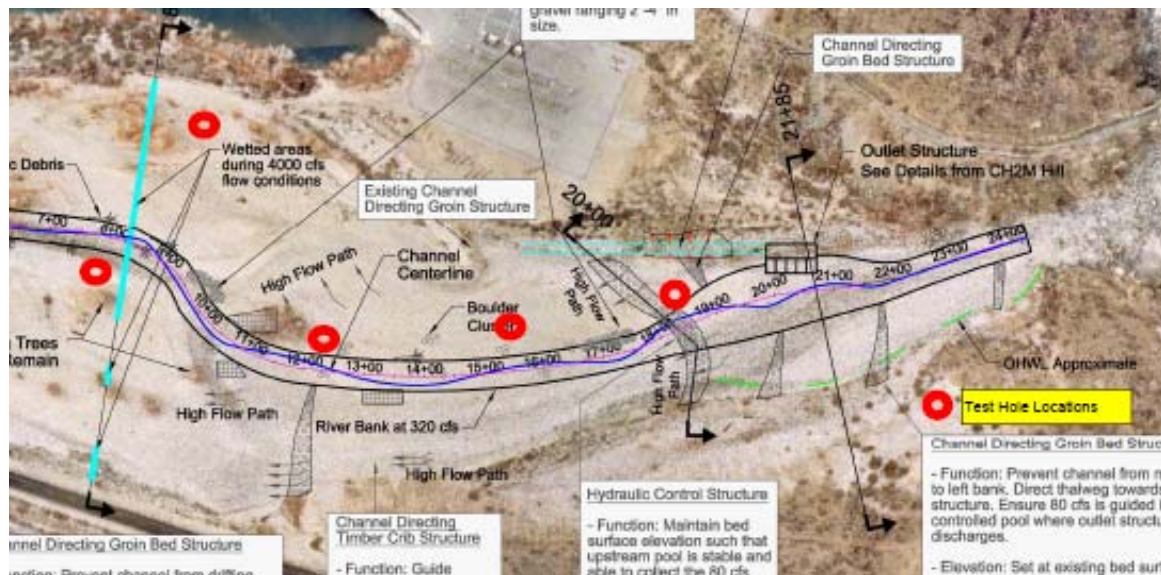
Figure 6
Test Pit Locations

On January 16, 2007, test pits and pumping tests were conducted at the Reach 4 channel. The weather was cold (10 to 20 degrees Fahrenheit and the top 16 inches of substrate was frozen). Six stations distributed throughout Reach 4 were sampled (Figure 6). Station reference is relative to the original Anchor Environmental, L.L.C. (Anchor), drawing and channel alignment that was staked in the field by the District¹. Station reference starts with STA 0+00 at the downstream end of Reach 4 and increases in number reference moving upstream. Table 4 identifies the tests conducted at each station. Additional tests relevant to sediments were conducted at each station and are reported in the sediment section of this report.

Note: STA 4+00 not shown
