Chelan PUD – Tumwater Fishway Improvements

PREPARED FOR: Justin Fletcher
COPY: Alene Underwood
PREPARED BY: CH2M
DATE: 18 October 2017
SA NUMBER: 16-084
CH2M PROJECT NUMBER: 680819

This memorandum documents the feasibility of improvements at the Tumwater Dam Fishway to enhance the upstream migration of Pacific Lamprey (*Entosphenus tridentatus*). This memorandum also summarizes the results of an alternatives review workshop and identifies steps for implementation of the preferred alternative.

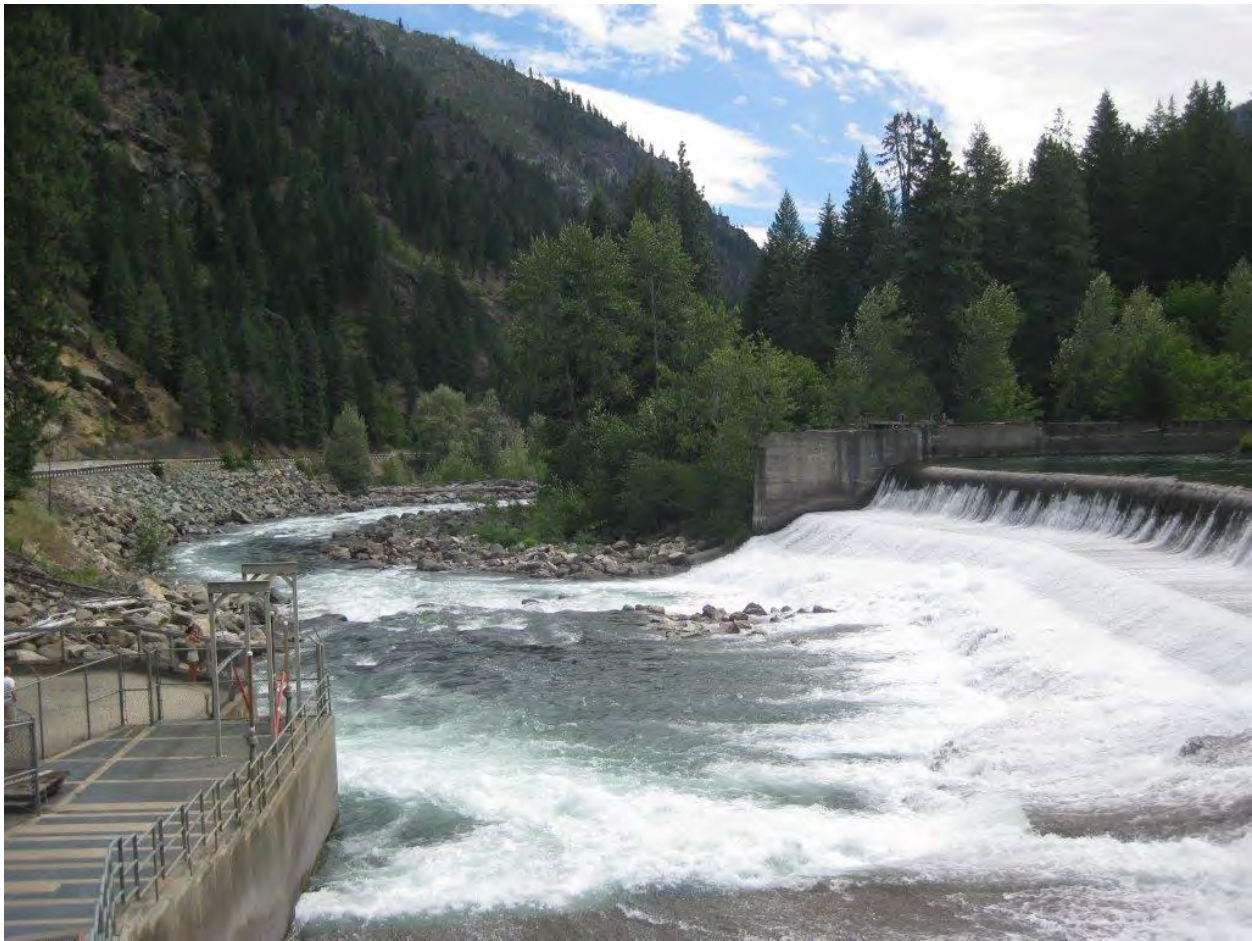
Figure 1. Fishway Entrance, Right Abutment and Tailwater
Chelan PUD Tumwater Fishway Modifications

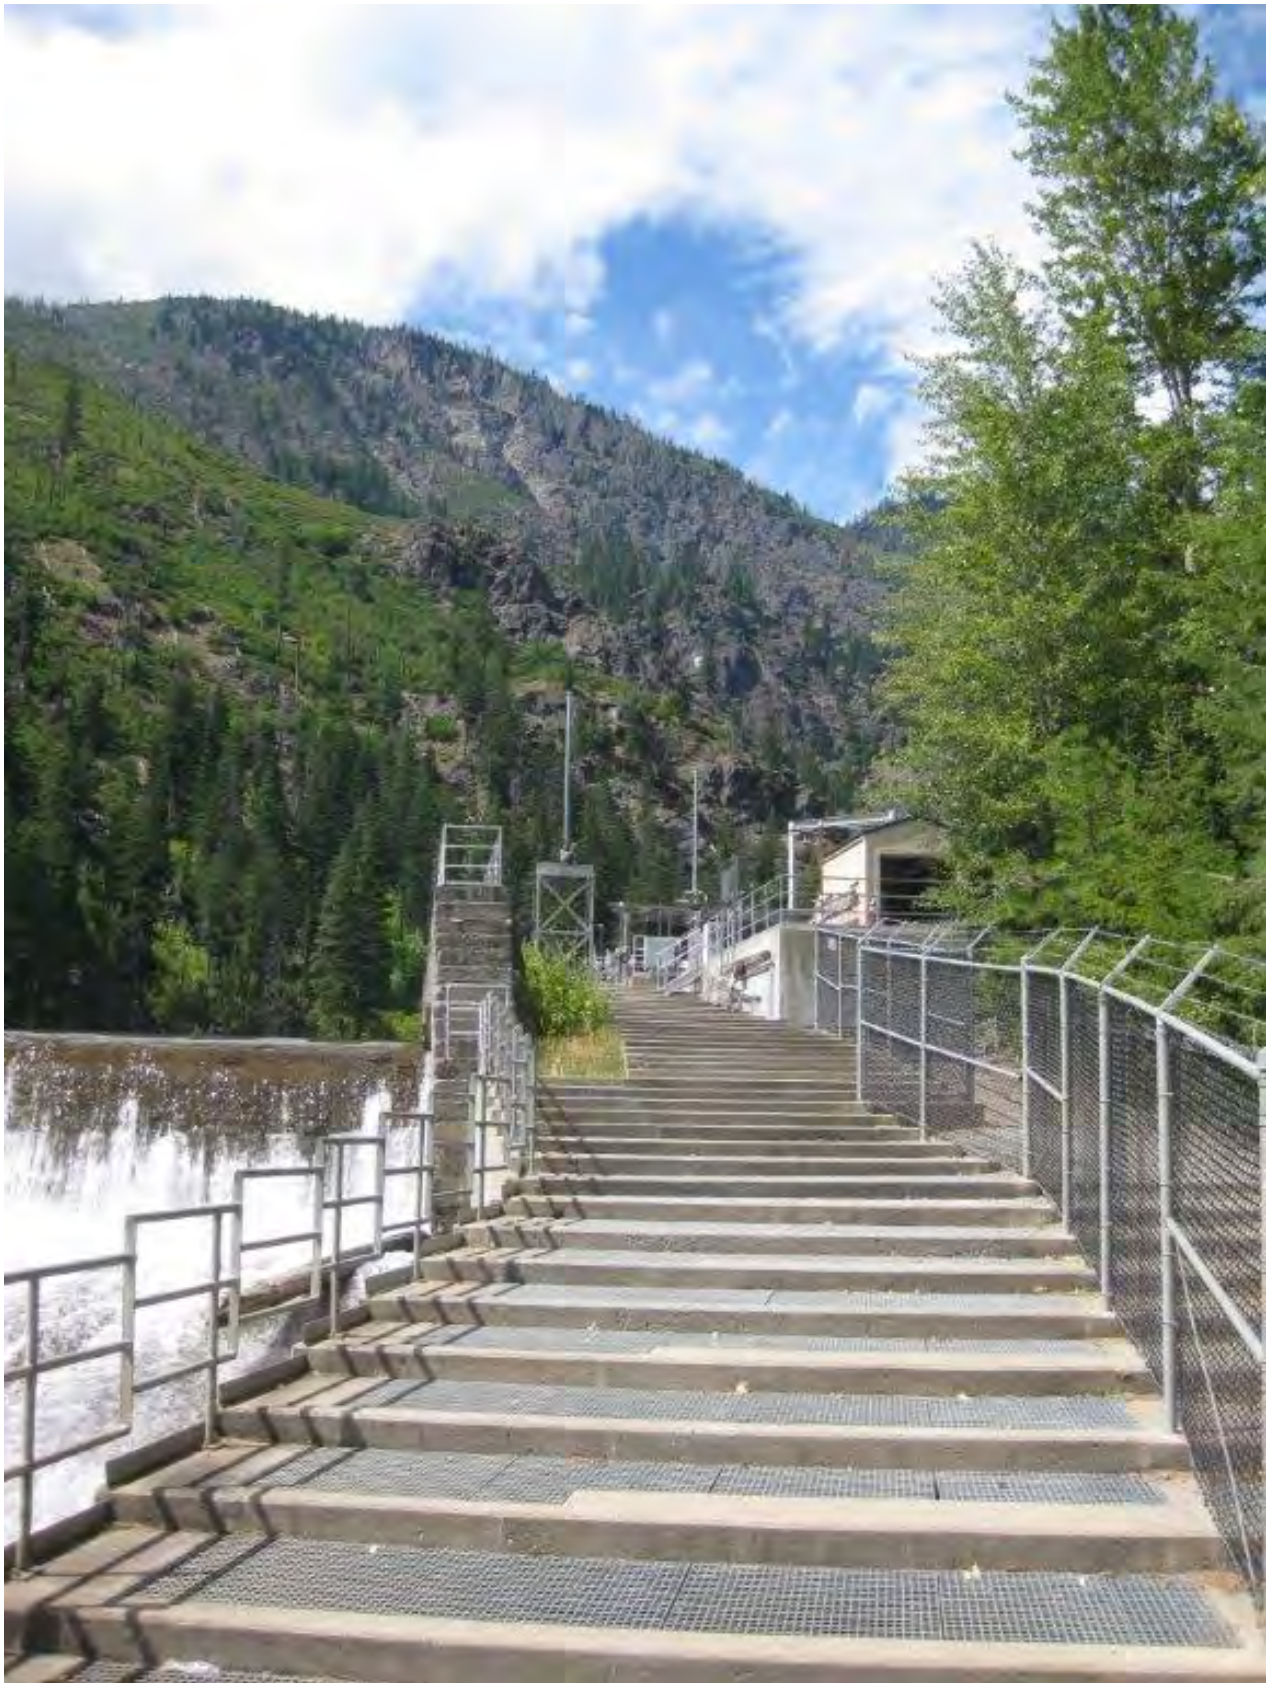
Figure 2. Left Abutment and Fishway
Chelan PUD Tumwater Fishway Modifications

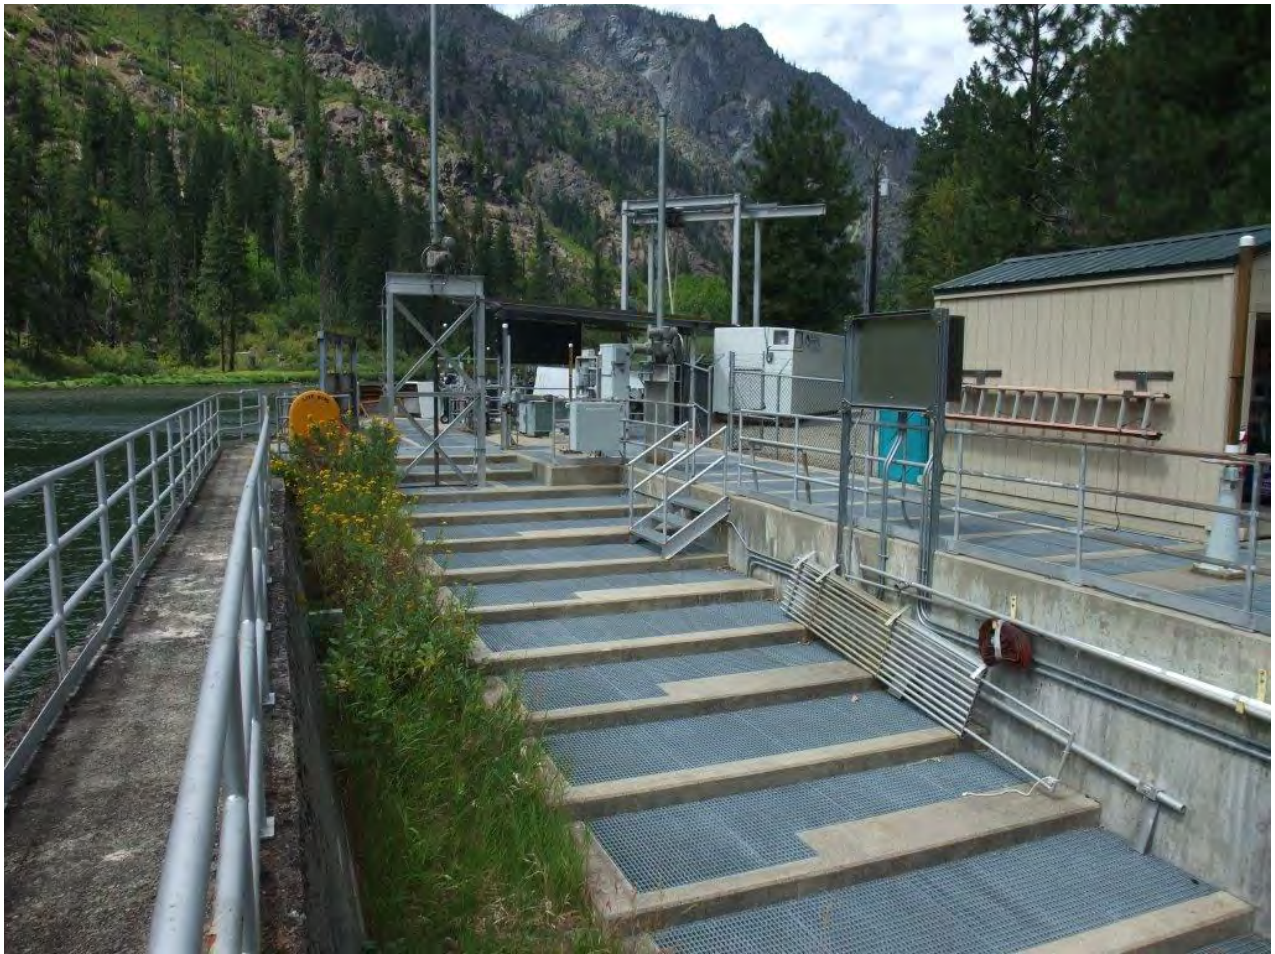
Figure 3. Fishway Exit and Trap Area
Chelan PUD Tumwater Fishway Modifications

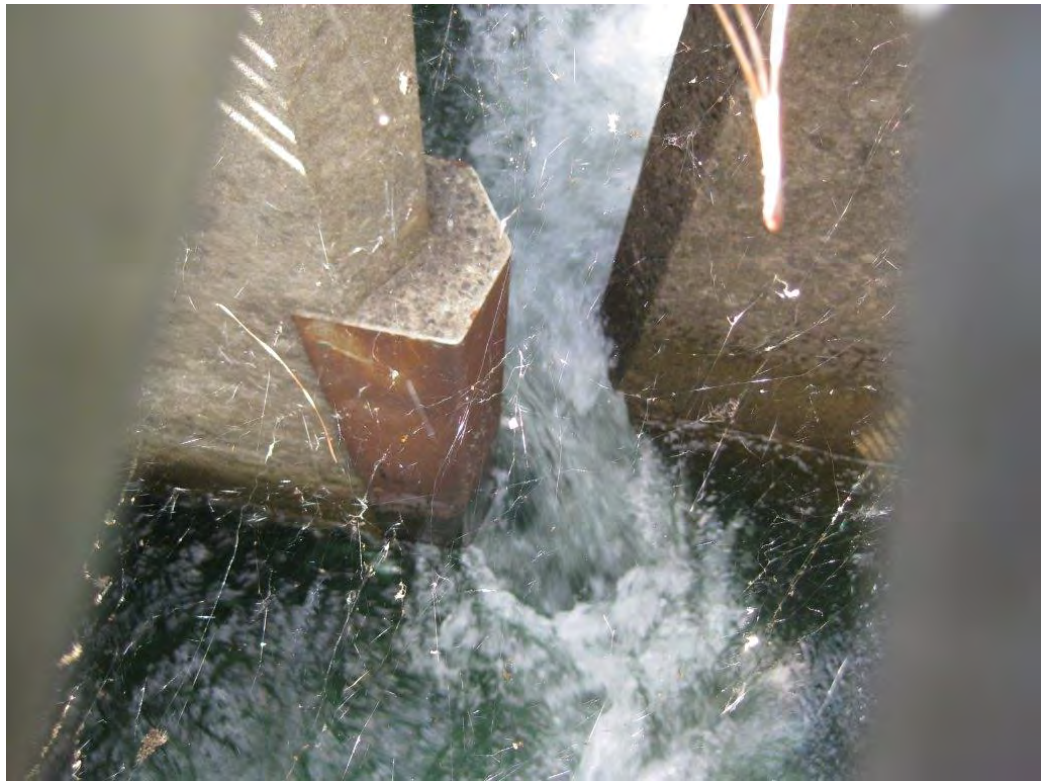
Figure 4. Fishway Vertical Slot, Modified from 15 to 12 inches
Chelan PUD Tumwater Fishway Modifications

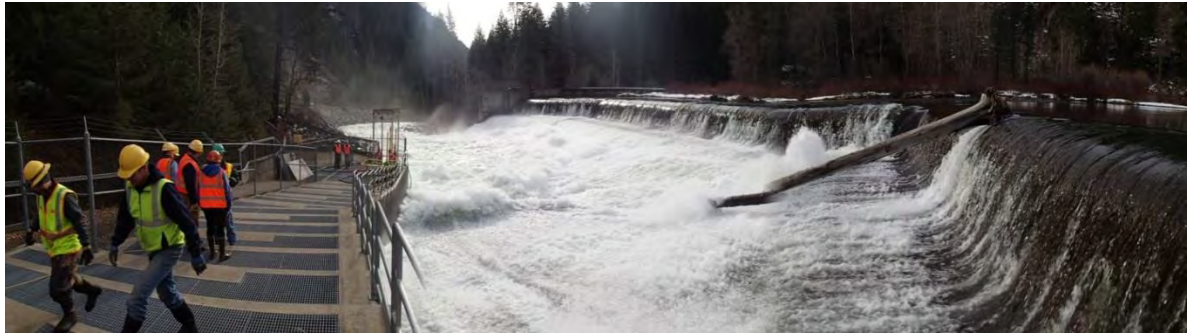
Figure 3. February 18, 2015 site visit tailrace hydraulic conditions at 4380 cfs (Peshastin gage)

- *Tailrace Hydraulics* – Discharge on the day of the AT site visit was reported as 4,380 cfs (Figure 3). The tailrace was extremely turbulent, but adult salmonids pass in large numbers at this flow magnitude. It is uncertain whether adult lamprey could approach the left shore fishway at this discharge. Adjacent to the fishway, flow passing down the ogee and onto the apron creates a hydraulic jump when high tailwater backwatered the apron. A standing wave upstream of the entrances occurred on the day of the site visit. Aerated and fast water is present in this area (see photos).

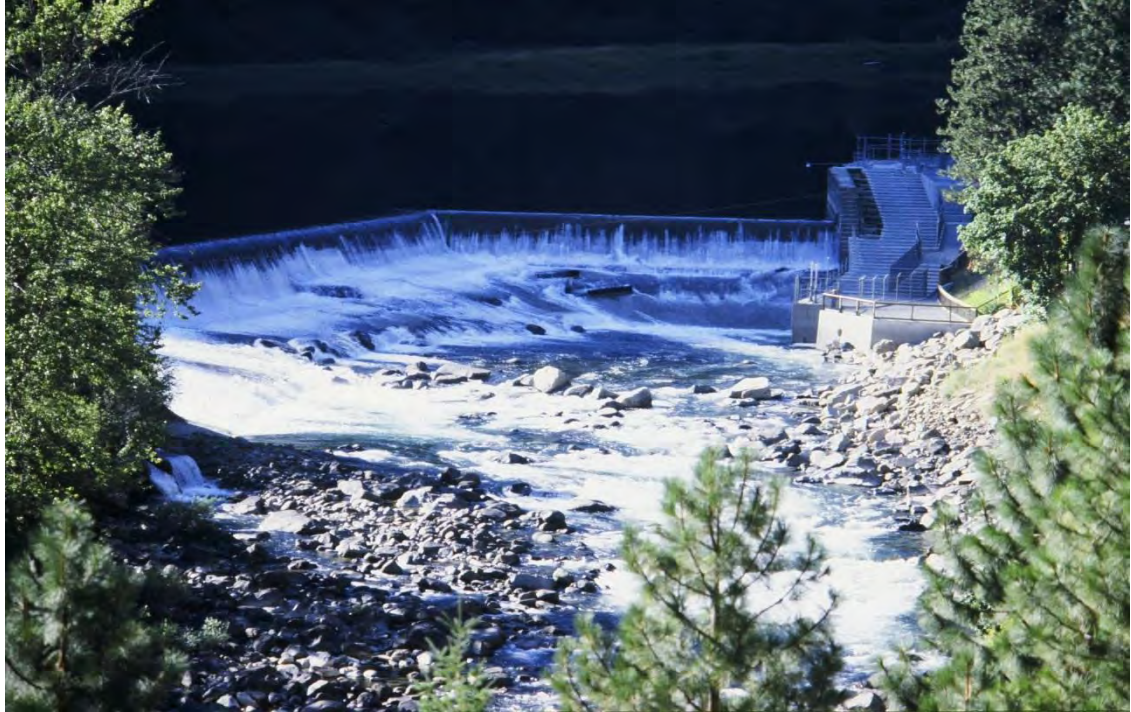
Figure 4. Dam Dog-leg Jet (jet extends diagonally to left shore near the fishway). Note that this is a previous photo during relatively low discharge period

- *Dam Dog-leg Jet* - The approximate 60 degree corner of the dam creates a “dog-leg”, and a distinct larger jet in the tailrace is caused from flow converging immediately downstream of the adjacent dam crests (Figure 4). Dam crest dog-leg jet merges on the dam apron, and extends across river at an angle below fishway (see in photo below at low streamflow). Adjacent to the fishway, flow passes down the ogee and onto the apron, before entering tailwater at high velocity. A standing wave upstream of the fishway entrances occurs at high flows. Water is aerated and turbulent in this area (see photos).

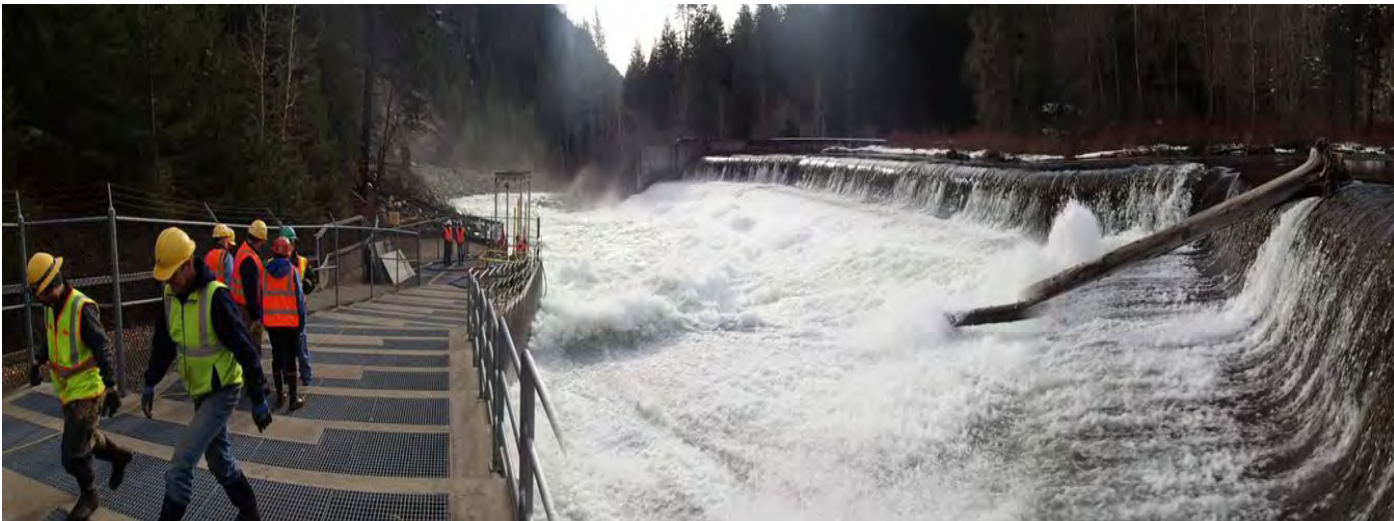
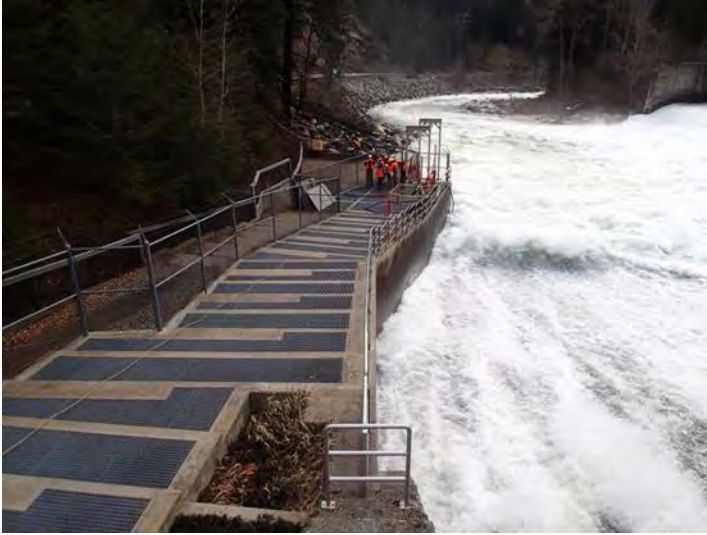
Figures 5 and 6. Turbulent tailwater adjacent to fishway on day of site visit

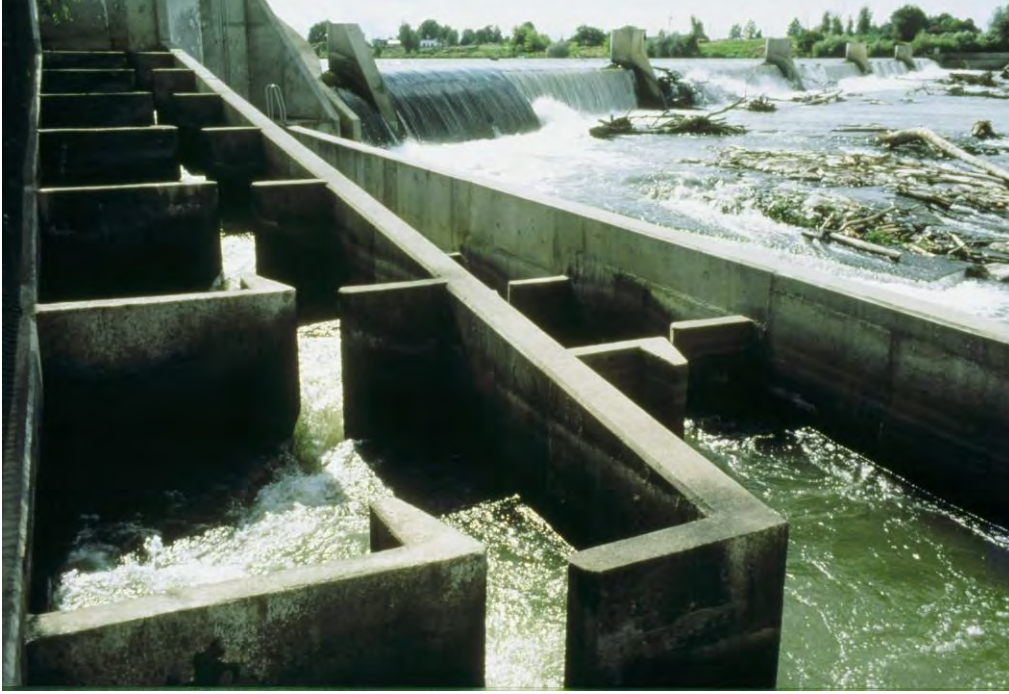
Figure 7. Example of vertical slot ladder pool and slot flow hydraulic conditions – note pools include both aerated turbulent flow near the slot jet, and lower turbulence, green water further from the jet

- Importance of the jet alignment in efficiently dissipating inflow energy, and avoiding lateral surging was reinforced at Tumwater Dam (see below).
- Many of the vertical slot fishways were suitable for 10-12 ft high diversion dams, and operated 95% of the time at higher streamflows and lower total static heads. Higher tailwater backwaters the lower ladder, reduces pool differentials in the lower ladder, and lowers velocities in the lower vertical slots. This is commonly referred to as a "backwater effect."

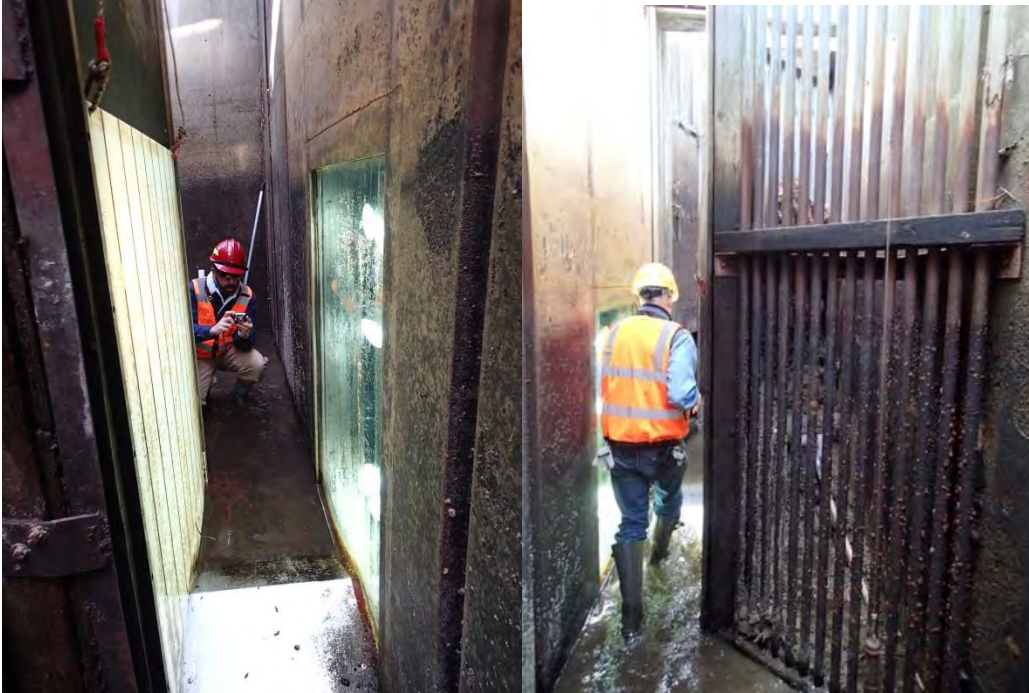
Figure 11 and Figure 12. Counting window and upstream picket lead crowder.

- Counting window (Figure 11) was designed to control temperature and humidity, for video counting

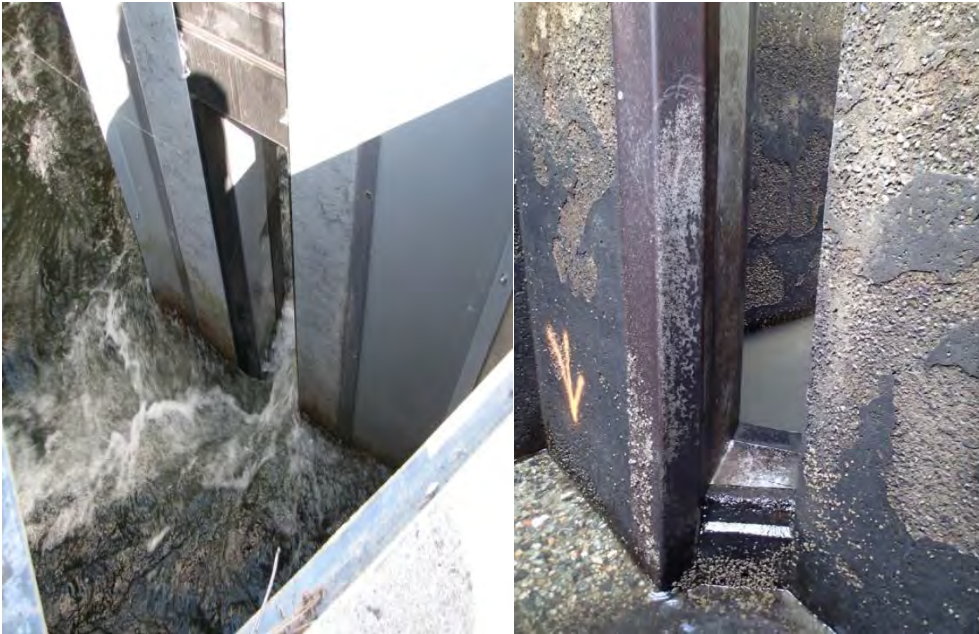
Figure 17 and 18. PIT detectors with short-channel flow at Slots 15 and 18

It is expected that the two PIT arrays will result in incrementally more challenging hydraulic conditions for lamprey passage, due to the greater length of flow (approximately 15 inches) from the upstream to downstream PIT detector longitudinal length. Rather than a 6 fps velocity flow at the typical slot perimeter, the longer “tube like” condition contrasts the slot configuration, and is more like a short channel. Velocity in this short length increases from approximately 6 fps at the upstream end to 8 fps at the downstream end.

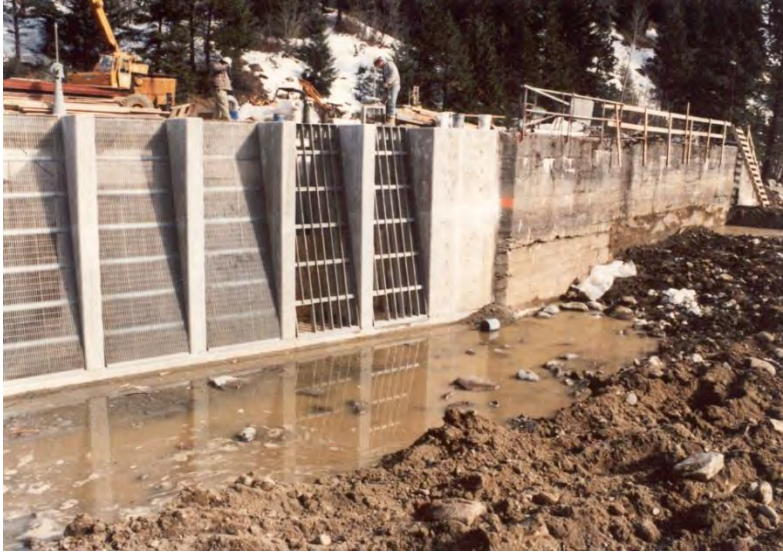
Figure 19. Tumwater AWS and lower ladder trash racks

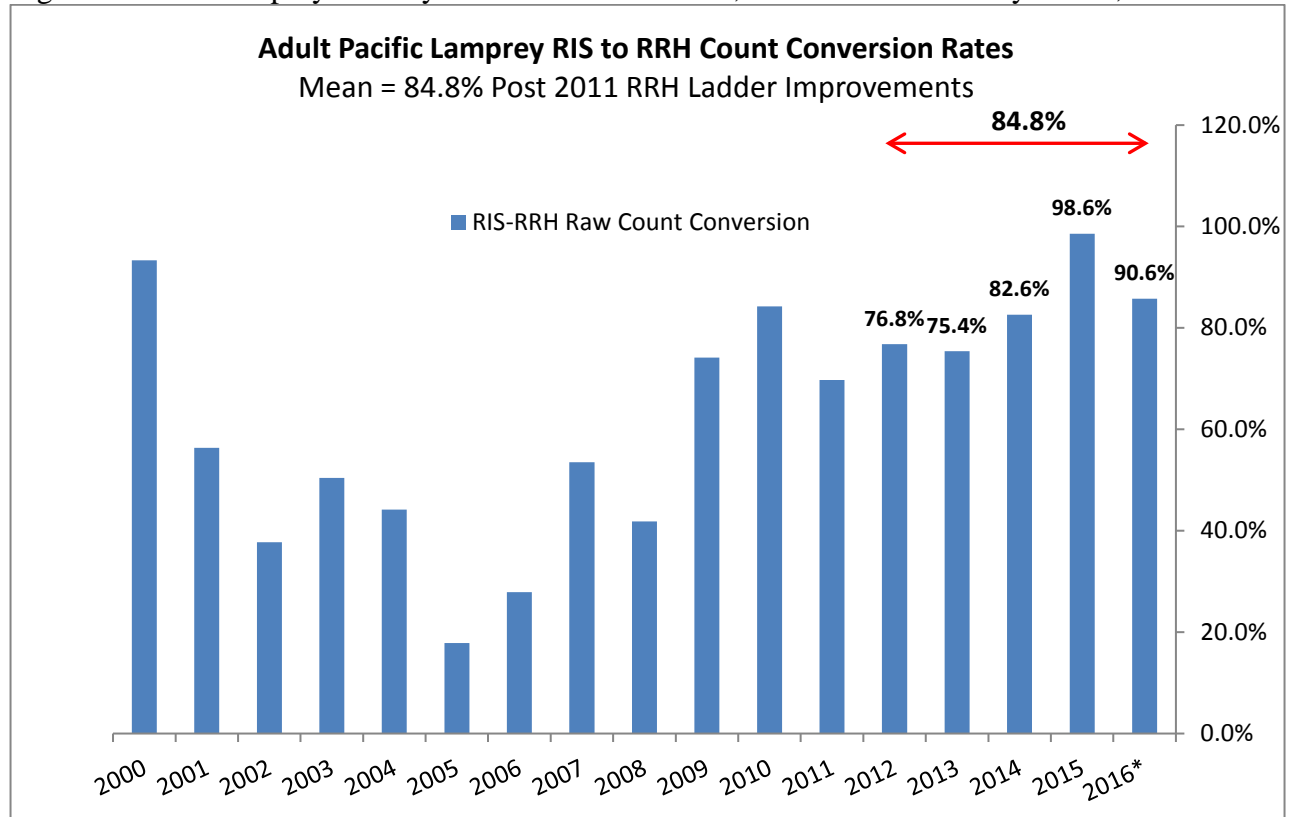
Figure 4. Adult lamprey fishway count conversion rates, Rock Island to Rocky Reach, 2000-2016.

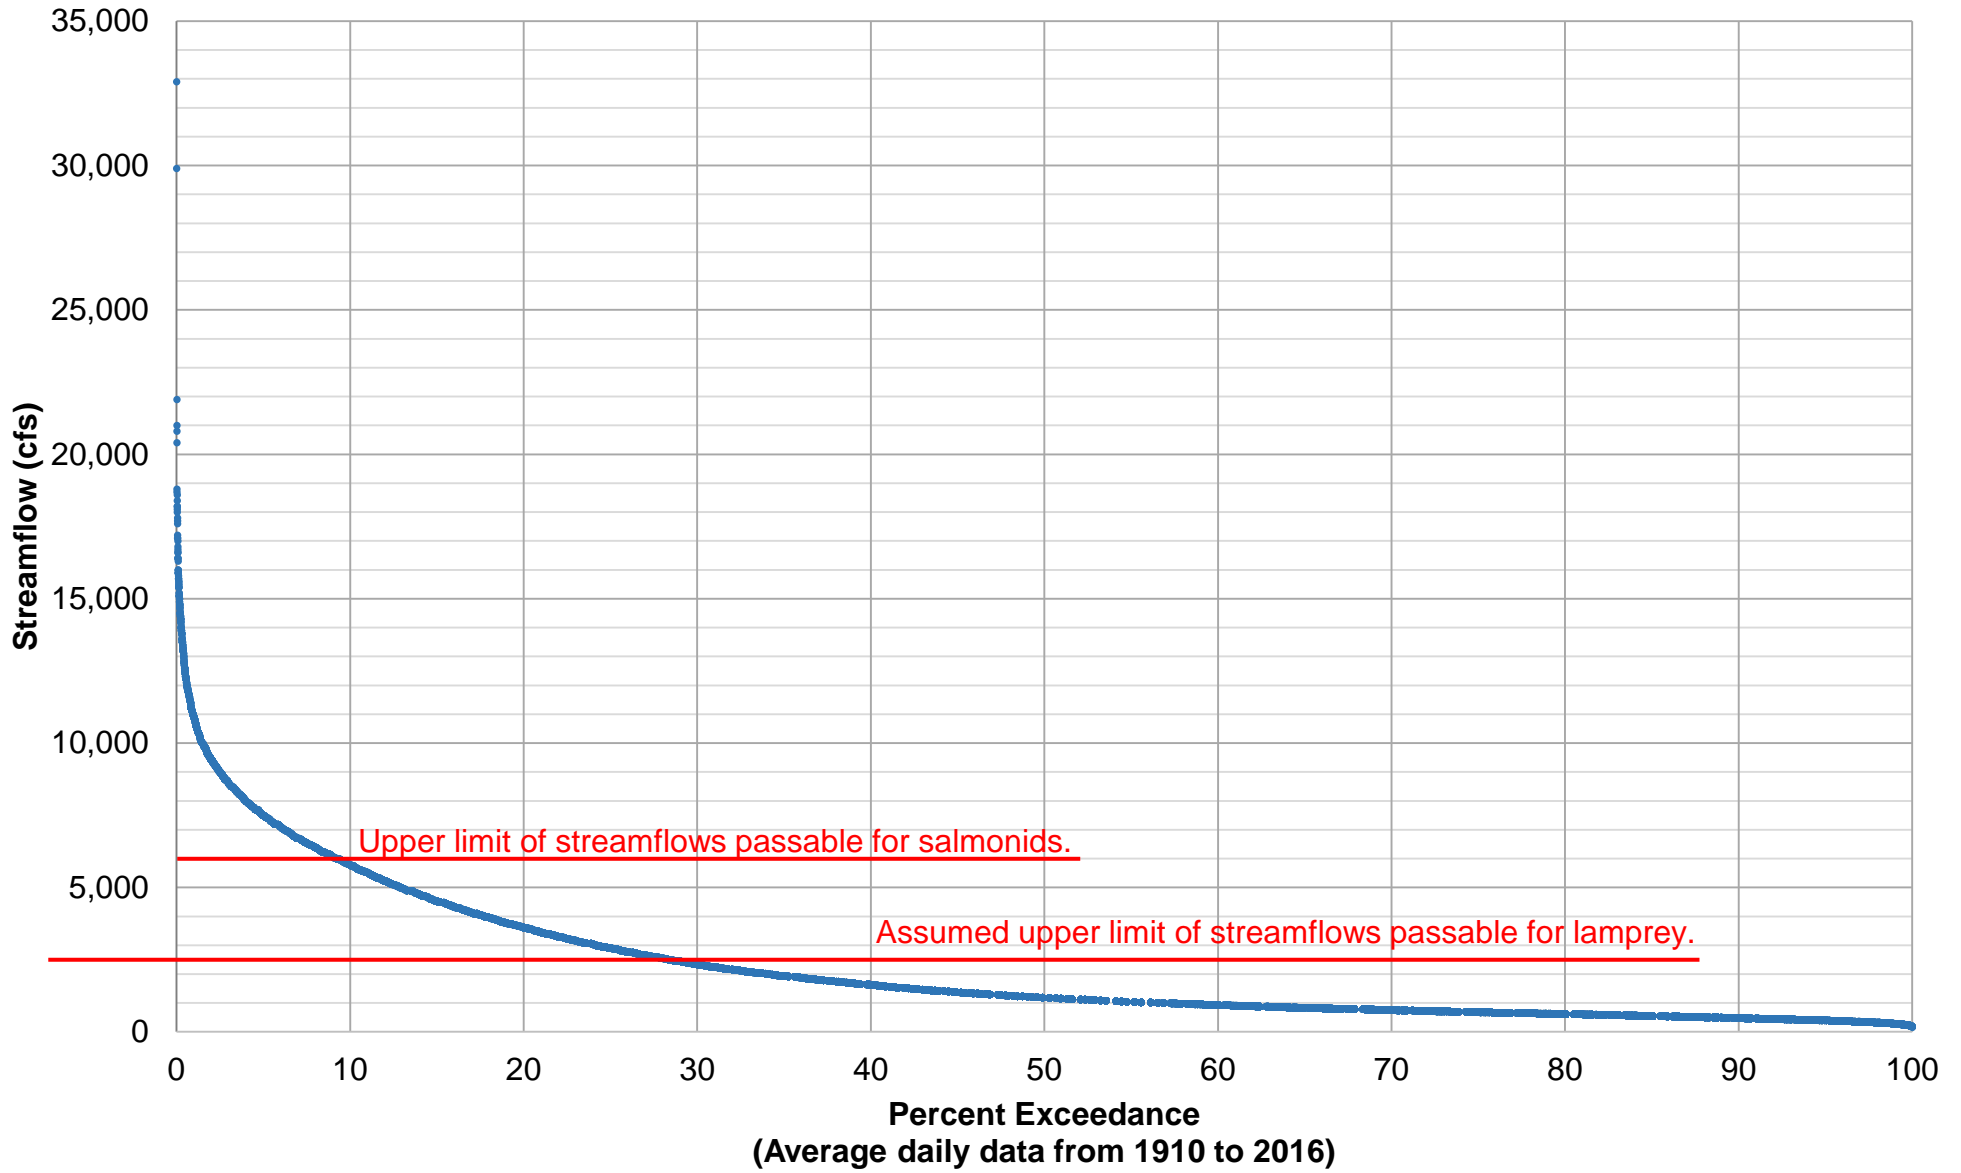
Annual Flow-Duration Curve
USGS Gage 12457000 Wenatchee River at Plain, WA

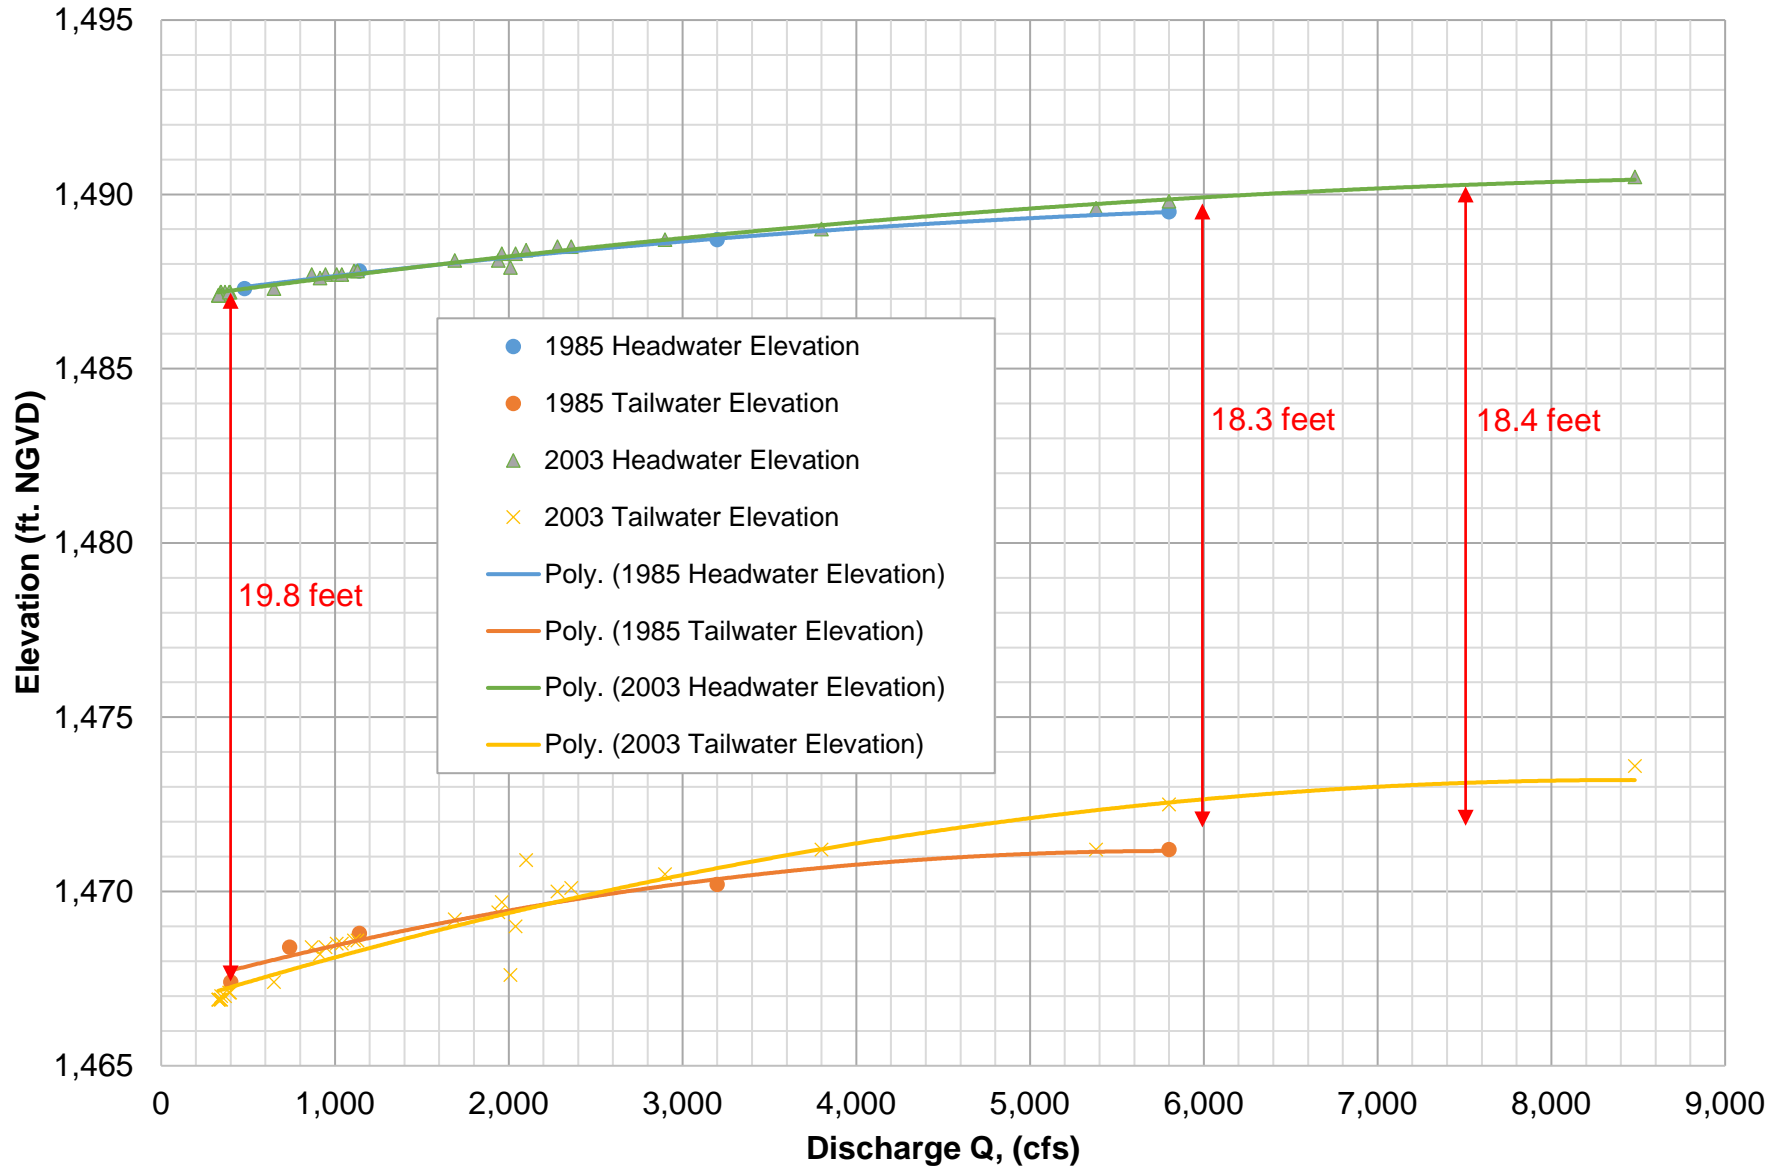
Headwater - Tailwater Curves Tumwater Dam, Left Bank

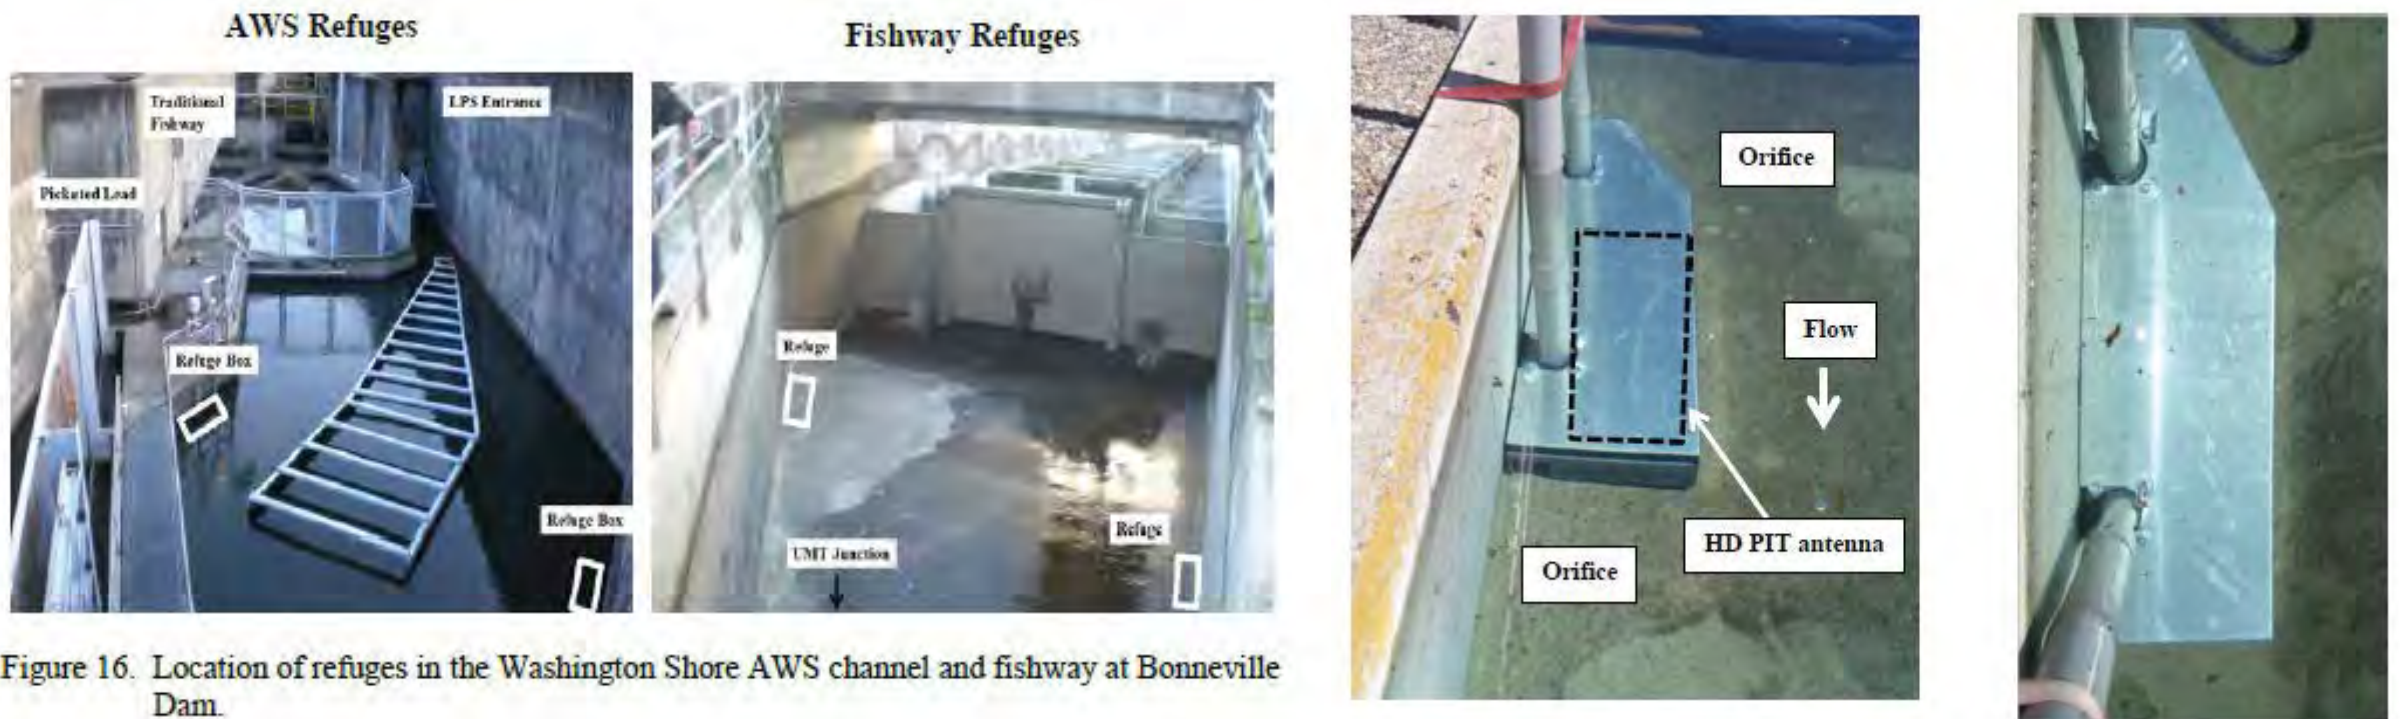
Figure 16. Location of refuges in the Washington Shore AWS channel and fishway at Bonneville Dam.

- Provide refuge for lamprey to reside during daylight that may otherwise have fallen back downstream
- May support passage for some lamprey that would have fallen back, but overall the fish using the refuge were less likely to pass than those which did not seek refuge
