Chelan PUD – Tumwater Fishway Improvements

PREPARED FOR: Justin Fletcher
COPY: Alene Underwood
PREPARED BY: CH2M
DATE: 18 October 2017
SA NUMBER: 16-084
CH2M PROJECT NUMBER: 680819

This memorandum documents the feasibility of improvements at the Tumwater Dam Fishway to enhance the upstream migration of Pacific Lamprey (*Entosphenus tridentatus*). This memorandum also summarizes the results of an alternatives review workshop and identifies steps for implementation of the preferred alternative.

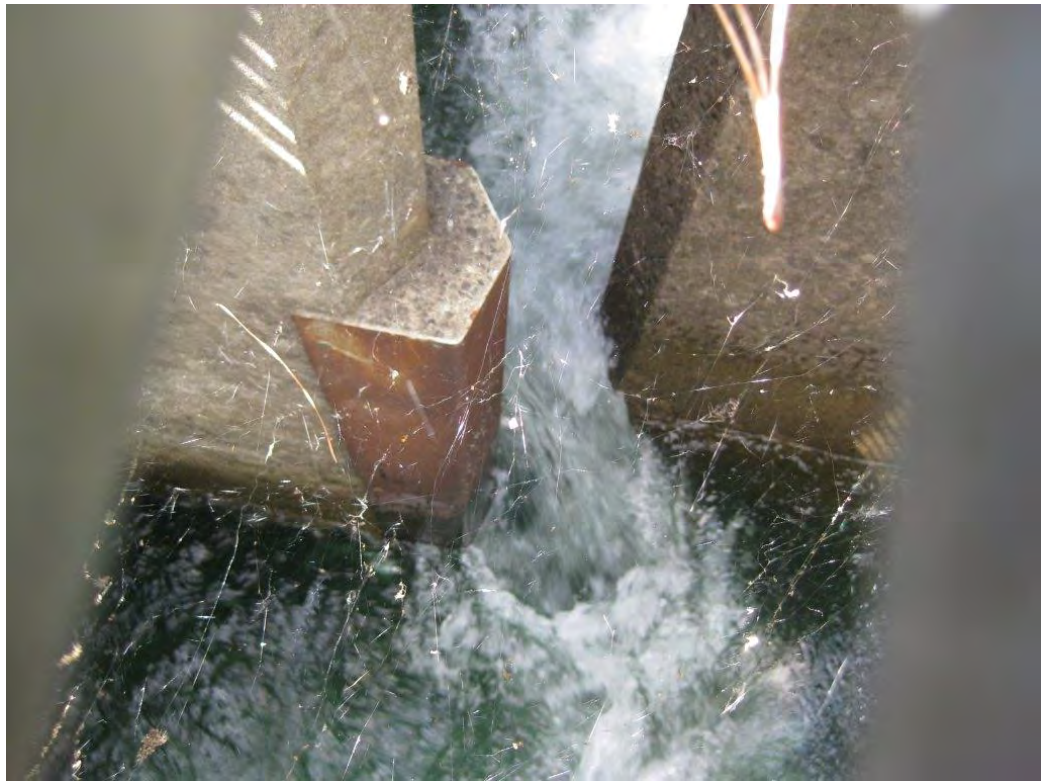
Figure 4. Fishway Vertical Slot, Modified from 15 to 12 inches
Chelan PUD Tumwater Fishway Modifications

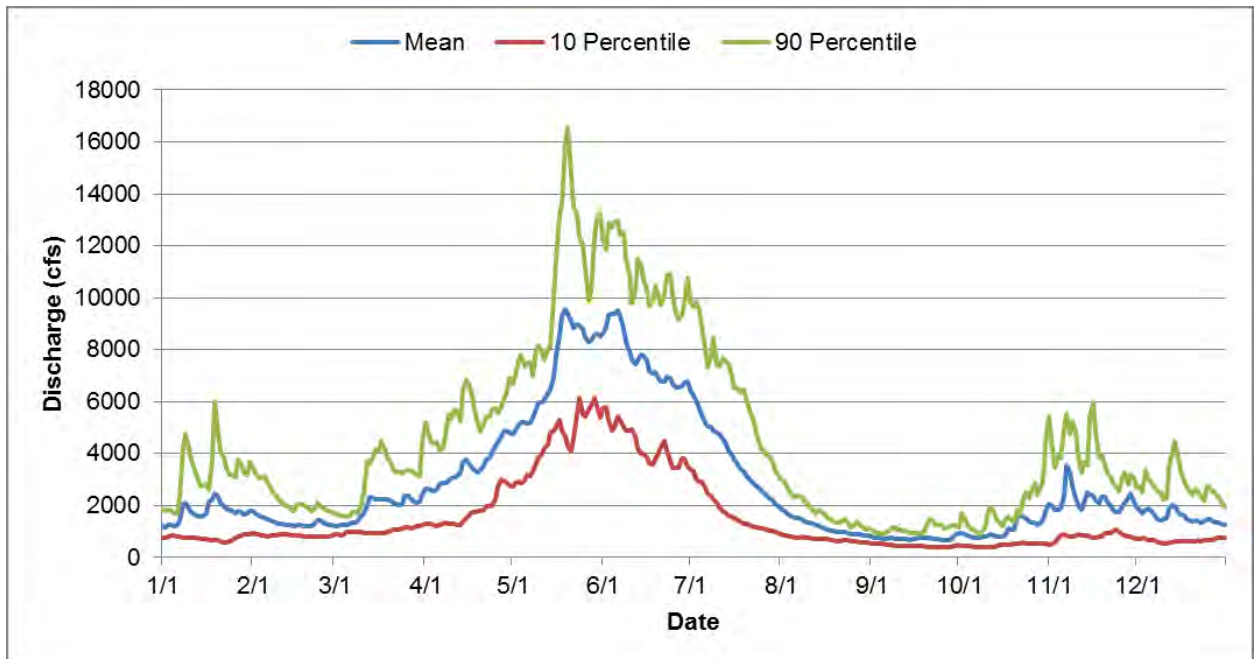
The Peshastin USGS streamflow gage is downstream of the Icicle Creek confluence, but is the nearest to the Tumwater Dam site, and should be within 10% or so of the corresponding flow at Tumwater Dam. Flow on February 18, during the tour, was reported at 4,380 cfs. This is over twice the mean flow for the month of February, nearly twice the mean flow during the March – June spring migration, and over twice the mean flow during the mid-July - October lamprey migration.

Figure 2. Streamflow data from Peshastin, 2000-14

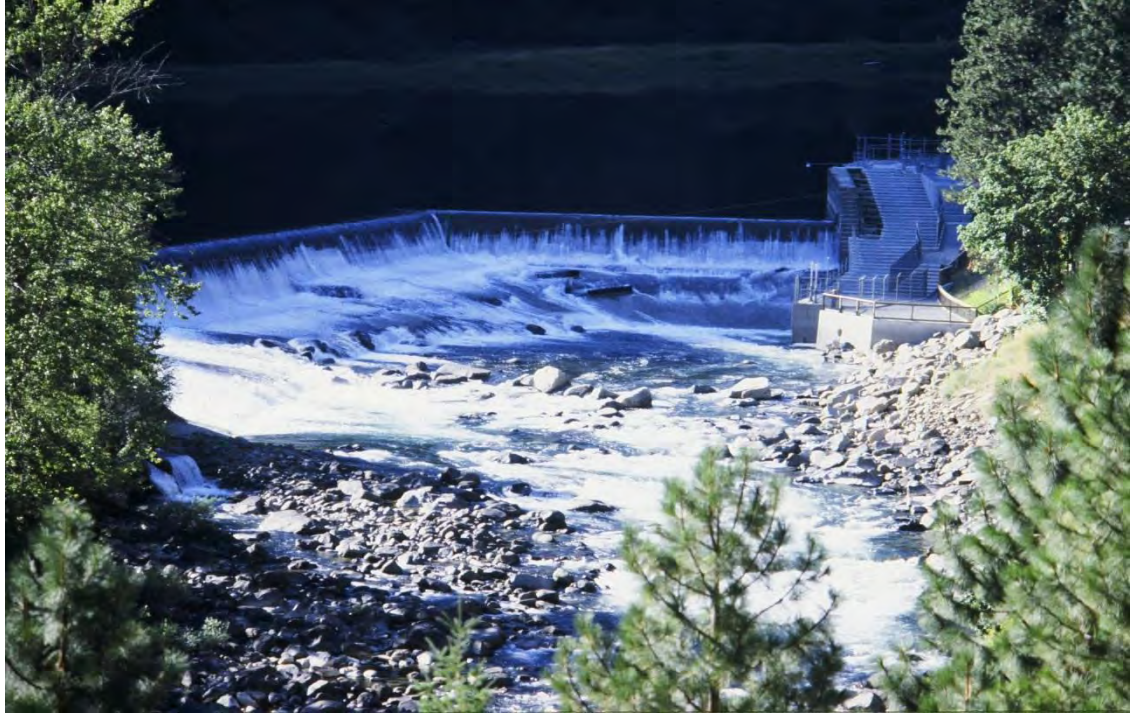
- *Dam Dog-leg Jet* - The approximate 60 degree corner of the dam creates a “dog-leg”, and a distinct larger jet in the tailrace is caused from flow converging immediately downstream of the adjacent dam crests (Figure 4). Dam crest dog-leg jet merges on the dam apron, and extends across river at an angle below fishway (see in photo below at low streamflow). Adjacent to the fishway, flow passes down the ogee and onto the apron, before entering tailwater at high velocity. A standing wave upstream of the fishway entrances occurs at high flows. Water is aerated and turbulent in this area (see photos).

Figure 4. Dam Dog-leg Jet (jet extends diagonally to left shore near the fishway). Note that this is a previous photo during relatively low discharge period

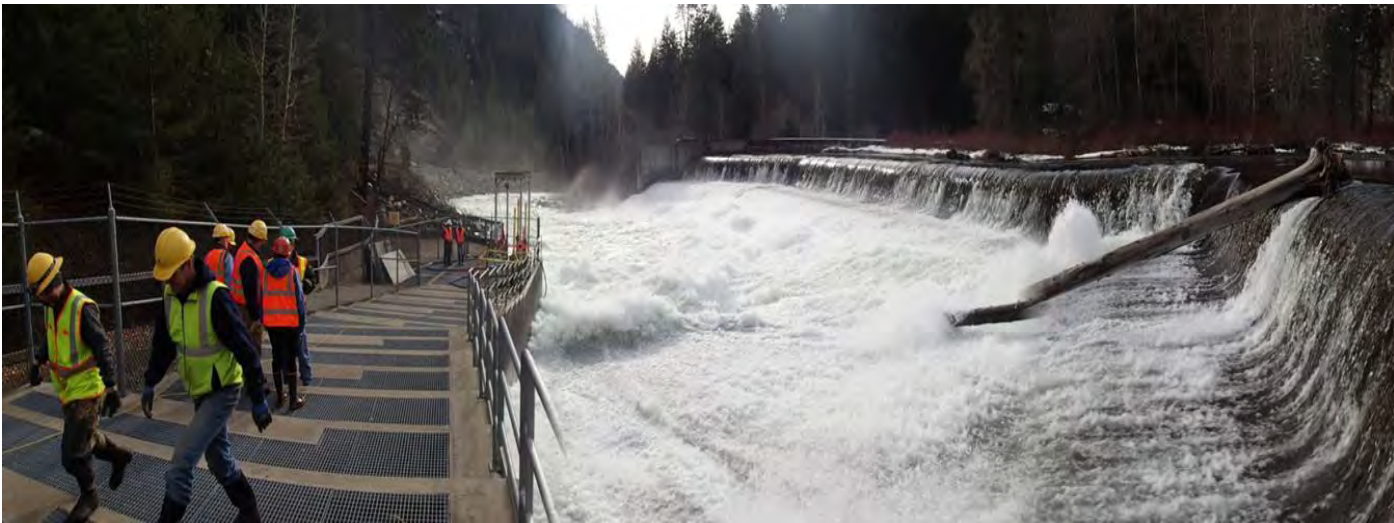
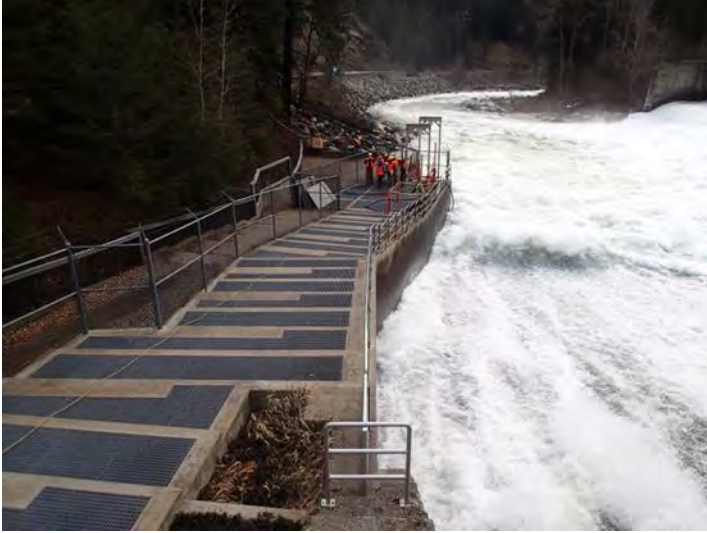
Figures 5 and 6. Turbulent tailwater adjacent to fishway on day of site visit

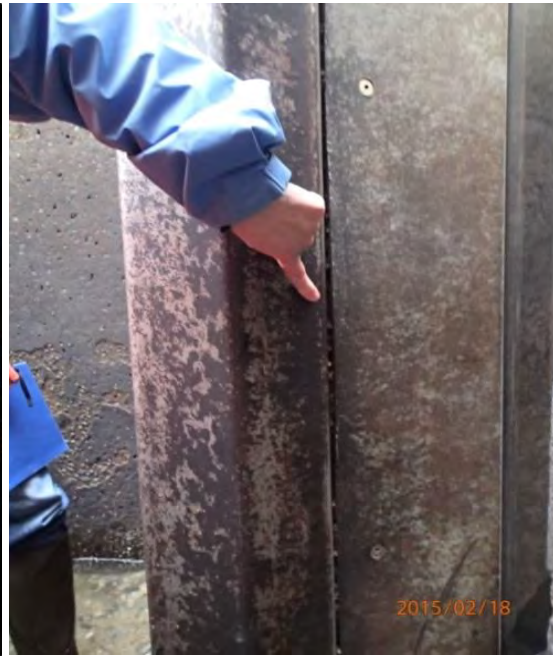
Figure 8. Typical stub wall slot nose extension

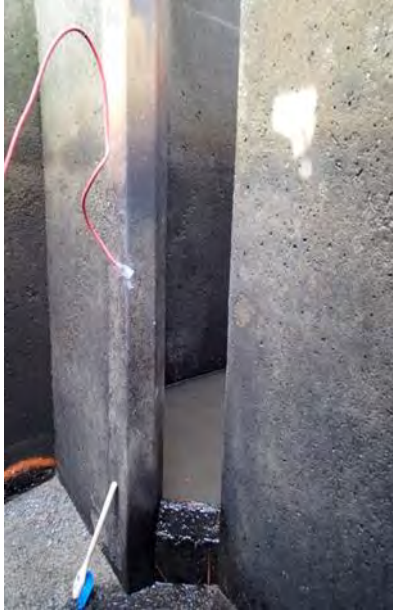
- It is important to note that the 12 inch and 15 inch slot widths both still are designed for a 1-foot drop. This means that jet velocities at the spring point of the slot are the same, as are the convergence jet velocities just downstream.
- Small gaps at upstream vertical edge of steel stubwall nose plate extensions were noted during the tour. These could adversely impact lamprey passage. (See Figure 9)
- The 1 ft high x 1 ft wide x 8 inch thick sill has a 3-inch wide top. Most sills have chamfers on the downstream face (Figure 10). Not all of the sills have the same sill design, some simply angled from the floor to attain the 3-inch top width.

Figure 10. Sill at base of typical Tumwater Dam fish ladder slot

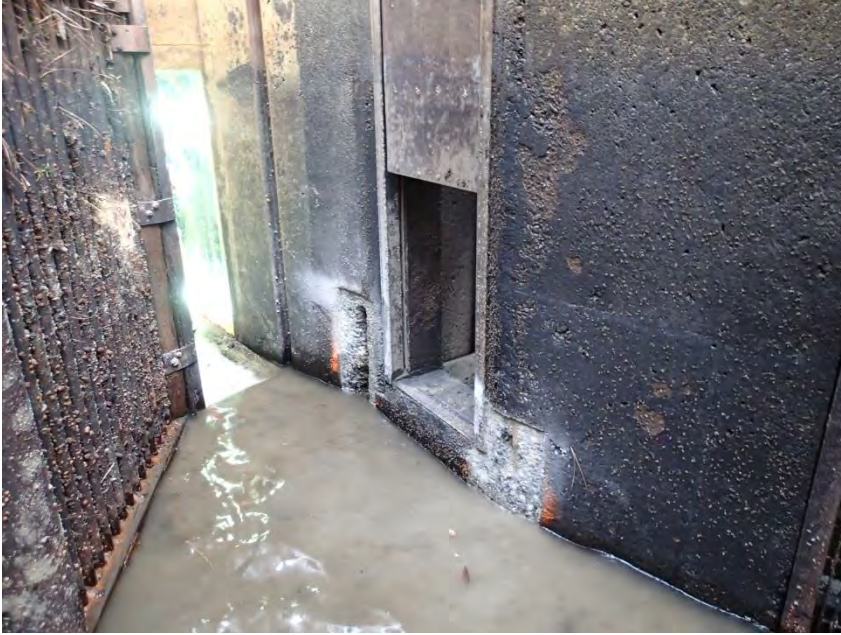
- Downstream and upstream angled picket leads with 1-inch openings are in the channel opposite to the counting window. (Figure 13) The upstream and downstream angled pickets serve as crowdors for guiding salmon past the counting window. However, lamprey are likely able to pass through the pickets, and some likely would not be counted

Figure 13 – Upstream-looking view of picket leads, counting window, and emergency trap adult return port (with gate in upward and open position)

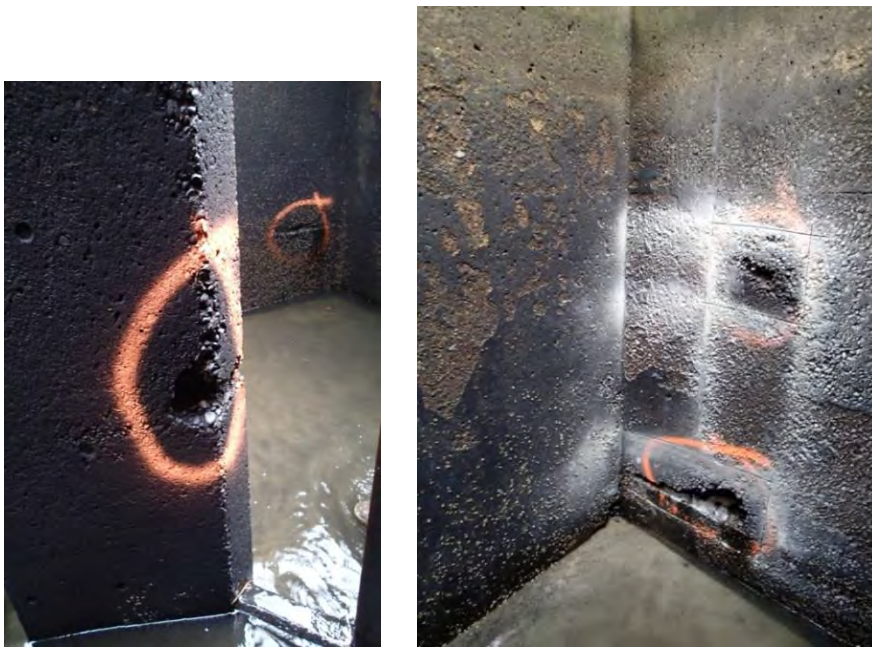
- Wall erosion (erosion of fine aggregate/ sand) was observed on the downstream side of each baffle wall, just above floor level, and in the lower 6-8 ft of each slot. Same observed at the opposite corner, low on the side wall. Erosion of fine aggregate was also observed on the left wall of each pool near the floor.
- Walls have also severely eroded at some isolated locations, exposing coarse aggregate, and deeper pitting. More severe pitting locations were to be re-finished by a contractor.

Figure 14 and Figure 15. Spalling concrete in slot surface and pool sidewall corner of Tumwater Dam fish ladder

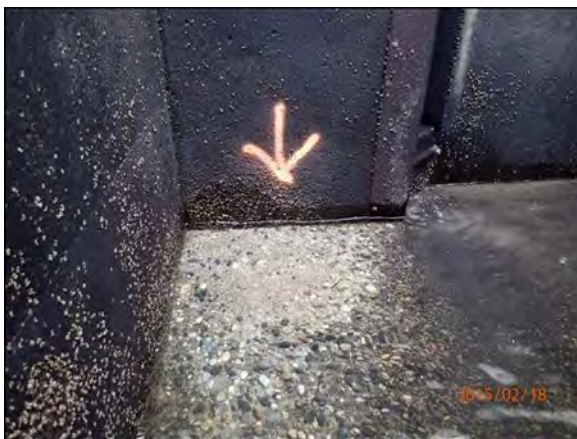
Figure 16- Sediment and gravel accumulations downstream of slot stub walls

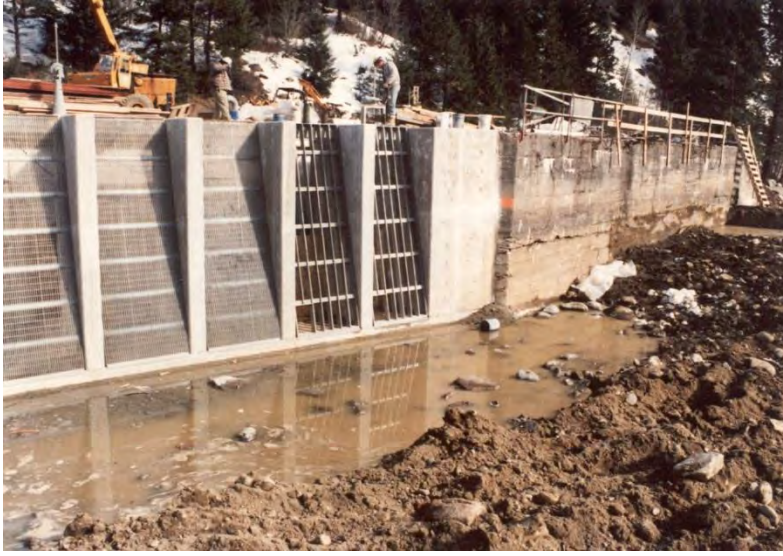
Figure 19. Tumwater AWS and lower ladder trash racks

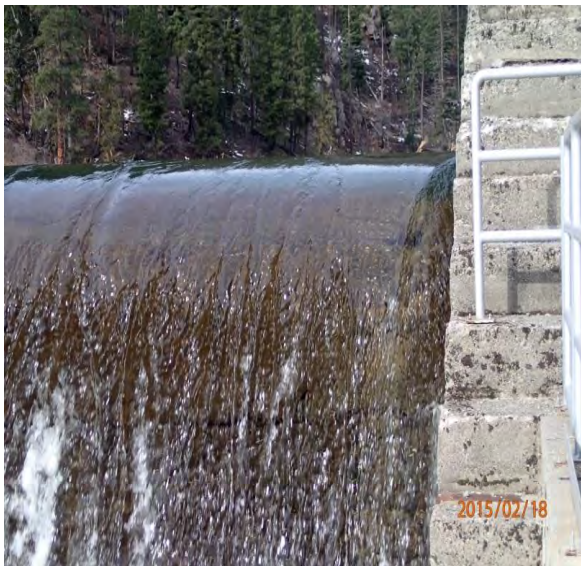
- Figure 26 shows erosion of concrete, and exposed aggregate can be seen.
- Dam face is has an ogee longitudinal section, with a steep-gradient apron (Figure 27).
- See also Section 5 for discussion of dam configuration.

Figure 26 – Flow over dam ogee

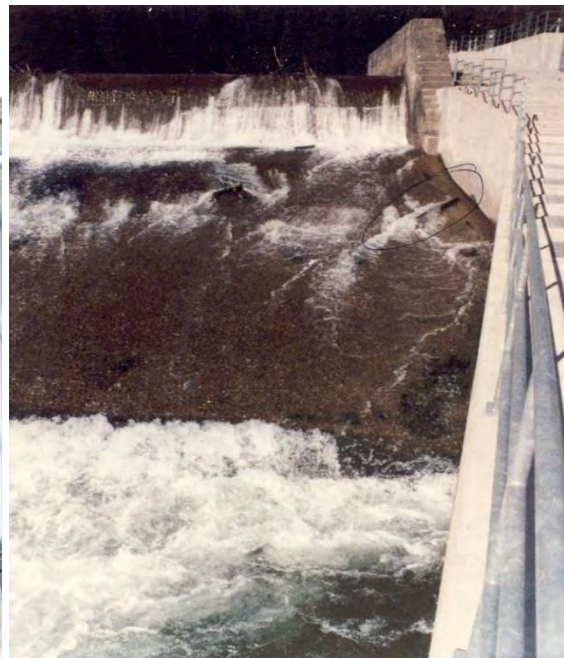
Figure 27 – Concrete apron, ogee in background

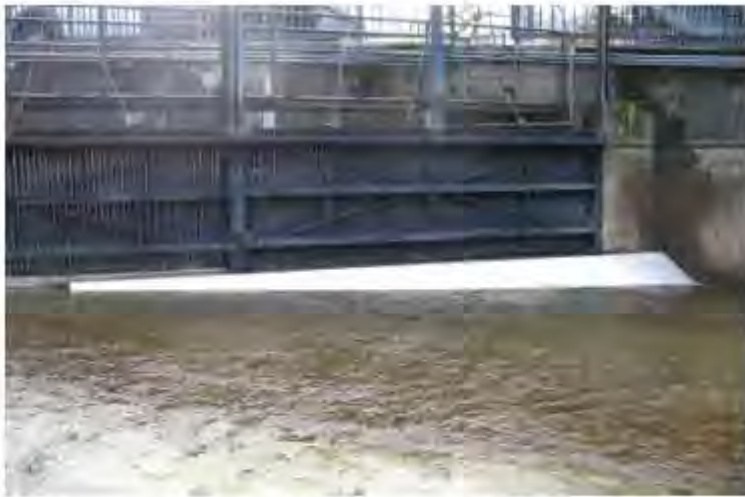
Increased access to AWS channel via metal ramp

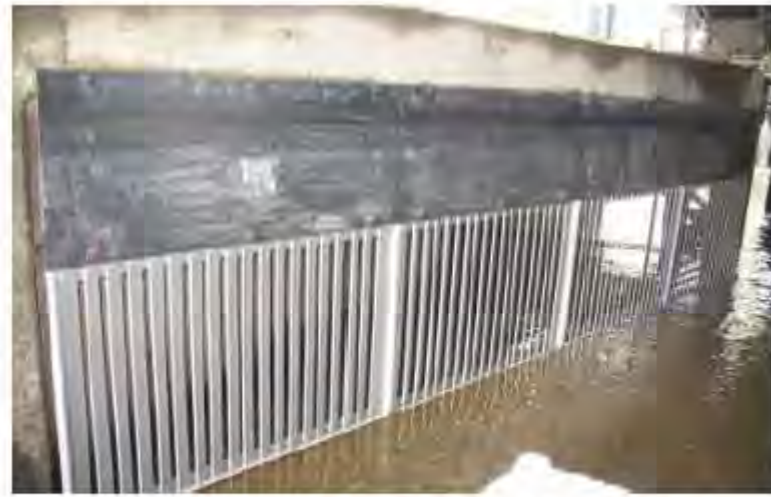
Reduced access to area behind count station crowder

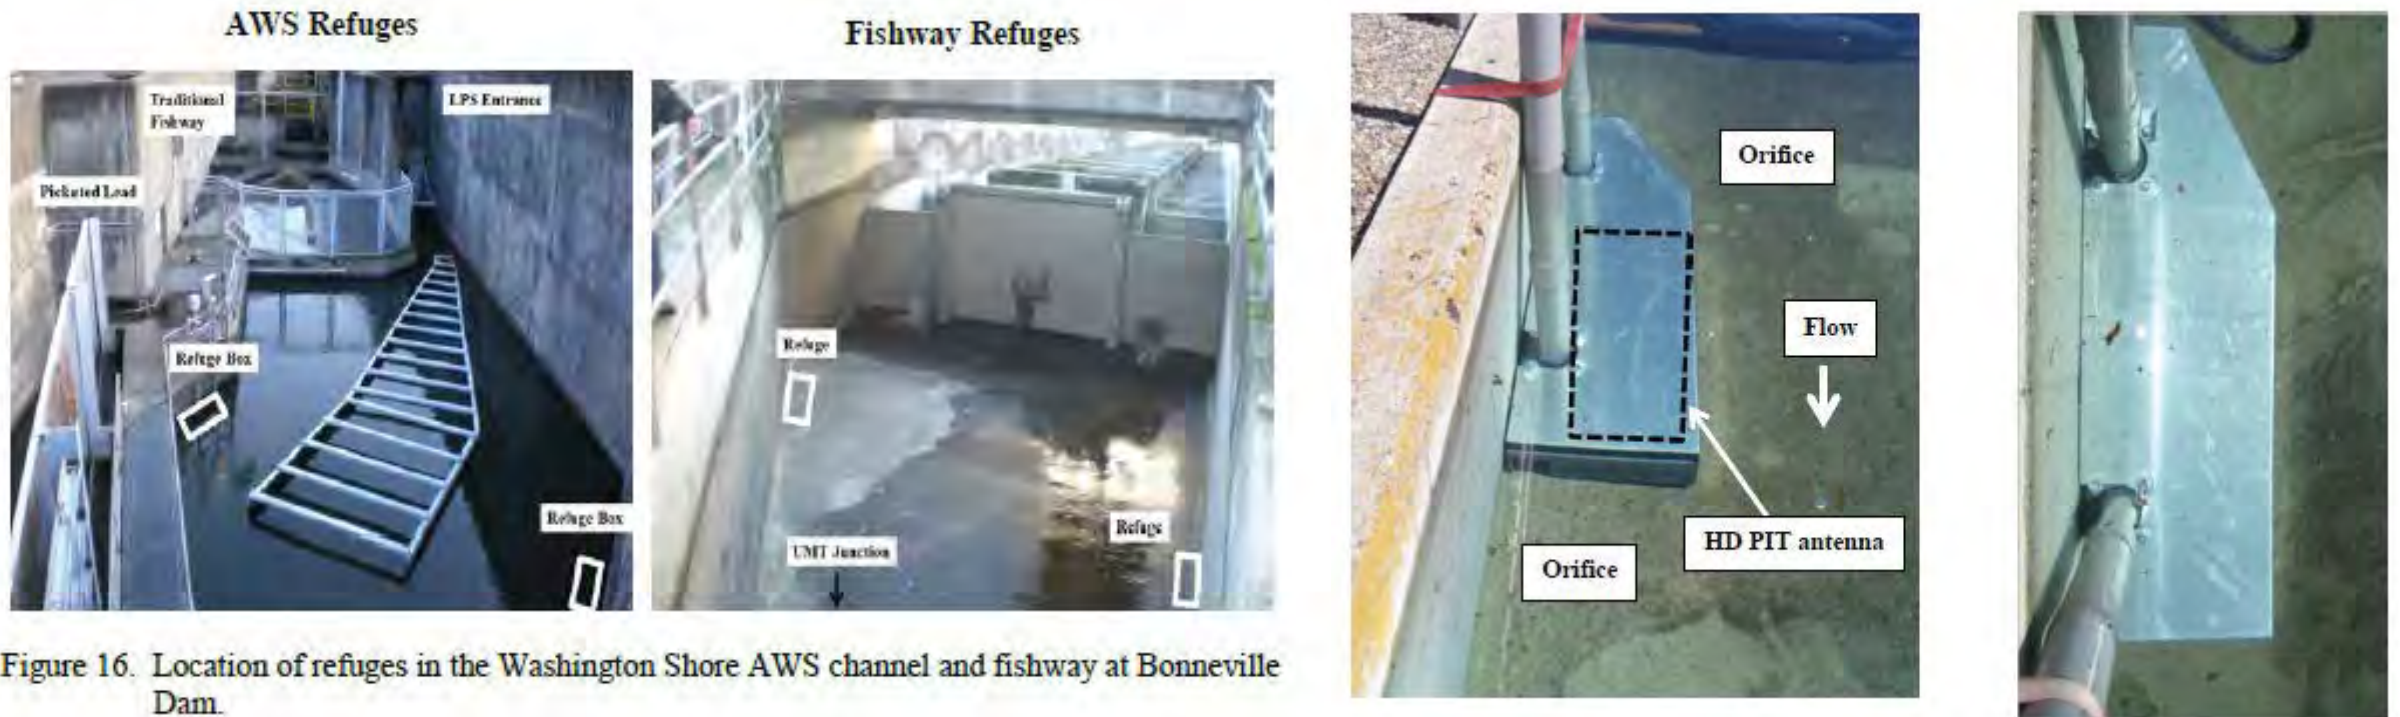
- Provide refuge for lamprey to reside during daylight that may otherwise have fallen back downstream
- May support passage for some lamprey that would have fallen back, but overall the fish using the refuge were less likely to pass than those which did not seek refuge

Figure 16. Location of refuges in the Washington Shore AWS channel and fishway at Bonneville Dam.

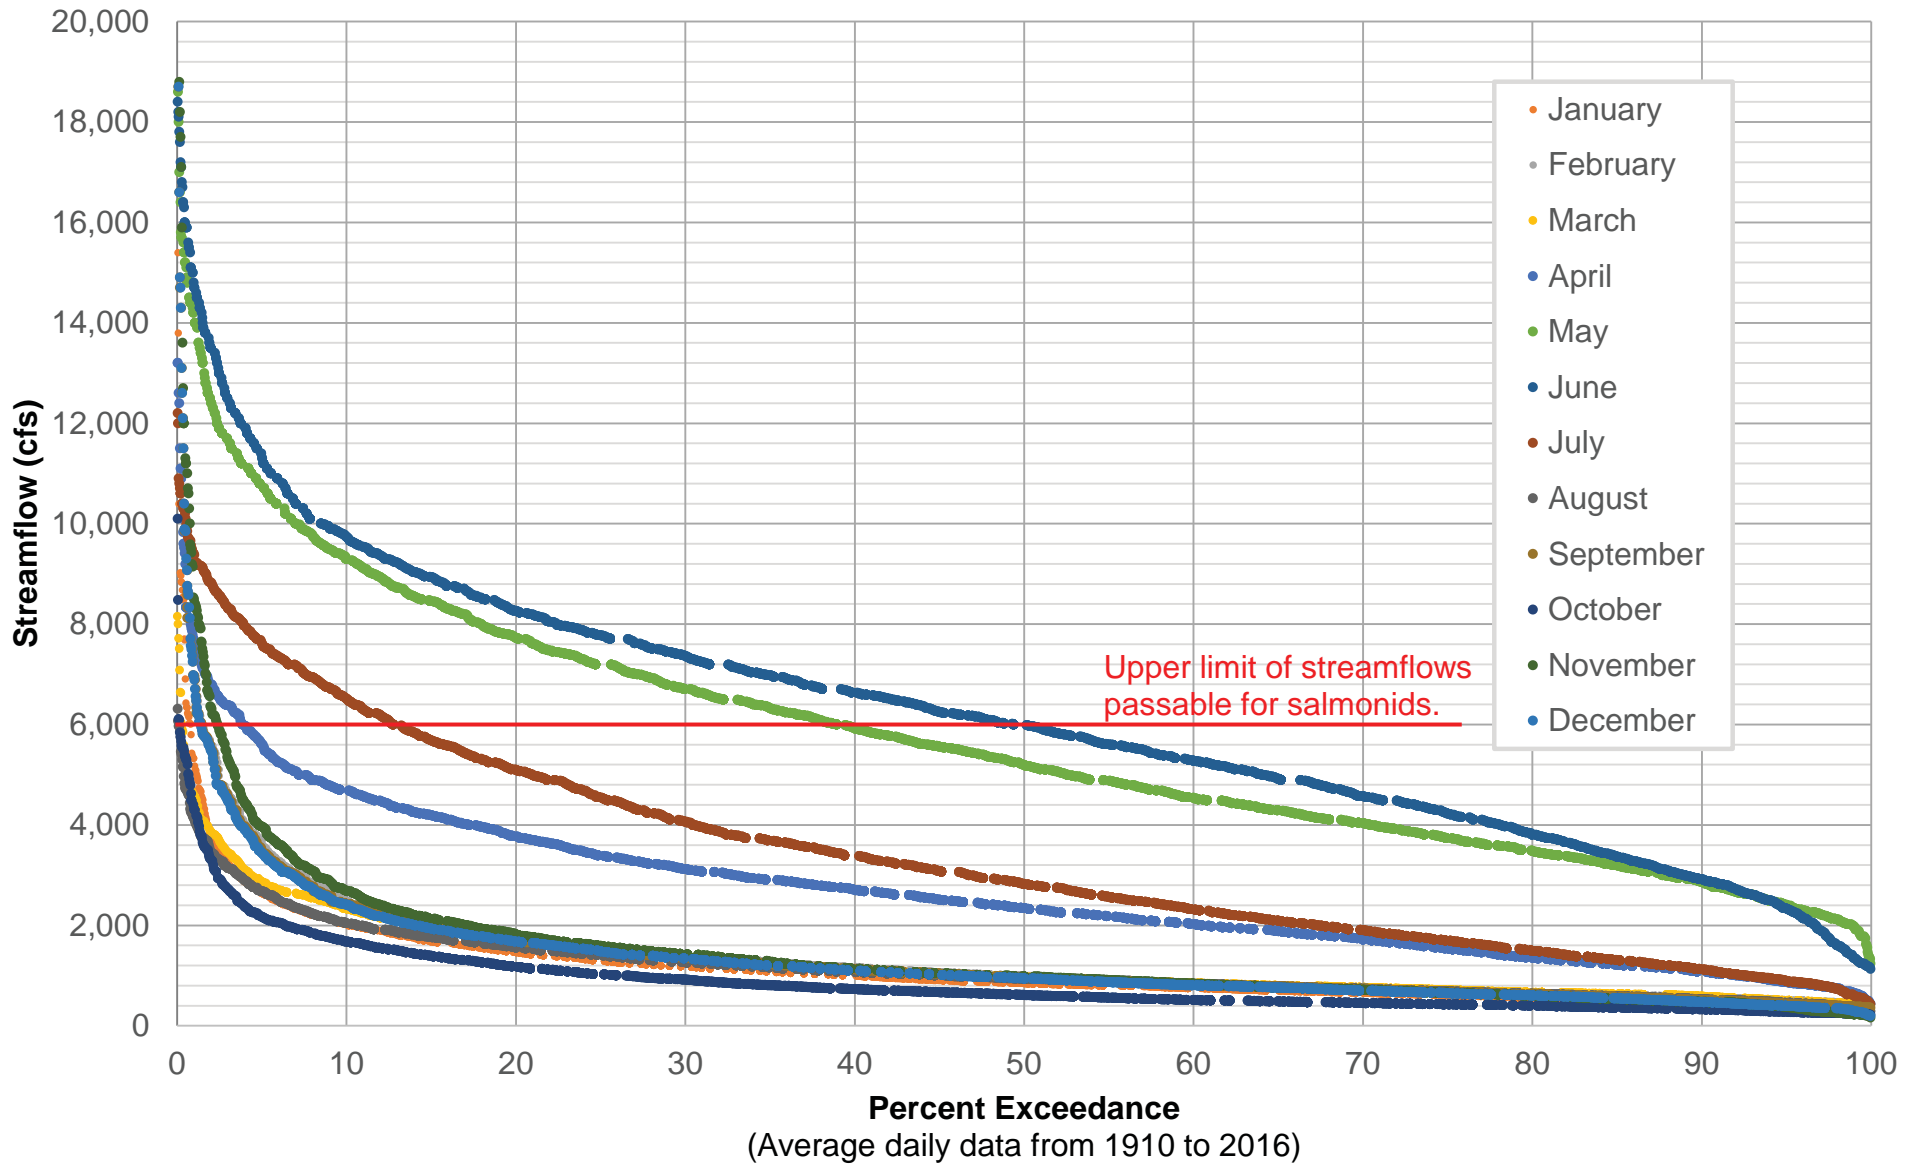
Flow-Duration Curves
USGS Gage 12457000 Wenatchee River at Plain, WA
