MEMORANDUM

RE: Investigation of June 13, 2018 Incident at Rock Island Dam, Gate No. 17

EXECUTIVE SUMMARY

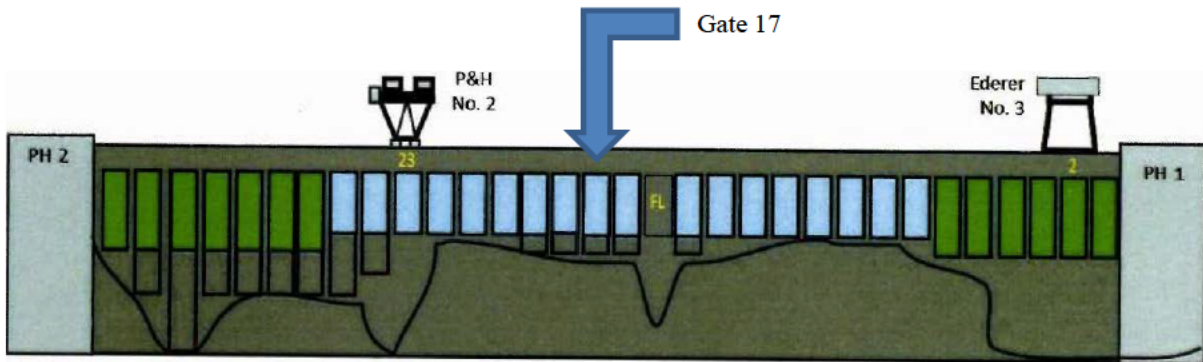
Diagram No. 2 - Rock Island Dam's two gantry cranes used in gate lifting operations are typically situated over Gate 23 and Gate 2. Gantry Crane 3 was used to lift Gate 17 on June 13, 2018.

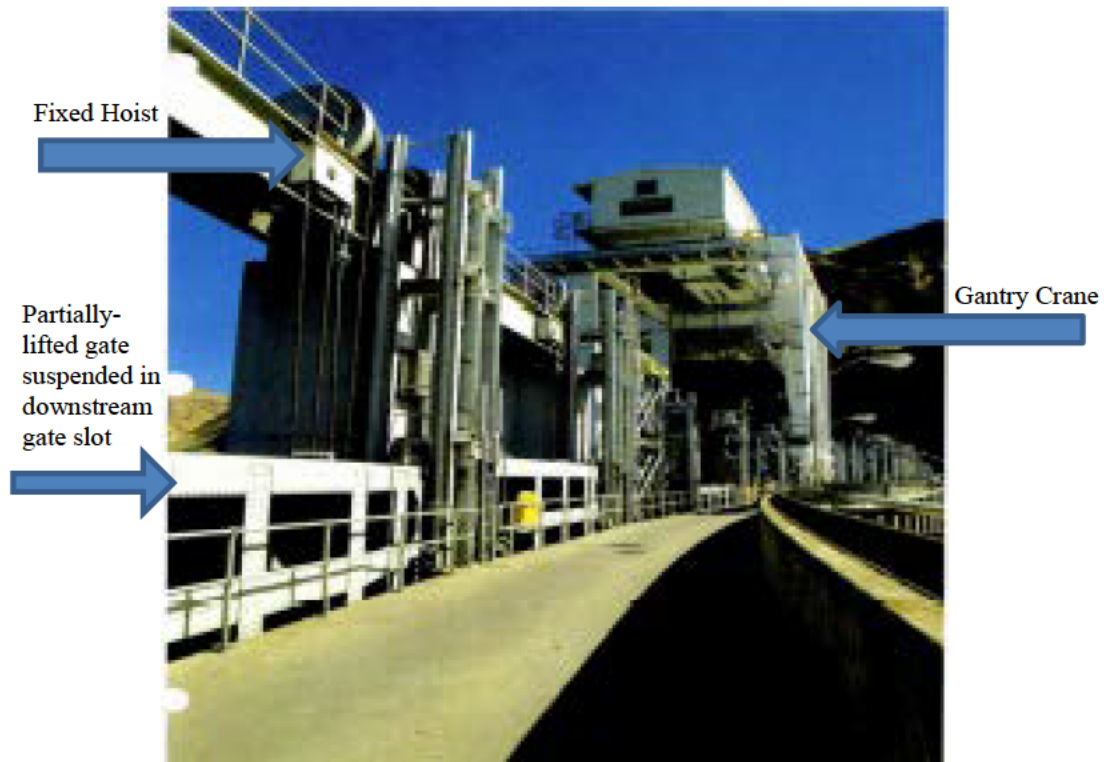
Photo No. 1 - View of spillway bays along spillway deck. The spillway bay in foreground is outfitted with a fixed hoist while a gantry crane is positioned over bay/gate in background.

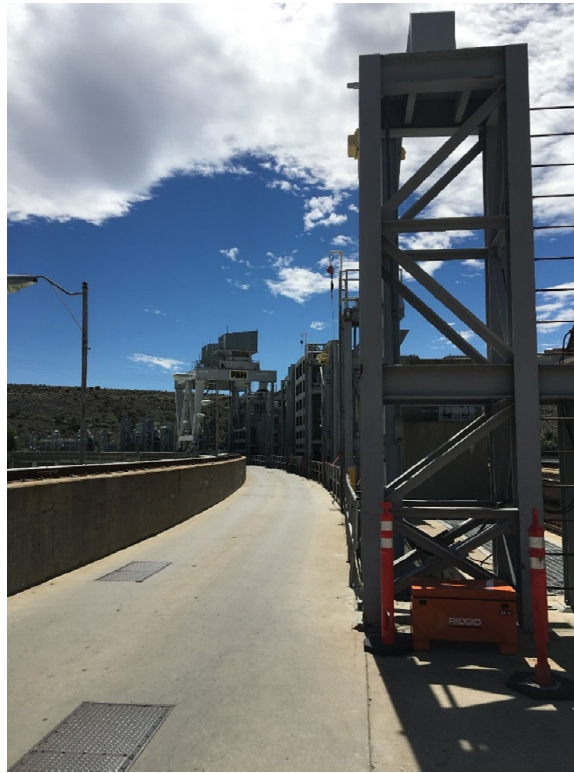
The spillway gates, which rest in slots in the dam, are operated by a variety of means, including automatic fixed hoist operation for Gate Bays 6-10, 17 (currently out of use), 19, 20, 22, 25 (out of use), and 27. The other spillway gates are manually operated with a gantry crane, including Bays 17 and 25 where the fixed hoists are not operable. There are three gantry cranes operating on the dam – the 80-ton Whiting gantry crane (Crane 1), the 200-ton P & H Gantry Crane (Crane 2), and the 200-ton Ederer Gantry Crane (Crane 3). Automatic fixed gate hoist types vary across the dam with 280-ton hoists at bays 6 and 27, 200-ton

hoists at bays 19, 20, and 22, a 190-ton hoists at bays 7, 8, 50-ton hoists at bays 9 and 10. The out of use fixed hoists at bays 17, and 25 are 100/118 tons. A view of the hoists and stanchion towers is shown below in a Photo 1.

Photo 1: Rock Island Dam Deck Supports Multiple Stanchions for Removal and Storage of Segmented Lift Gates
