# **Rock Island Spillway Bays 17 & 25 Hoist Replacement**

## **Commission Presentation**

April 15, 2019

Review staff recommendation to revise scope and budget from repair to replace.

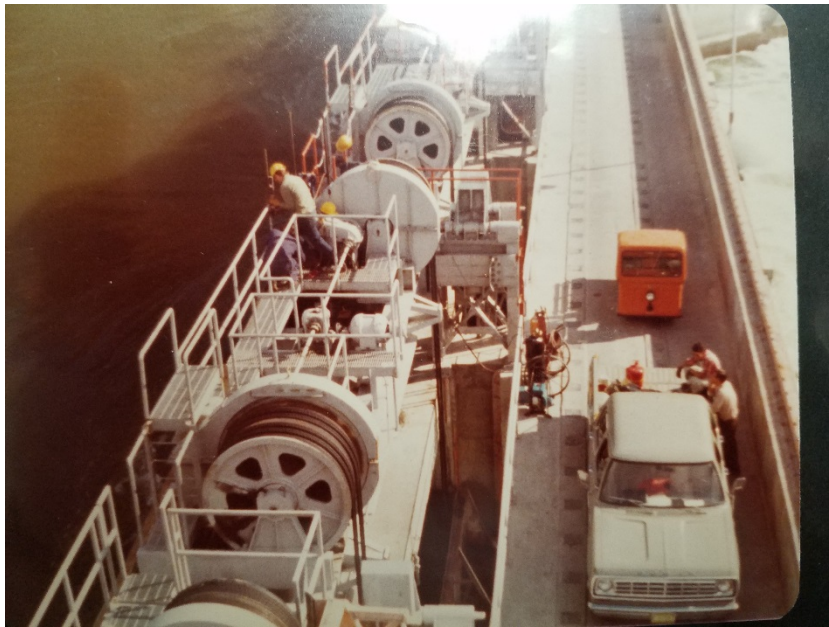
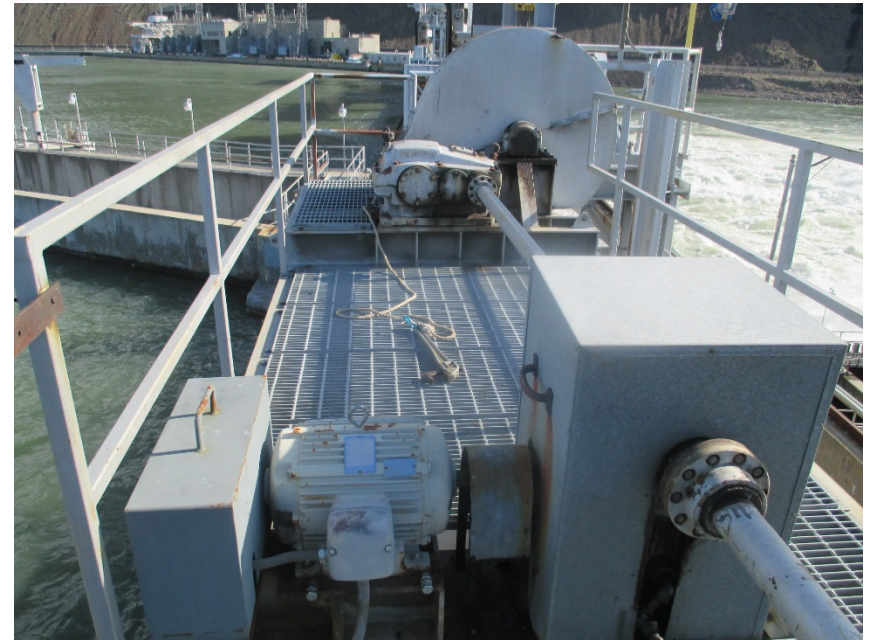
**100 Ton Hoist Original 1970**

**Rerated to 116 Ton in early 90's  
Relocated to spill bays 17 & 25.**

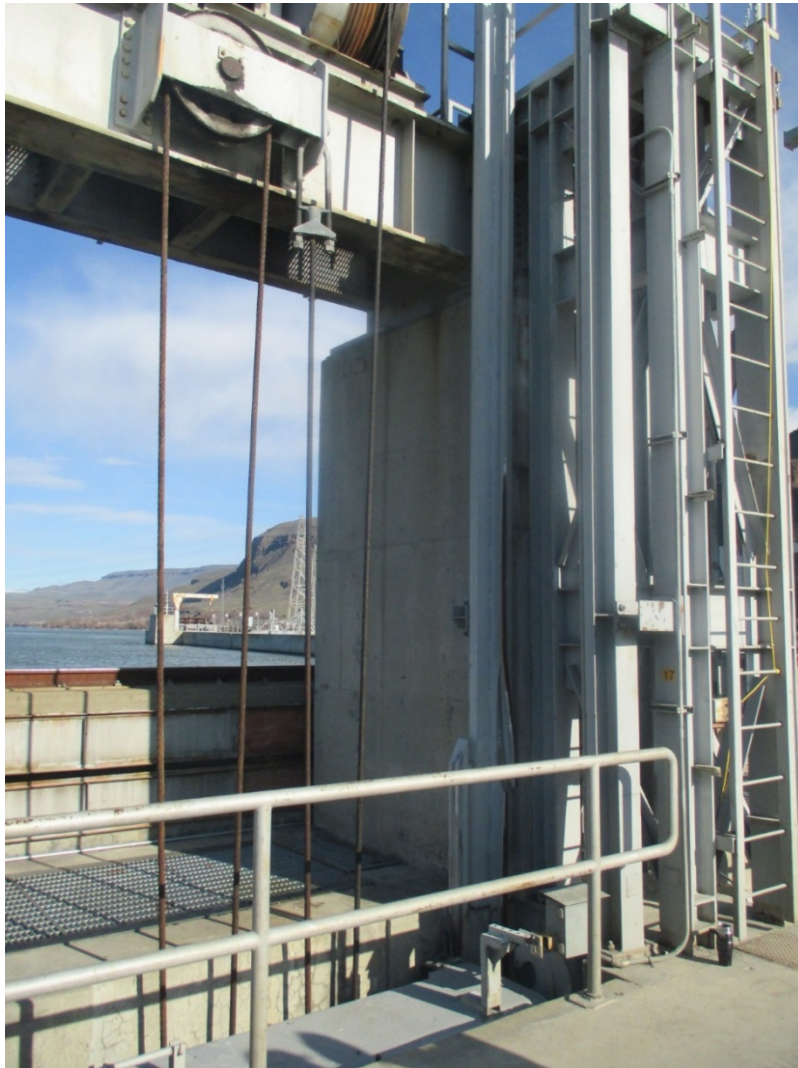
## Bay 17 & 25 Hoist Configurations

- Allows remote gate operation from RI Control Room or Dispatch
- Located at shallow spill bays - one 22-foot gate linked to one 11-foot gate.
- Flow Capacity approx. 16 to 20 kcfs per bay
- Critical to managing reservoir water elevations, especially during unexpected flow changes such as powerhouse unit load rejections.
