B1 to B4 Rehab

Assessment of Reused Components

Commission Presentation

August 7, 2017

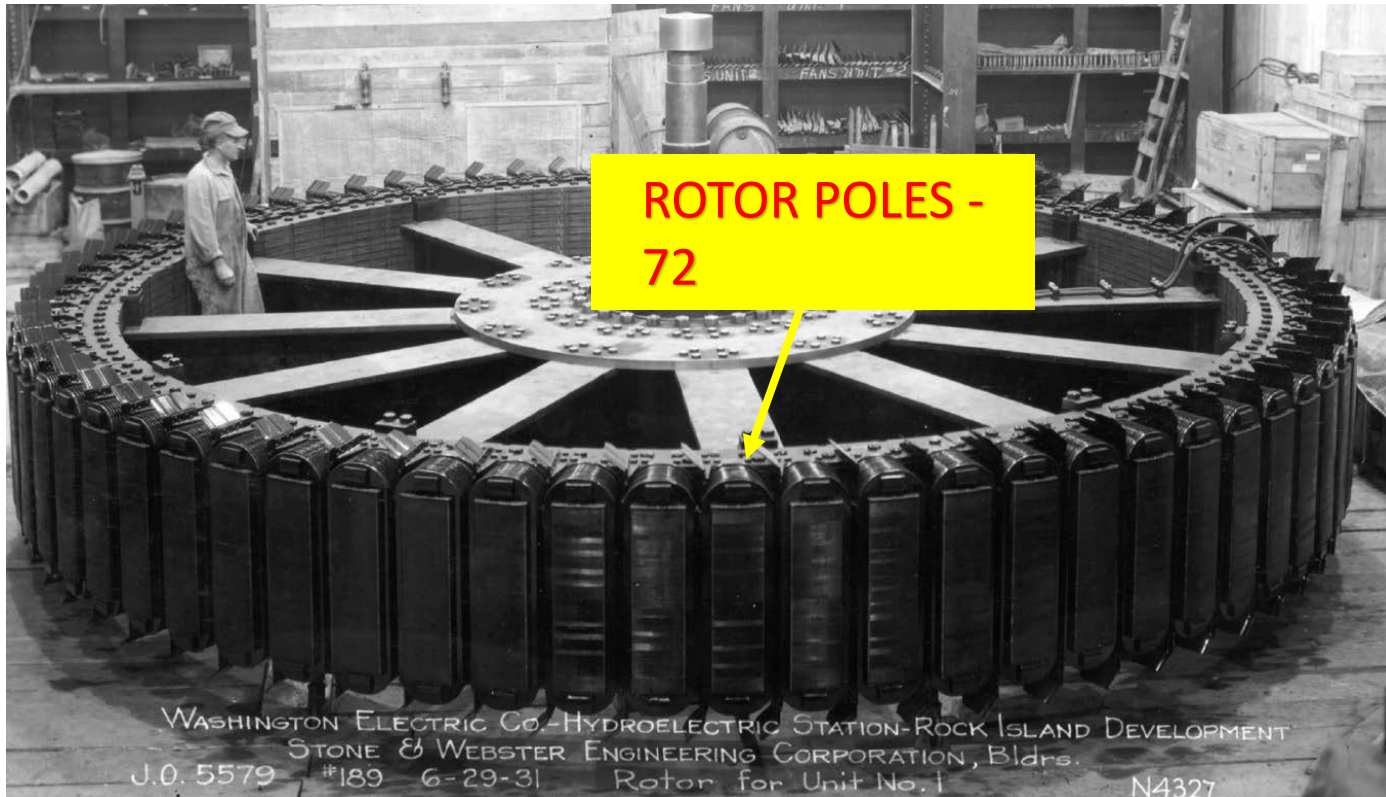
B1 ROTOR FROM 1931, ROTOR POLES TODAY ARE STILL ORIGINAL

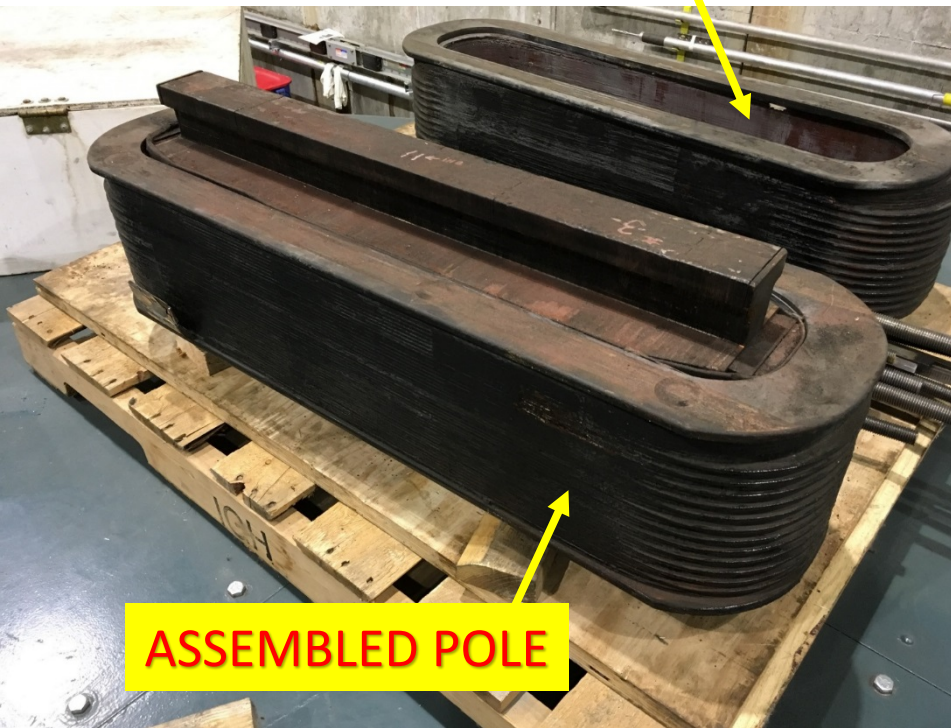
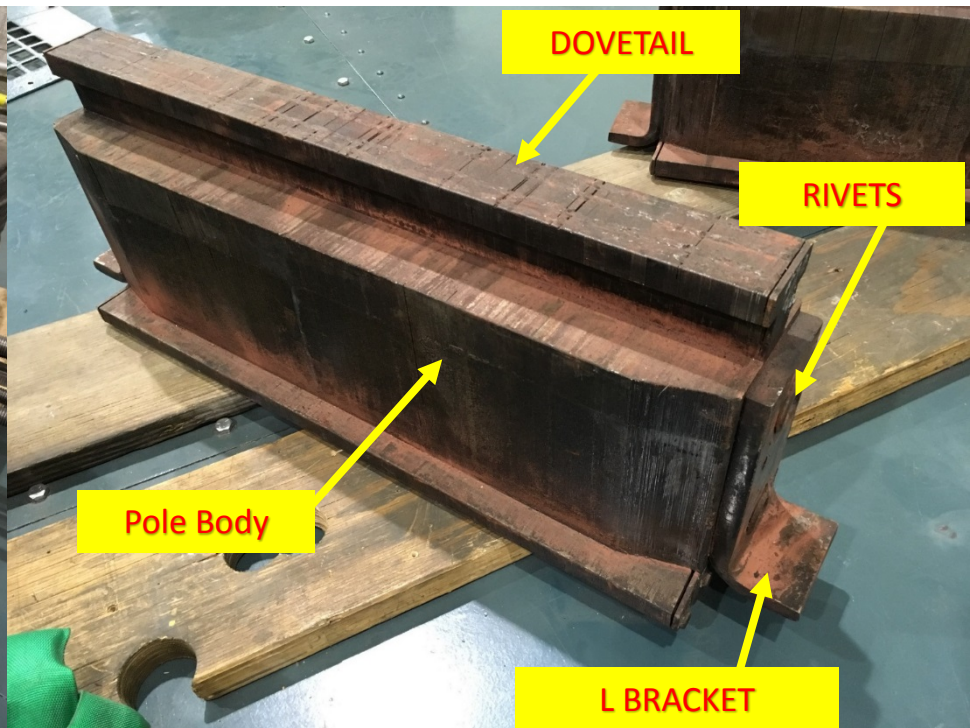
Pole L Bracket FEA

Von Mises stress in top side of endplate radius at runaway.

Bulk: $P_L + P_b \in (41.4\text{ksi}, \dots 68.5\text{ksi}) \gg 1.155 \times 0.667 \times S_y = 31.6 \therefore$ not acceptable per contract

This region is under serious risk of plastic collapse during runaway speed.

Local: $P_L + P_b + Q + F = 68.5\text{ksi} \rightarrow$ fatigue analysis conducted for completeness

- Contract has option for new poles at \$1.15 million per unit additional cost (\$1.65M).
- Recommendation – Because of cracks in material and overstress at runaway, propose to replace pole body and reinsulate winding all 4 units.
- Cost estimated at \$750k per unit additional cost (\$1.25M).

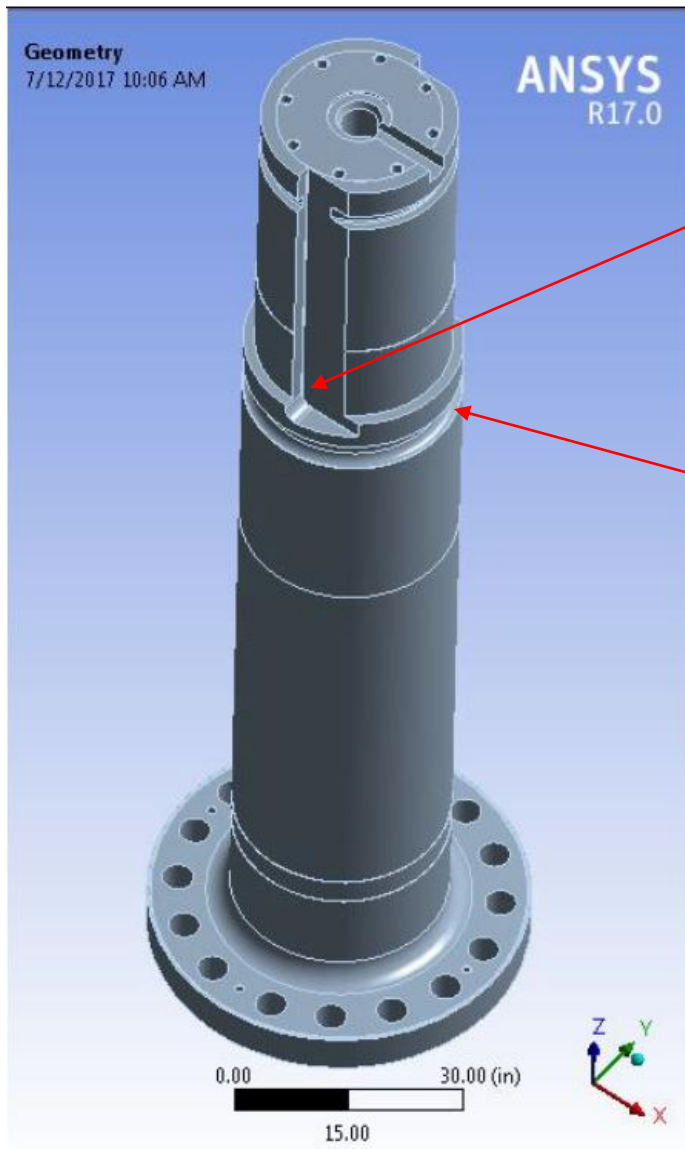
Generator (Gen) Shaft FEA

- FEA of reused components 85% complete.
- Items with less than 50-year remaining fatigue life and stresses greater than allowables for at least 1 load case include:
 - Rotor pole L bracket for unit runaway case.
 - Generator shaft keyway connections at maximum output.
 - Wicket gate body and stems at maximum head.
 - Gate ring FEA not yet completed.

Rotor spider to shaft
keyway

Axial thrust bearing
keyway

- Recommendation – Purchase new gen shaft all 4 units
 - Benefits are that \$100k goes to new purchase with full 50-yr life and no schedule impacts.
