# Long Range Facilities Plan

## COMMISSION BRIEFING State of Facilities Conditions

January 9, 2017

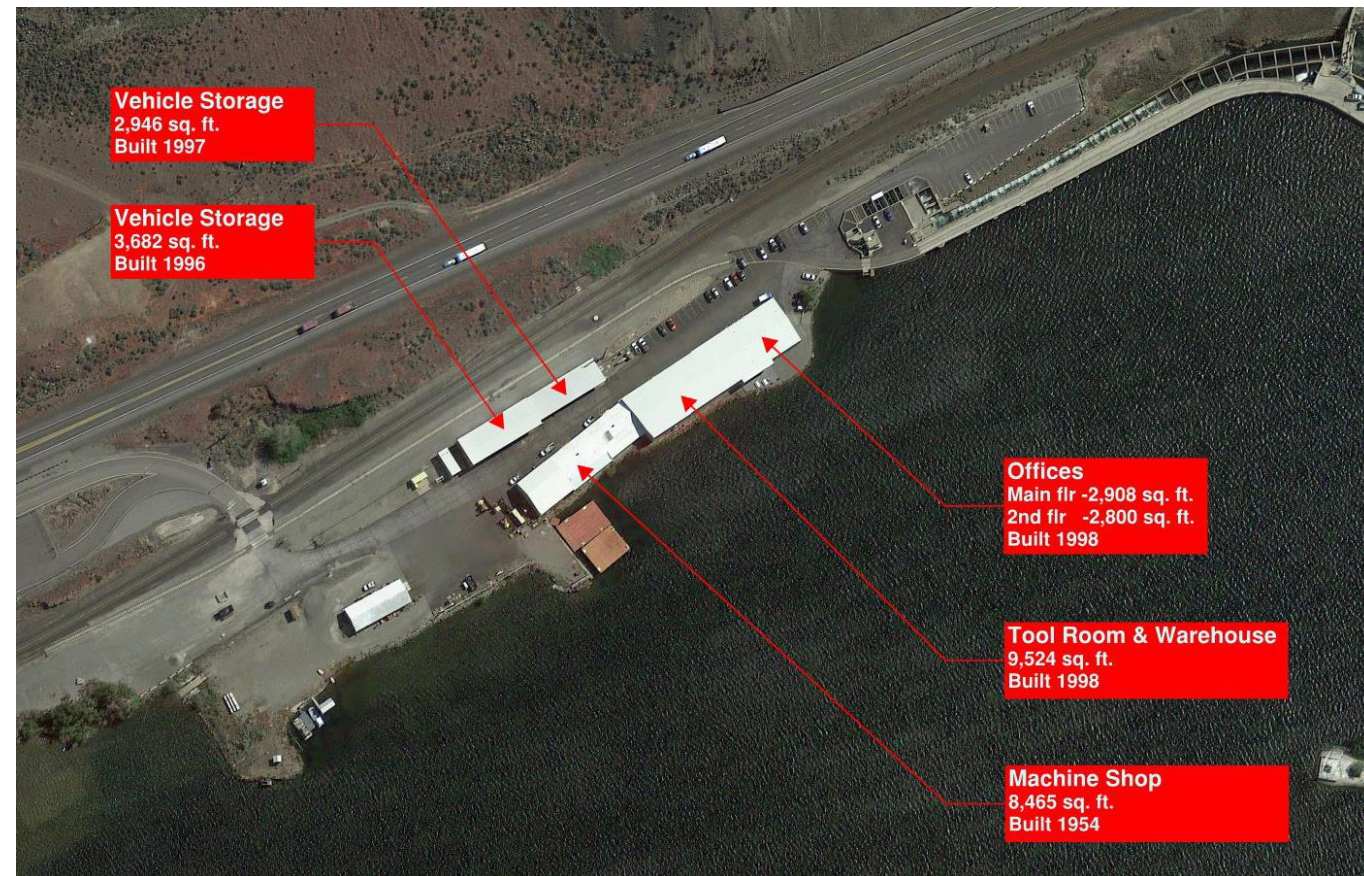
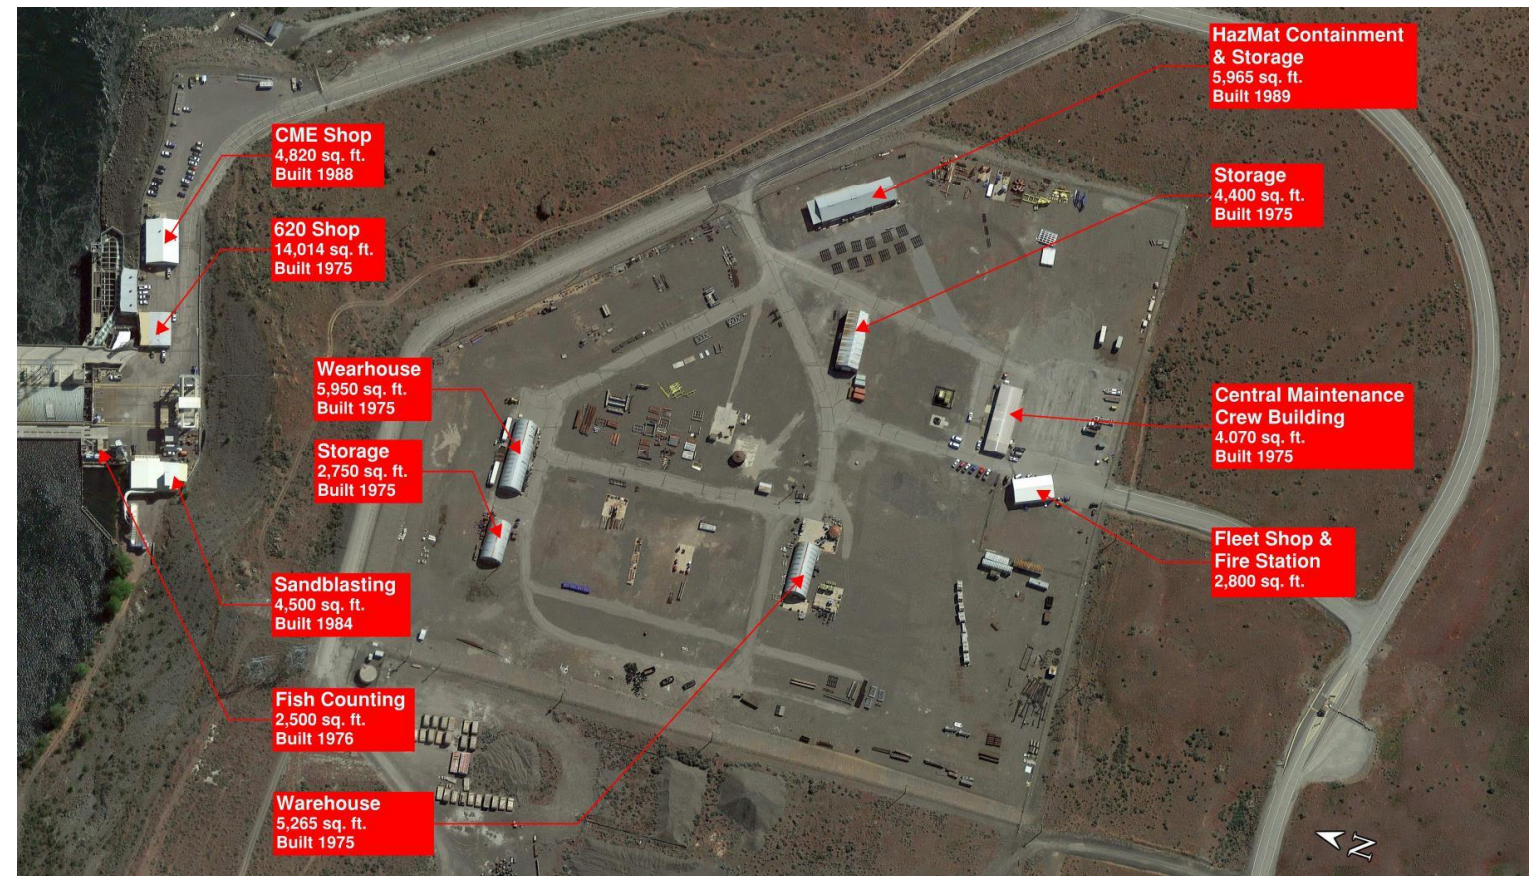
## Douglas County Side

Buildings range in age from the 1950's (machine shop) to the 1990's.

## Chelan County Side

Most buildings are left from the mid 1970's PH2 construction, left behind by the contractors.
