FEASIBILITY ASSESSMENT

CHELAN RIVER RIPARIAN REVEGETATION FEASIBILITY INVESTIGATION (CHELAN COUNTY, WASHINGTON)

Prepared by
Herrera Environmental Consultants, Inc.
1220 Fourth Avenue East
Olympia, Washington 98506
Telephone: 360-754-7644

June 18, 2015

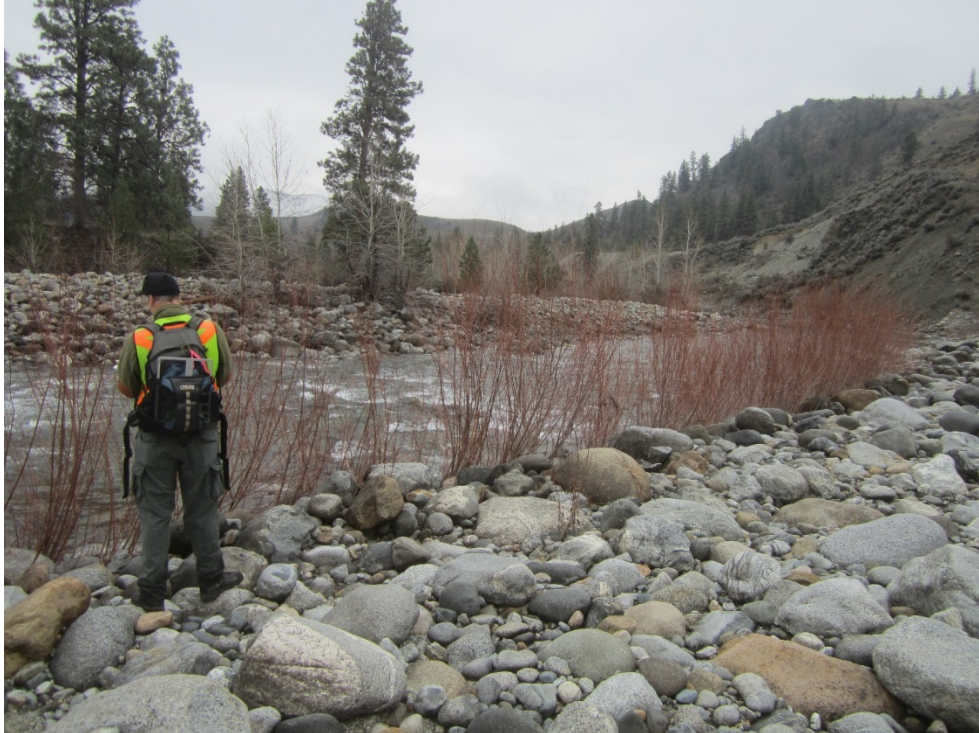
Willow patch along bank in Sub-reach A

Dense willow and cottonwood planting of selected banks could also provide some shade on the water. These banks would be selected by considering where plantings could provide shade to the water surface. During the field survey, a patch of willows was observed that almost looked like it had been planted and appeared to be expanding (see photo below). Subsequent investigation by PUD staff led to the conclusion that the source of the willows was likely one old willow that is completely inundated at 80 cfs. These willows are growing through a boulder bank that is high above the water's edge at 80 cfs, demonstrating that it is possible to establish willows on the banks; and that if even a few willows and cottonwoods get started from initial planting, they should expand both laterally and inland in even the toughest rocky shoreline.

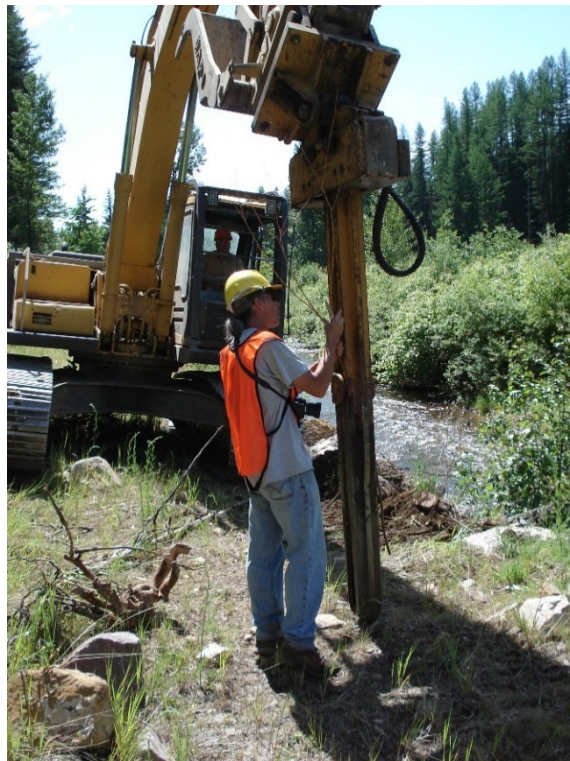
Expandable stinger

If access by heavy equipment can be provided, container grown plants could be installed with an expandable stinger mounted on an excavator arm (see photo below). This method could be used to establish willow and cottonwood bands from 3 to 6 feet wide in strategic placements on the banks.

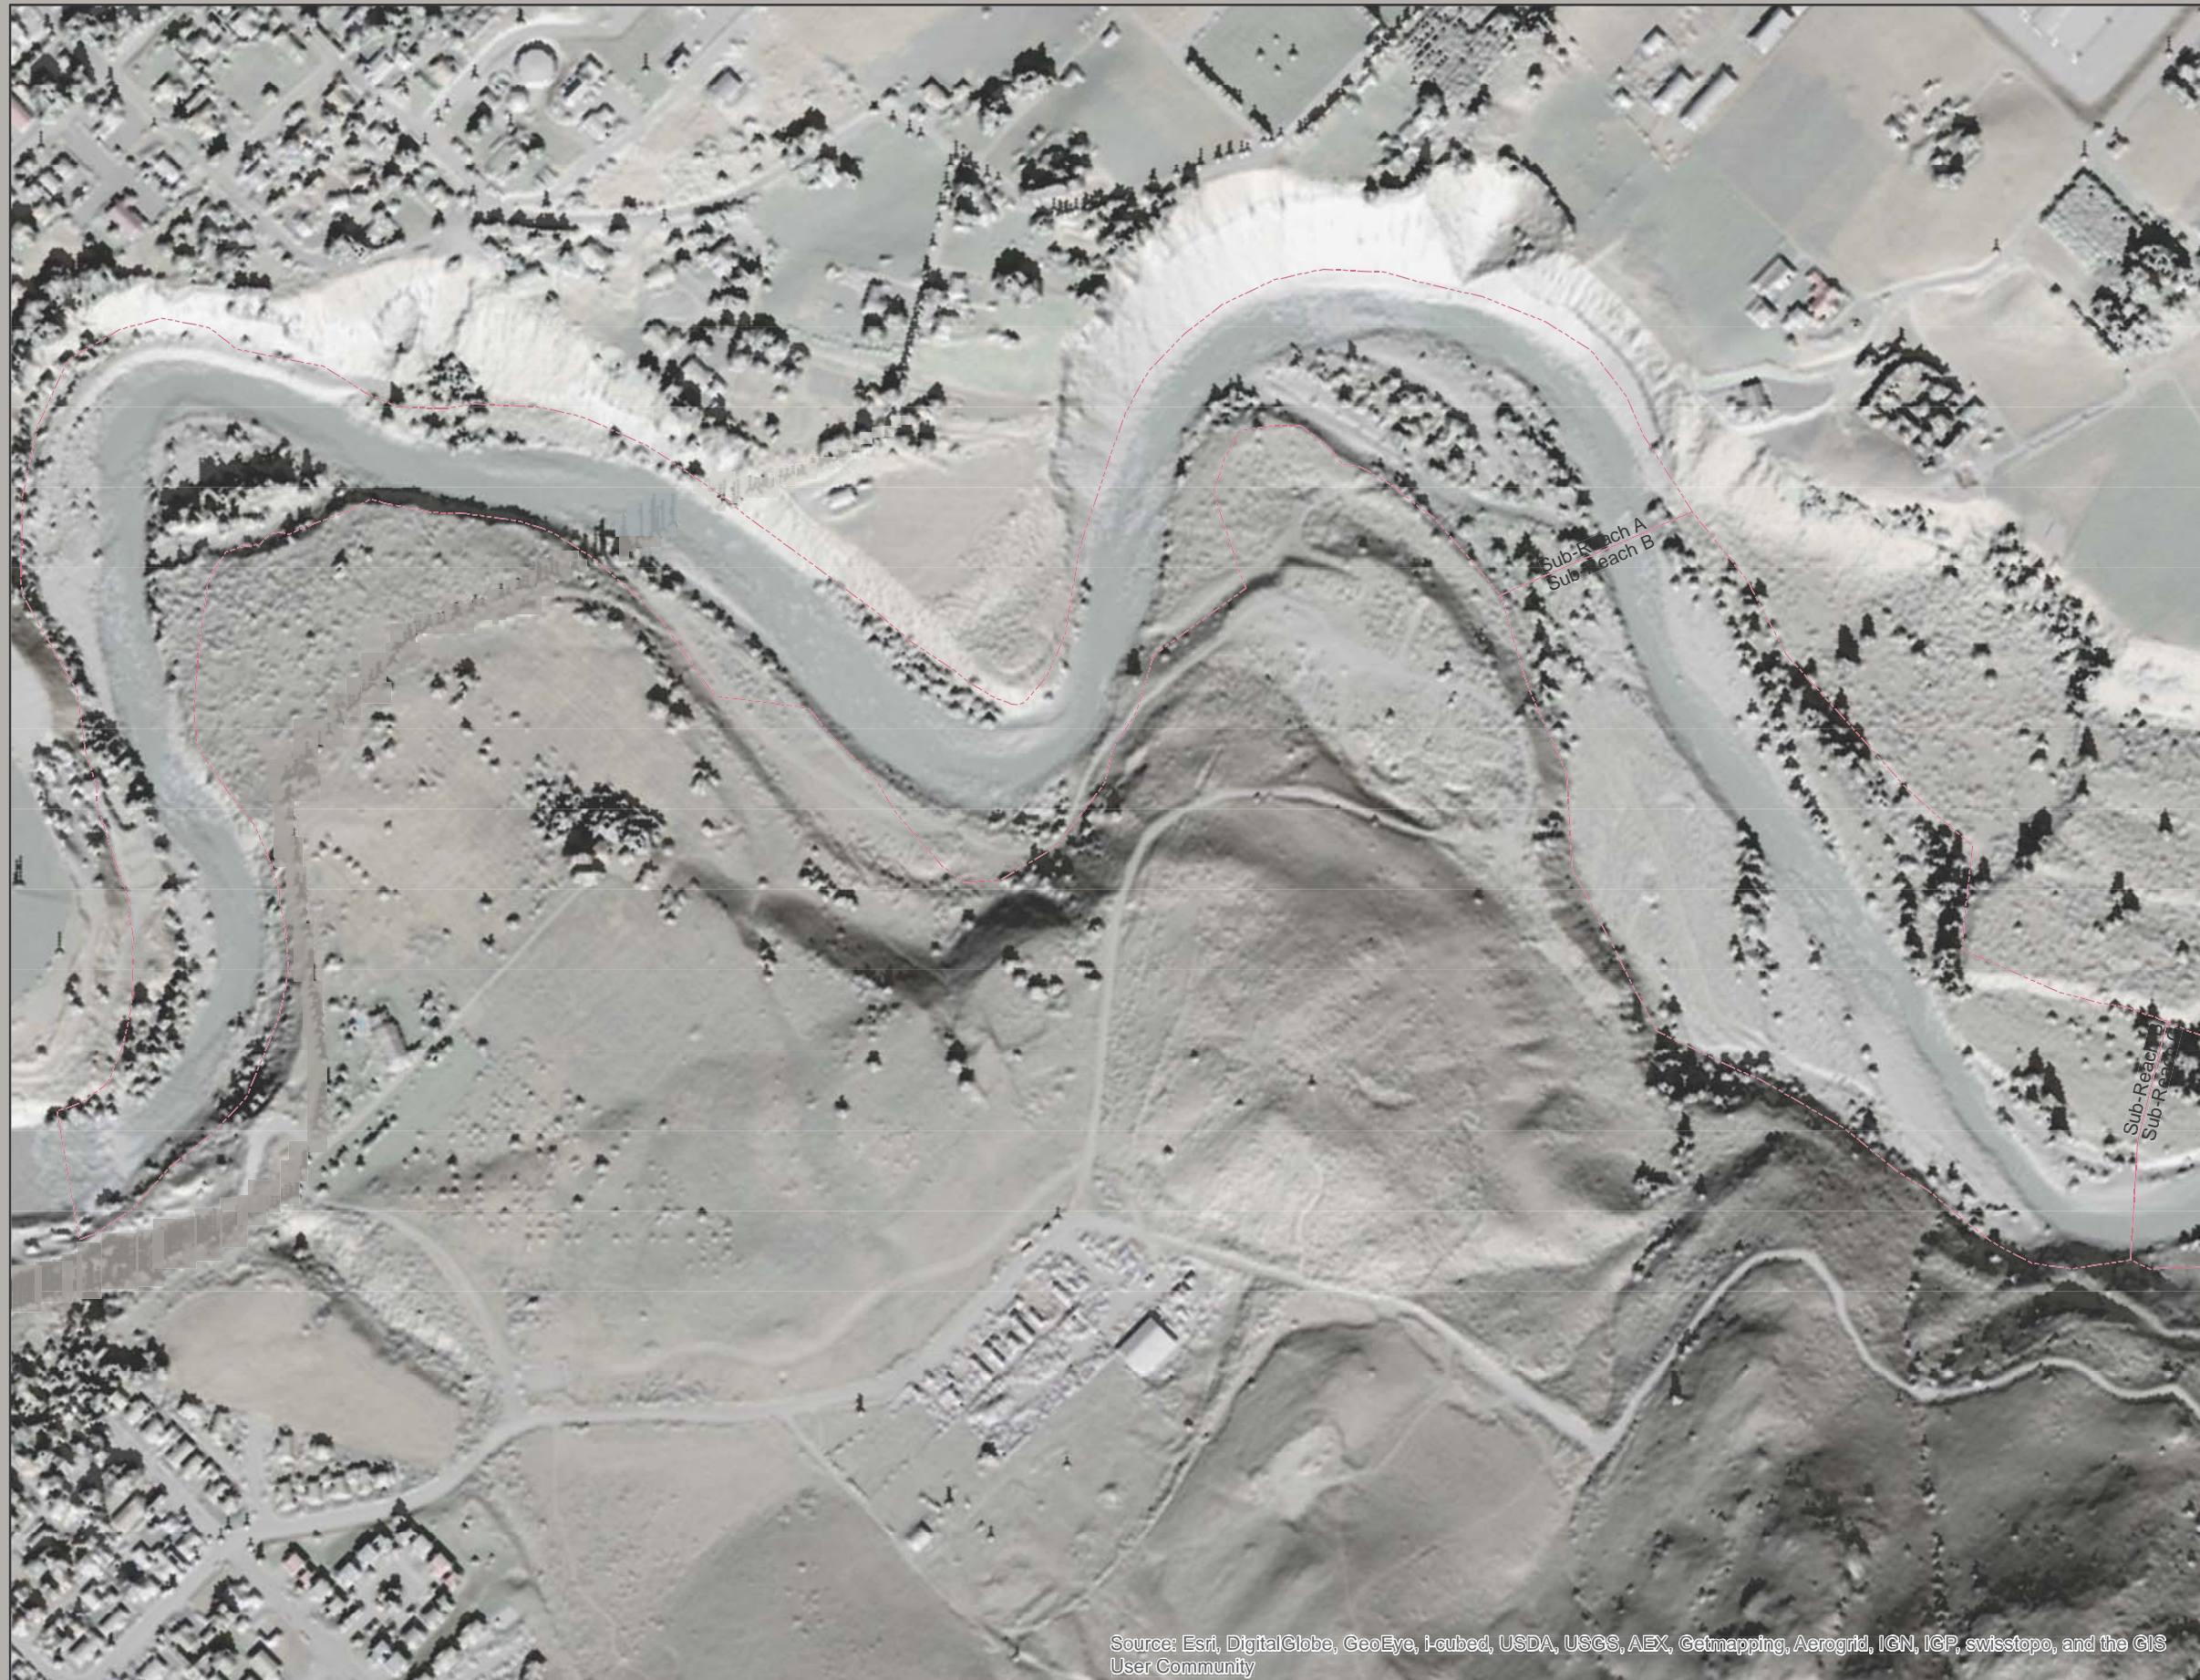
Figure 4a.
Chelan River
Existing Conditions Shade Map,
Sub-Reaches A & B
(August 21, 2:00 pm)

Hourly solar elevation and azimuth were calculated for August 21, 2015, using the Washington Department of Ecology's SolRad solar radiation model. These were entered into the ArcGIS Hillshade tool, along with 2009 top surface lidar elevation data from Puget Sound Lidar Consortium. The hillshade tool was then used to calculate shadows at 2-hour increments between the hours of 6:00 a.m. and 6:00 p.m. Figures 4a and 4b depict the resulting existing conditions shade map for 2:00 p.m.

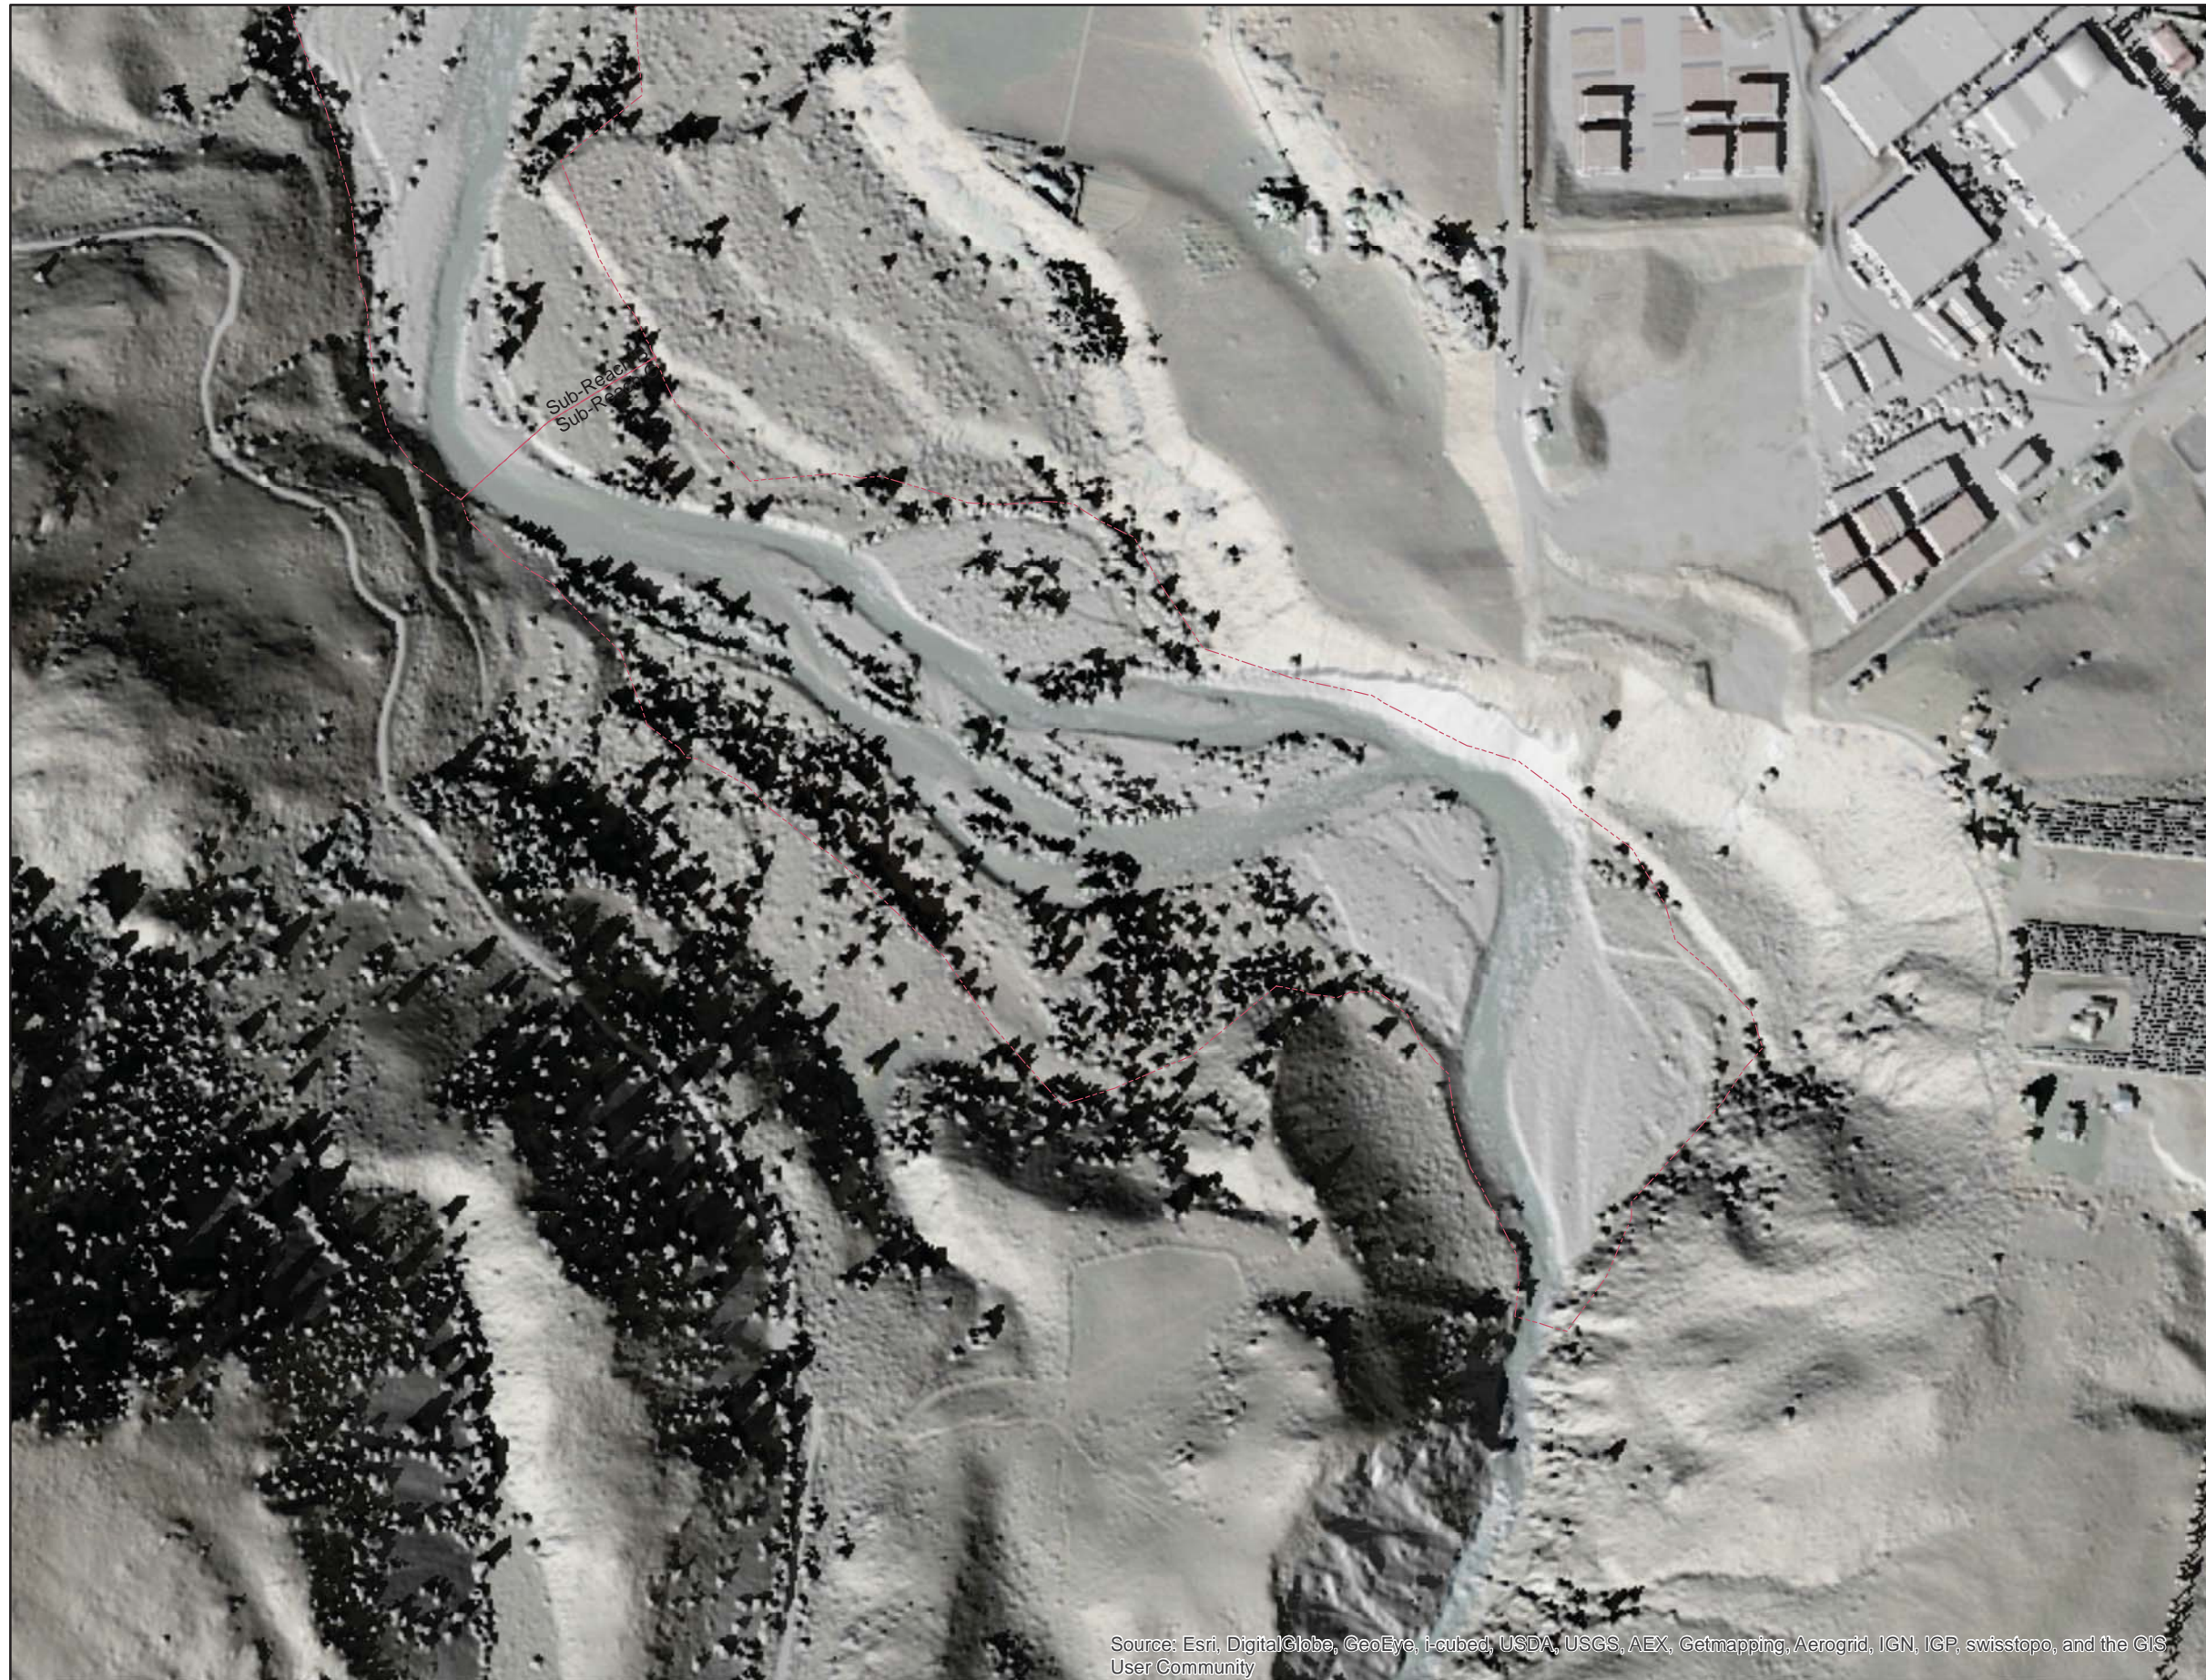
Figure 4b.
 Chelan River
 Existing Conditions Shade Map,
 Sub-Reach C
 (August 21, 2:00 pm)

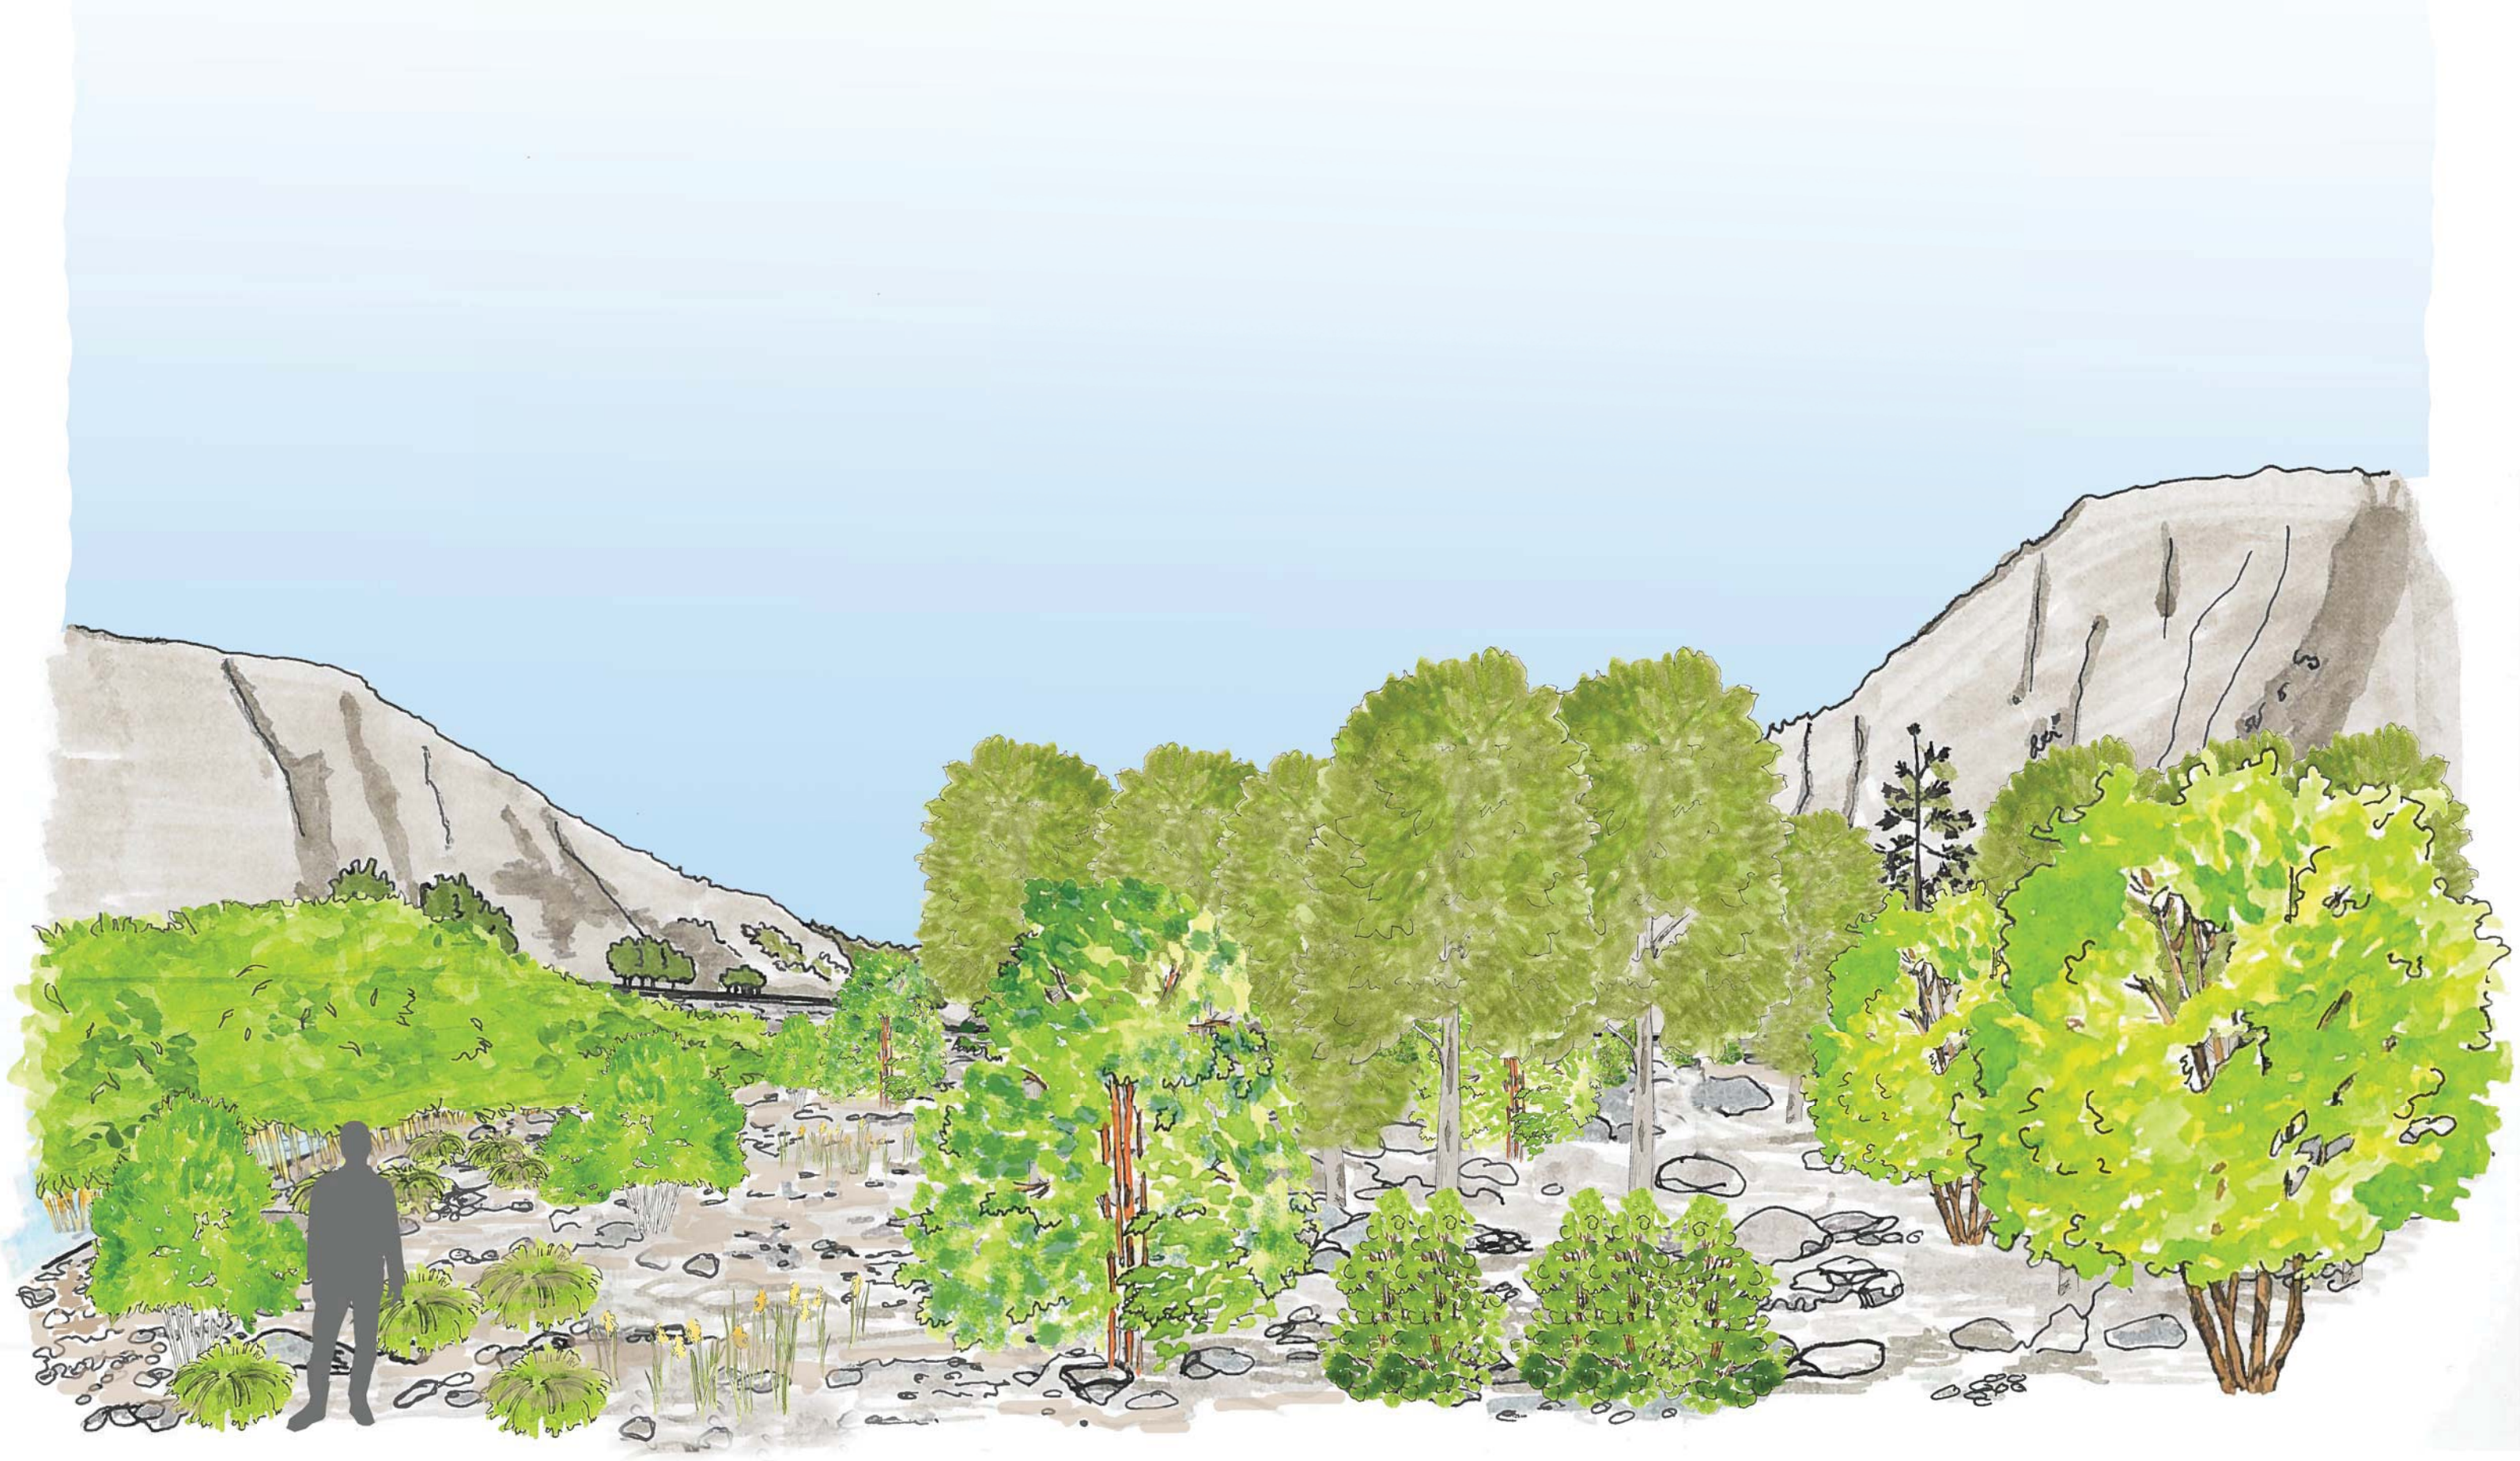
Figure 8: 20-Year Site Condition With Riparian Planting.

Conceptual drawings have been developed for a typical Riparian Planting site such as those sites identified in Figure 2. Figure 6 depicts current conditions. Figure 7 depicts conditions that could be expected in 20 years, if unplanted; and Figure 8 depicts the projected appearance of that same site in 20 years, if planted. The current condition drawing was based upon a typical riparian planting area. The depiction of the 20-year future appearance with no planting takes into account the slow growth and minimal colonization that would be expected without supplemental planting. Figure 7 depicts the increased plant cover that proper planting techniques and planting treatments could attain 20 years after planting. These conceptual drawings are predictions of conditions that may occur in planting areas identified in Figure 2. However, it is not expected that all of Sub-reach A could achieve the same level of vegetation due to the many limiting factors along this reach that were described previously and in the Limiting Factors Analysis (Appendix A). Developing a "lush riparian forest in the Chelan River" is an unrealistic expectation.

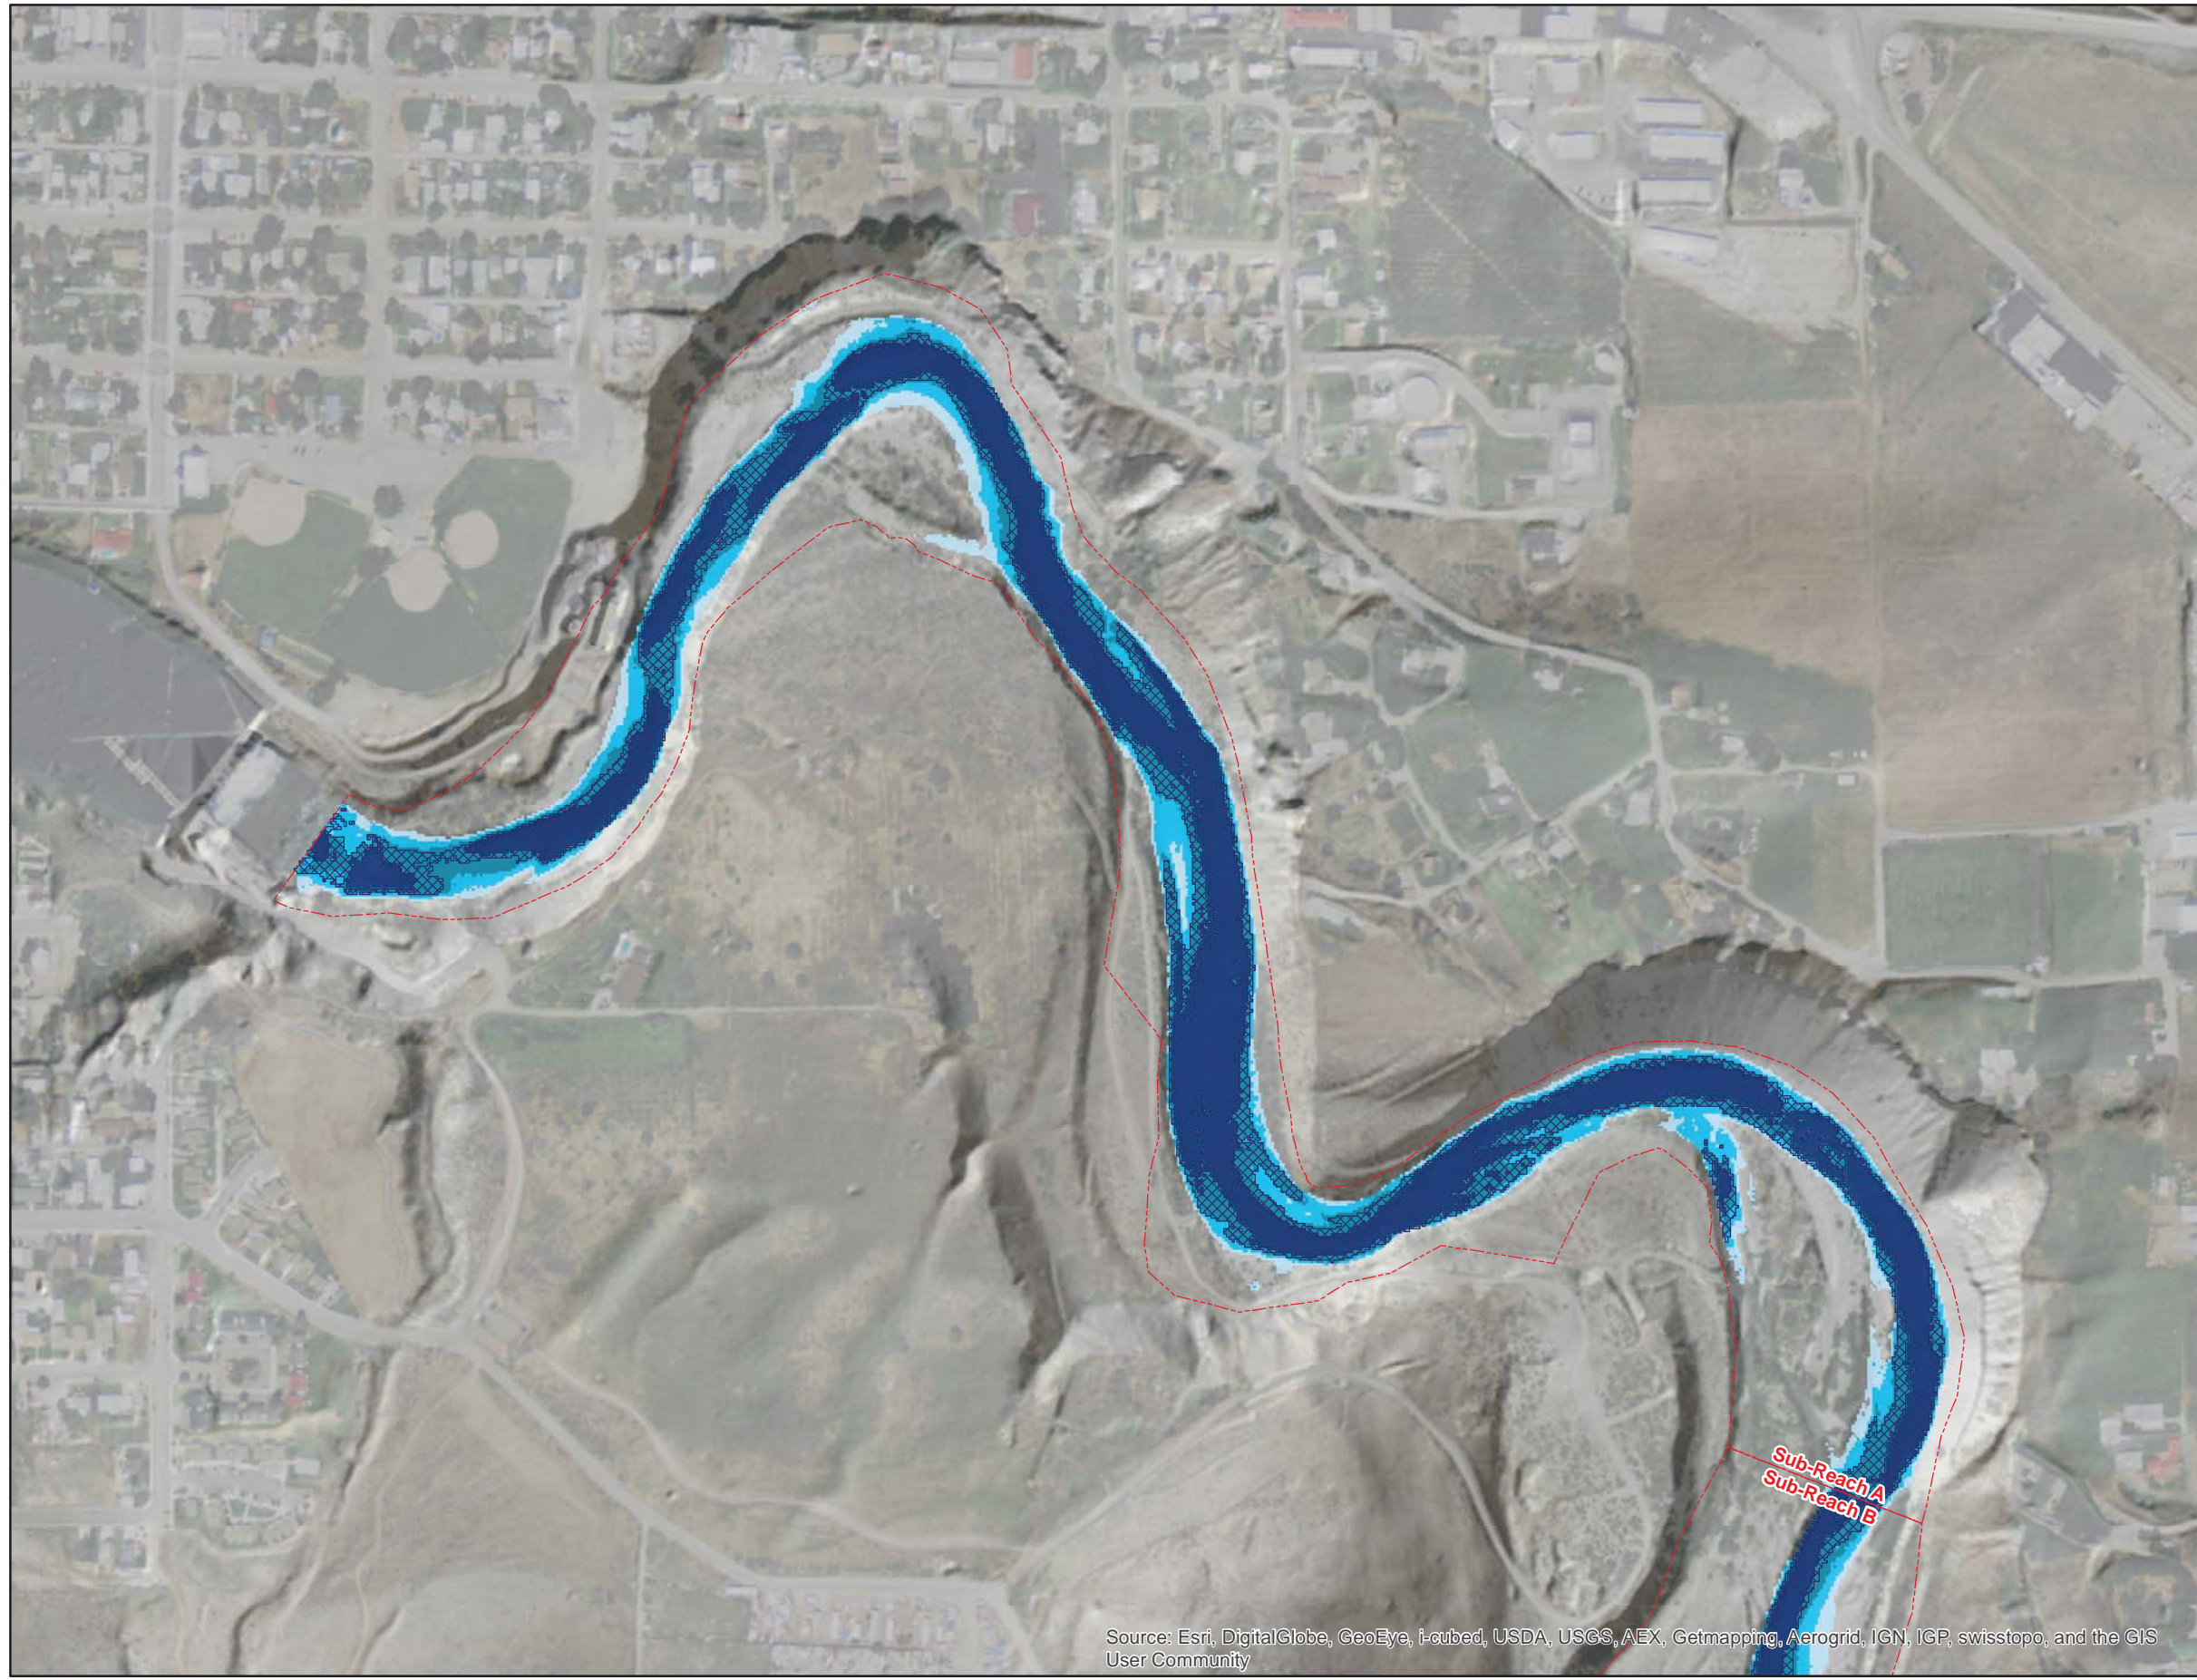
Figure A-1.
Chelan River
Modeled Groundwater and Inundation
Limiting Factor Zones
Sub-Reach A

Limiting-factor maps were developed that depict depth-to-groundwater at low river flows, inundation periods, velocity zones and substrate suitability. Substrate and depth to groundwater data collected during the field survey were used in conjunction with aerial photographs and hydraulic model output to map the limiting factors of substrate composition and depth to consistent moisture. Information on flow velocities and inundation periods was developed from flow data provided by County Public Utility District (Chelan PUD) and a HEC-RAS hydraulic model provided by West Consultants. This information was used to map inundation-period and peak-flow velocity limiting factors.

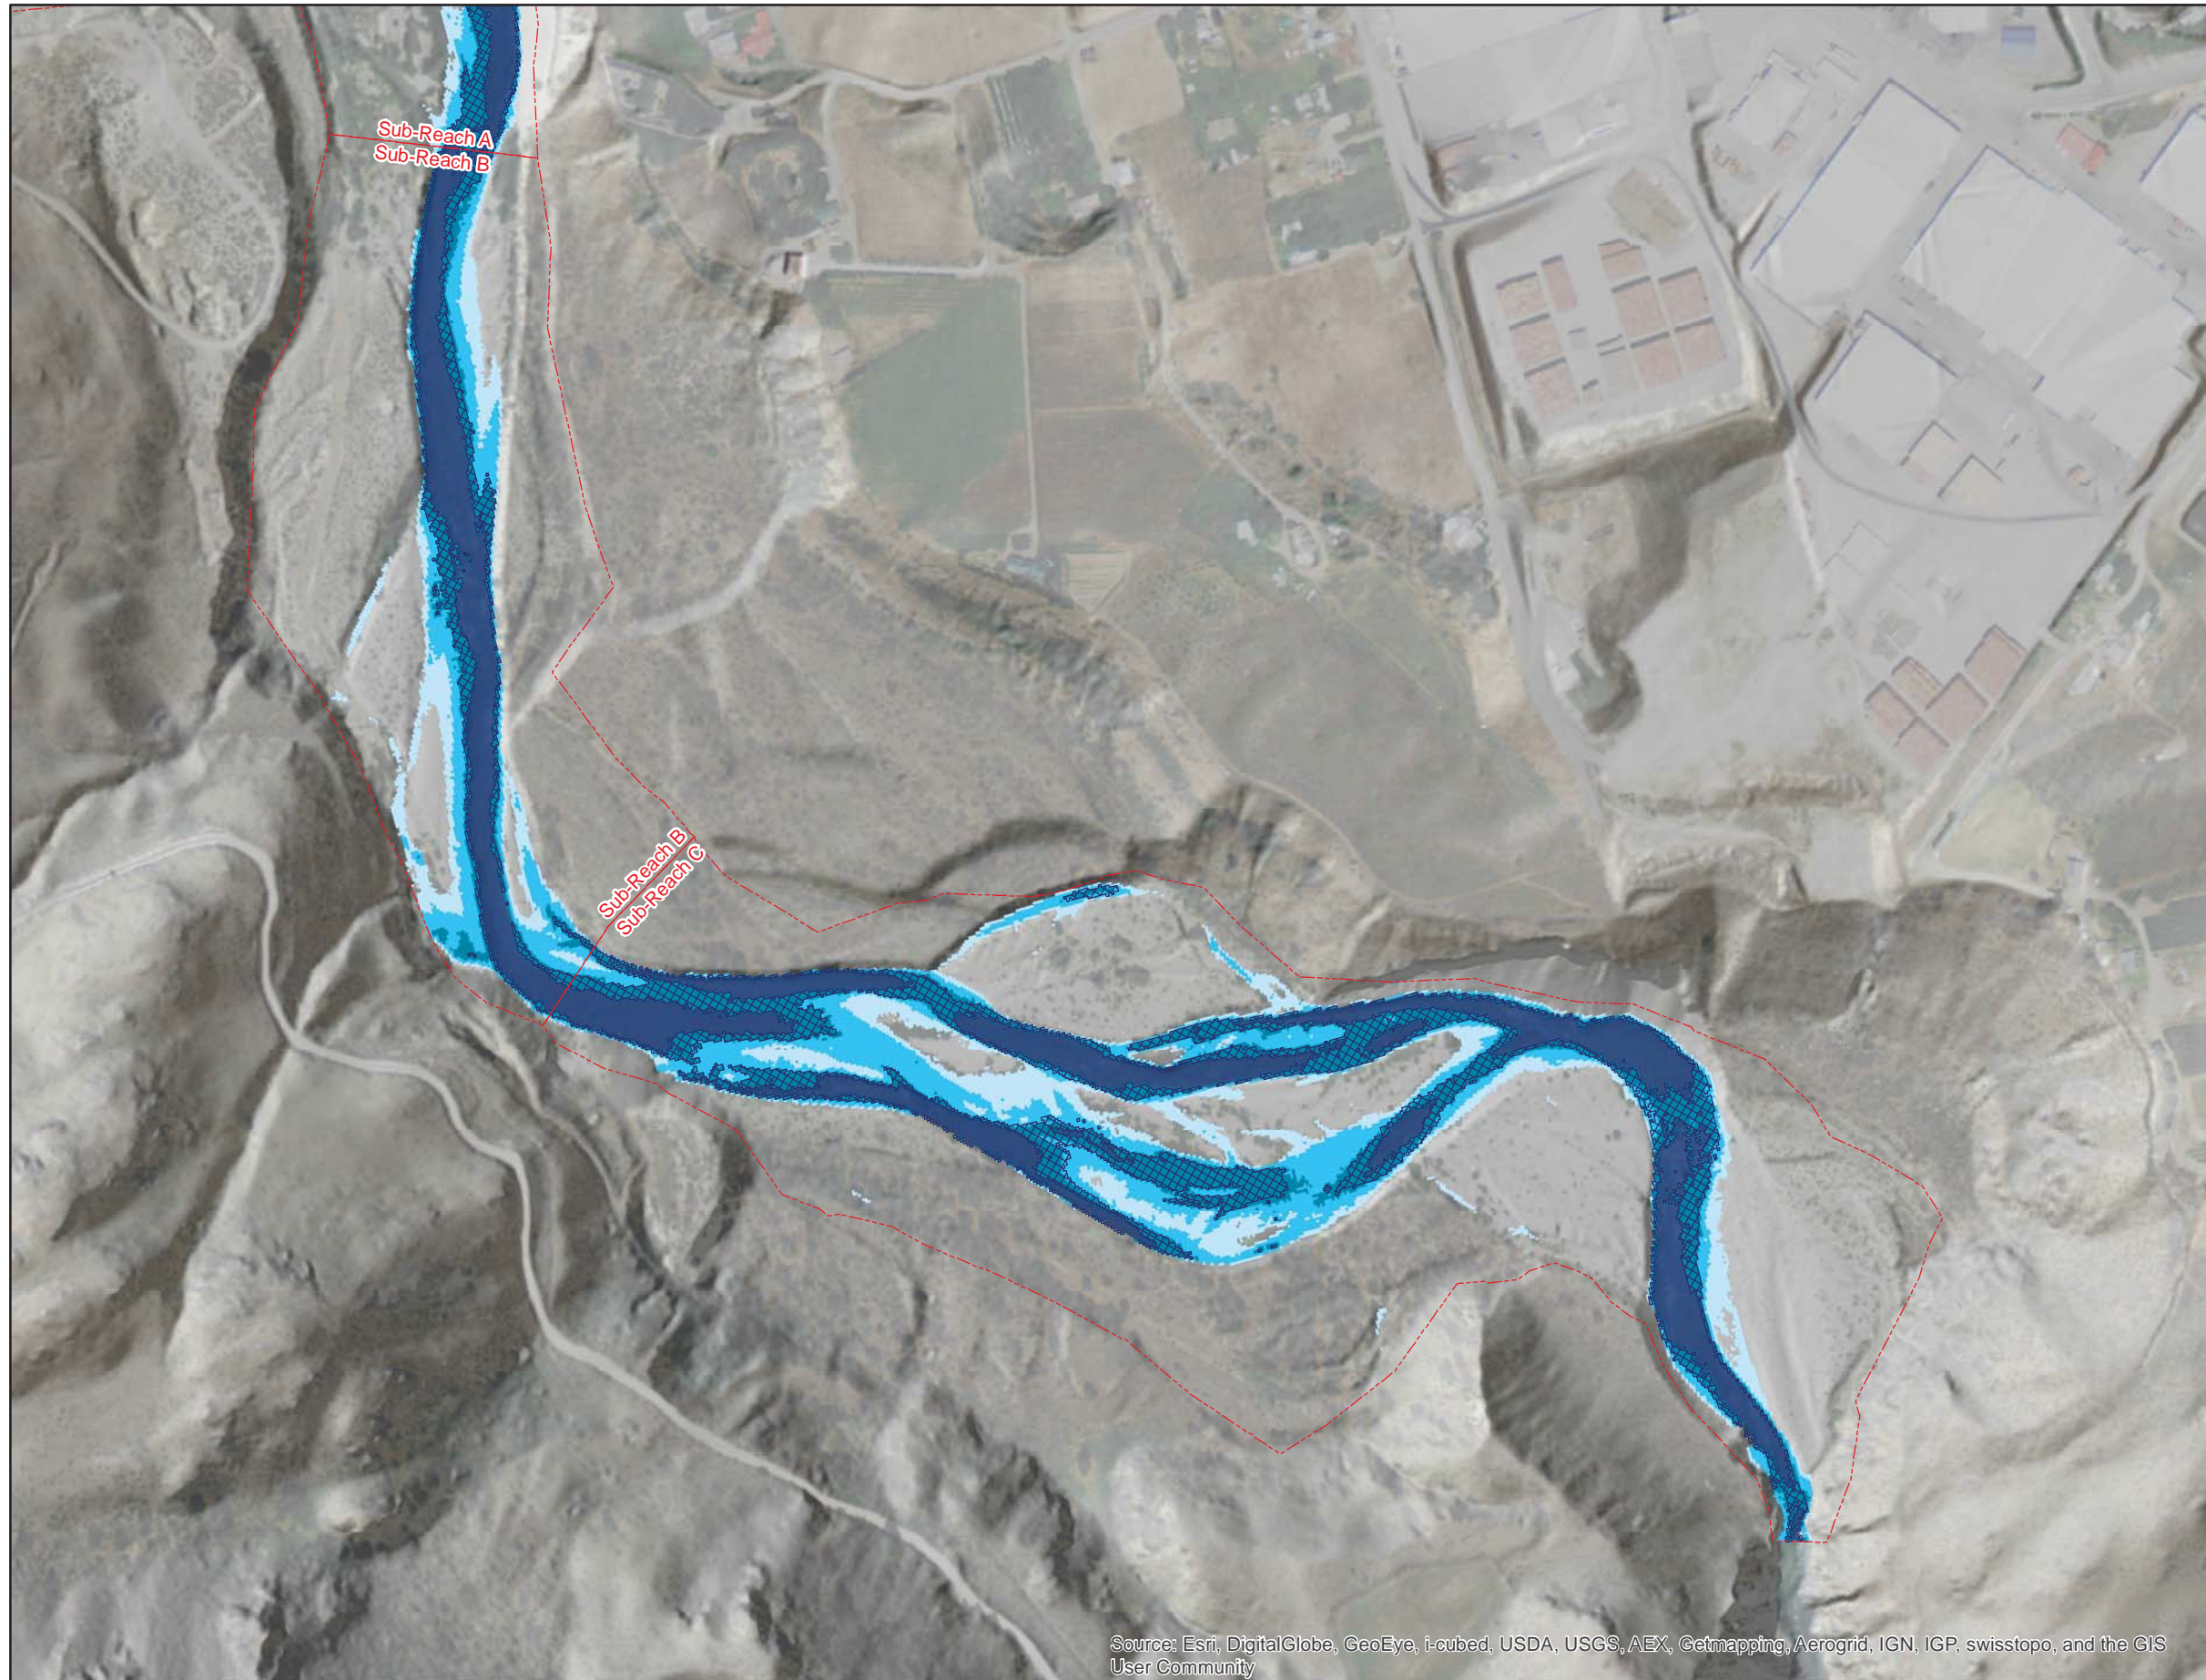
Figure A-2.
Chelan River
Modeled Groundwater and Inundation
Limiting Factor Zones
Sub-Reaches B & C
