FEASIBILITY ASSESSMENT

CHELAN RIVER RIPARIAN REVEGETATION FEASIBILITY INVESTIGATION (CHELAN COUNTY, WASHINGTON)

Prepared by
Herrera Environmental Consultants, Inc.
1220 Fourth Avenue East
Olympia, Washington 98506
Telephone: 360-754-7644

June 18, 2015

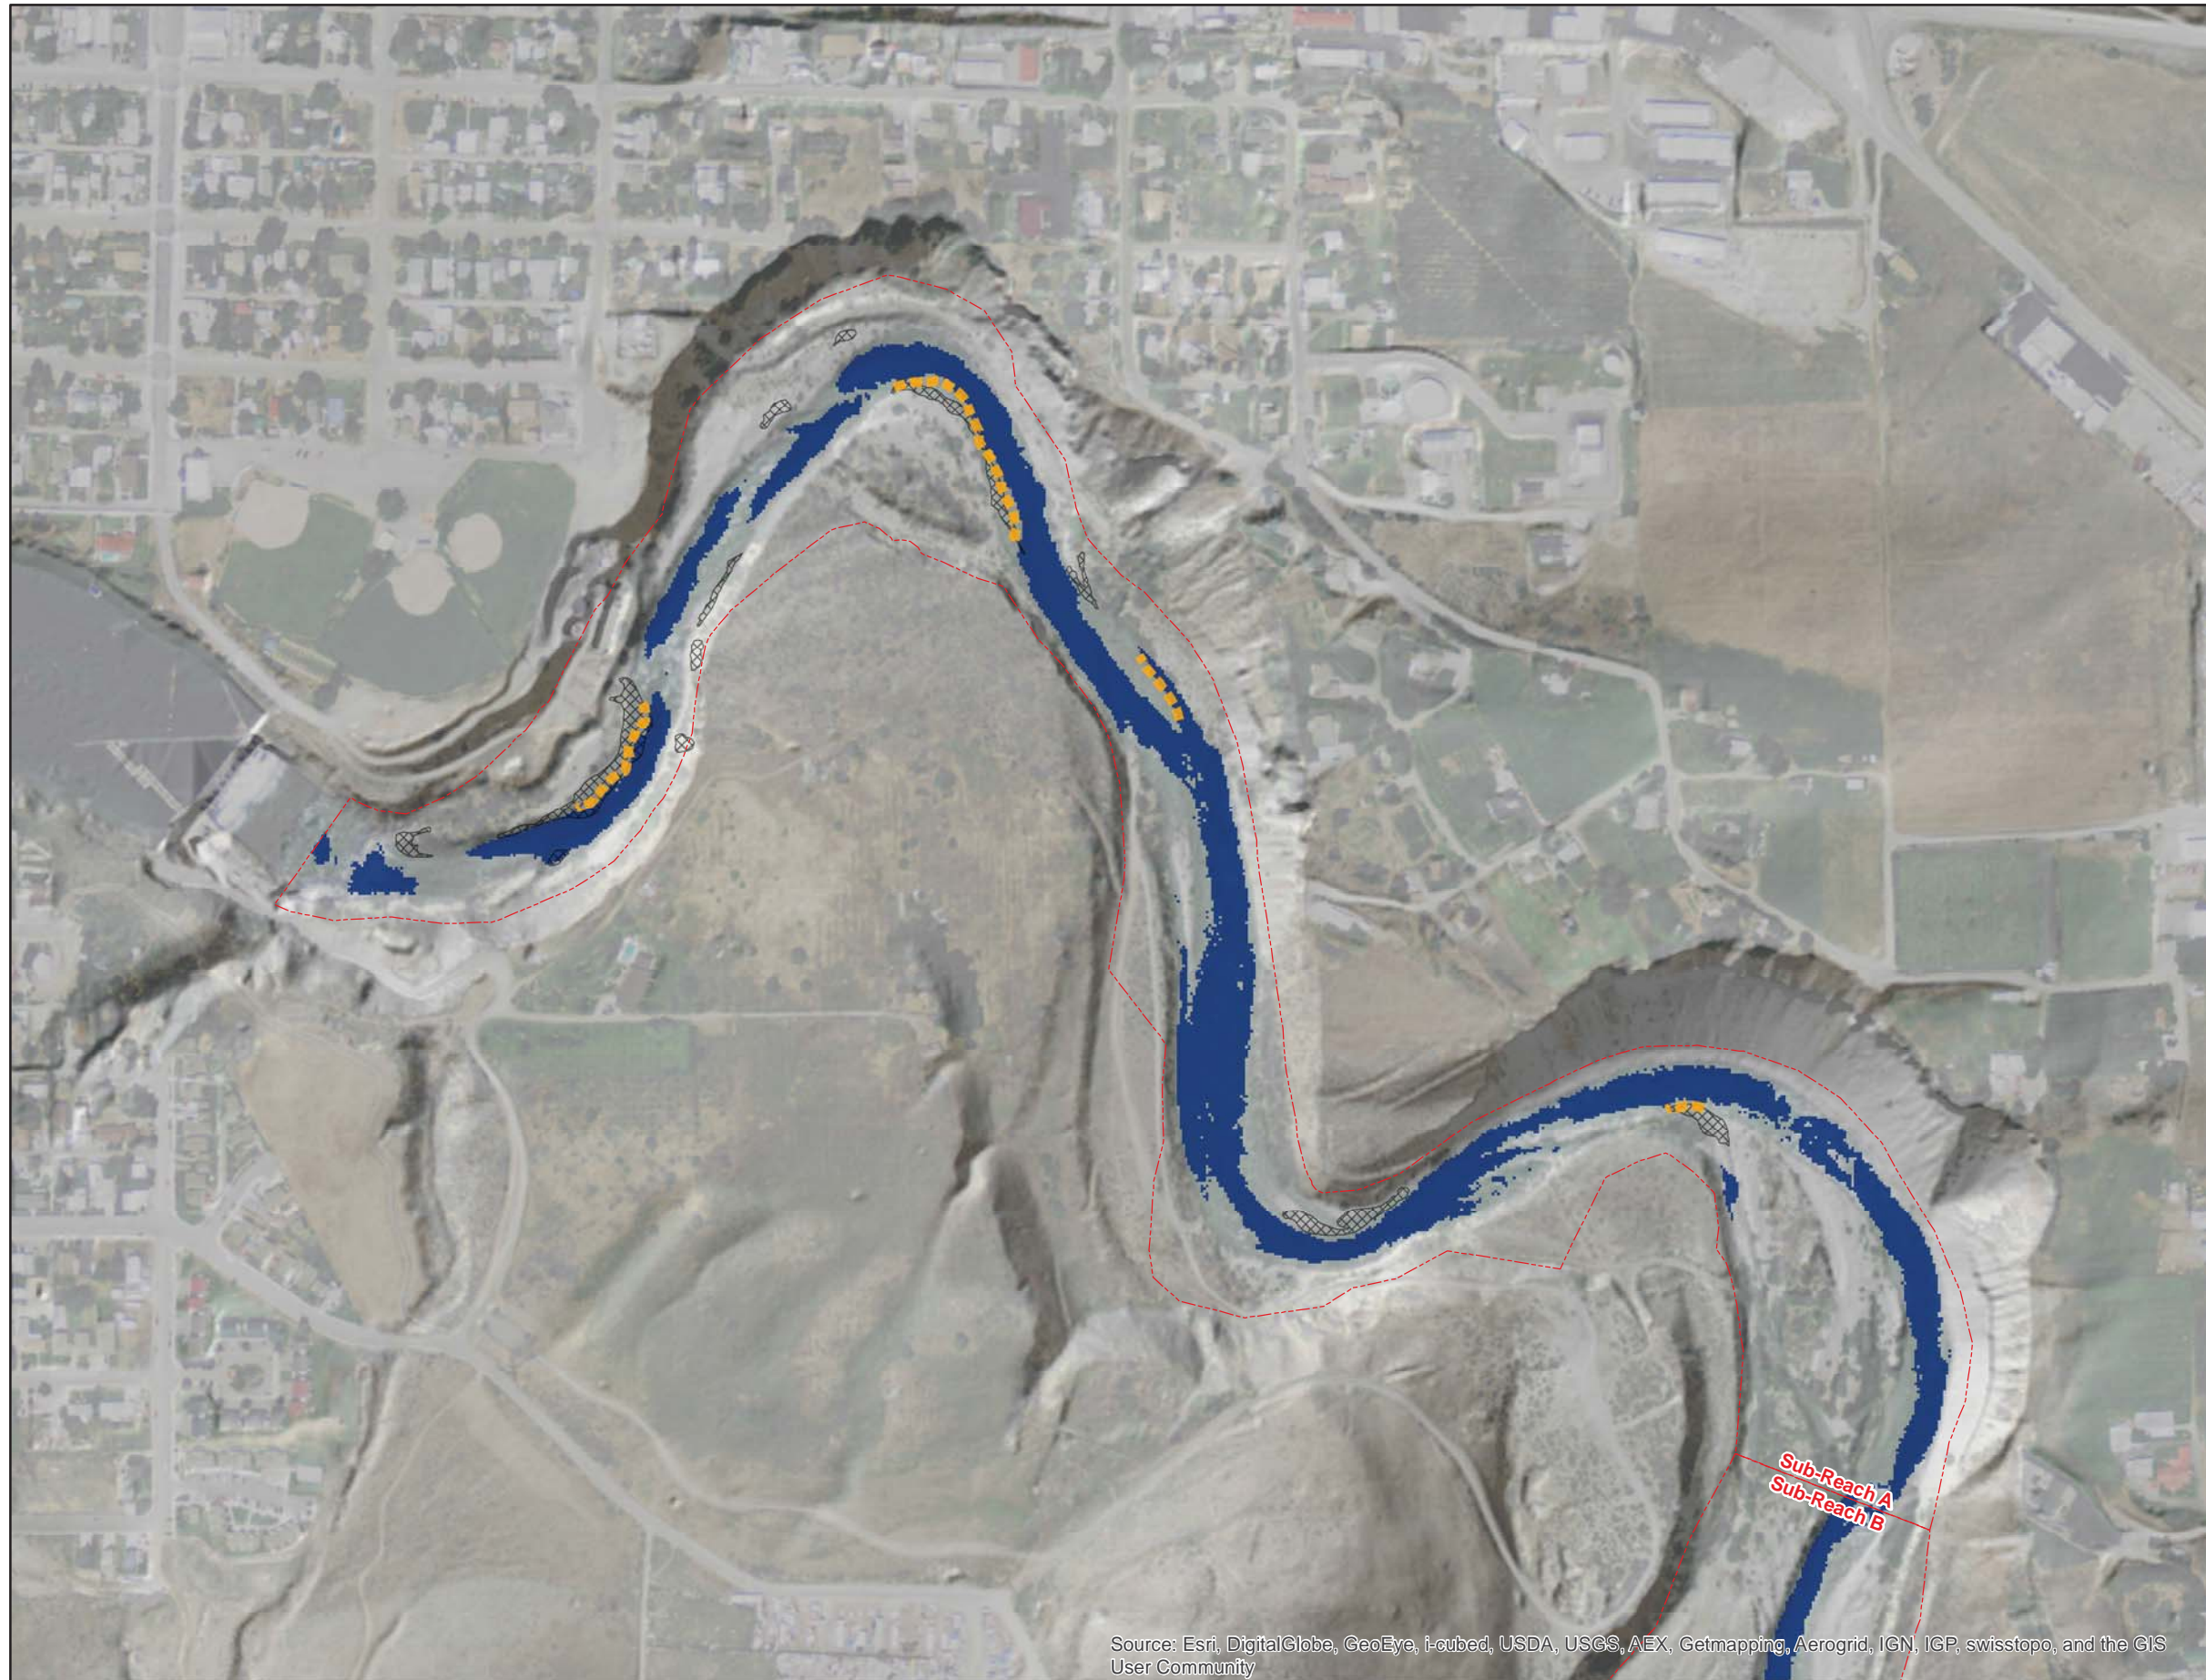
Figure A-5.
Chelan River
Modeled Substrate Suitability
Limiting Factor Zones
Sub-Reach A

Sub-reach A has several meanders where point bars have formed and where some fine substrate material has collected under the rocky surface substrate. Areas with appropriate planting substrate were identified during the field survey and by using aerial photos (Appendix A: Figure A-5). Riparian plants of several species could be planted in these areas and would be able to withstand the predicted high flows, periods of inundation, and periods of low flow.
