100 PERCENT DESIGN REPORT

HABITAT RESTORATION OF THE CHELAN RIVER REACH 4 AND TAILRACE

Public Utility District Number 1 of Chelan County
327 North Wenatchee Avenue
Wenatchee, Washington 98801

Anchor Environmental, L.L.C.
1423 Third Avenue, Suite 300
Seattle, Washington 98101

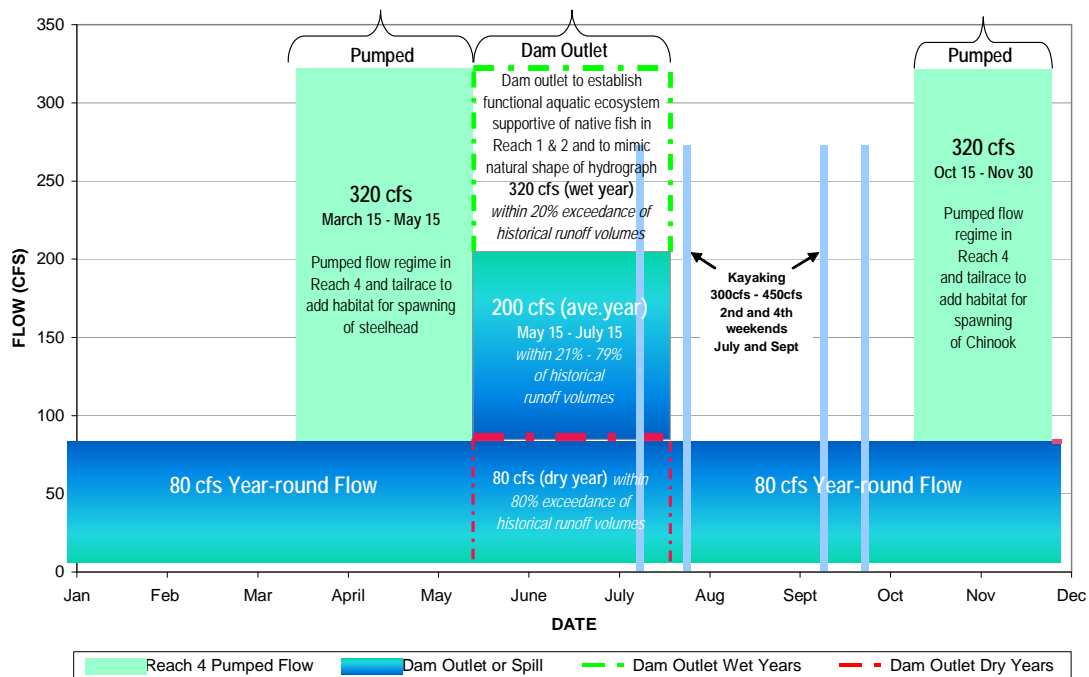
Figure 1
Flows in Reach 4 under New License Settlement Agreement

Under the terms of the settlement agreement and as part of the new license, instream flow releases from the dam will provide a minimum of 80 cfs to the lower Chelan River, with additional flow for spawning and incubation provided to Reach 4 by either water pumped from the tailrace during specified months or spilled from the dam (Table 1 and Figure 1).

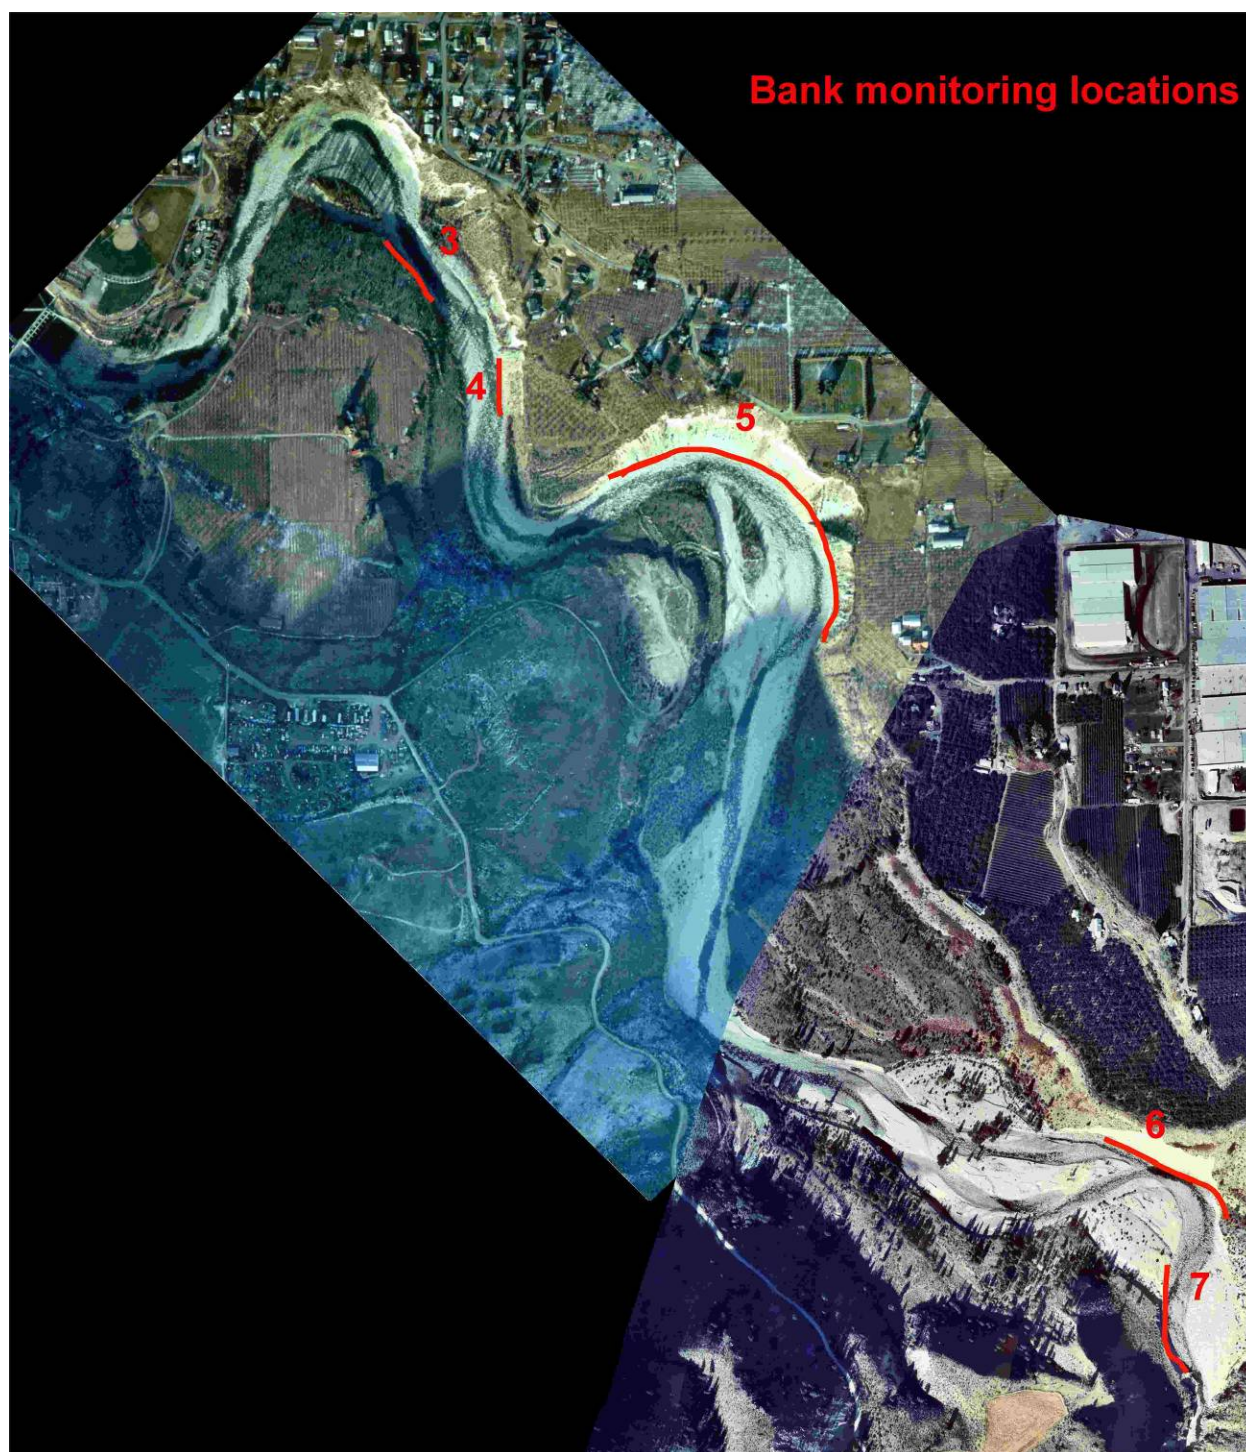
Figure 10
Chelan River Reach 1 Streambank Erosion Test Locations

All unarmored streambank locations in Reach 1 that had shown evidence of past erosion in the aerial photograph analysis were surveyed and marked. Five banks (numbers 3 through 7) were selected for monitoring (Figure 10). The banks with marked rocks were classified as either primarily fine-grained (Banks 3 and 4) or coarse-grained (Banks 5, 6, and 7). The fine-grained banks had a mantle of silty/sandy sediment over the underlying glacial deposits. The coarse-grained banks had a mantle of cobble/gravel over the underlying glacial deposits.

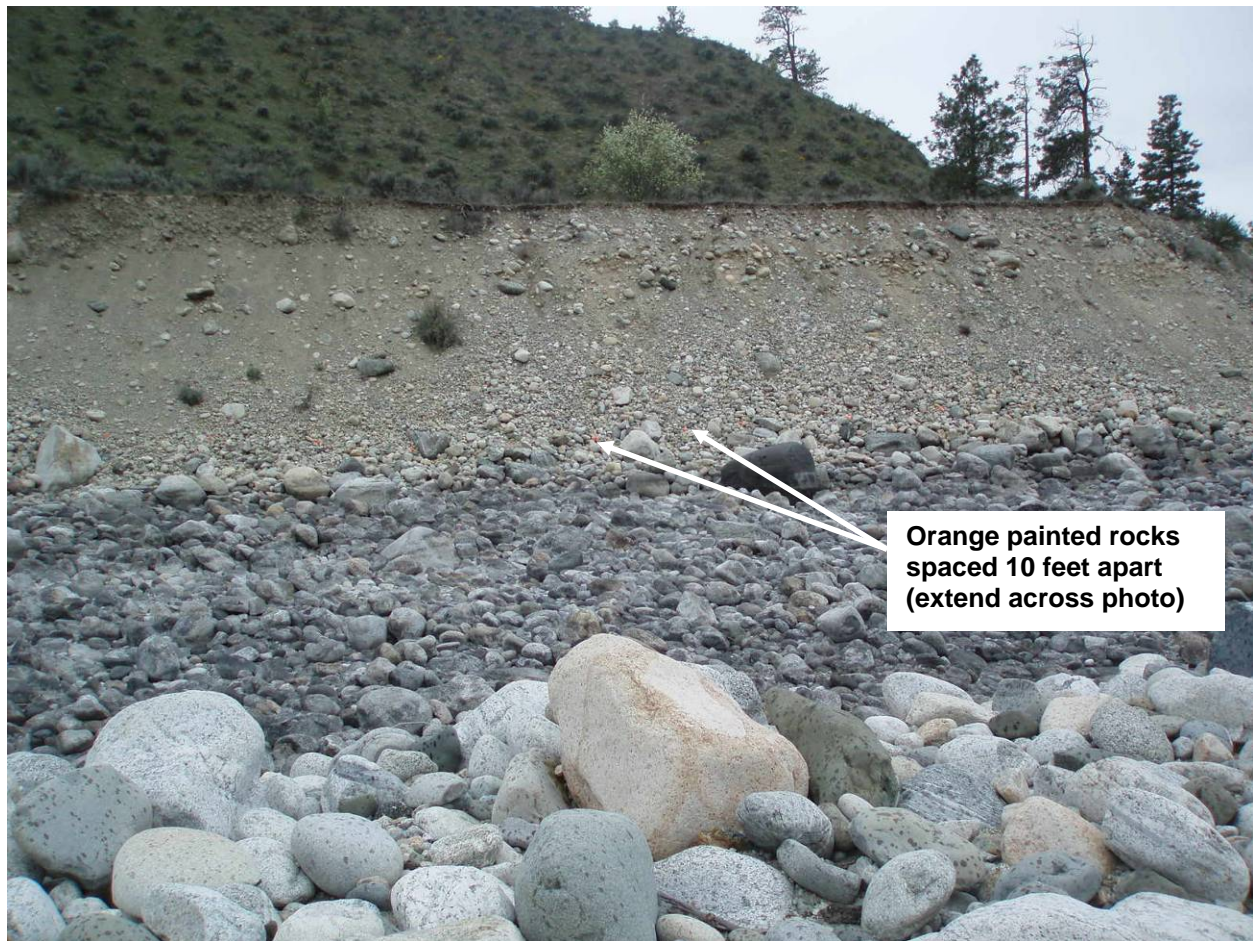
Figure 11
Bank 7 (Reach 1) Marked Rocks Prior to Spill

Along each of the banks, a series of representative-sized rocks at or just above the estimated high water level was painted bright orange (Figure 11). Painted rocks were spaced 10 feet apart in a line along the target elevation. The location of each marked rock was also surveyed by District personnel using global positioning system (GPS). The length of the bank painted varied between locations and ranged from 200 feet to 1,800 feet.

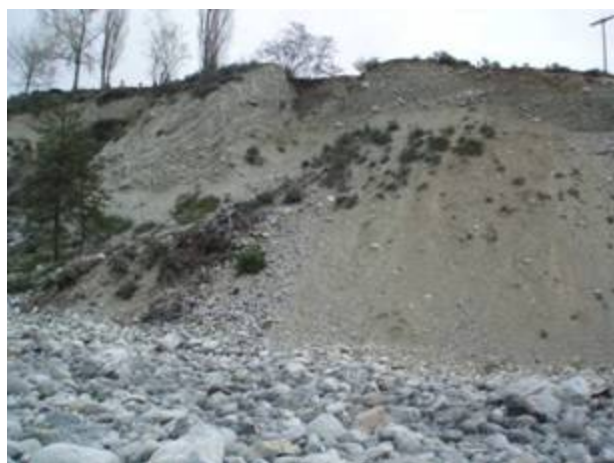
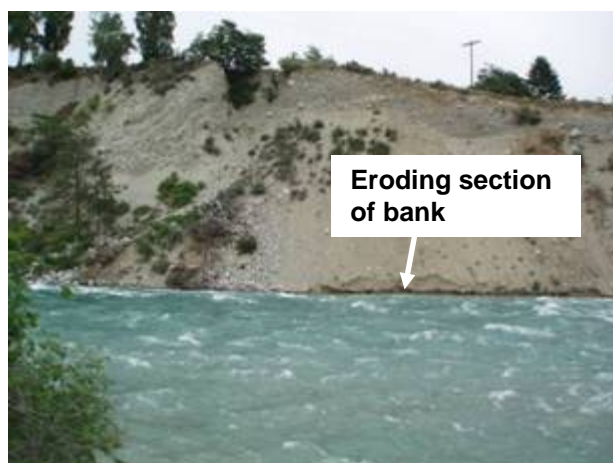
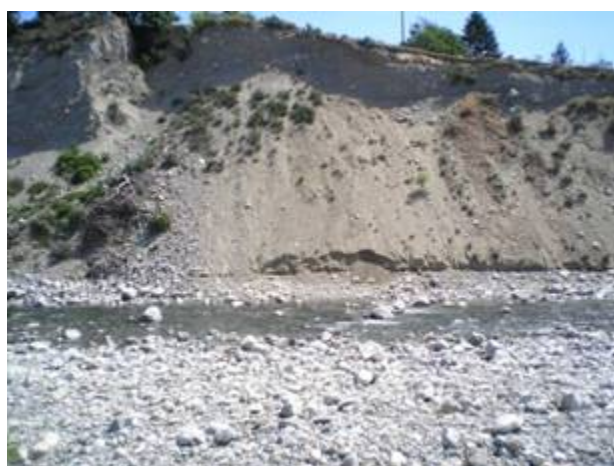
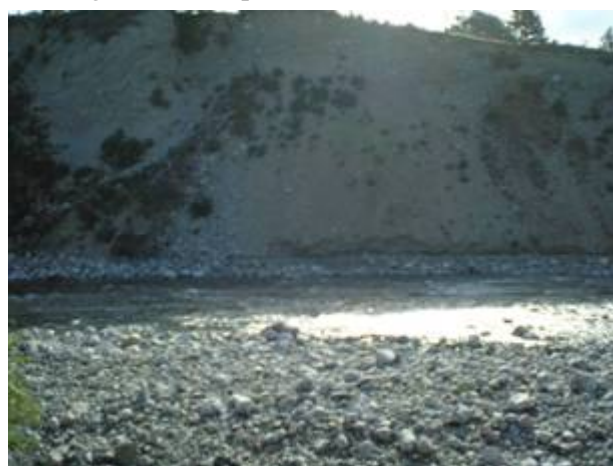
Prior to spill

During 6,710 cfs spill

Following 8,000 cfs spill

Following 10,000 cfs spill

Figure 12
Bank Erosion at Bank 4 (Fine-grained Bank)

The data sheets from the Reach 1 painted rock study are included in Appendix C. In general, the fine-grained banks (Banks 3 and 4) had more erosion at lower flows than the coarse-grained banks (Banks 5, 6, and 7) (Figures 12, 13, and 14; Table 5).

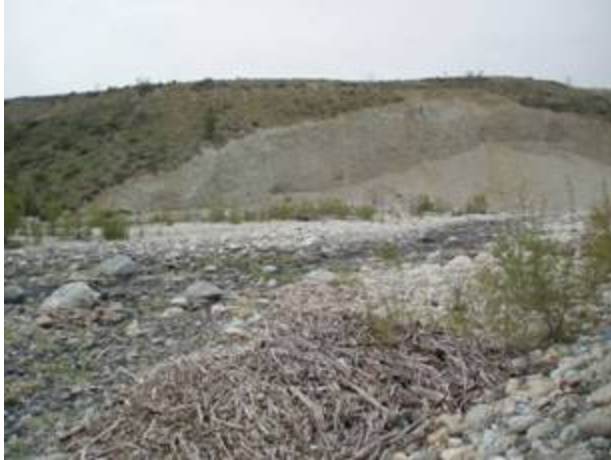
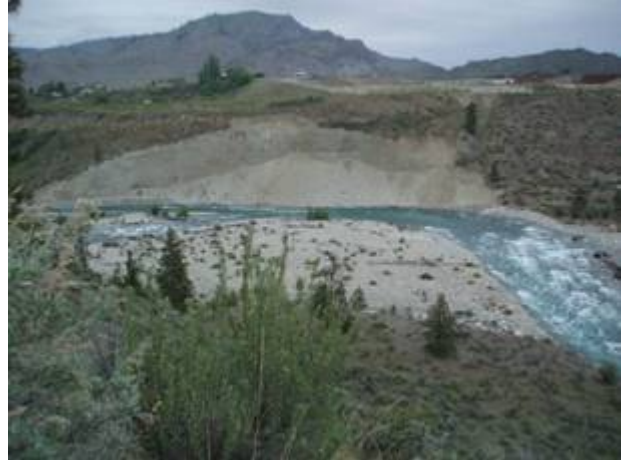
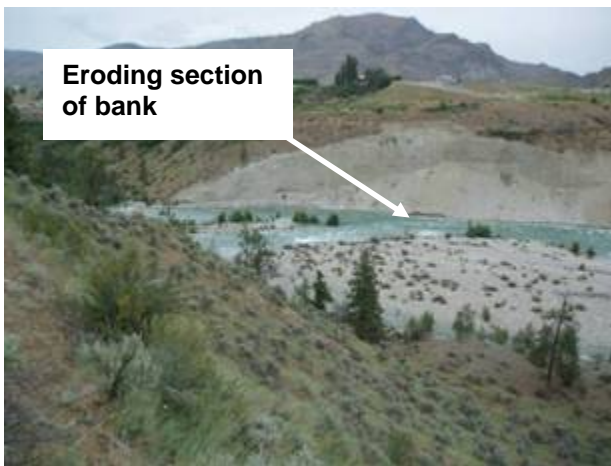
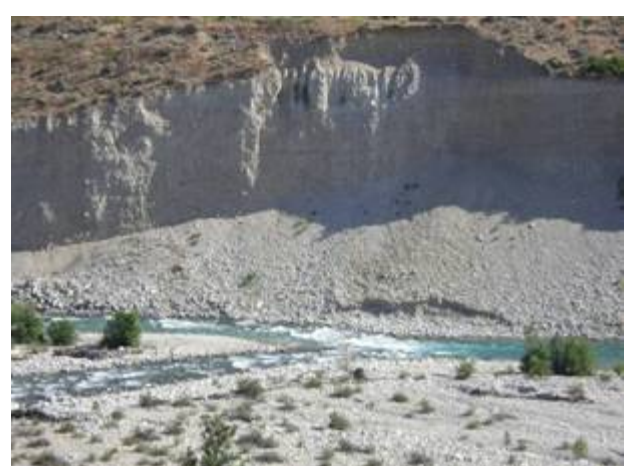
Prior to spill

During 6,710 cfs spill

During 8,000 cfs spill

Following 10,000 cfs spill

Figure 13
Bank Erosion at Bank 6 (Coarse-grained Bank)

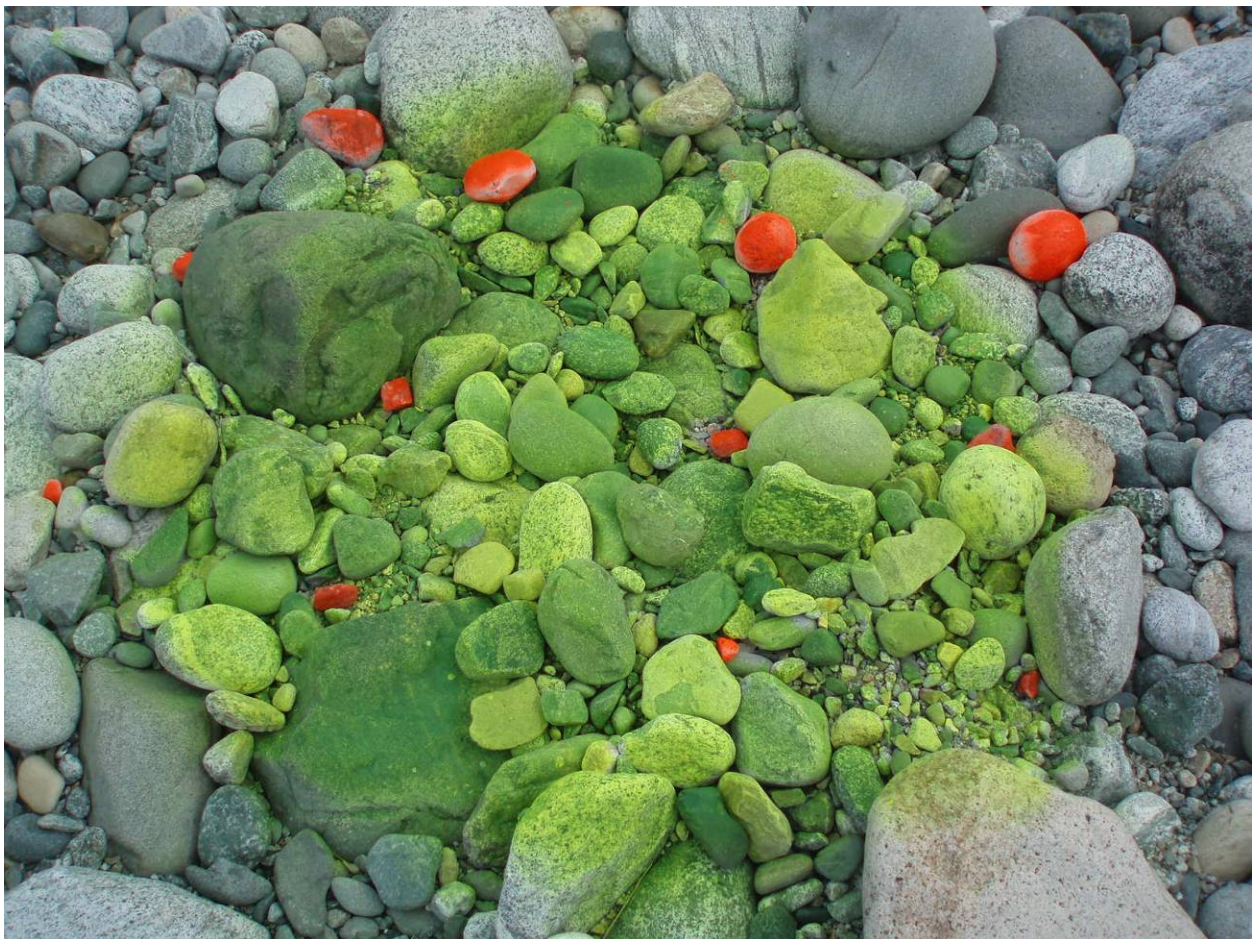
Figure 17

Gravel Test Site 1 (Reach 4) Prior to Spill

Twelve orange rocks representative of the fish mix size range were placed on top of the yellow painted substrate in a 3 x 4 grid pattern (Figure 17). Rock spacing along each row and column of the grid was approximately 1 foot. Each row in the grid contained a different size rock. The largest rocks were placed at the downstream end, with incrementally smaller rocks placed in upstream rows. This rock placement design ensured that the larger orange rocks did not shield the smaller orange rocks from oncoming flow. Each orange rock was placed in the substrate by removing a similarly sized existing rock and replacing it with the orange rock to mimic exposure on the bed of the river.

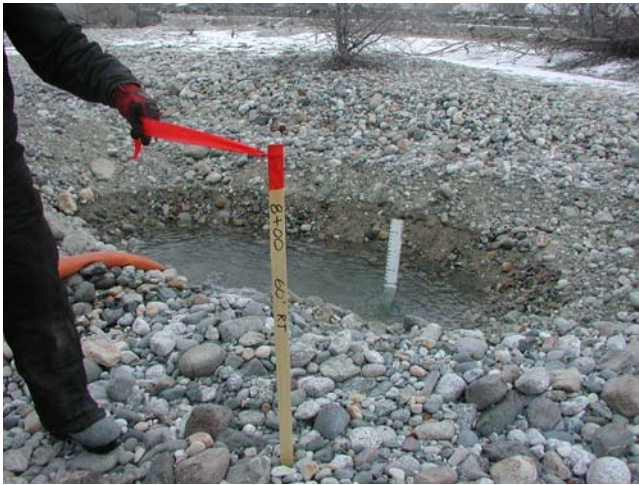
Photograph 1 – STA 8+00 Falling Head Test

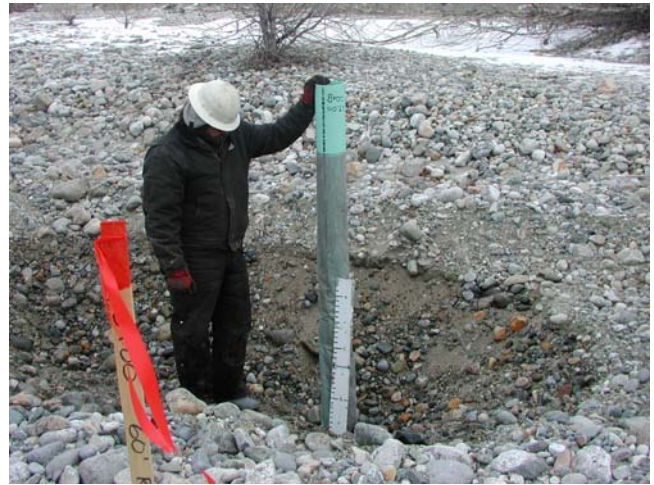
Photograph 2 – STA 8+00 Staff Gage

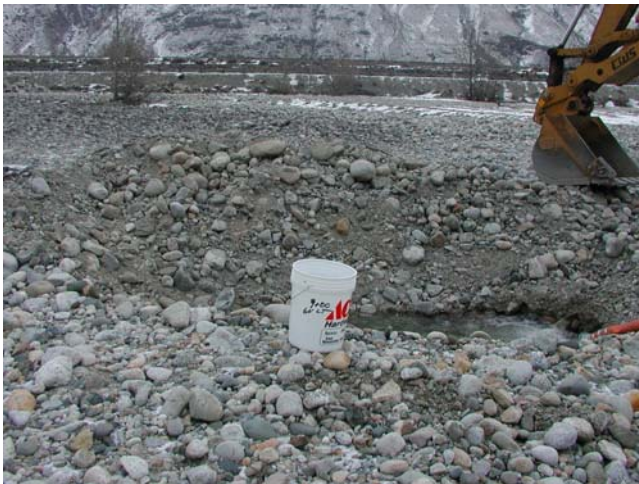
Photograph 3 – STA 9+00 Test Hole

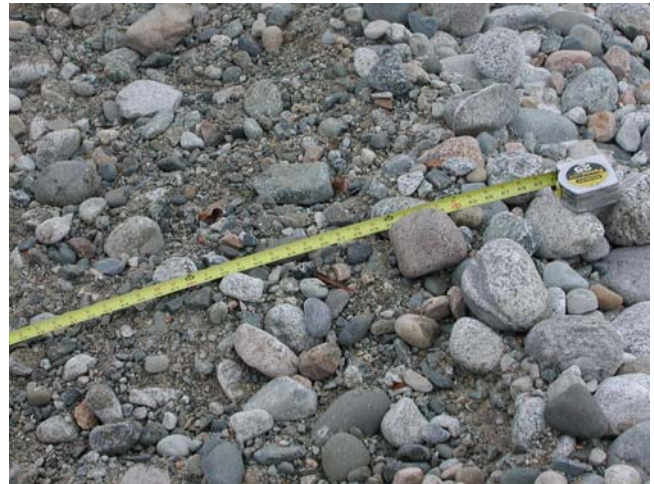
Photograph 4 – STA 9+00 Substrate

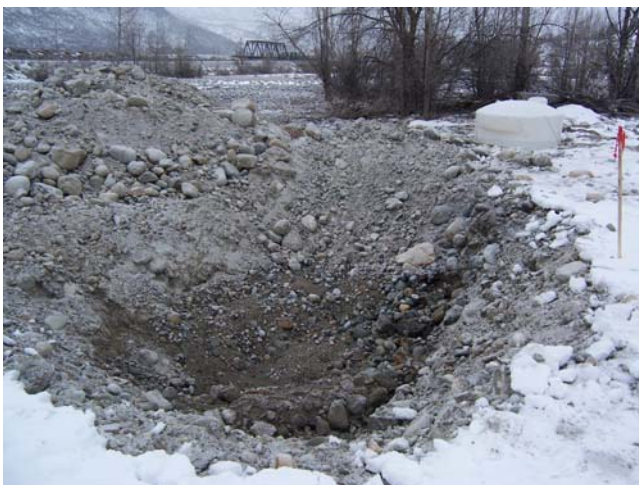
Photograph 5 – STA 12+00 Test Hole

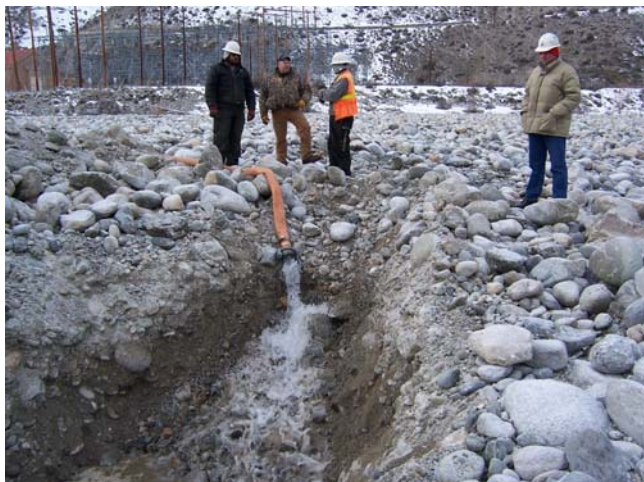
Photograph 7 – STA 15+50 Charging Test Hole

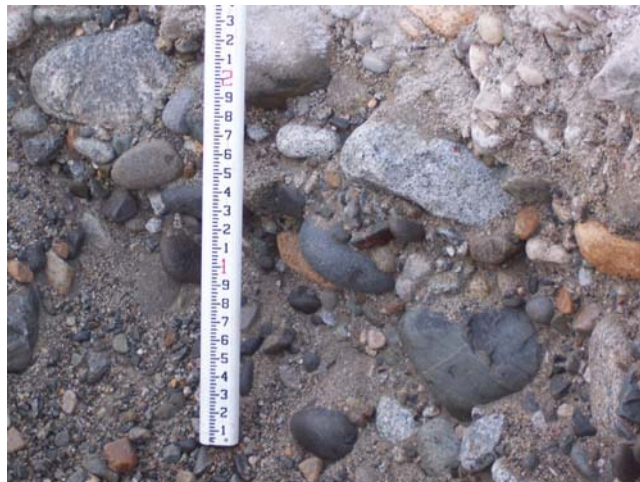
Photograph 8 – STA 15+50 Substrate

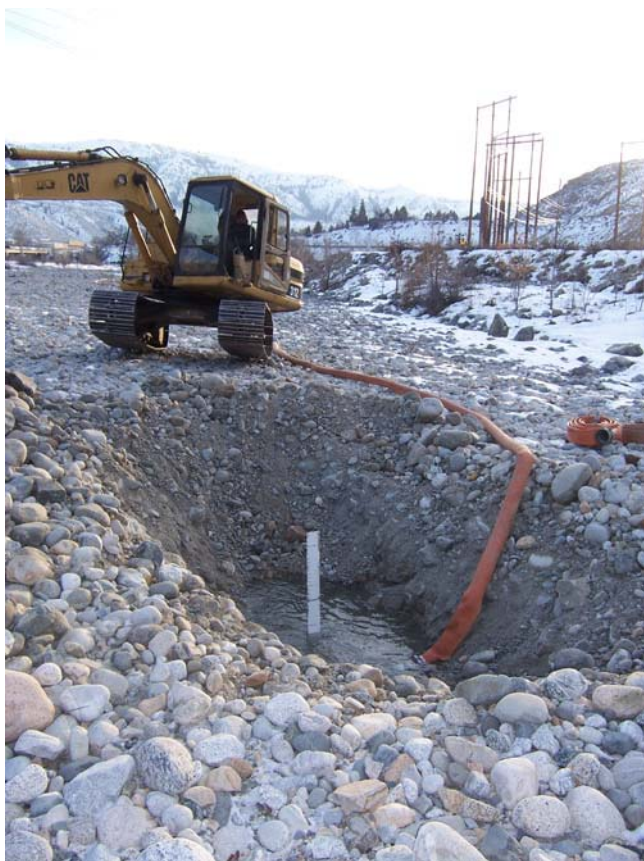
Photograph 9 – STA 18+50 Charging Test Hole

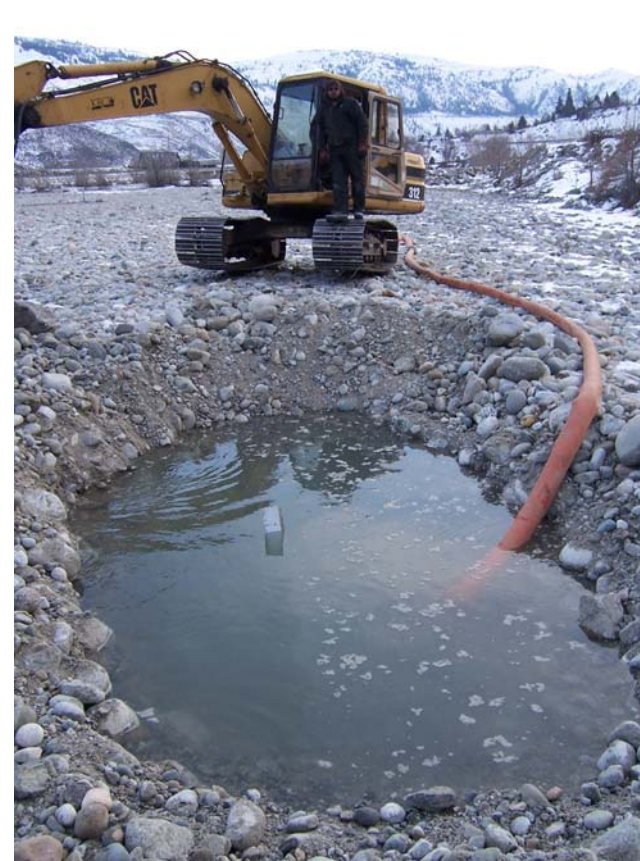
Photograph 10 – STA 18+50 Falling Head Test

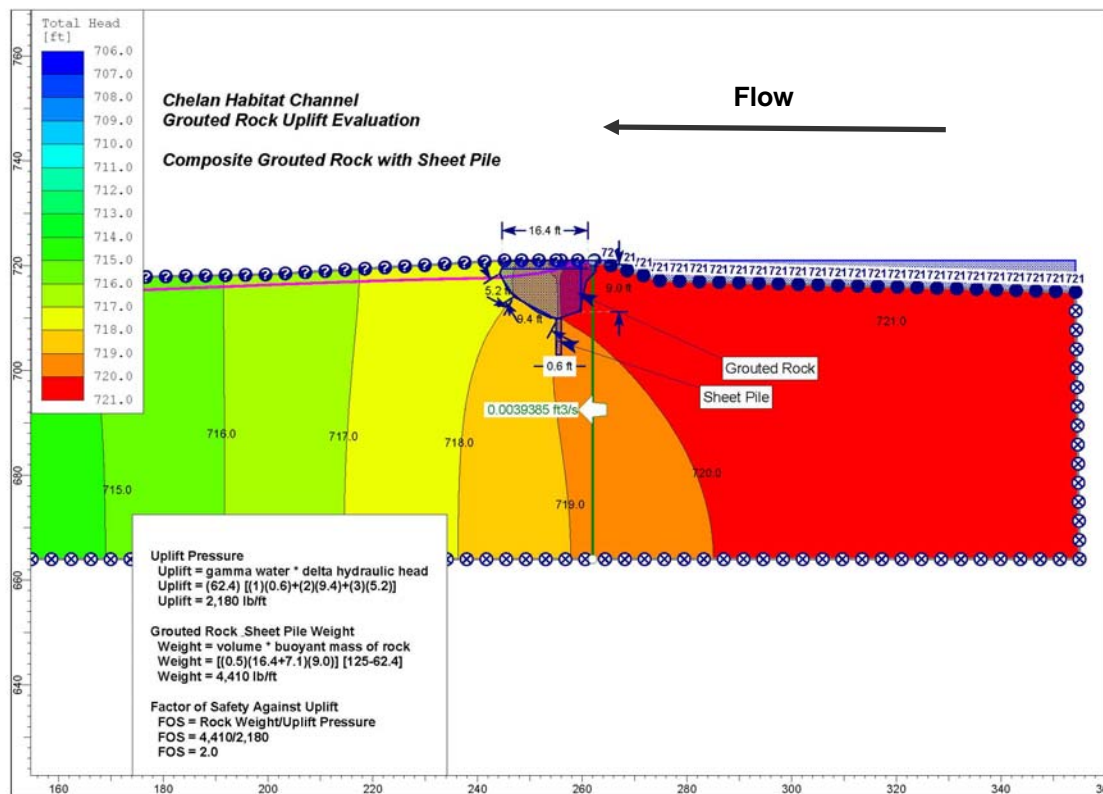
Figure 25
Uplift with Sheet Pile and Grouted Rock

For each flow scenario, a ponded water elevation of 721 feet behind the HCS and a downstream groundwater elevation of 706 feet (which was the condition with the greatest estimated seepage) were assumed. The Slide 5.0 software was used to generate a flow net, and the net uplift on the grouted structure was computed using this information. The resisting force was computed as the buoyant unit weight of the grouted rock mass. Figures 25 and 26 depict the flow net as well as the calculations of factor of safety against uplift. The factor of safety ranged from 2.0 to 2.4, which indicates that uplift is not expected under these flow conditions.

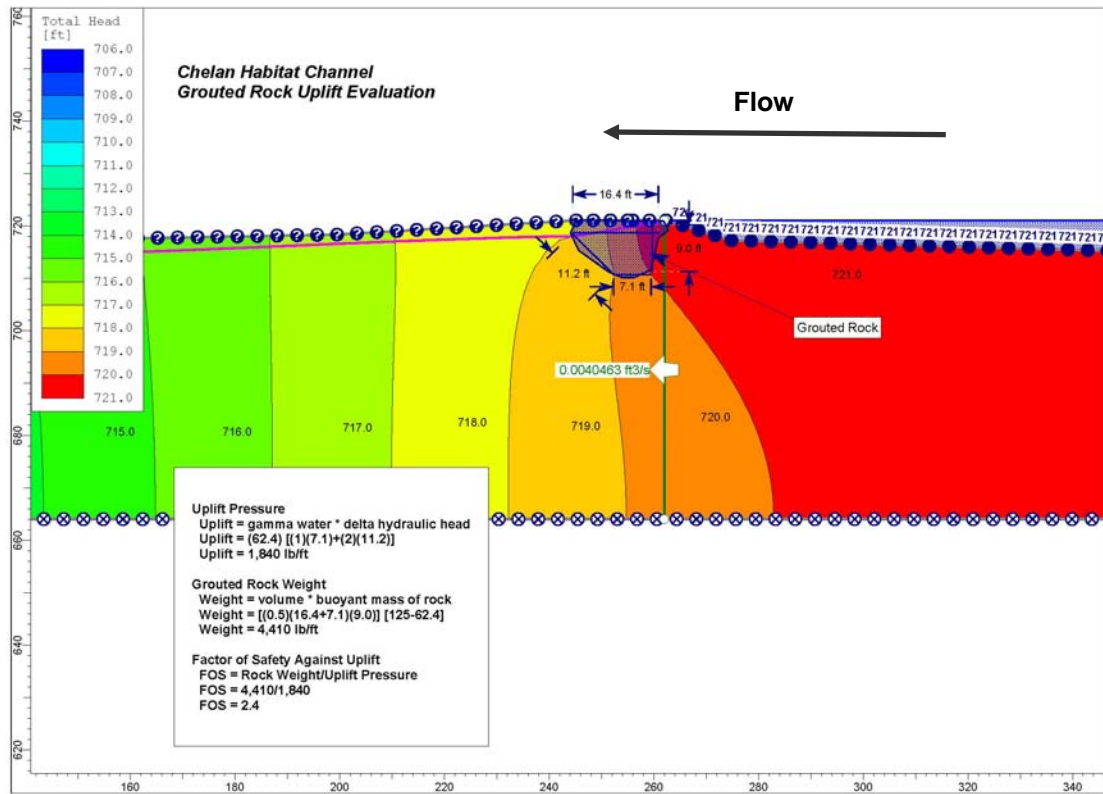
Figure 26
Uplift with Grouted Rock

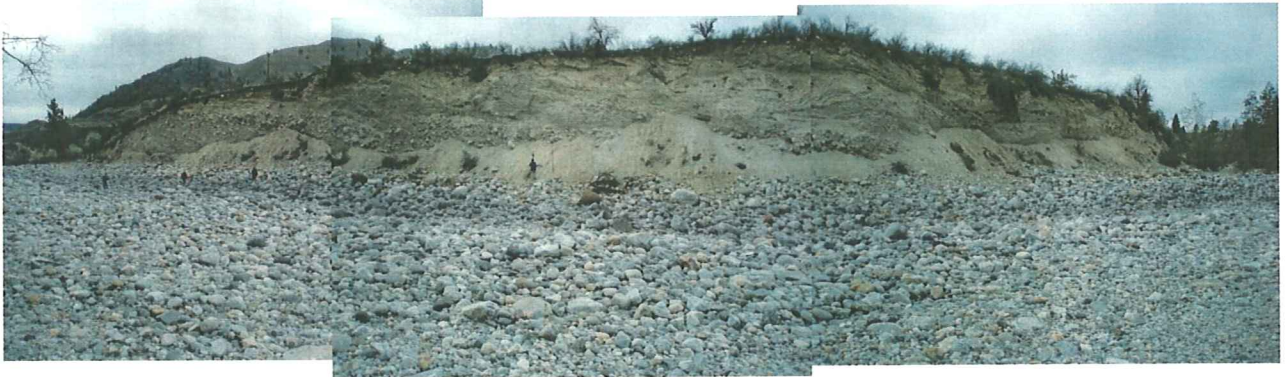
Chelan River Reach 1 Spill Test - Erosion Form
Site: Bank 3

Description: raveling outwash. 200 feet of orange dots; start at bush on upstream end

After Flow (cfs)	Date	Surveyor	Photo #s	Description of Change (#, position of missing dots; type of erosion – ravel or block fall?)
1,850	4/25/07	Gordon B		#2 & 3 dots washed away; #19 & 20 covered by dirt from hill
3,250	4/26/07	Gordon B		First 60 feet soil eroded, rocks moved. End 20-30 ft covered by dirt from hill above. Does not appear to be flow related
4,780	4/27/07	Gordon B		More significant erosion throughout entire length. Loose dirt eroded away, some block fall and some paint left behind on the rocks
6,710	5/1/07	Gordon B, Kathy D.	74-75	4-5 scattered rocks remain; rest are eroded (soil/bank erosion)
8,000	5/30/07	Gordon B		Definite erosion but most rocks are at where I painted them. I painted rocks above erosion point also this time
10,000	6-6-07	G. Boon		over half the painted rocks are still in the area; Dirt from hill has been washed down River leaving the rock

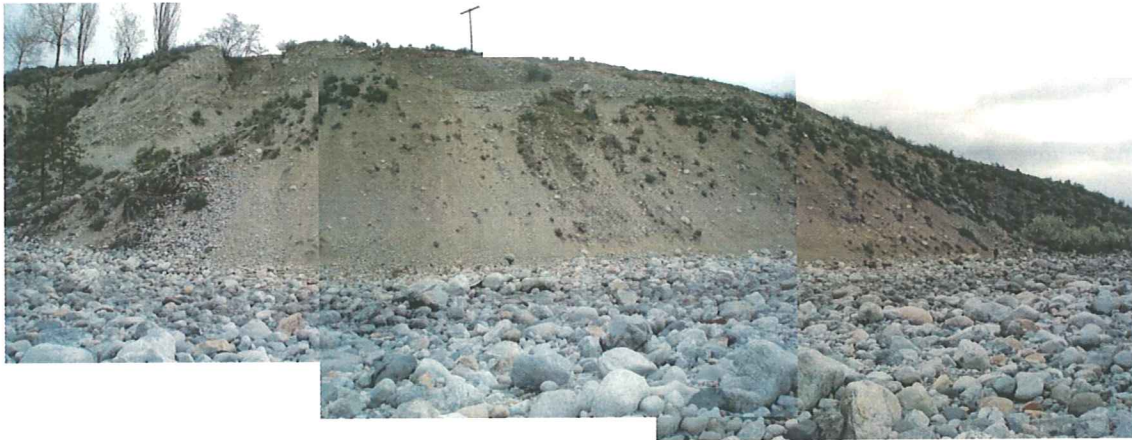
Chelan River Reach 1 Spill Test - Erosion Form
Site: Bank 4

Description: raveling outwash. 200 feet of orange dots; start at boulder on upstream end

After Flow (cfs)	Date	Surveyor	Photo #s	Description of Change (#, position of missing dots; type of erosion – ravel or block fall?)
1,850	4/25/07	Gordon B		No change
3,250	4/26/07	Gordon B		Dots 14-19 (counting from upstream) are missing. Dots 7, 9 are sliding toward river. Dot 11 is 90% covered by dirt sliding from above. 21 dots counted total
4,780	4/27/07	Gordon B		First 50-60 feet – slight erosion. Paint marks still visible. Last 150 ft more significant erosion, dirt from bank eroded and river rocks left behind, no visible paint marks
6,710	5/1/07	Gordon B, Kathy D.	70-73	Rocks #1, 2 remain; rest gone. Bank erosion
8,000	5-30-07	G Boon		Definite erosion 15 of 25 Rocks still visible.
10,000	6-6-07	G Boon		5 painted Rocks left. The dirt from the hill side has been washed away + Rocks are left.

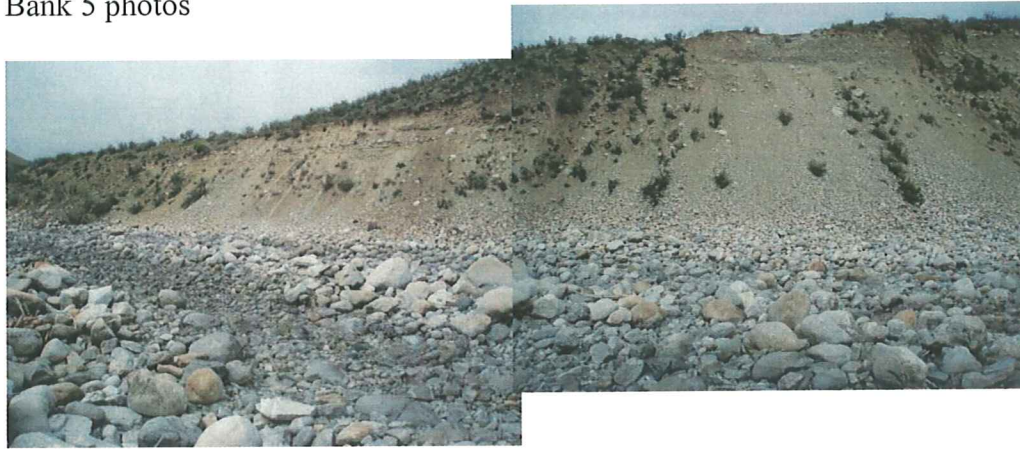
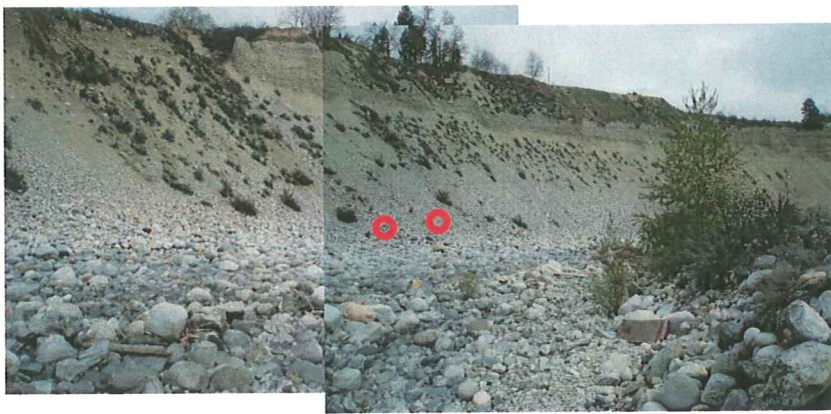
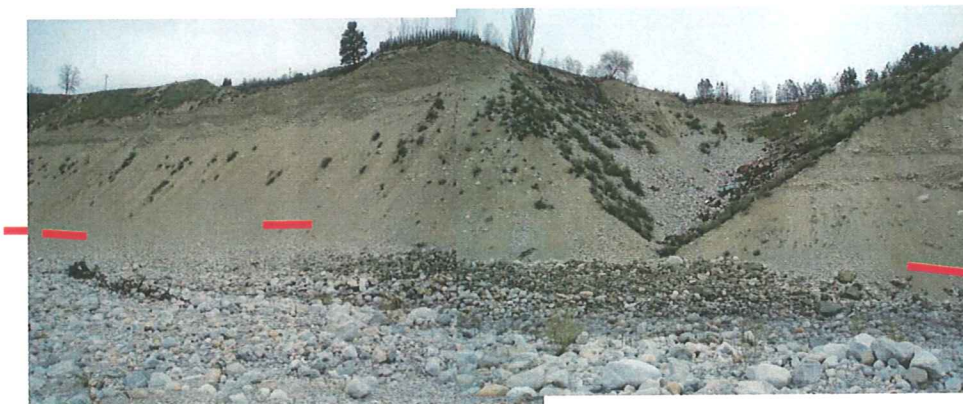
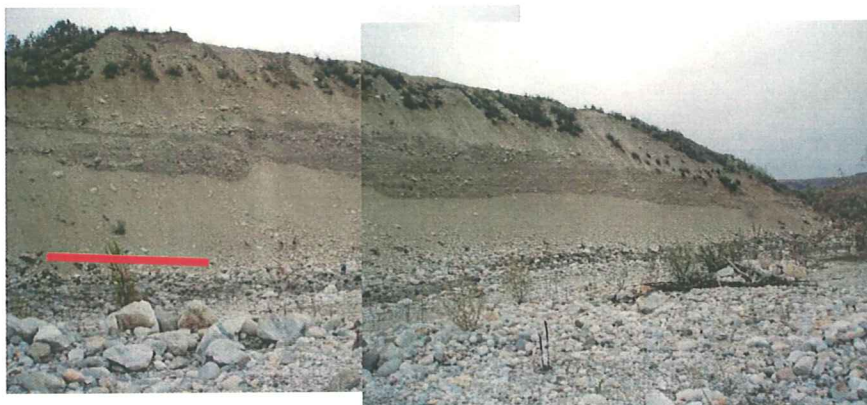
Bank 5 photos

After Flow (cfs)	Date	Surveyor	Photo #s	Description of Change (#, position of missing dots; type of erosion – ravel or block fall?)
1,850	4/25/07	Gordon B		No change
3,250	4/26/07	Gordon B		Area downstream of "V" 60 feet of dots missing near end of rip rap
4,780	4/27/07	Gordon B		Same as above with more erosion of dirt and rock from uphill
6,710	5/1/07	Gordon B, Kathy D.	51-69	Soil areas – 1-2 rocks missing in dirt areas upstream of "V" 3-4 rocks missing in 2 places upstream of "V" Plus 100 feet of erosion downstream of "V" See red areas on photos on next page.
8,000	5-30-07	G Boon		upriver of V 85% of painted rocks are still visible. Down Stream of V 75% of painted rocks are visible
10,000	6-6-07	G Boon		Upstream from V there are 20 rocks painted + down stream there are 14. Dirt from the hill side has been washed away and rocks are left in its place. Some erosion but bank is sluffing down to the river also

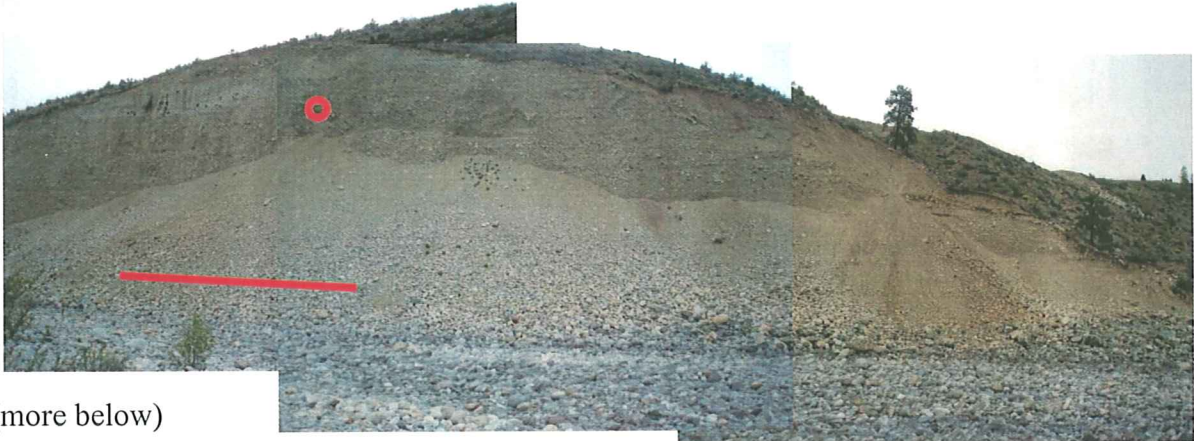
Chelan River Reach 1 Spill Test - Erosion Form
Site: Bank 6

Description: high bank of raveling outwash orange dots; rip rap on downstream end

After Flow (cfs)	Date	Surveyor	Photo #s	Description of Change (#, position of missing dots; type of erosion – ravel or block fall?)
1,850	4/25/07	Gordon B		No change
3,250	4/26/07	Gordon B		About 100 feet downstream from rip rap – block fall for 1 dot.
4,780	4/27/07	Gordon B		Same as above. Some block fall from above throughout length.
6,710	5/1/07	Gordon B, Kathy D.		Ravel; block fall occurred recently from top at location noted. Erosion as noted in photo above (6 rocks from downstream end of rip rap still there, then gone for 100-200 feet, then all present).
8,000	5-30-07	G Boor		The painted rocks are gone. There is visible erosion.
10,000	6-6-07	G Boor		The dirt from above has been washed away + rocks are visible now

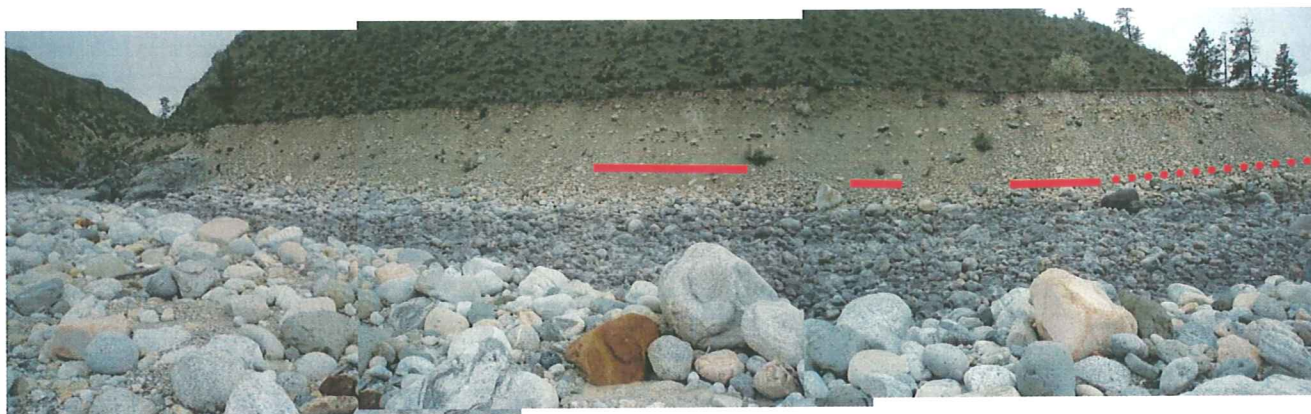
Chelan River Reach 1 Spill Test - Erosion Form
Site: Bank 7

Description: raveling outwash orange dots along terraces (high/low)

After Flow (cfs)	Date	Surveyor	Photo #s	Description of Change (#, position of missing dots; type of erosion – ravel or block fall?)
1,850	4/25/07	Gordon B		No change
3,250	4/26/07	Gordon B		No substantial change. Possibly 1-2 rocks missing in the vicinity of where the bank changes form high to low.
4,780	4/27/07	Gordon B		Same as above
6,710	5/1/07	Gordon B, Kathy D.		Starting at downstream end, rocks # 1-13 still there; then many missing (from dirt areas) on high bank. Most still present on lower bank (see next page; solid lines indicate all eroded, dashed lines indicate some missing)
8,000	5-30-07	G Boon		I found 2 painted rocks here. Visible erosion Painted new rocks
10,000	6-6-07	G Boon		There are 14 painted Rocks left. The dirt has been washed down River leaving only the rock at high water cut.

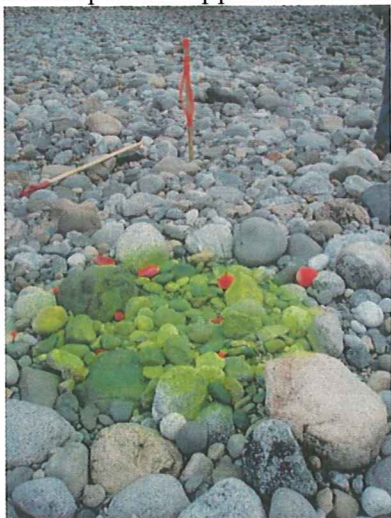
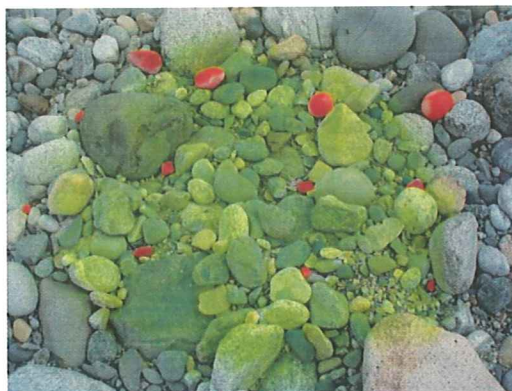
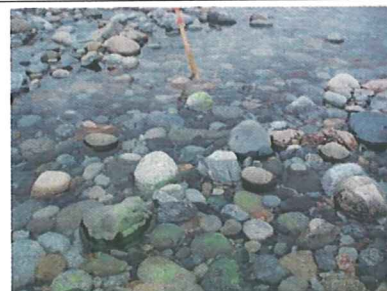
Chelan River Reach 4 Spill Test - Erosion Form
Site: Gravel Site 1

Description: Approx. Station 21+50

After Flow (cfs)	Date	Surveyor	Photo #s	Description of Change (#, position of missing dots; type of erosion – ravel or block fall?)
1,850	4/25/07	Gordon B		No change. Was under water
3,250	4/26/07	Gordon B		No apparent change
4,780	4/27/07	Gordon B		Significant change. (Gordon has photo)
6,710	5/1/07	Gordon B, Kathy D.		All of orange rocks gone, most of yellow rocks gone (see photo below). Rocks over 12" still on site; marked rocks smaller than approx. 6" have moved 5-50 feet downstream. Peak water depth est. 5 feet.
8,000	5-30-07	Gr. Boon		Was unable to locate
10,000	6-6-07	Gr Boon		Washed away

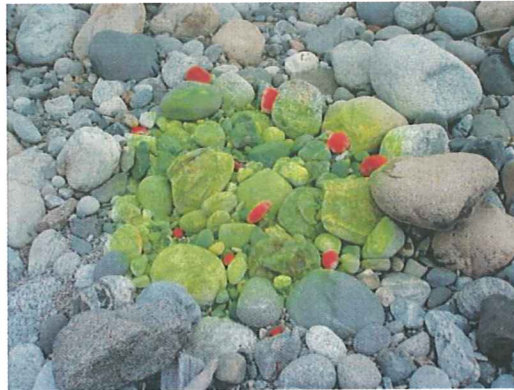
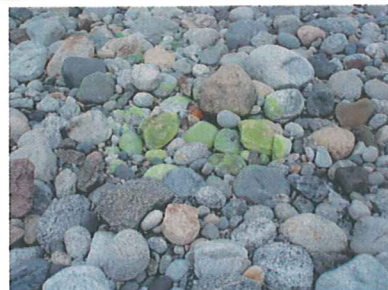
Chelan River Reach 4 Spill Test - Erosion Form
Site: Gravel Site 2

Description: Approx. Station 19+00

After Flow (cfs)	Date	Surveyor	Photo #s	Description of Change (#, position of missing dots; type of erosion – ravel or block fall?)
1,850	4/25/07	Gordon B		No change
3,250	4/26/07	Gordon B		No change
4,780	4/27/07	Gordon B		Slight change (Gordon has photo)
6,710	5/1/07	Gordon B, Kathy D.		12" boulder moved on top of the one large orange rock that remains (rest gone). 8-10" yellow rocks stable. 4-6" yellow rocks found 5-40 feet downstream. Smaller rocks gone (see photo below)
8,000	5-30-07	G. Boon		found yellow rocks scattered over a large area no orange rocks
10,000	6-6-07	G. Boon		Looked but couldn't find any painted Rocks

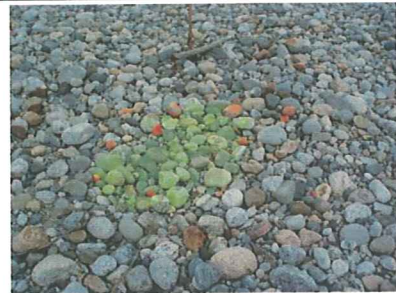
Chelan River Reach 4 Spill Test - Erosion Form
Site: Gravel Site 3

Description: Approx. Station 15+50 – near standpipe

After Flow (cfs)	Date	Surveyor	Photo #s	Description of Change (#, position of missing dots; type of erosion – ravel or block fall?)
1,850	4/25/07	Gordon B		No change
3,250	4/26/07	Gordon B		No change
4,780	4/27/07	Gordon B		No change
6,710	5/1/07	Gordon B, Kathy D.		One medium rock moved approx. 1 foot downstream. Est. high water depth 1 foot. Photo below.
8,000	5-30-07	G Boon		Stake still in place yellow square visible 3 little rocks, 4 medium in area 3 large rocks where they were placed
10,000	6-6-07	G Boon		Scattered yellow about 30' down str. 2 large rocks 2 med + 1 small in area

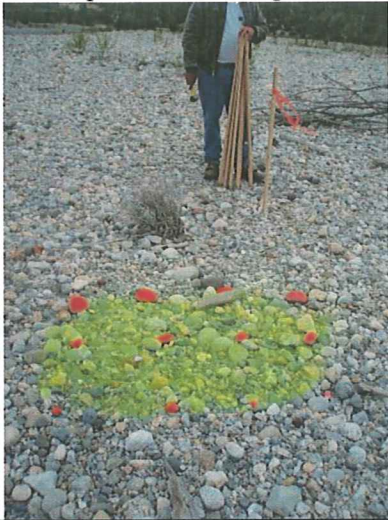
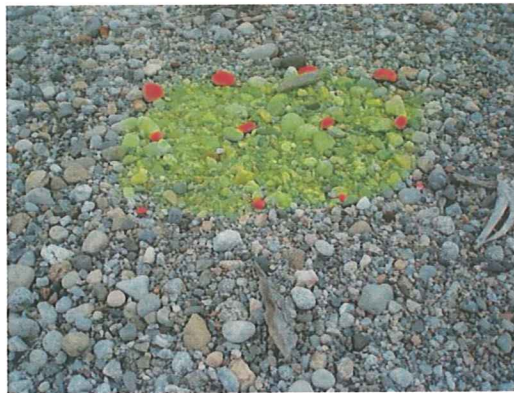
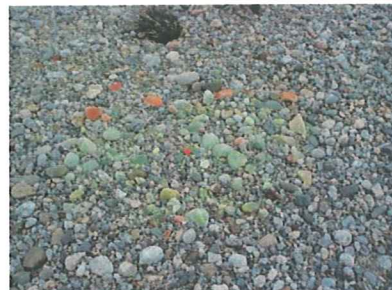
Chelan River Reach 4 Spill Test - Erosion Form
Site: Gravel Site 4

Description: Lines up with downstream end of powerhouse

After Flow (cfs)	Date	Surveyor	Photo #s	Description of Change (#, position of missing dots; type of erosion – ravel or block fall?)
1,850	4/25/07	Gordon B		No change
3,250	4/26/07	Gordon B		No change
4,780	4/27/07	Gordon B		No change
6,710	5/1/07	Gordon B, Kathy D.		Small (0.5-1") one moved 1 ft Med (1-2") 2 moved 2-5 ft Large (3-4") all stable Many yellow rocks up to 1" moved downstream. High water depth est. 0.5-1 ft. See photo.
8,000	5-30-07	G. Boon		Stake in place yellow area spread out 4 large rocks in original location # small + 2 medium outside yellow area
10,000	6-6-07	G. Boon		Stake in place yellow scattered over large area 2 large close to original area 1 med 20' down stream 1 med 30' down stream

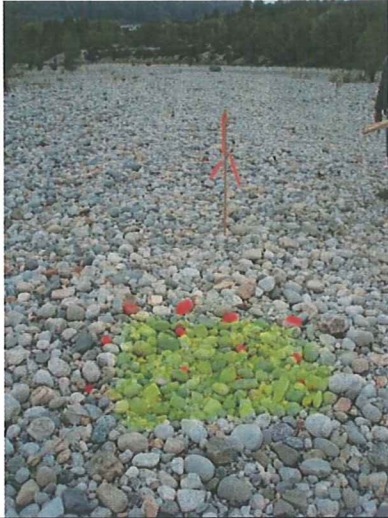
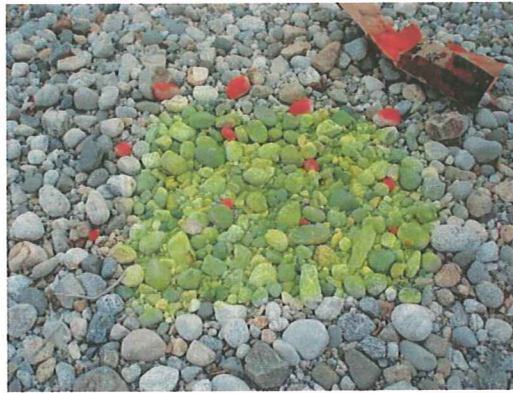
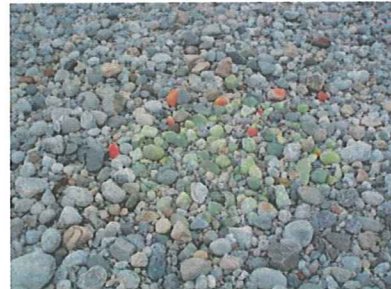
Chelan River Reach 4 Spill Test - Erosion Form
Site: Gravel Site 5

Description: Just downstream of red/white fencepost line

After Flow (cfs)	Date	Surveyor	Photo #s	Description of Change (#, position of missing dots; type of erosion – ravel or block fall?)
1,850	4/25/07	Gordon B		No change
3,250	4/26/07	Gordon B		No change
4,780	4/27/07	Gordon B		No change
6,710	5/1/07	Gordon B, Kathy D.		2 small (0.5-1") rocks missing. One medium, one large moved. 0.5"-1" yellow rocks moved 15-25 feet. High water depth est. 1 ft. See photo below.
8,000	5-30-07	G Boon		<i>I couldn't locate</i>
10,000	6-6-07	G Boon		<i>Found 5 yellow scattered over large area 1 large orange stone</i>

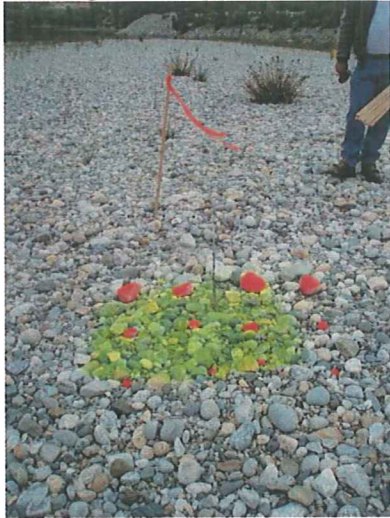
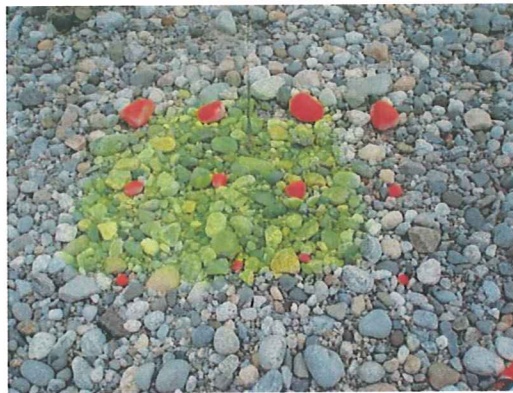
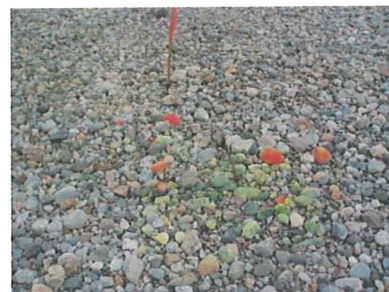
Chelan River Reach 4 Spill Test - Erosion Form
Site: Gravel Site 6

Description: Approx. Station 4+00

After Flow (cfs)	Date	Surveyor	Photo #s	Description of Change (#, position of missing dots; type of erosion – ravel or block fall?)
1,850	4/25/07	Gordon B		No change
3,250	4/26/07	Gordon B		No change
4,780	4/27/07	Gordon B		No change
6,710	5/1/07	Gordon B, Kathy D.		3 small (0.5-1") rocks moved 1-3 ft 2 med (1-2") rocks moved 0.5-8 ft 1 large (3-4") moved 1 ft Yellow rocks - <1" moved 15 ft Est. high water depth 0.5-1 ft See photo below
8,000	5-30-07	G Boon		Stake in place, yellow area scattered out 4 large rocks in area 1 little rock in area 1 med about 30' down stream
10,000	6-6-07	G Boon		yellow scattered out about 60' 3 large stones about 20' apart going down stream

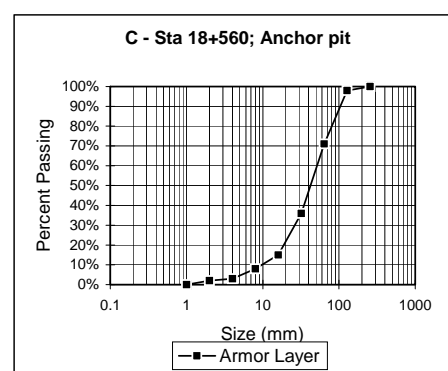
C - Sta 18+560; Anchor pit

Armor Layer Size (mm)	Armor Layer Size (in)	Percent	Cum %	Avg size	No.
1	0.04	0%	0%	0.00	0
2	0.08	2%	2%	0.06	2
4	0.16	1%	3%	0.06	1
8	0.31	5%	8%	0.60	5
16	0.63	7%	15%	1.68	7
32	1.26	21%	36%	10.08	21
64	2.52	35%	71%	33.60	35
128	5.04	27%	98%	51.84	27
256	10.08	2%	100%	2.56	2
Dg 100.48 mm 0.3297 ft					100

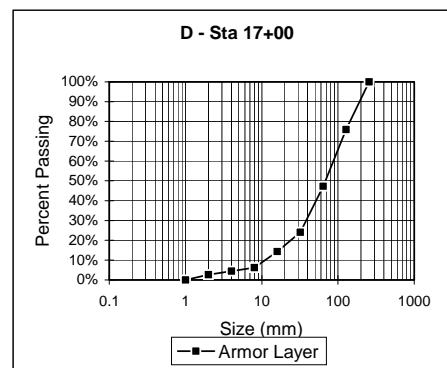
D - Sta 17+00

Armor Layer Size (mm)	Armor Layer Size (in)	Percent	Cum %	Avg size	No.
1	0.04	0%	0%	0.00	0
2	0.08	3%	3%	0.08	3
4	0.16	2%	4%	0.11	2
8	0.31	2%	6%	0.21	2
16	0.63	8%	14%	1.93	9
32	1.26	10%	24%	4.71	11
64	2.52	23%	47%	22.29	26
128	5.04	29%	76%	54.86	32
256	10.08	24%	100%	30.86	27
Dg 115.04 mm 0.3774 ft					112

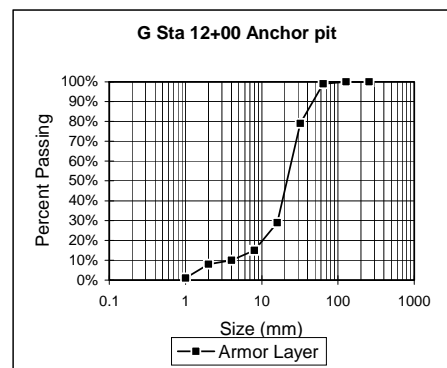
G Sta 12+00 Anchor pit

Armor Layer Size (mm)	Armor Layer Size (in)	Percent	Cum %	Avg size	No.
1	0.04	1%	1%	0.01	1
2	0.08	7%	8%	0.21	7
4	0.16	2%	10%	0.12	2
8	0.31	5%	15%	0.60	5
16	0.63	14%	29%	3.36	14
32	1.26	50%	79%	24.00	50
64	2.52	20%	99%	19.20	20
128	5.04	1%	100%	1.92	1
256	10.08	0%	100%	0.00	0
Dg					100
					49.42 mm
					0.1621 ft
