# FACT SHEET CHELAN TRANSMISSION FIRE HARDENING

### PROPOSED CHELAN TRANSMISSION FIRE HARDENING TIMELINE

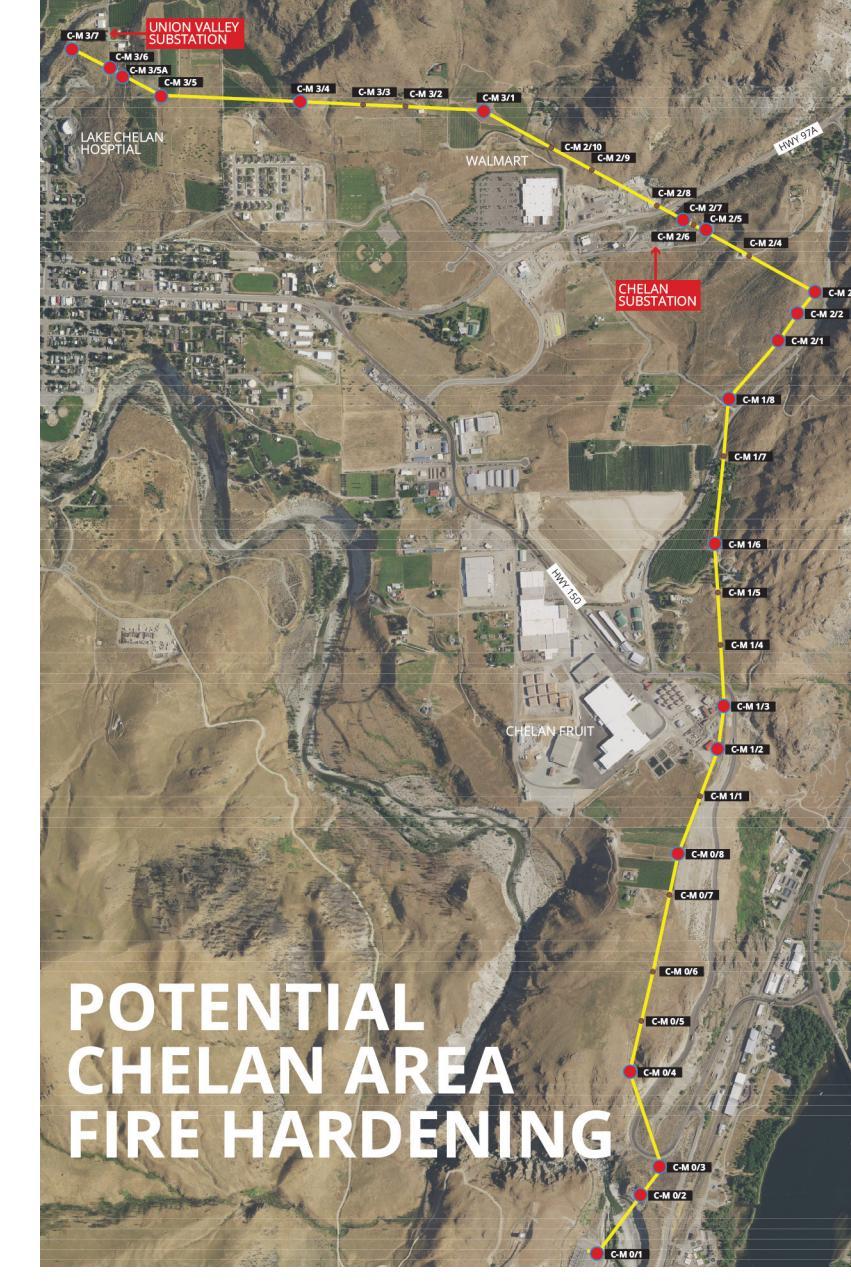
Identified as the red/blue circles on the map, these structures are more difficult to access or take longer to reconstruct, and by replacing these structures in steel, downtime could be shortened after a fire.

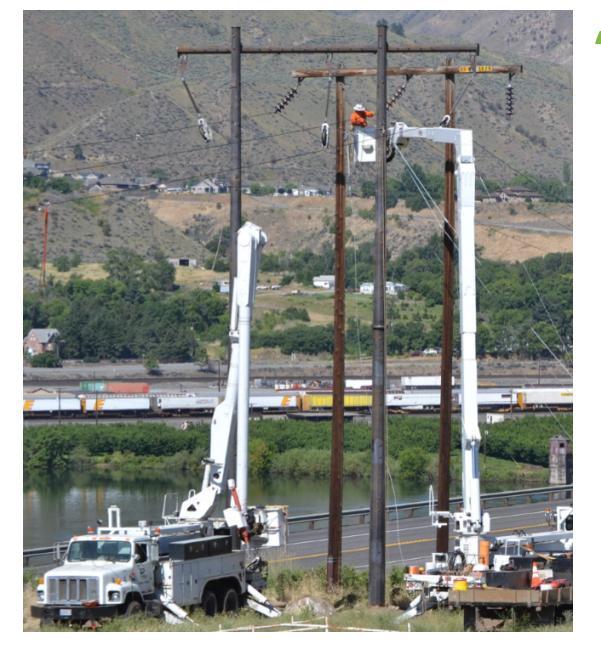
### REPLACING WOOD POLES WITH STEEL:

- Steel poles allow fires to pass with limited damage to the electrical system
- Same alignment as existing
- Same general look and feel as original
