2014
GAS ABATEMENT ANNUAL REPORT

ROCKY REACH HYDROELECTRIC PROJECT
FERC Project No. 2145
and
ROCK ISLAND HYDROELECTRIC PROJECT
FERC Project No. 943

December 31, 2014

Public Utility District No. 1 of Chelan County
Wenatchee, Washington

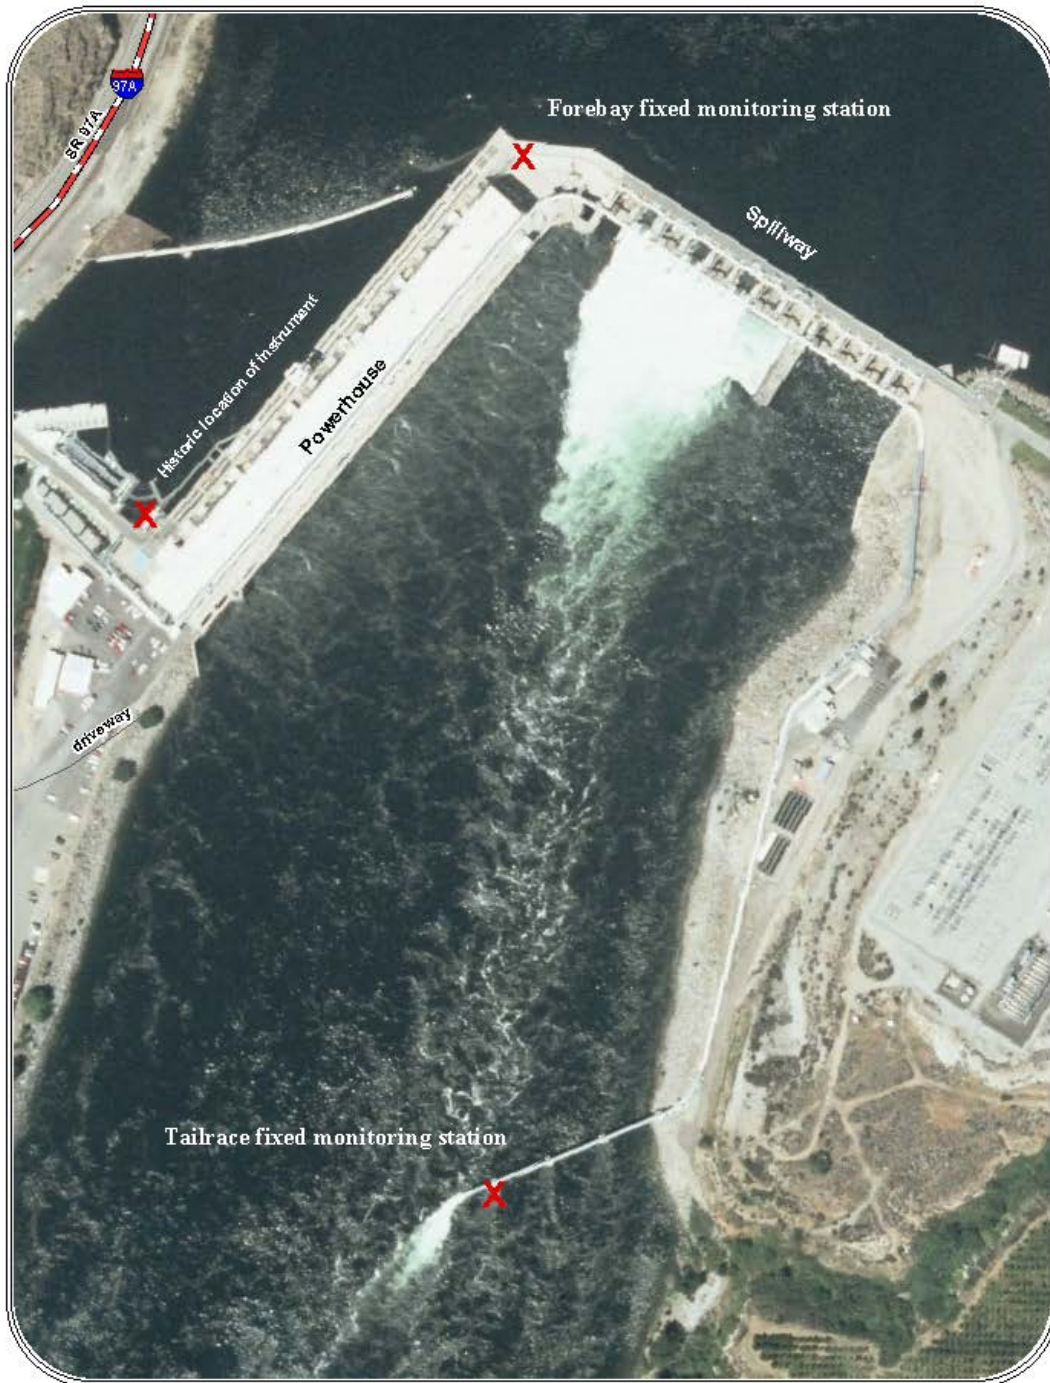
Figure 1-2: Rocky Reach project, forebay, tailrace and fixed monitoring stations.

Each Chelan PUD FMS is equipped with a Hydrolab® Minisonde® 5 enclosed in a submerged conduit (Figures 1-2 through 1-4). Multi-probes are connected to an automated system that allows Chelan PUD to monitor barometric pressure, TDG, and water temperature on an hourly basis. Probes are maintained and calibrated as outlined in the QAPP. For a complete description of the FMS see the QAPP (Chelan PUD, 2010b).

Forebay FMS were located at fixed sites on the upstream face of Rocky Reach and Rock Island projects (Figures 1-2 and 1-3, respectively). Dissolved gas probes were lowered down a conduit and secured to the upstream face of each project and submerged to a depth of approximately 15 feet

Tailrace monitoring stations are located downstream of both projects. The Rocky Reach monitoring station is located approximately one third of a mile downstream of the spillway on the juvenile fish bypass outfall (Figure 1-2), as required by the 401 WQC (Ecology, 2006). This location was chosen because it was the most feasible location near the end of the aerated zone, which is the compliance point for the Mid-Columbia TDG TMDL.

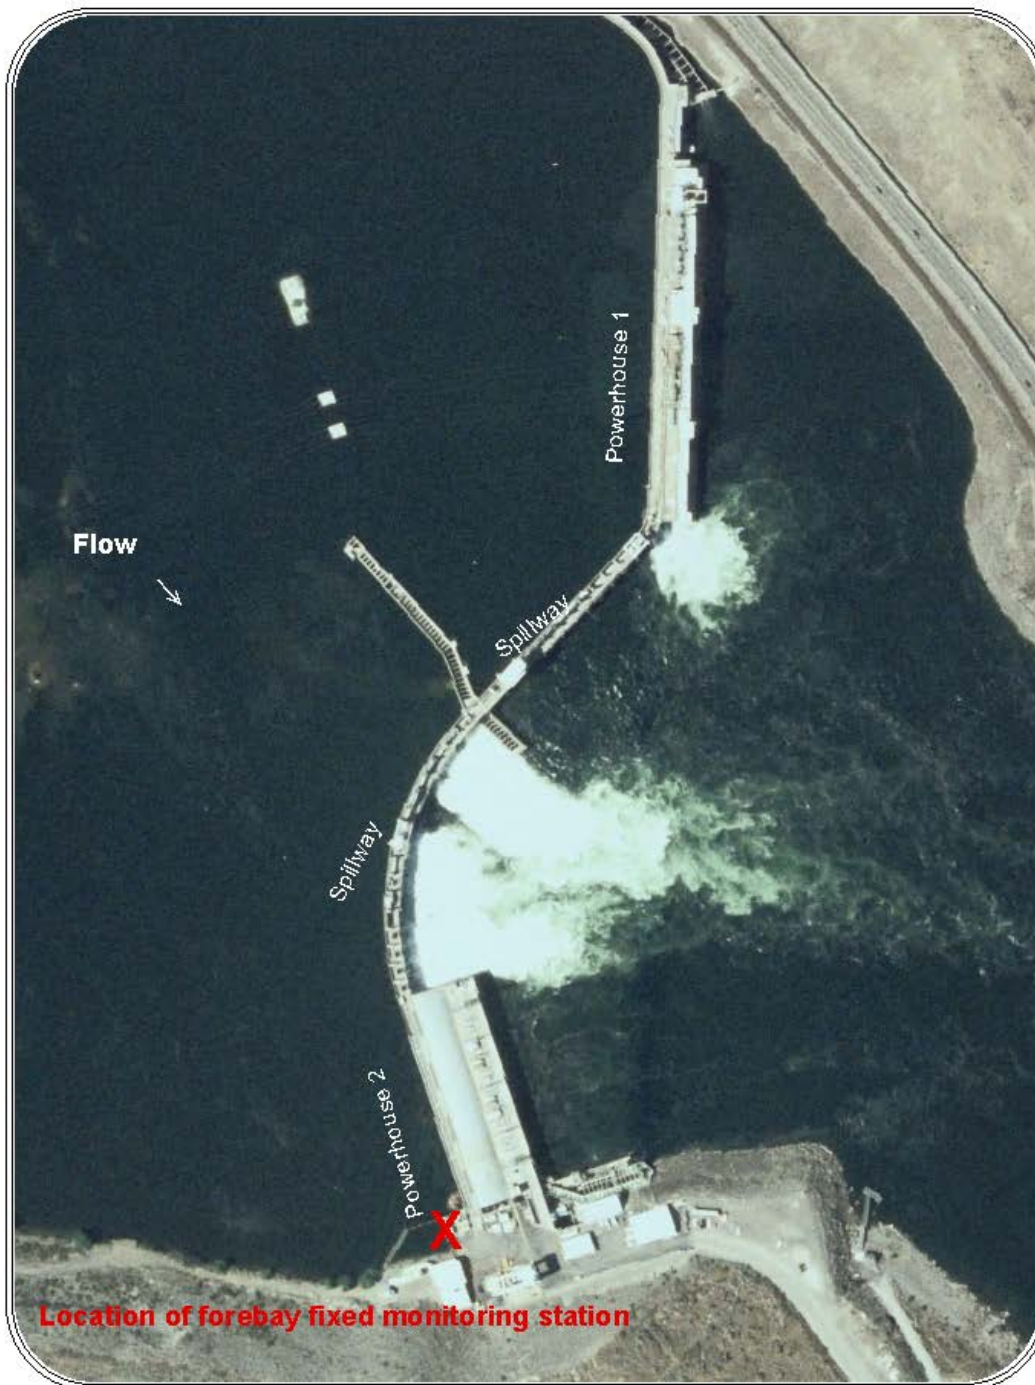
Figure 1-3: Rock Island project, forebay, tailrace and fixed monitoring stations.

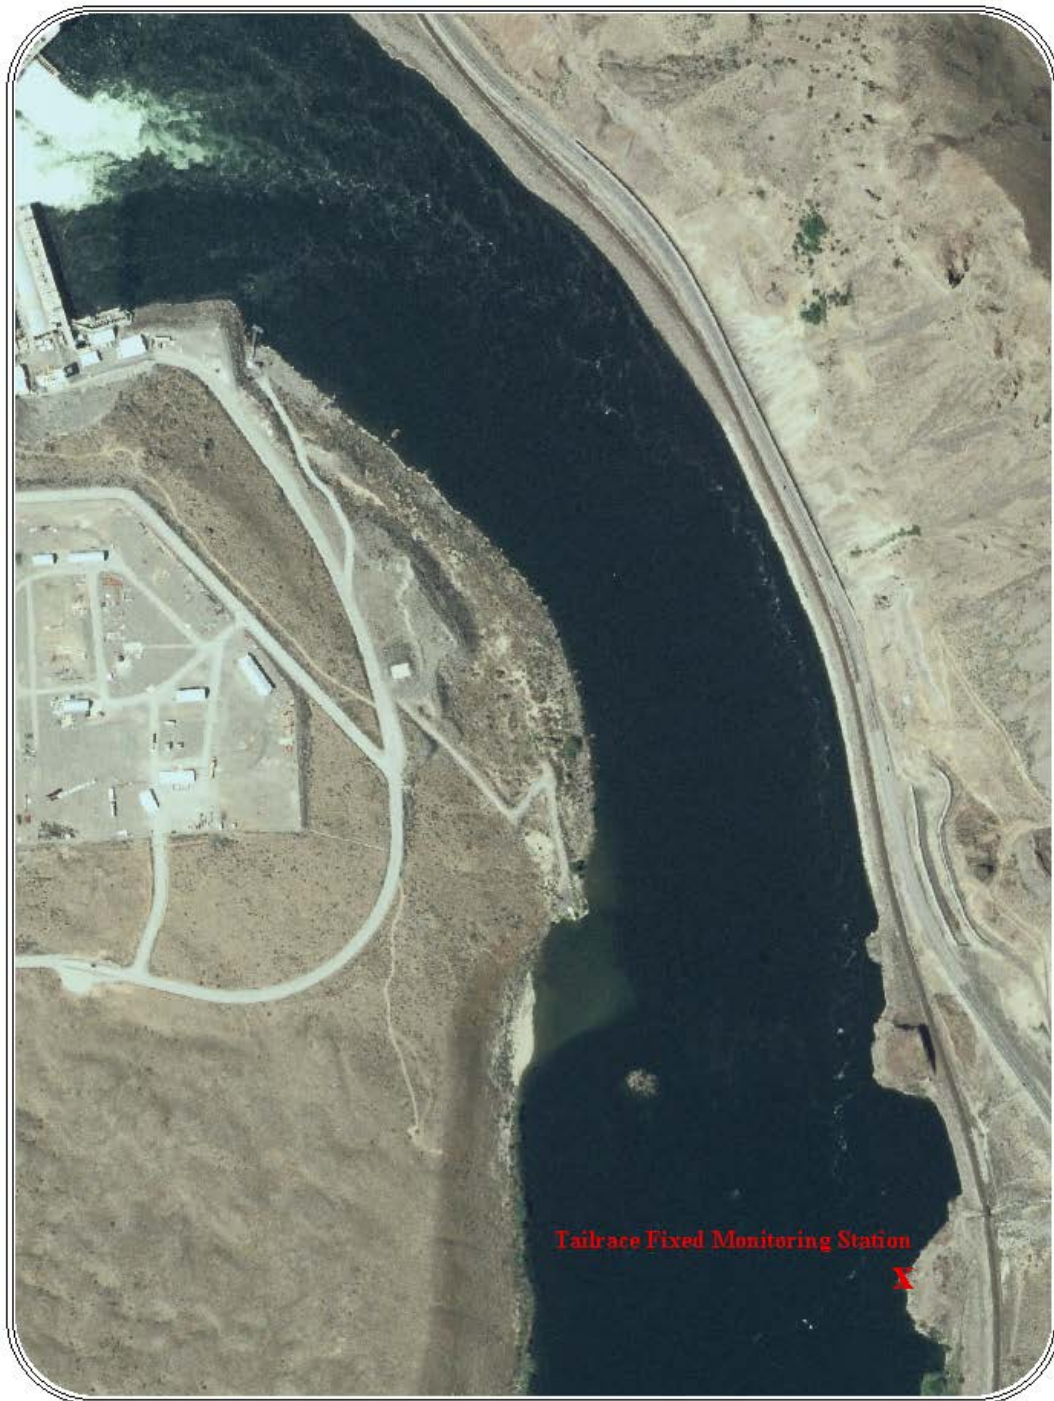
Figure 1-4: Rock Island project, tailrace fixed monitoring station.

No bridge or other permanent in-water structure is available downriver of Rock Island project on which to attach a monitoring station. For this reason, Chelan PUD developed a monitoring station about 1.5 miles downriver from the project on the eastern shoreline (Figure 1-4). This FMS has two means of deploying the dissolved gas probe, a carriage system with a cable attached to an ecology block in the river, and a fixed pipe attached to the scaffold that holds the carriage system. The fixed pipe was installed August 25, 2014 due to the extreme fluctuations of the Rock Island tailrace as a result of the Wanapum drawdown emergency.

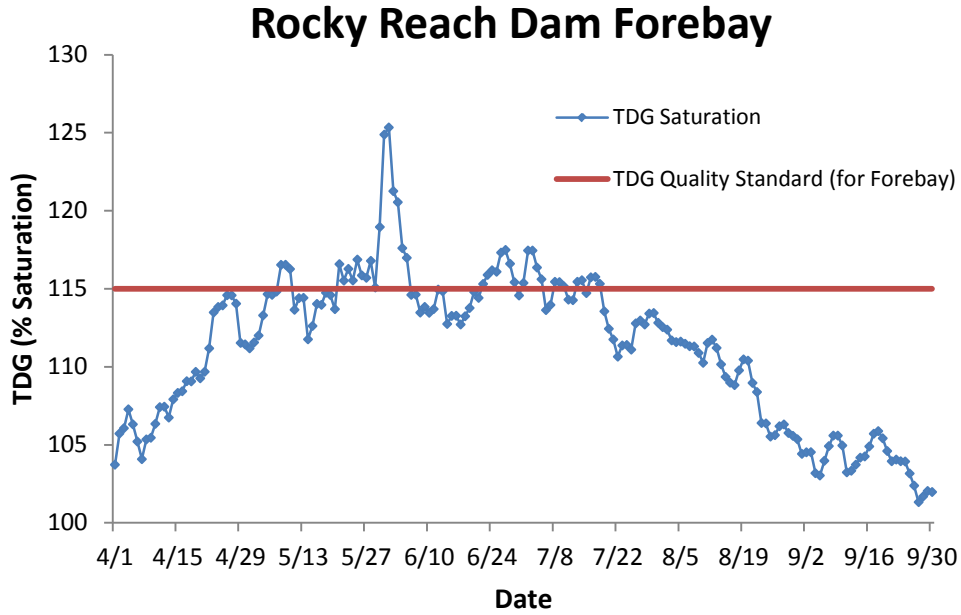
Figure 3-1: Total dissolved gas measurements (average of the 12-highest consecutive hourly TDG readings in a 24-hour period) from the 2014 fish-spill season recorded at the Rocky Reach dam forebay FMS.

Total Dissolved Gas Averages during the Fish-Spill Season in Figures 3-1 through 3-9 display the average of the 12-highest consecutive hourly readings, spill vs. TDG, and a regression analysis of relationship between the total volume spilled to percent change in TDG. The average of the 12-highest consecutive hourly TDG readings from each day during the spring and summer fish-spill seasons from each FMS is presented in Appendix D of this report.

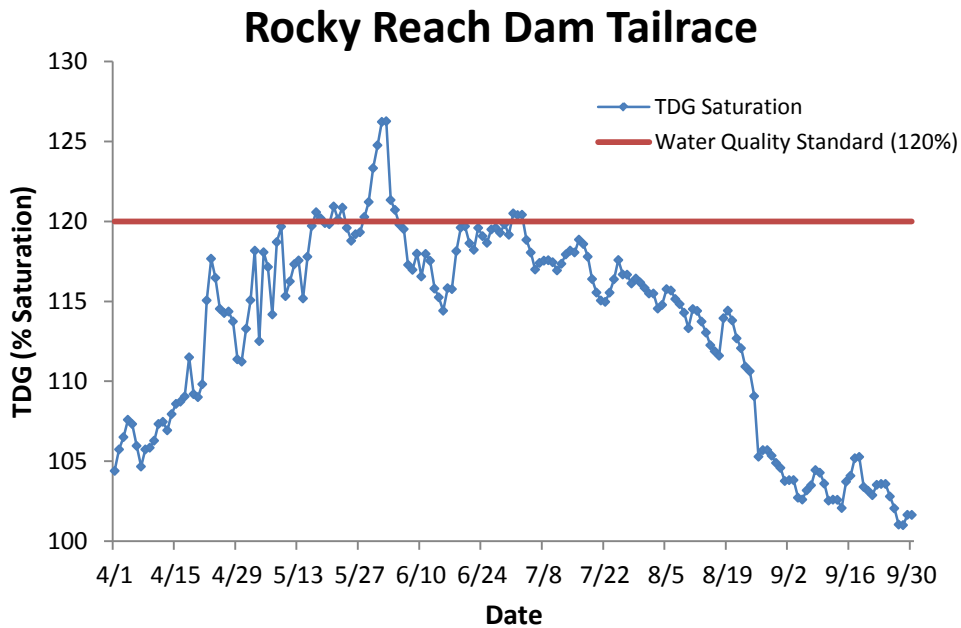
Figure 3-2: Total dissolved gas measurements (average of the 12-highest consecutive hourly TDG readings in a 24-hour period) from the 2014 fish-spill season recorded at the Rocky Reach dam tailrace FMS.

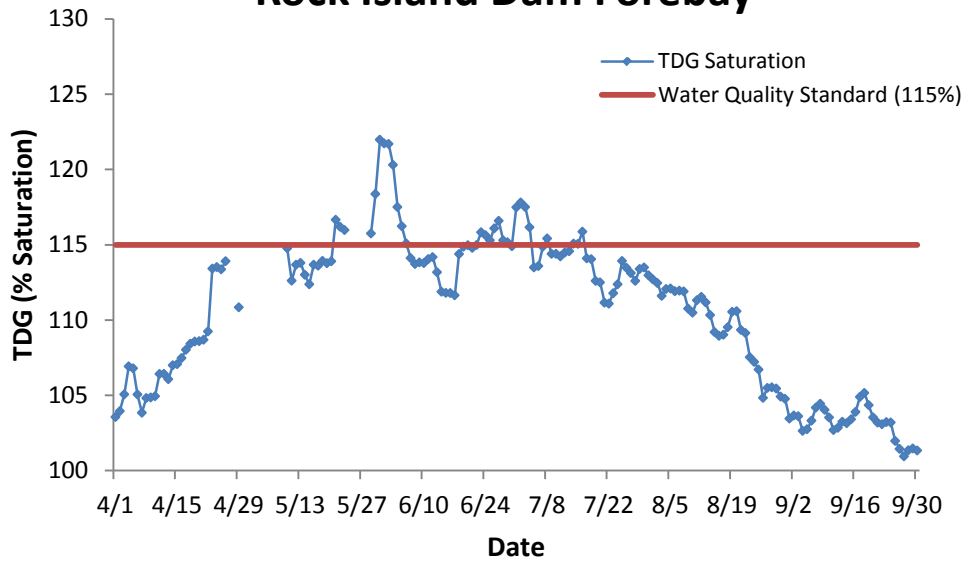
Rock Island Dam Forebay

Figure 3-3: Total dissolved gas measurements (average of the 12-highest consecutive hourly TDG readings in a 24-hour period) from the 2014 fish-spill season recorded at the Rock Island dam forebay FMS.

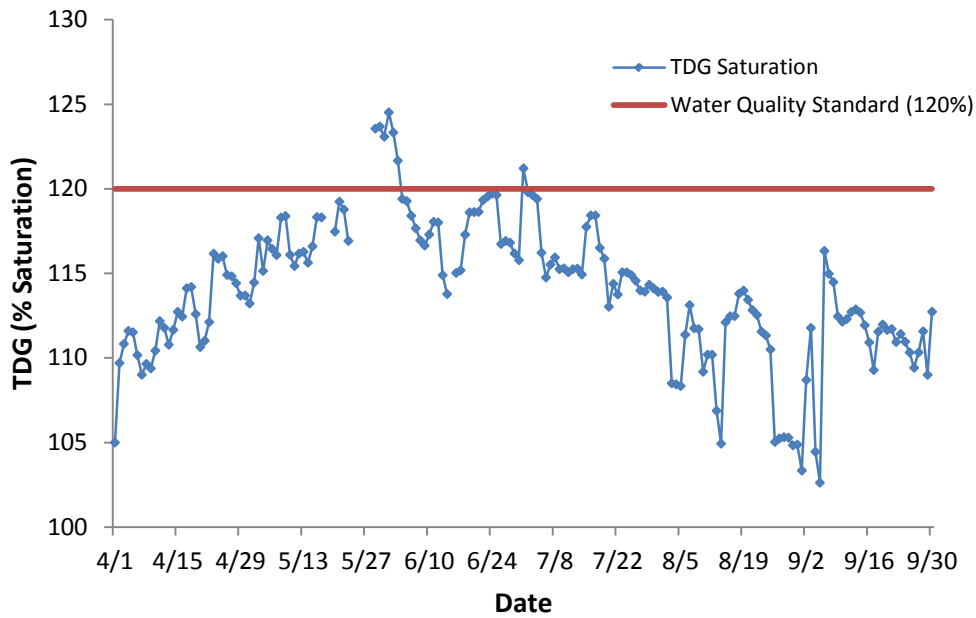
Rock Island Dam Tailrace

Figure 3-4: Total dissolved gas measurements (average of the 12-highest consecutive hourly TDG readings in a 24-hour period) from the 2014 fish-spill season recorded at the Rock Island dam tailrace FMS.

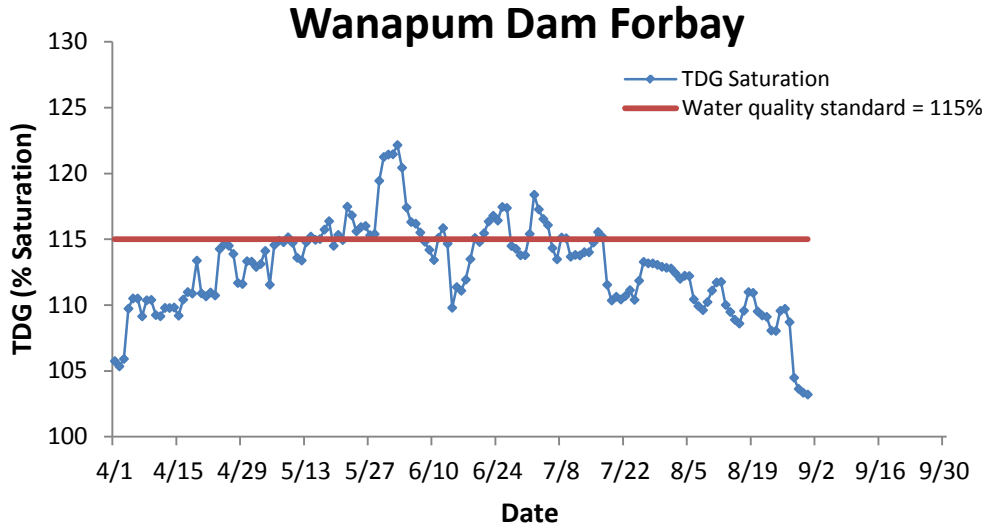
Figure 3-5: Total dissolved gas measurements (average of the 12-highest consecutive hourly TDG readings in a 24-hour period) from the 2014 fish-spill season recorded at the Wanapum dam forebay FMS.

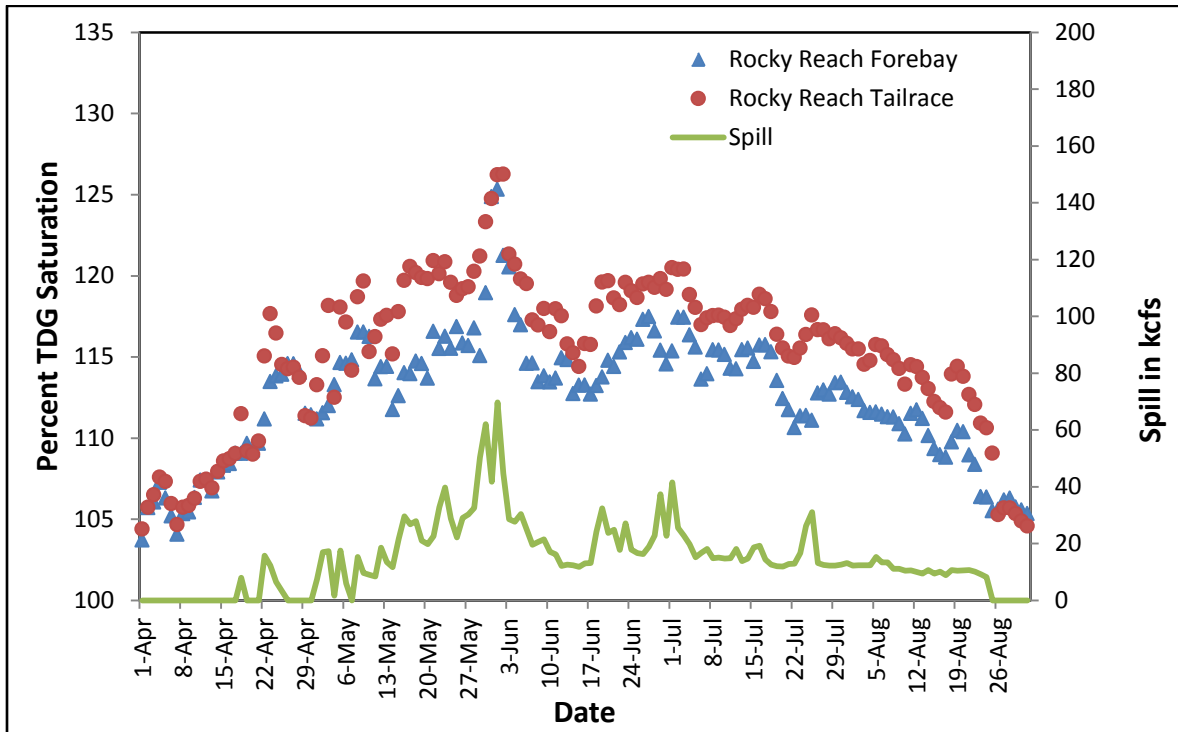
Figure 3-6: Spill and total dissolved gas measurements (average of the 12-highest consecutive hourly TDG readings in a 24-hour period) from the 2014 fish-spill season recorded at the Rocky Reach forebay and tailrace FMS.

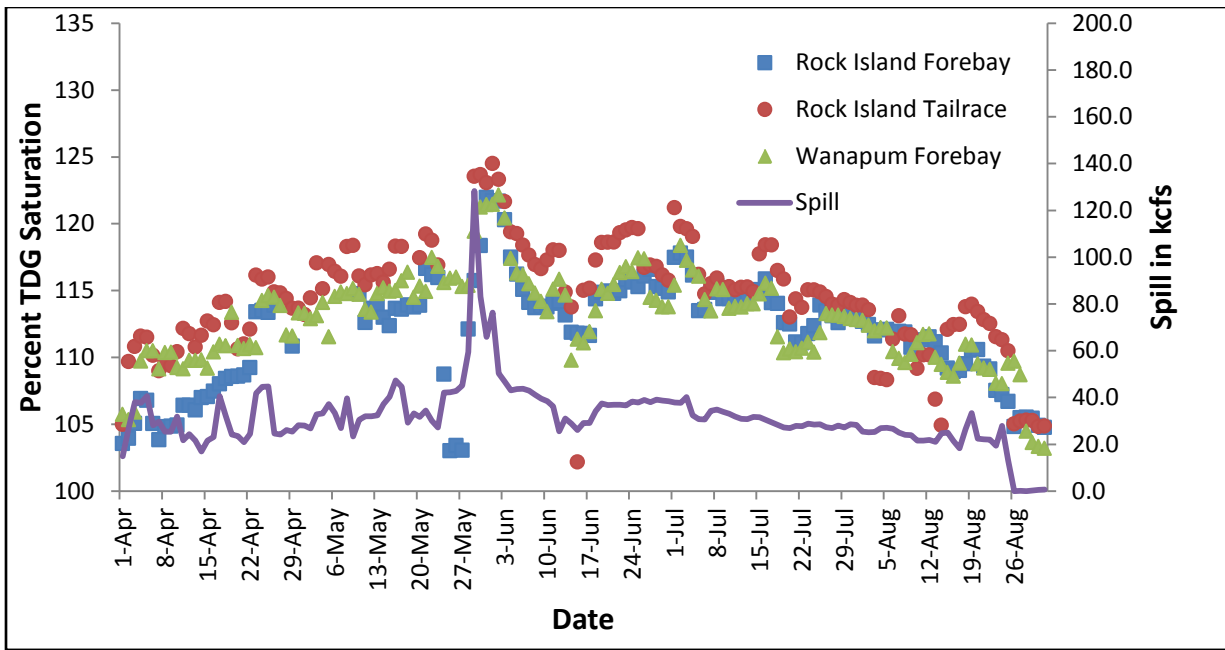
Figure 3-7: Spill and total dissolved gas measurements (average of the 12-highest consecutive hourly TDG readings in a 24-hour period) from the 2014 fish-spill season recorded at the Rocky Island forebay and tailrace and the Wanapum forebay FMS.

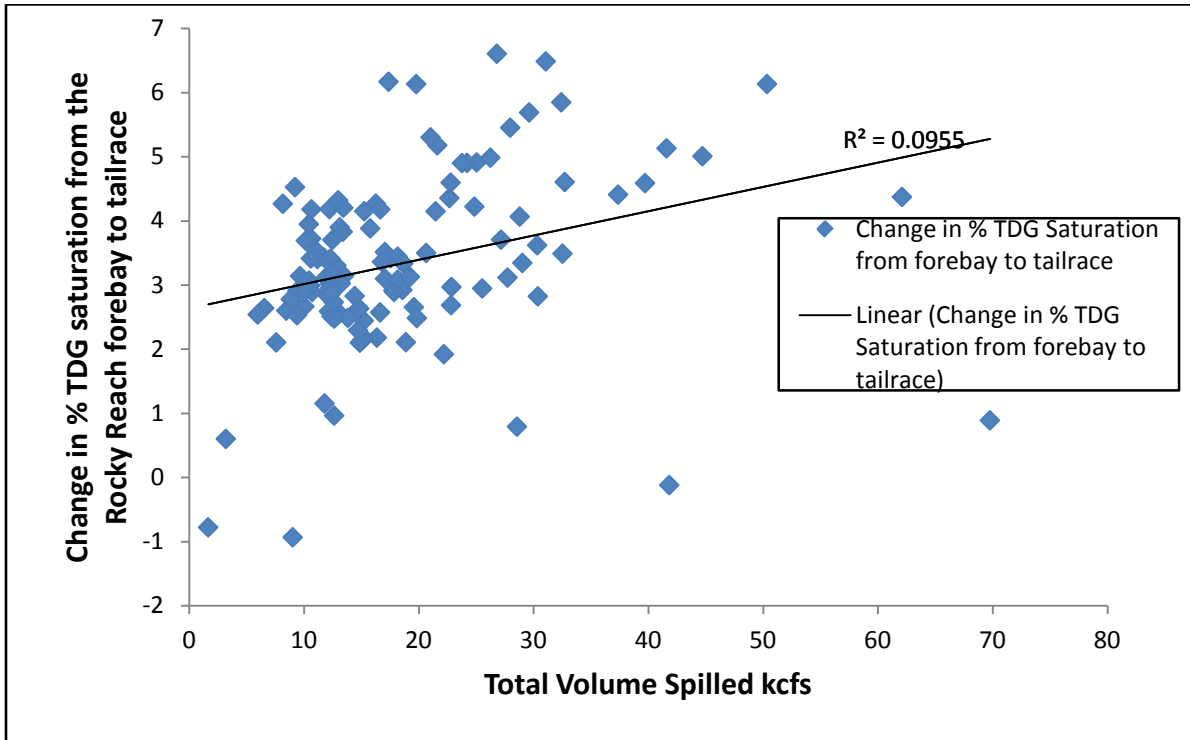
Figure 3-8: Regression analysis showing a moderate relationship between the total volume spilled to percent change in TDG at Rocky Reach forebay to tailrace.

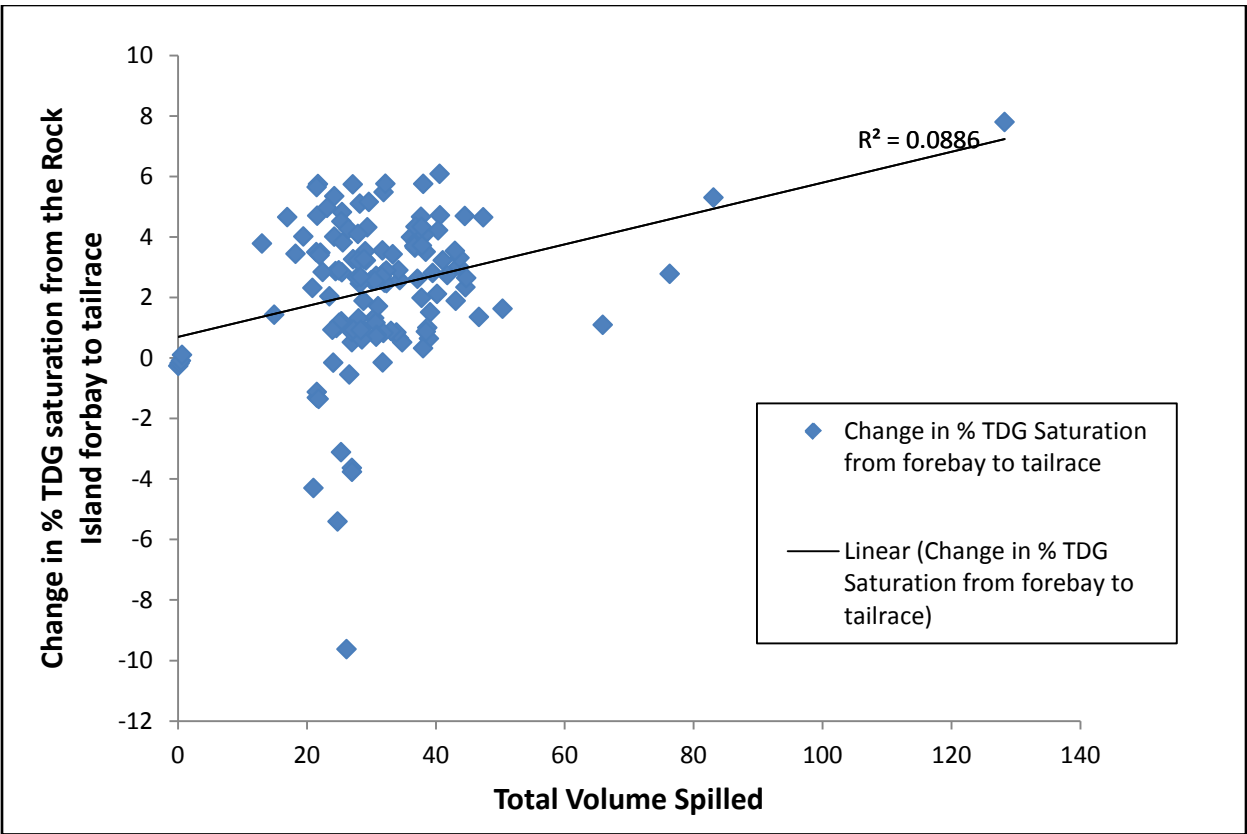
Figure 3-9: Regression analysis showing a moderate relationship between the total volume spilled to percent change in TDG at Rock Island forebay to tailrace.

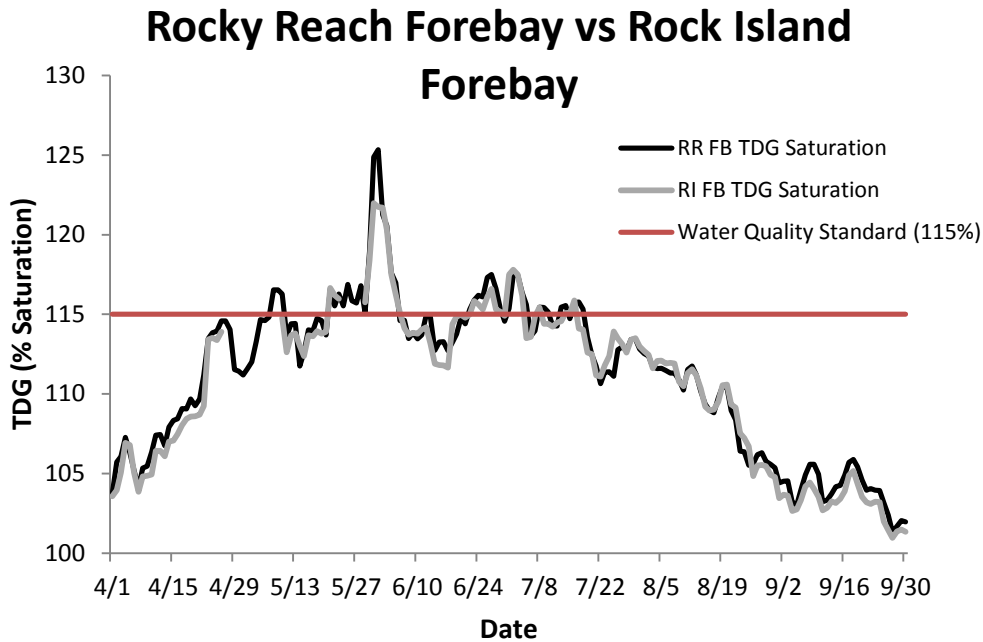
Figure 3-10: Total dissolved gas measurements (average of the 12-highest consecutive hourly TDG readings in a 24-hour period) from the 2014 fish-spill season recorded at the Rocky Reach and Rock Island dam forebays FMS.

Data analysis showed that water coming into the Rocky Reach forebay from upstream exceeded Washington State water quality criteria on 32 days (20.9% of the total number of days observed). TDG exceeded the modified Washington State TDG fish spill water quality criteria on 11 days (7.2% of the total number of days observed) in the Rocky Reach tailrace, 20 days (5.0% of the total number of days observed) in the Rock Island forebay, and 7 days (4.8% of the total numbers of days observed) in the Rock Island tailrace during this monitoring period. Numeric criteria were exceeded on 29 days (15.0% of the total number of days observed) in the Wanapum forebay (Grant County PUD). These exceedances of the water quality criteria did not necessarily result in noncompliance, as many of the forebay exceedances occurred when the upstream dam's forebay exceeded 115%. Spill upstream of each project resulted in occasionally high incoming TDG levels in the Rocky Reach and Rock Island forebays. Figure 3-6 shows the Rocky Reach forebay and the Rock Island forebay total dissolved gas measurements (average of the 12-highest consecutive hourly TDG readings in a 24-hour period) from the 2014 fish-spill season.

When the upstream dam's forebay TDG exceeded 115%, TDG values for that 24-hour period were omitted from the data set used for determination of compliance.
