Re: Chelan River Project Monthly Report

Chelan River Project – Monthly Report Lake Chelan Hydroelectric Project – FERC No. 637 Public Utility District No. 1 of Chelan County

October 15th, 2008

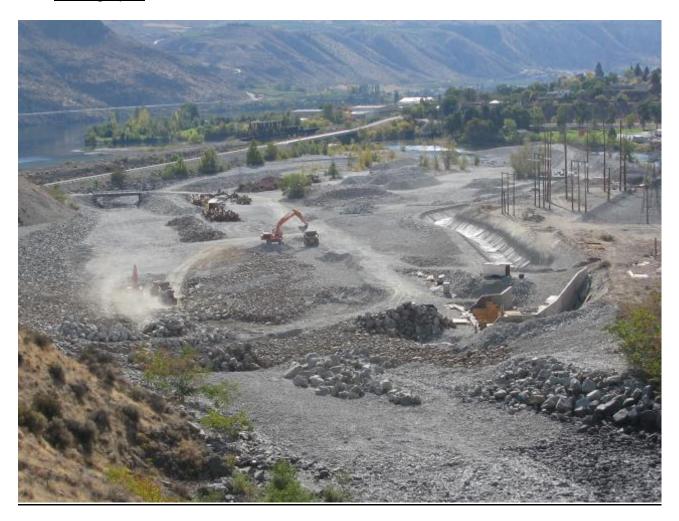
This shows Reach 4 looking south, on October 13th, 2008. The pumped water conveyance canal has been shotcreted. Concrete and forms for the Pumped Water Outlet Structure are visible. Grading in the Hydraulic Control Structure area is seen in the foreground, as well as stockpiling of boulders for the construction.

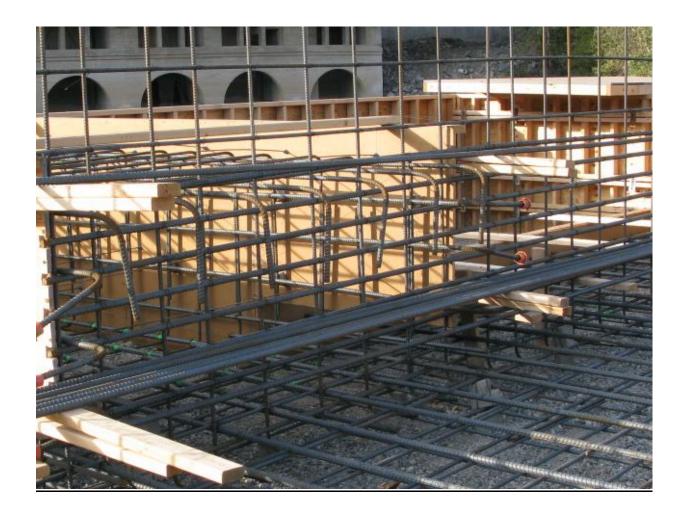
Pump station grade beams under construction. 10/8/08.

Work has begun on the pump station concrete grade beam installation. Forming and rebar placement are underway, with the first concrete placement scheduled in October.

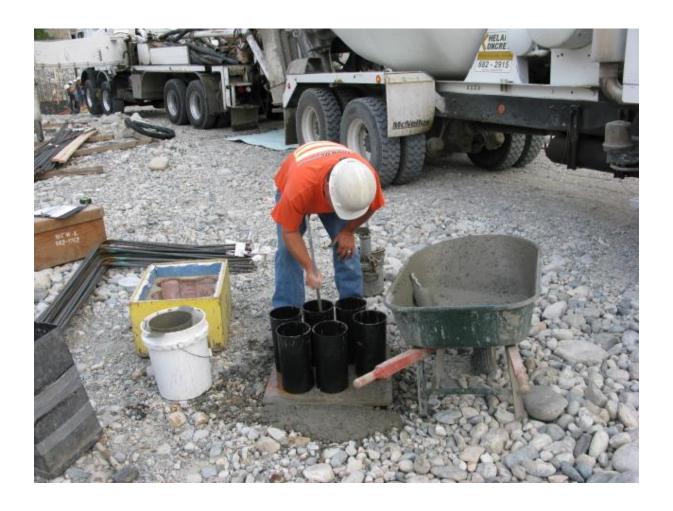
Quality control sampling and testing underway, typical for all concrete placements.

Structural concrete has been placed and tested, and structural embankment material for which density tests are required has been placed. Test results meet the contract specifications. Canal shotcrete lining has been placed, and tested to verify conformance with the contract specifications. No exceptions have been noted.

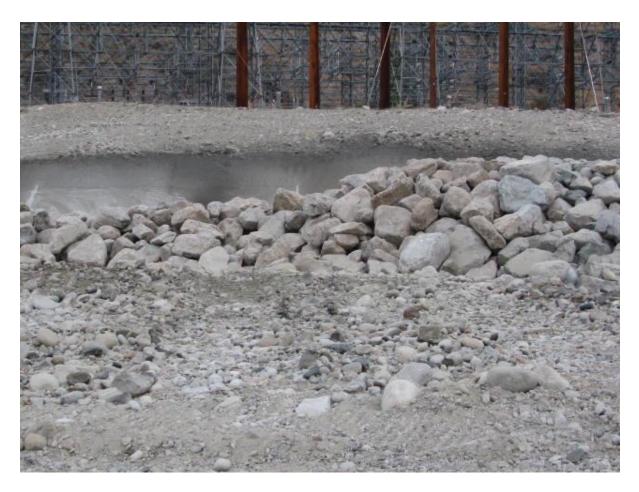
Rip-rap slope stabilization for the east side berm on the conveyance canal. 10/3/08
