Re: Chelan River Project Monthly Report

Chelan River Project – Monthly Report
Lake Chelan Hydroelectric Project – FERC No. 637
Public Utility District No. 1 of Chelan County

January 15th, 2009

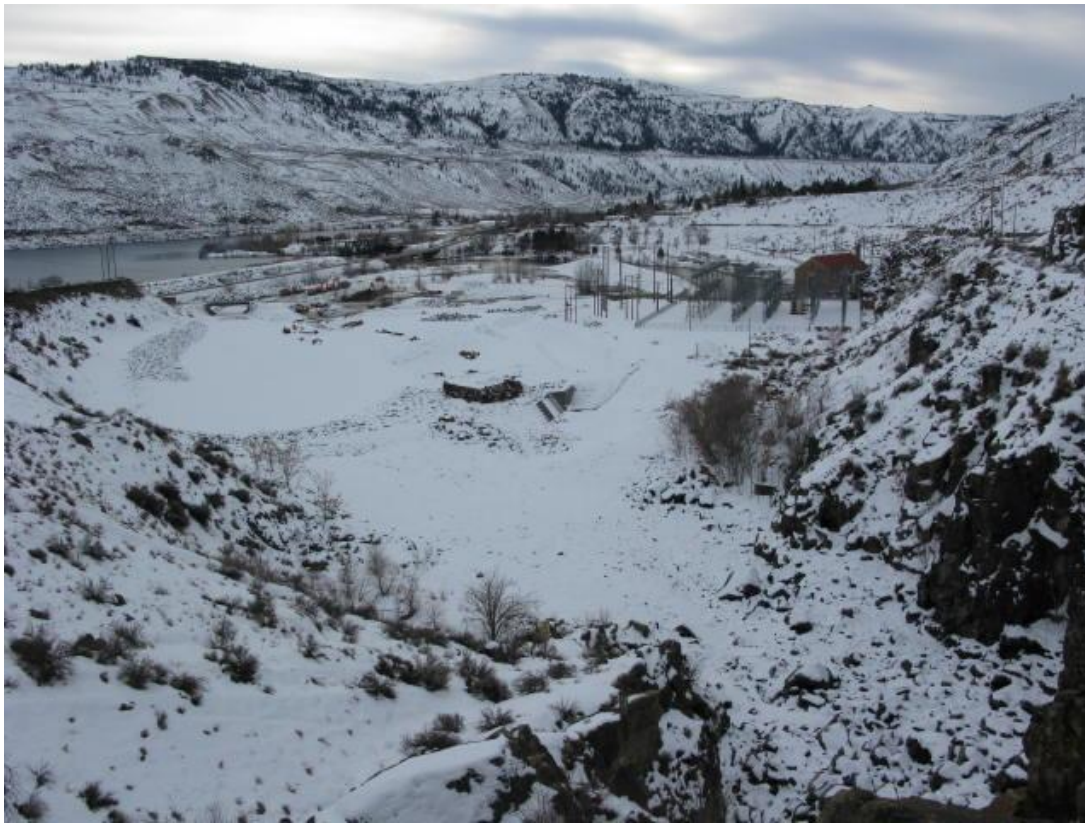
This shows Reach 4 looking south, on January 7th, 2009.
