Re: Chelan River Project Monthly Report

Chelan River Project – Monthly Report
Lake Chelan Hydroelectric Project – FERC No. 637
Public Utility District No. 1 of Chelan County

February 15th, 2009

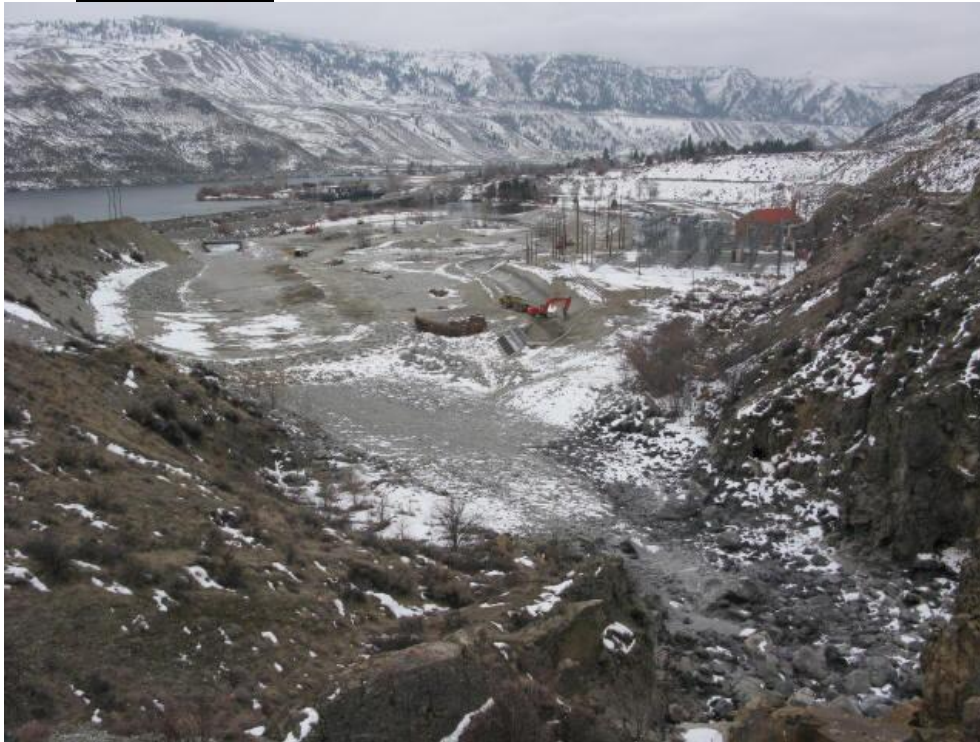
This shows Reach 4 looking south, on February 10th, 2009.

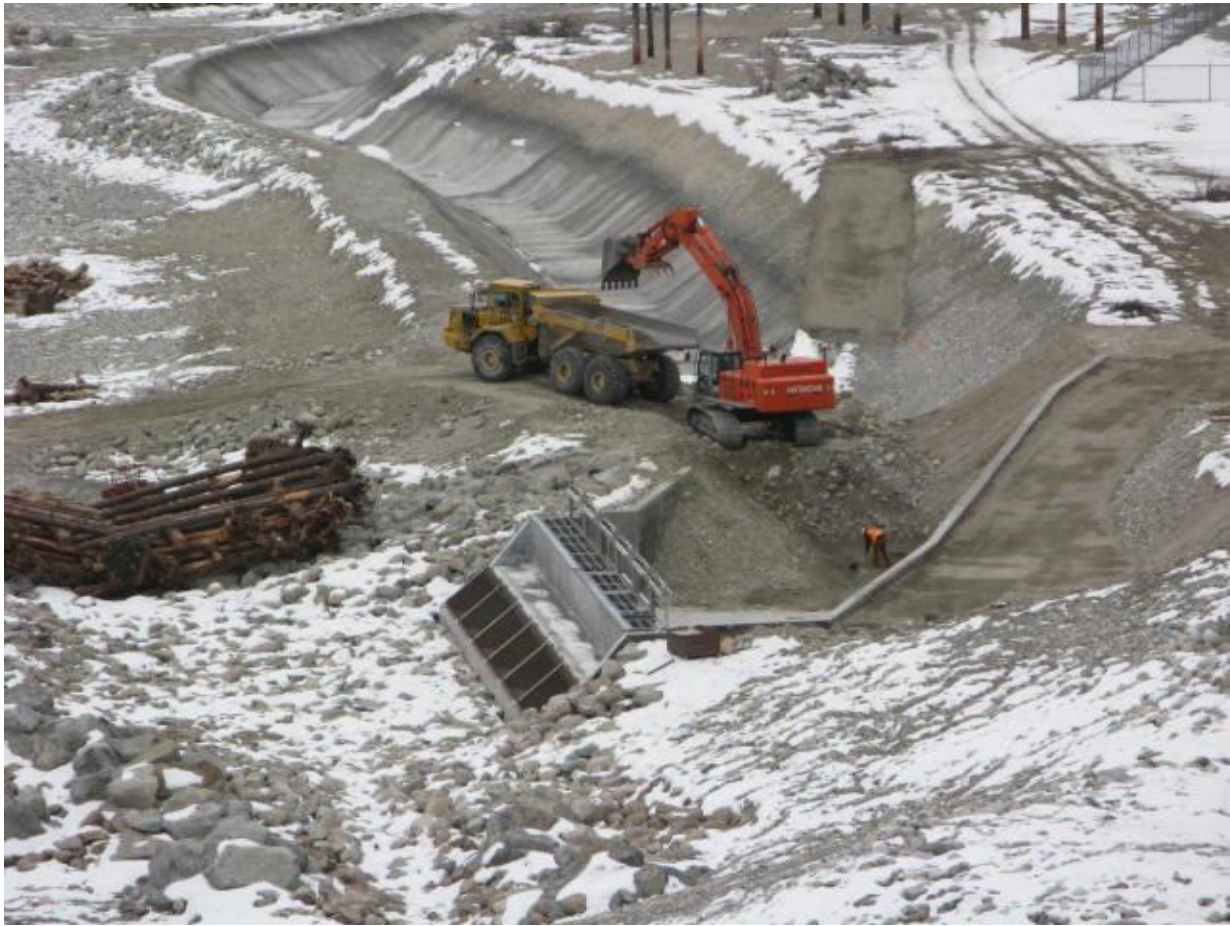
This shows Reach 4 looking south, on February 10th, 2009. Notice that the slide gates have been installed. Also, excavation work is underway towards completing the conveyance canal tie-in to the outlet structure.

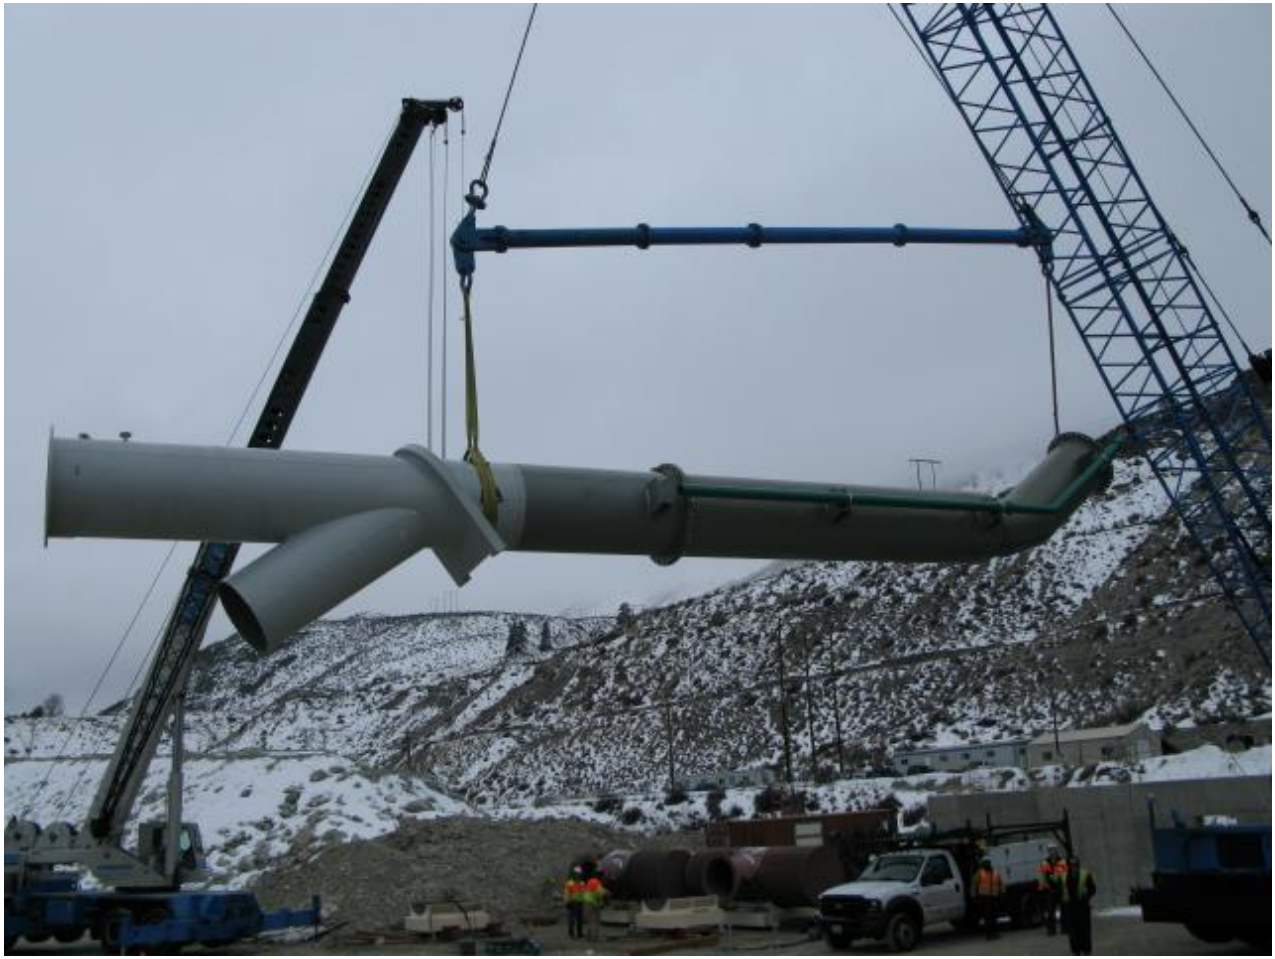
This picture shows the setting of the first pump tube, on 1/21/09. Notice the 6" air burst piping mounted to the side of the pump tube.

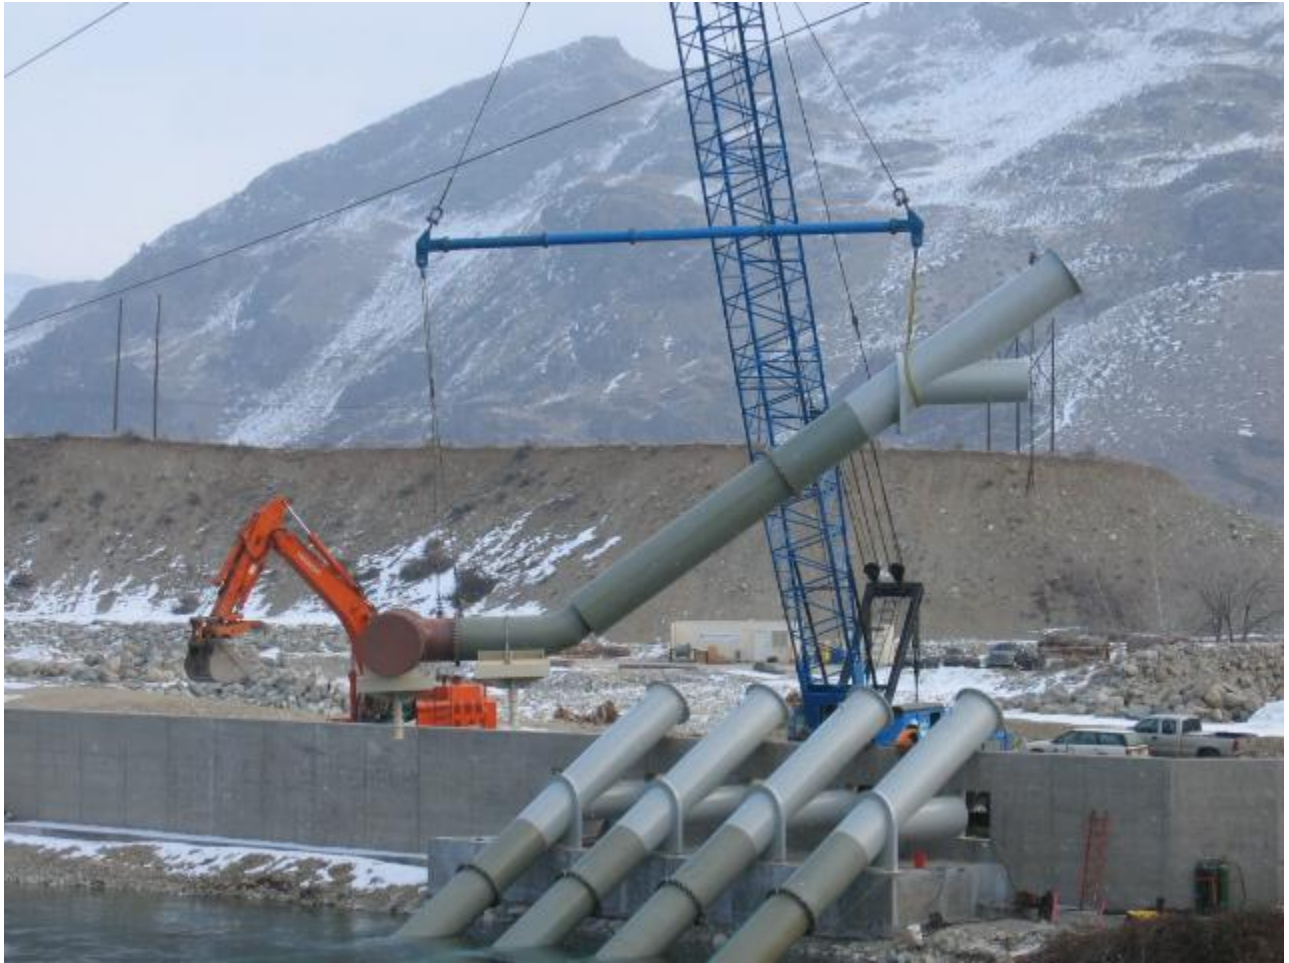
This picture shows the setting of the 5th pump tube, on 1/27/09.

Work continues on the pump station. Footing slab and grade beams are in place, as well as the concrete retaining wall. The five pump tubes were set and their supports grouted into the drilled pier casings.

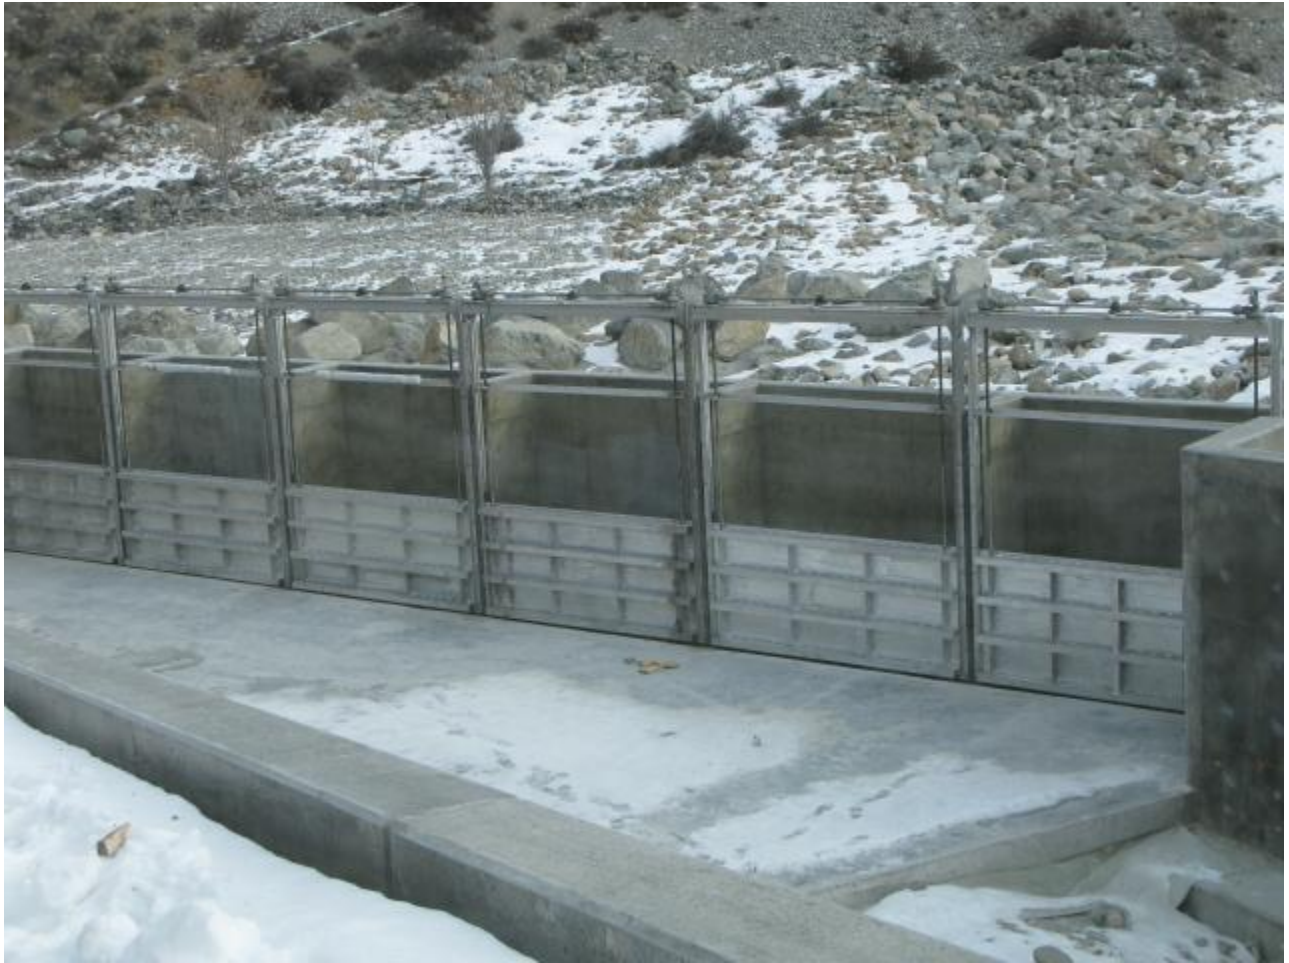
This is a photo of the aluminum slide gates at the Canal Outlet Structure. Picture was taken on 1/29/09. The walkway and gate operators have not yet been installed.

Canal outlet structure concrete construction is complete, on schedule, and slide gates and diffusion gratings are in place. Installation of miscellaneous metals (e.g. walkway grating) is underway.

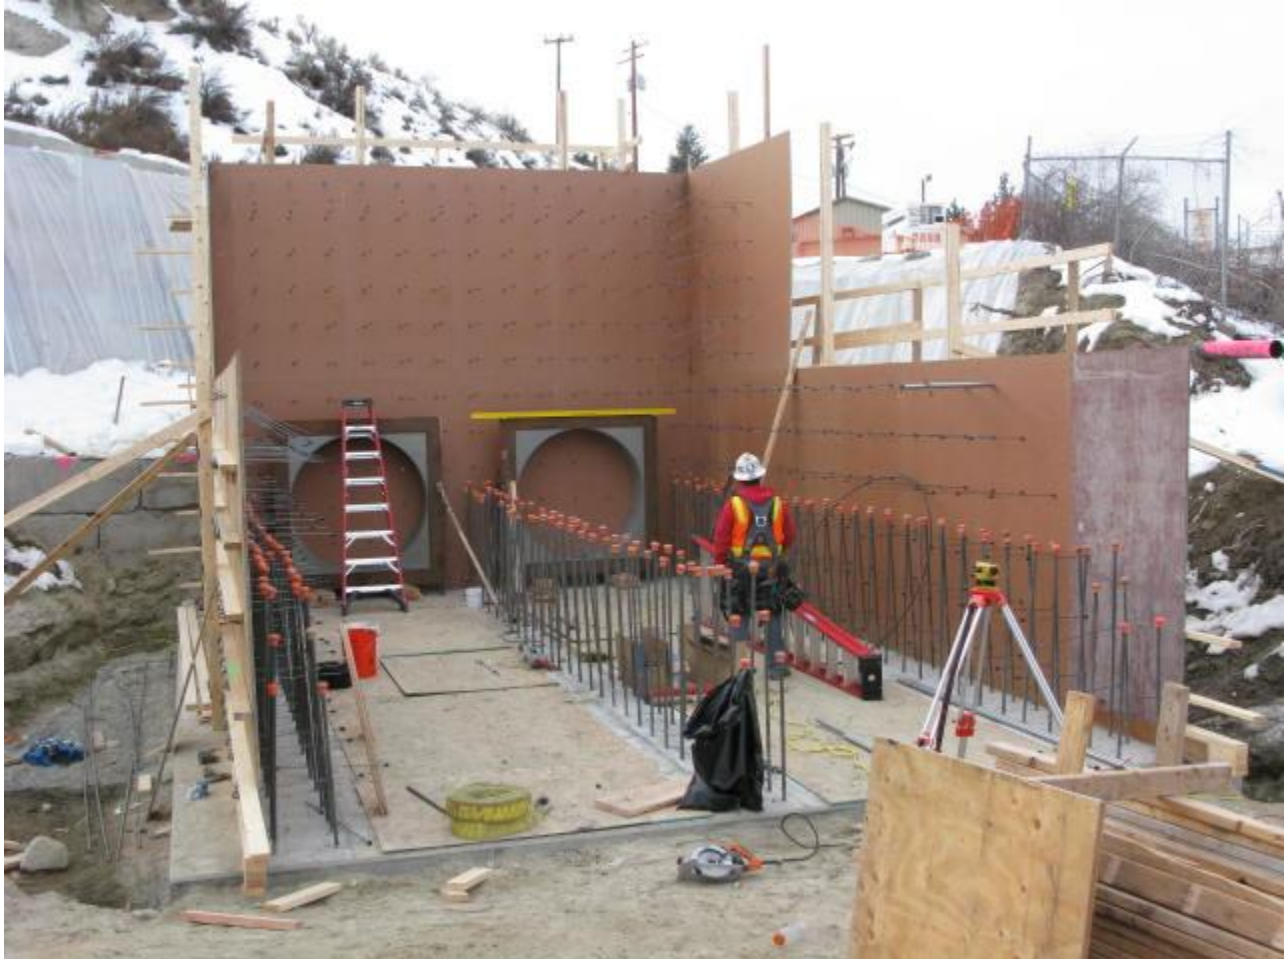
This is a picture of the outlet structure, at Lake Chelan Dam, the site of the Low Level Outlet. Picture was taken on 2/5/09. Notice the mounting thimbles that fit between the gate valves and the sluice gates, in two locations.

Concrete has been placed for the Low Level Outlet's slab and footings. The contractor is currently installing rebar and forms for the walls. Installation of the thimbles between the gate valves and the sluice gates is underway.
