# **LAKE CHELAN ANNUAL FLOW AND WATER TEMPERATURE REPORT 2015**

**LICENSE ARTICLES 405 & 408**

**LAKE CHELAN HYDROELECTRIC PROJECT  
FERC Project No. 637**

**June 15, 2016**

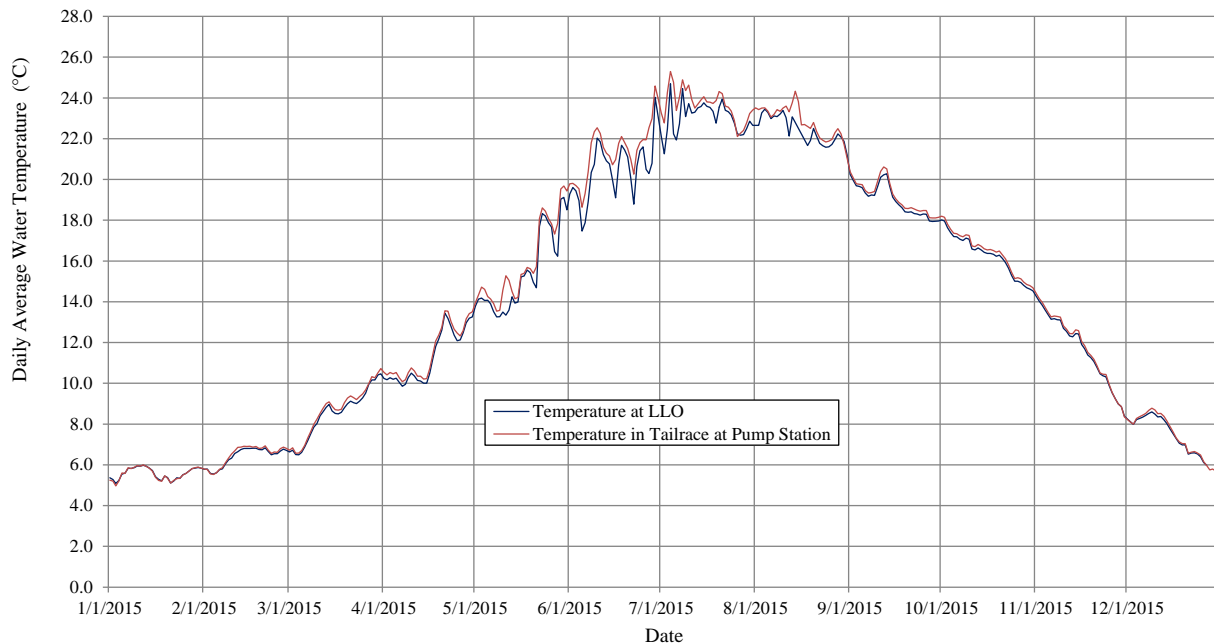
**Figure 4-1. Low Level Outlet and Tailrace Daily Average Water Temperatures.**

Automated water temperature monitoring equipment is installed at two locations, within the pipe that draws water from the base of the Chelan Dam and discharges to the Chelan River through the Low Level Outlet and in the Chelan Powerhouse Tailrace from a sensor mounted on the Pump Station intake screens. These monitoring locations measure water temperatures that reflect the coolest water available for the Chelan River (Low Level Outlet temperature) and the average of water temperatures arriving at the face of Chelan Dam as drawn through the powerhouse intakes (Chelan Powerhouse Tailrace). Water temperatures measured in the tailrace also represent the temperature of water that is being discharged to the Reach 4 Habitat Channel when the Pump Station is in operation.

Water temperatures from these sources (Figure 4-1) generally show little stratification in water temperatures at the face of Chelan Dam. The maximum daily average water temperature measured in the Low Level Outlet pipe was 24.7 °C. Hourly water temperatures peaked at 25.1 °C on July 4. Tailrace maximum daily average temperature was 25.3 °C, while hourly temperatures peaked at 25.8 °C on July 4.
