**ROCKY REACH and ROCK ISLAND  
HYDROELECTRIC PROJECTS  
FERC No. 2145 AND 943**

**2012  
GAS ABATEMENT ANNUAL REPORT**

Waikele Frantz  
Public Utility District No. 1 of Chelan County  
Wenatchee, WA 98801

December 2012

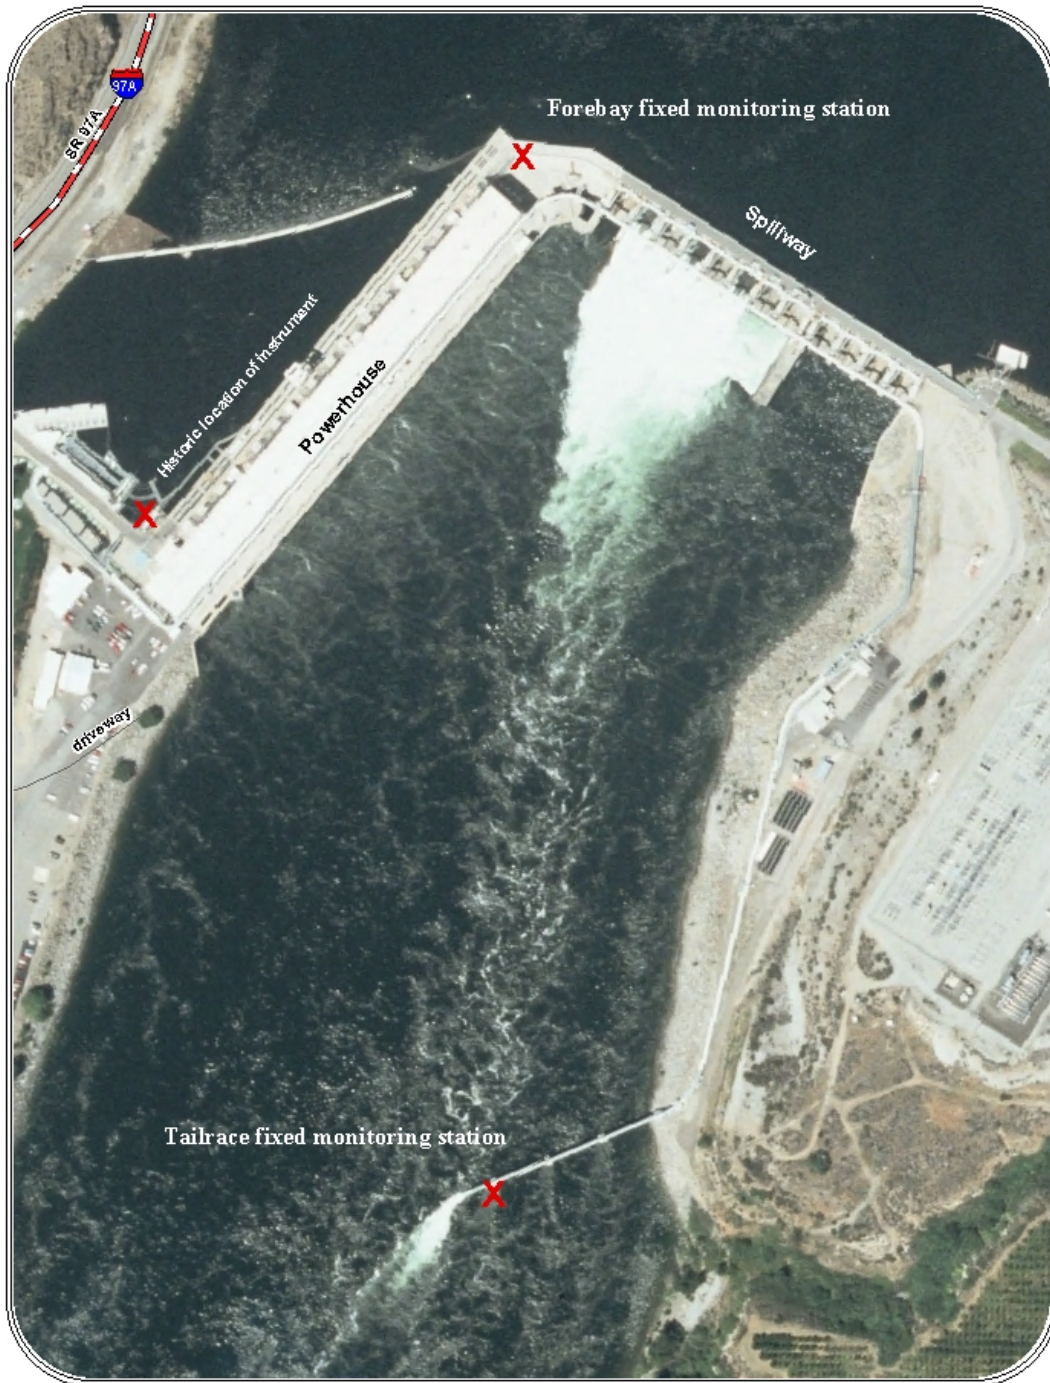
Figure 2. Location of forebay and tailrace fixed monitoring stations at Rocky Reach Project.

The powerhouse at Rocky Reach Project contains a total of 11 vertical axis-generating units and is situated on the west half of the river parallel to the flow (Figure 2). The spillway at Rocky Reach houses 12 individually opening 170-ton tainter gates arranged on the east half of the river, perpendicular to the river flow. The normal maximum reservoir water surface elevation is 707 ft. with an average tailrace water surface elevation of 618 ft., providing a gross head of 89 ft. The depth of the stilling basin immediately downstream of the project is approximately 40 ft. at average tailwater elevation.

Forebay FMS were located at fixed sites on the upstream face of Rocky Reach and Rock Island projects (Figures 2 and 3, respectively). A dissolved gas probe (Minisonde) developed by Hydrolab, Inc. was lowered down a conduit secured to the upstream face of each project and submerged to a depth of approximately 15 ft.

Tailrace monitoring stations were located downstream of both projects. The Rocky Reach monitoring station was located approximately one third of a mile downstream of the spillway on the juvenile fish bypass outfall (Figure 2), as required by the 401 Water Quality Certification (Ecology, April 4, 2006). This location was chosen because it was the most feasible location near the end of the aerated zone, which is the compliance point for the Mid-Columbia TDG TMDL. There is not a bridge or other structure downriver of Rock Island Project to which a monitoring station can be attached. For this reason, Chelan PUD developed a monitoring station about 1.5 miles downriver from the project on the eastern shoreline (Figure 4). Representativeness of the site is summarized in the Total Maximum Daily Load for Total Dissolved Gas in the Mid-Columbia River and Lake Roosevelt Submittal Report (2004):

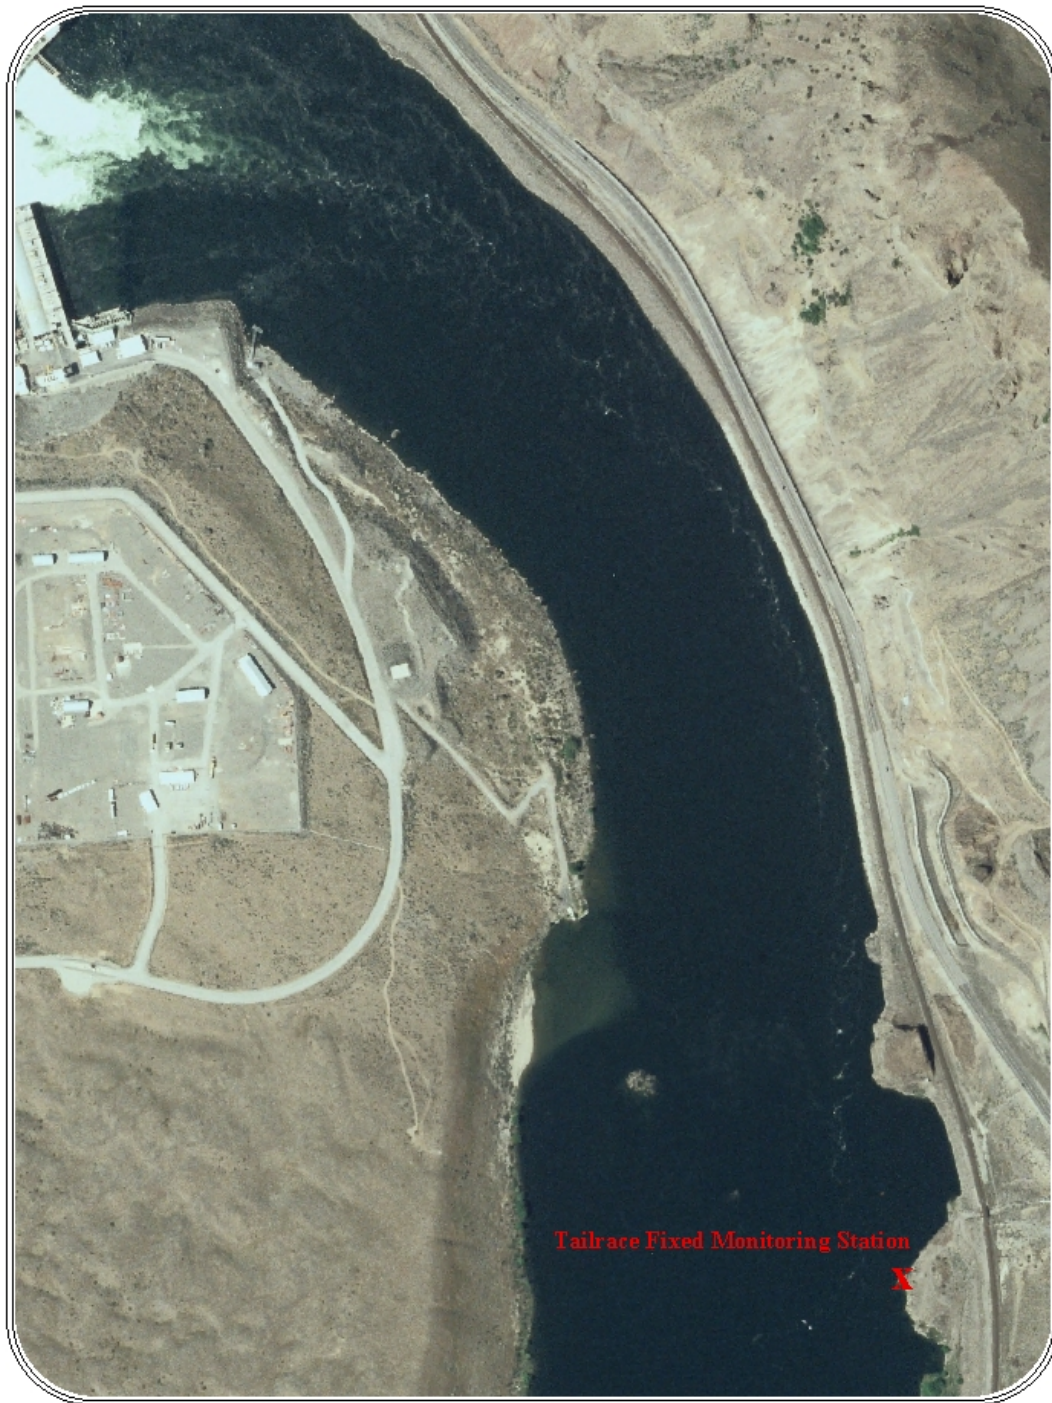
Figure 4. Location of tailrace fixed monitoring station below Rock Island Project.

Either a Hydrolab Minisonde or Datasonde4 was deployed at each tailrace station. The units were submerged approximately 15 ft. below the surface using a 3/8-inch weighted wire cable.
