Subject: Rocky Reach Hydroelectric Project, FERC No. 2145
Article 401 and Appendix A, Sections 5.6(1), 5.7(1) and 5.7(2) –
Annual Quality Assurance Project Report and QAPP Update

ROCKY REACH ANNUAL WATER ASSURANCE PROJECT REPORT AND QAPP UPDATE, 2014

**ROCKY REACH HYDROELECTRIC PROJECT
FERC Project No. 2145**

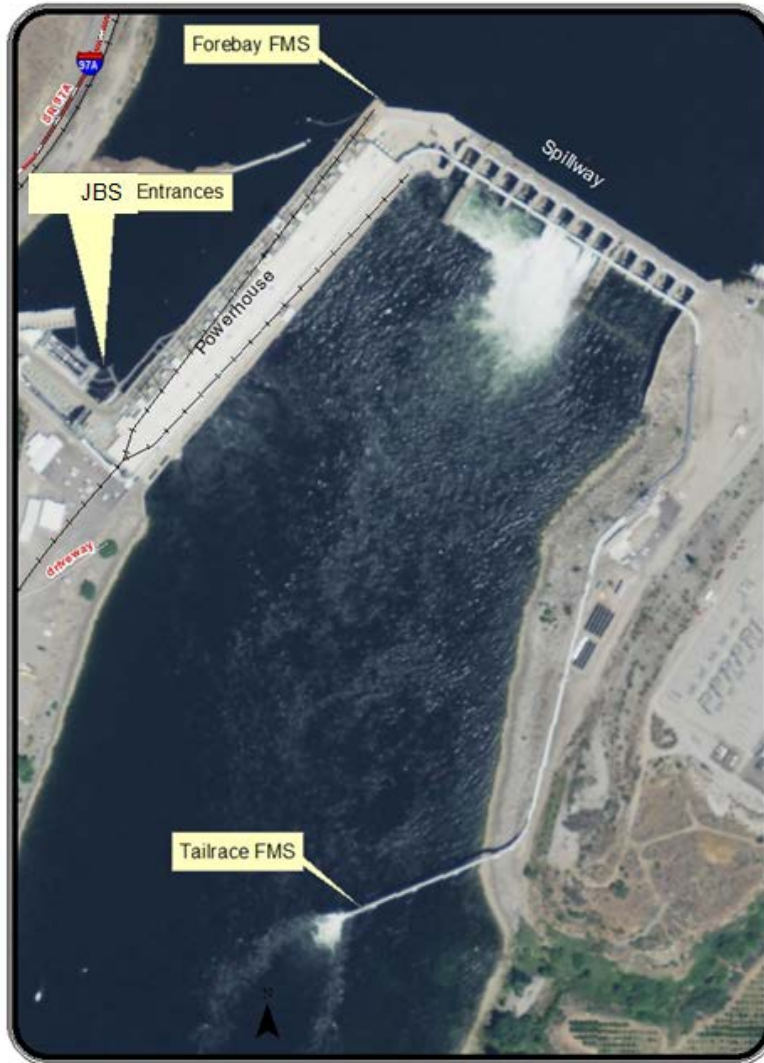
Figure 2-1: Location of the forebay and tailrace FMSs, and the JBS entrances.

The forebay fixed monitoring station (FMS) is located on the upstream side of the dam (Figure 2-1), the standpipe affixed to the corner between the powerhouse and spillway, approximately mid-channel. Consistent with the 401 Certification (Ecology, 2006), the tailrace fixed monitoring station is located approximately 0.38 miles downstream of the dam (Figure 2-2). The standpipe is affixed to the downstream side of a pier nose supporting the juvenile bypass system outfall pipe. This location is east of mid-channel, and is minimally impacted by powerhouse flows when the project is passing water over the spillway (Schneider and Wilhelms, 2005). This location was chosen because it was the most feasible location near the end of the aerated zone, which is the compliance point for the Mid-Columbia TDG Total Maximum Daily Load (TMDL).

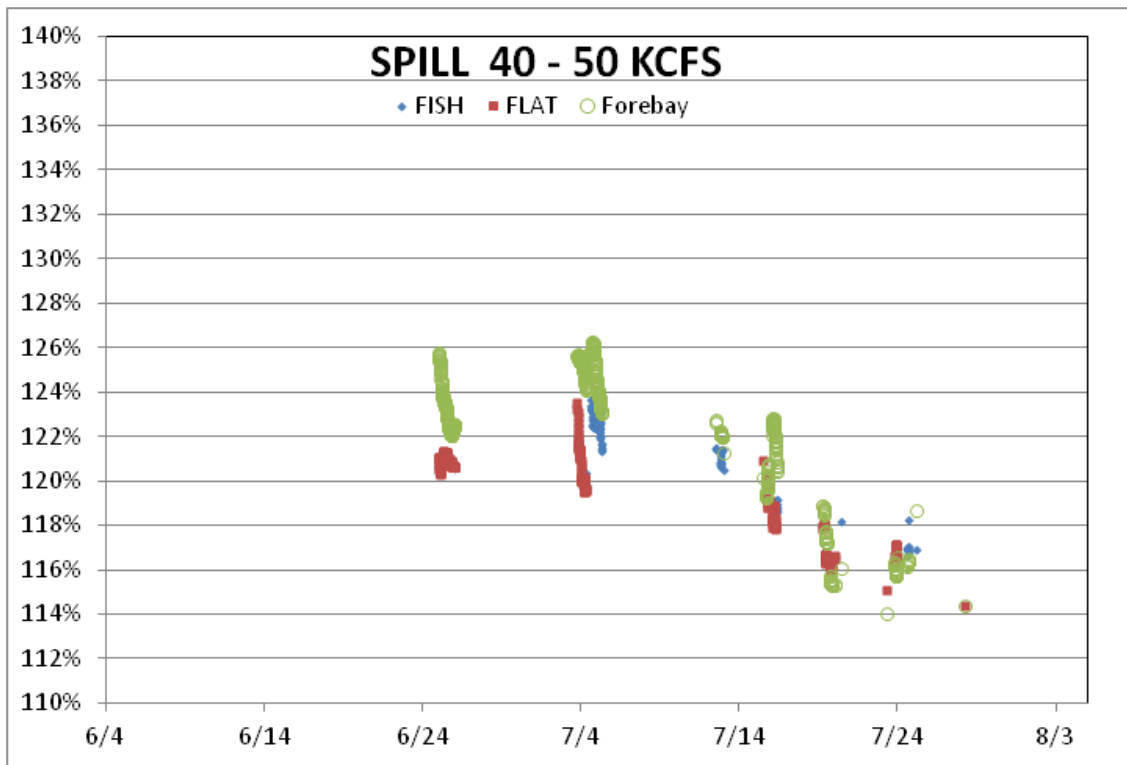
Figure 3-1: TDG levels at the Rocky Reach tailrace monitoring station for spillway flows from 40- 50 kcfs.

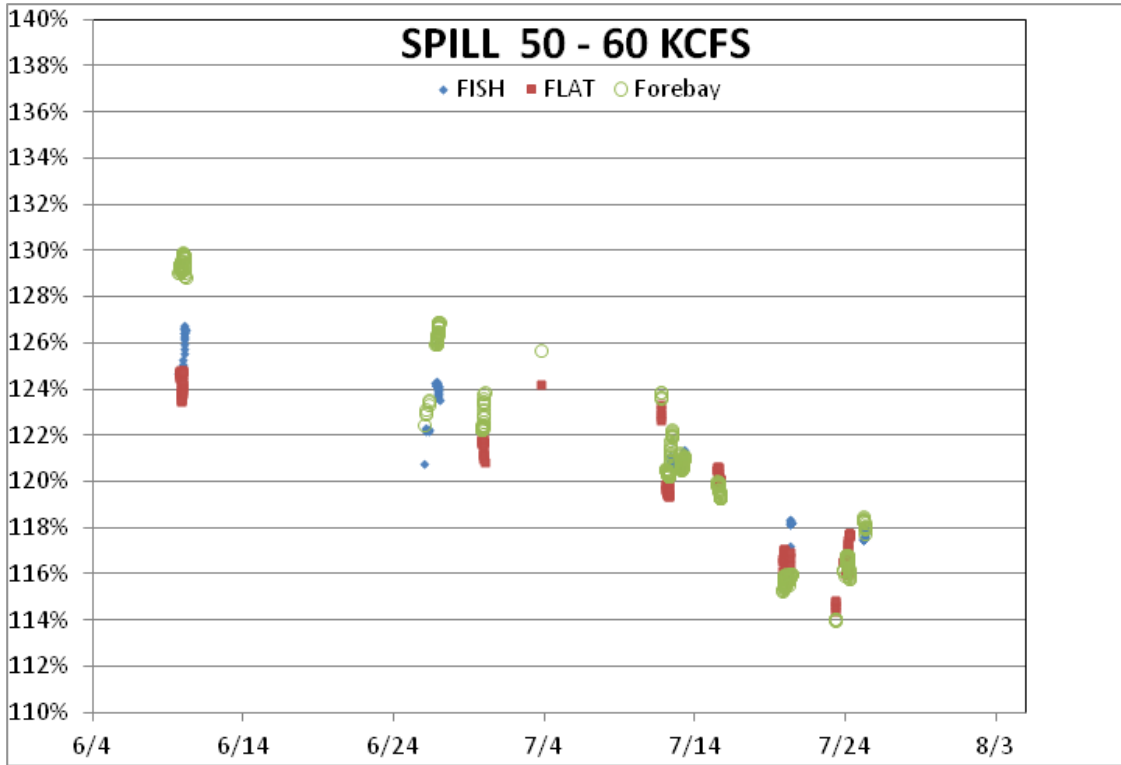
Figure 3-2: TDG levels at the Rocky Reach tailrace monitoring station for spillway flows from 50- 60 kcfs.

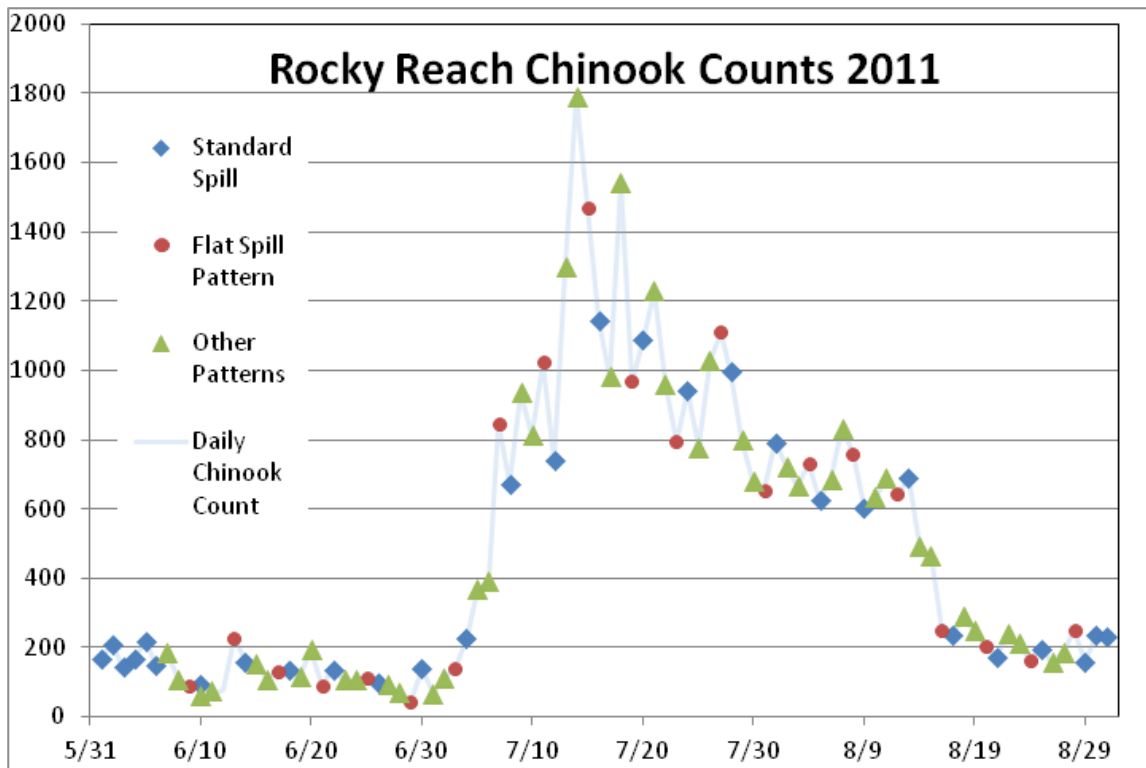
Figure 3-3: Daily passage counts of Chinook salmon at Rocky Reach, with spill pattern in effect that day.

The use of different spill patterns did not appear to have any adverse effect on adult salmon passage at the Rocky Reach Project. The two species of salmon with peak migrations during the study were Chinook salmon and sockeye salmon. Plots of daily passage counts for these two species did not demonstrate any apparent delays or failures to find the fishway entrances. The daily passage counts of Chinook and sockeye salmon, with the spill pattern in effect each day, are shown in Figures 3-3 and Figure 3-4. Further study of the flat spill pattern, particularly for spill flows less than 50kcfs where the standard pattern creates a well defined V-shaped pattern, would be needed to evaluate whether adult salmon passage is adversely affected by use of the flat spill pattern.

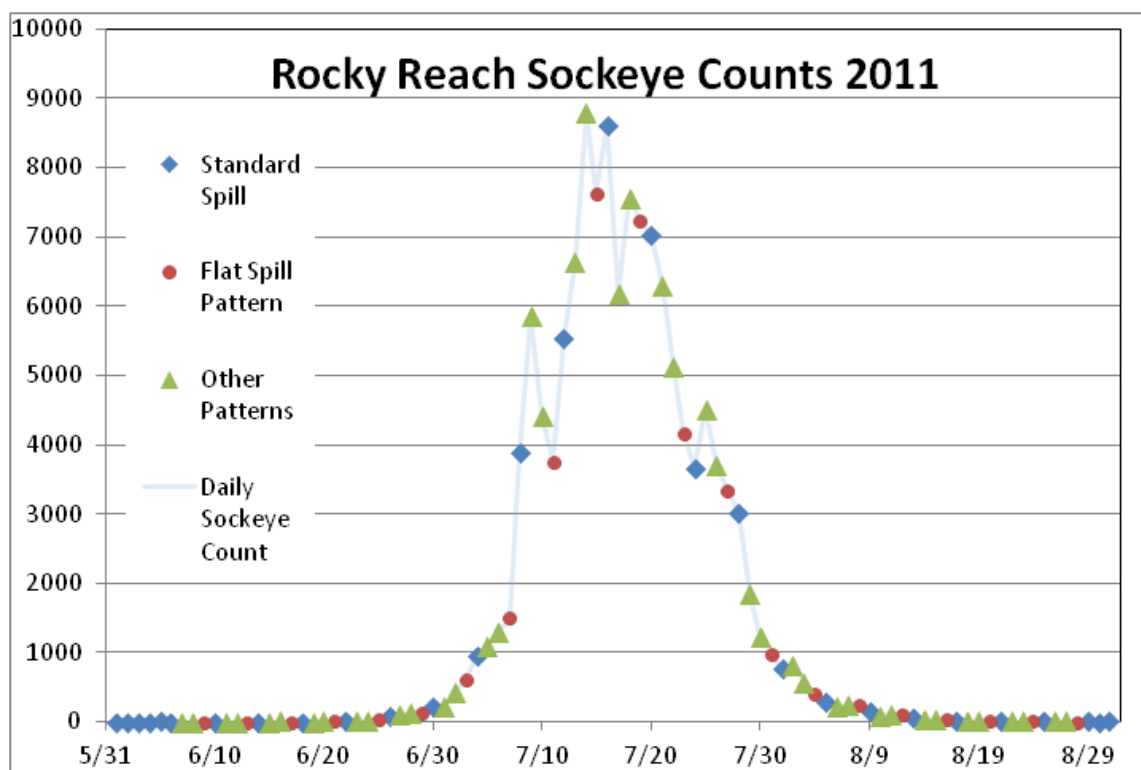
Figure 3-4: Daily passage counts of sockeye salmon at Rocky Reach, with spill pattern in effect that day.

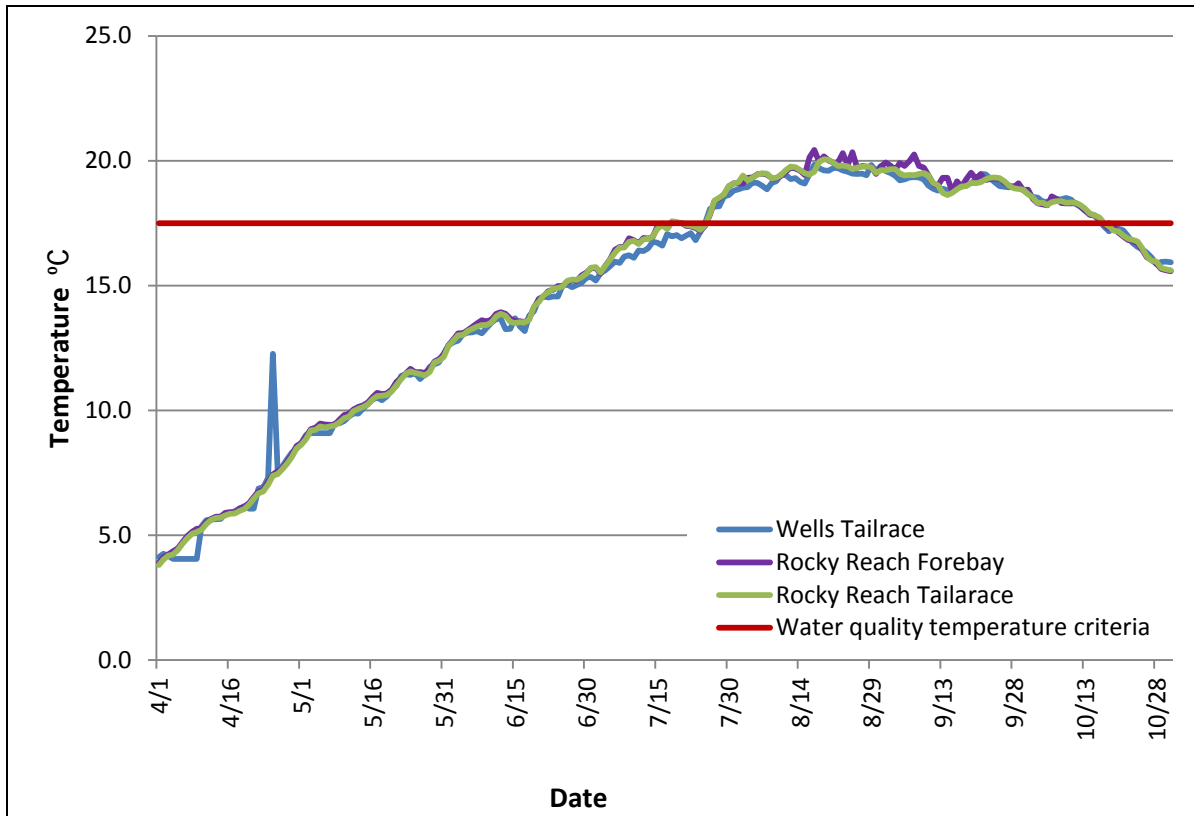
Figure 3-5: Daily maximum water temperature values recorded at each site in 2014.

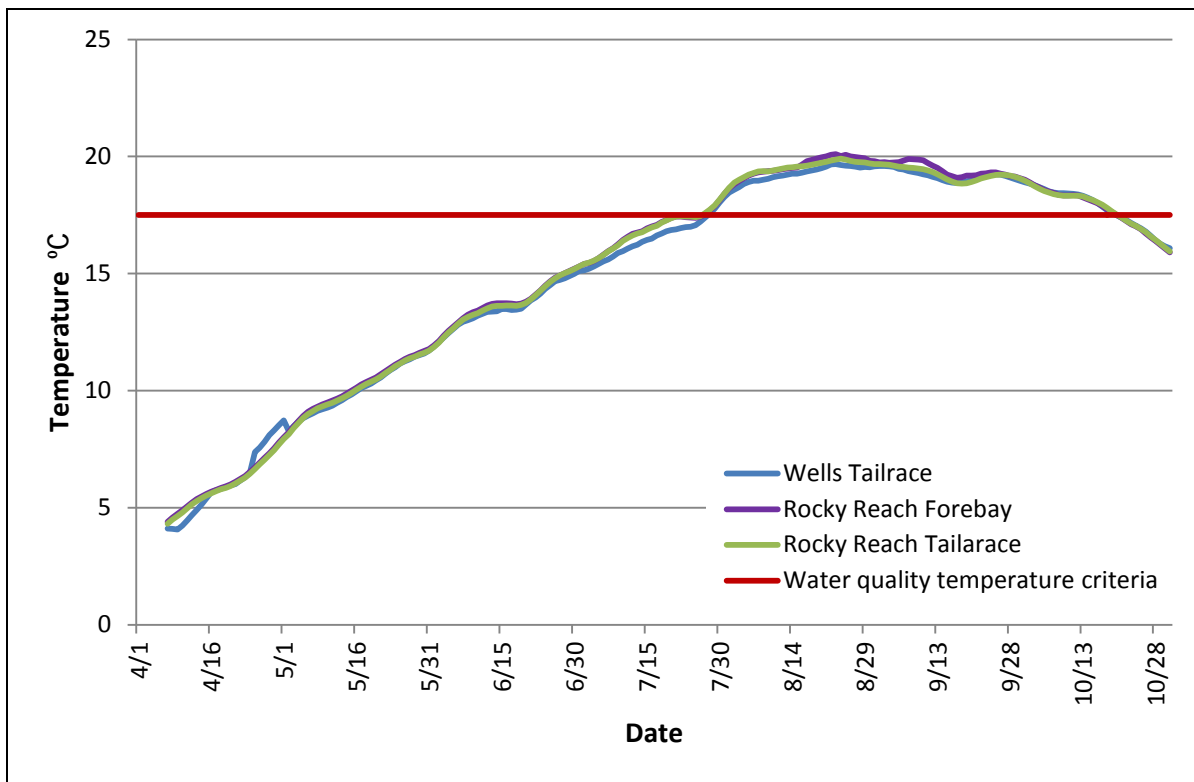
Figure 3-6: Seven day rolling average of daily maximum temperature values recorded at each site in 2014.

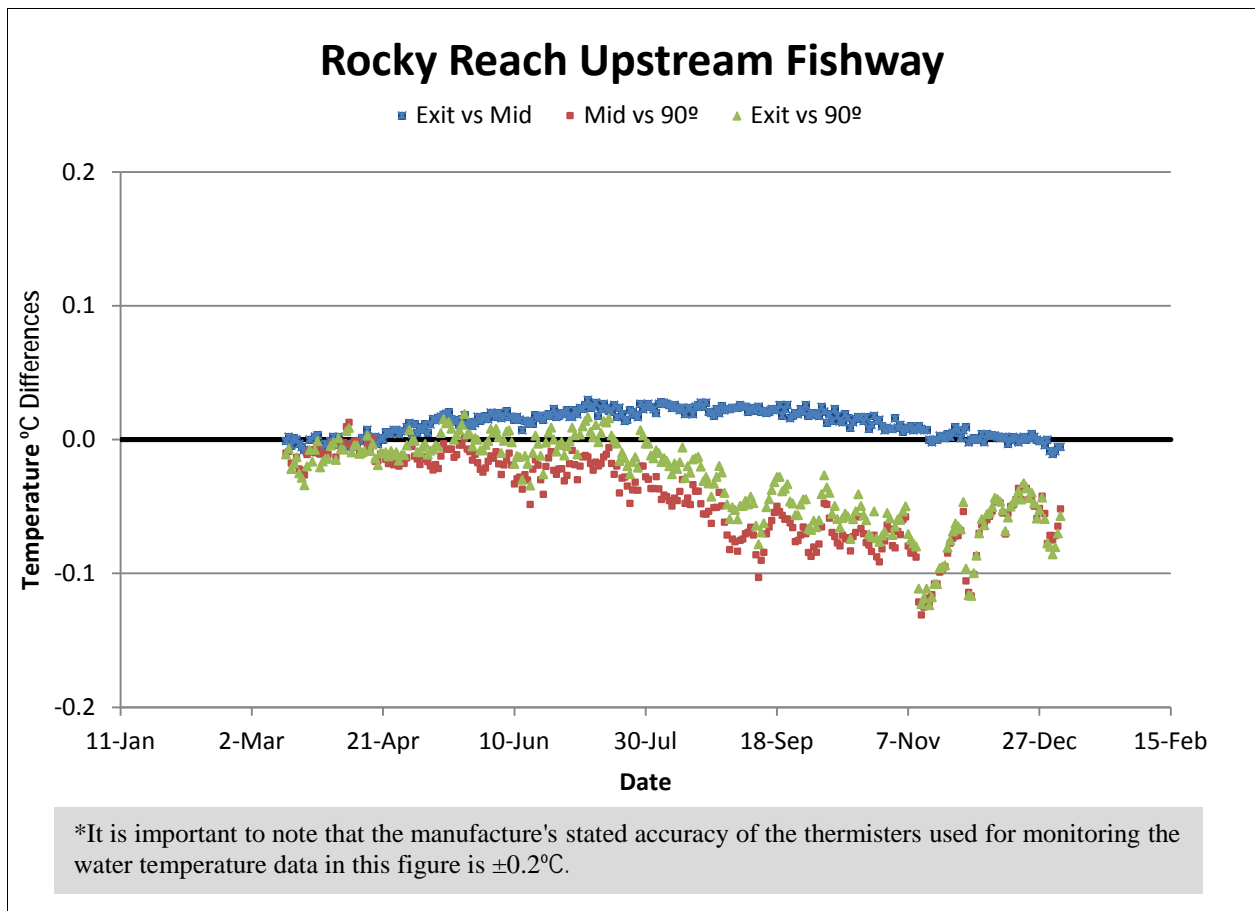
Figure 3-7: Comparison of daily average water temperature °C differences within the Upstream Fishway at three sample location (Exit, Mid, 90°) at Rocky Reach Dam
