Re: Chelan River Project Monthly Report

Chelan River Project – Monthly Report
Lake Chelan Hydroelectric Project – FERC No. 637
Public Utility District No. 1 of Chelan County

March 15th, 2009

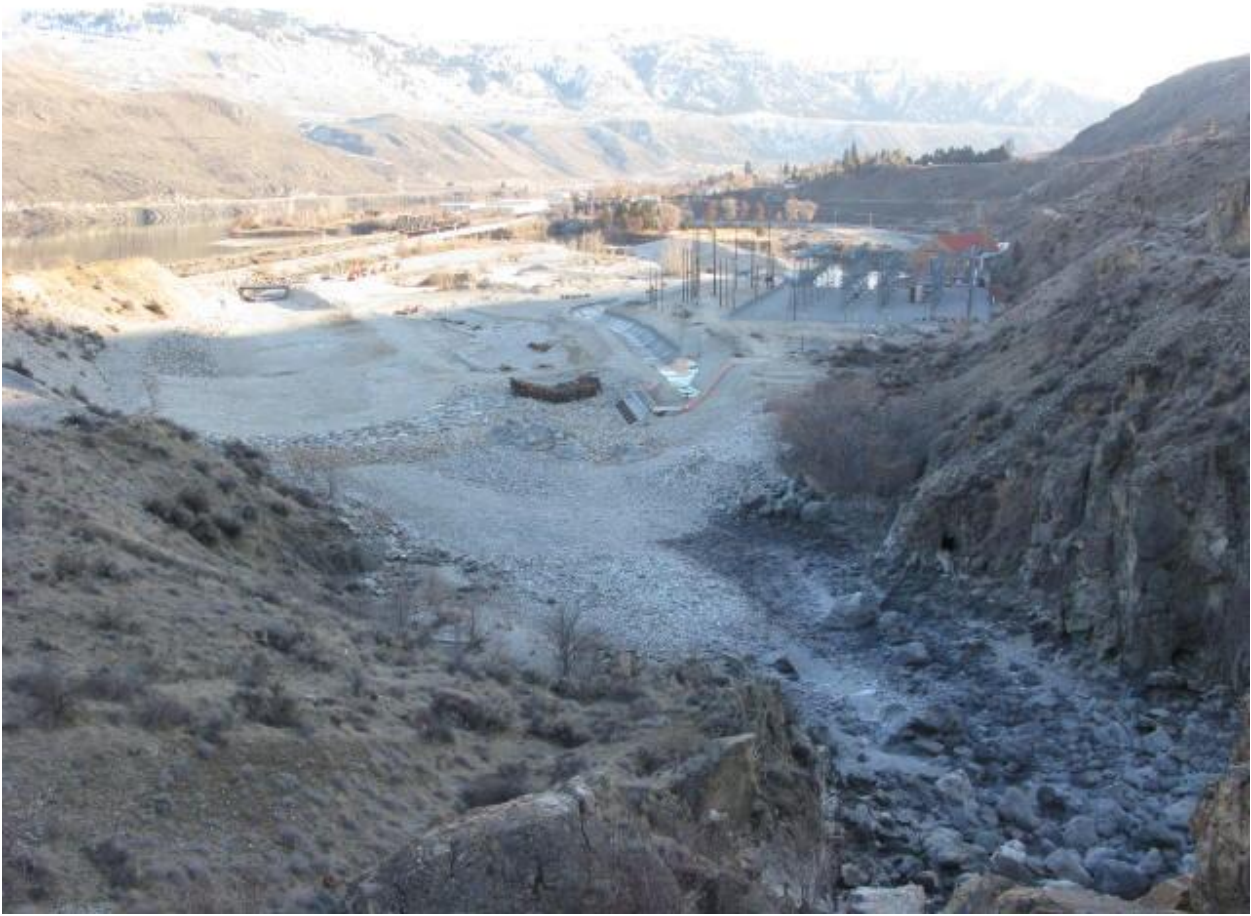
This shows Reach 4 looking south, on March 11th, 2009. The only noticeable item of change is the conveyance canal connection to the outlet structure. Notice that the canal liner is in place, but has not yet had shotcrete applied.

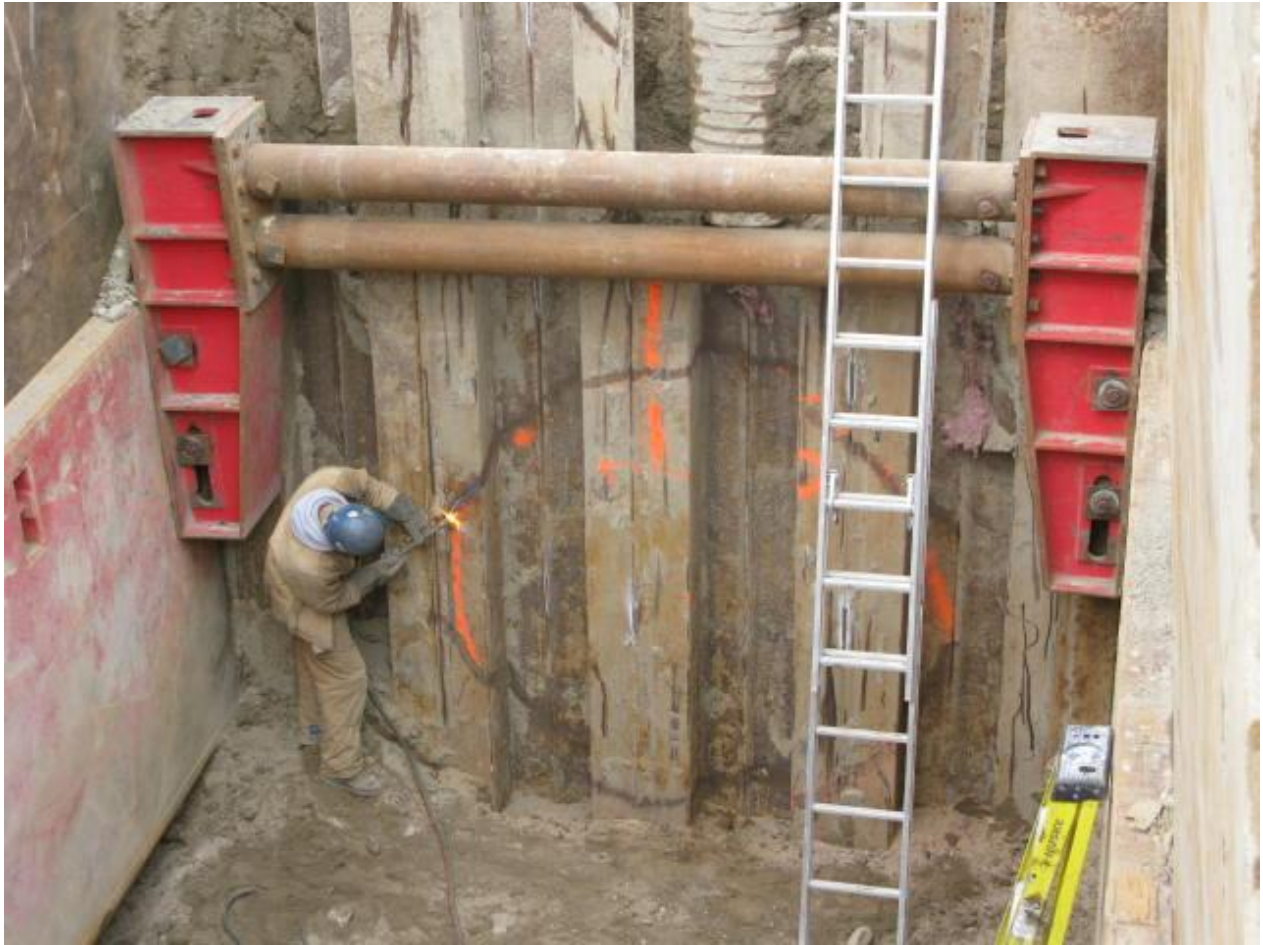
This is a picture from 3/9/09, of the sheet pile wall, with the dry tunnel and bulkhead for the 17-foot diameter penstock behind. The hole being cut is for the eventual LLO pipe installation.

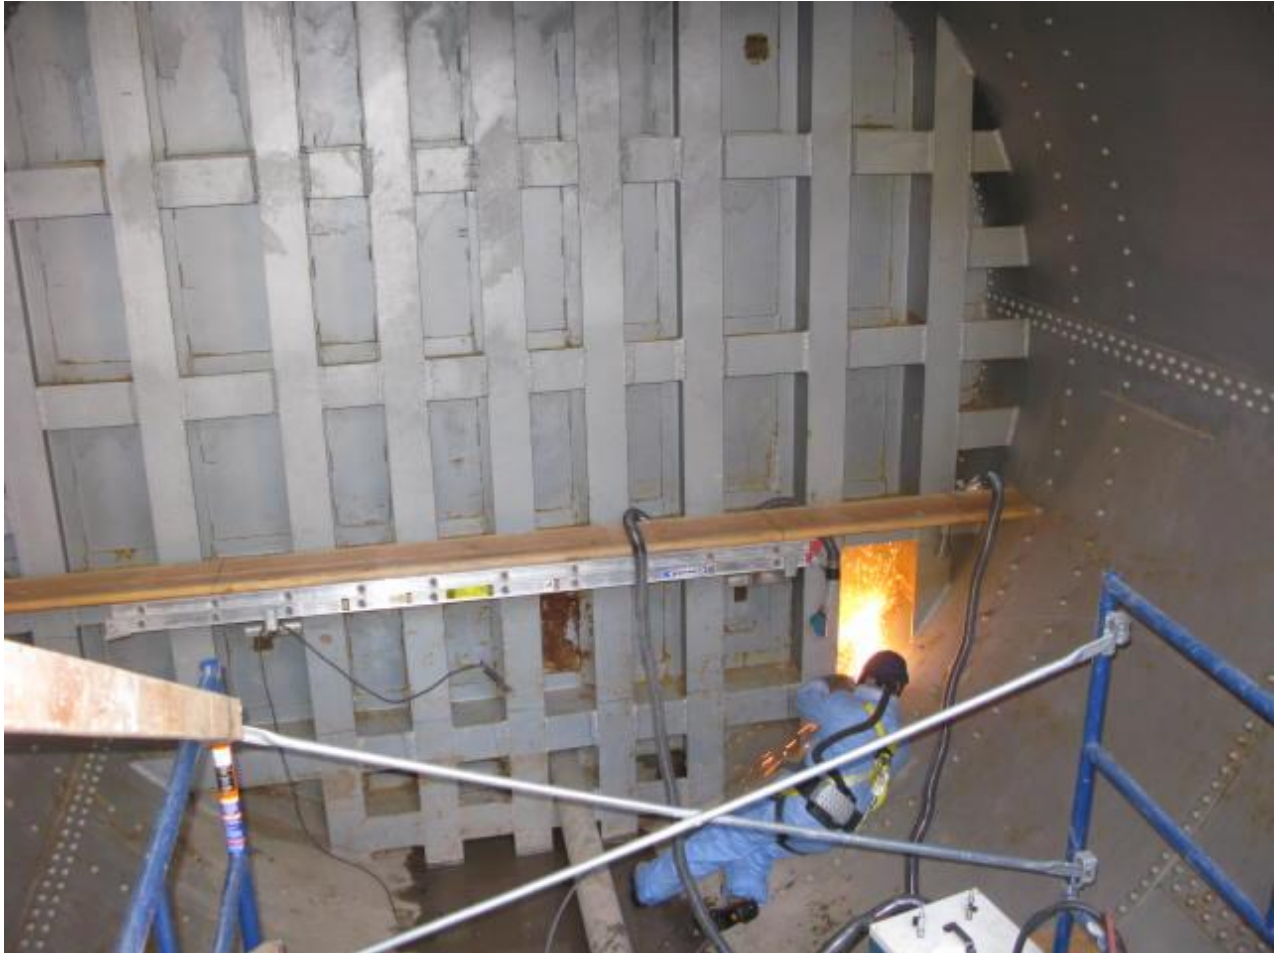
This picture was taken on 3/10/09. After the sheet pile wall was cut open, work removing the beams from the bulkhead steel began.

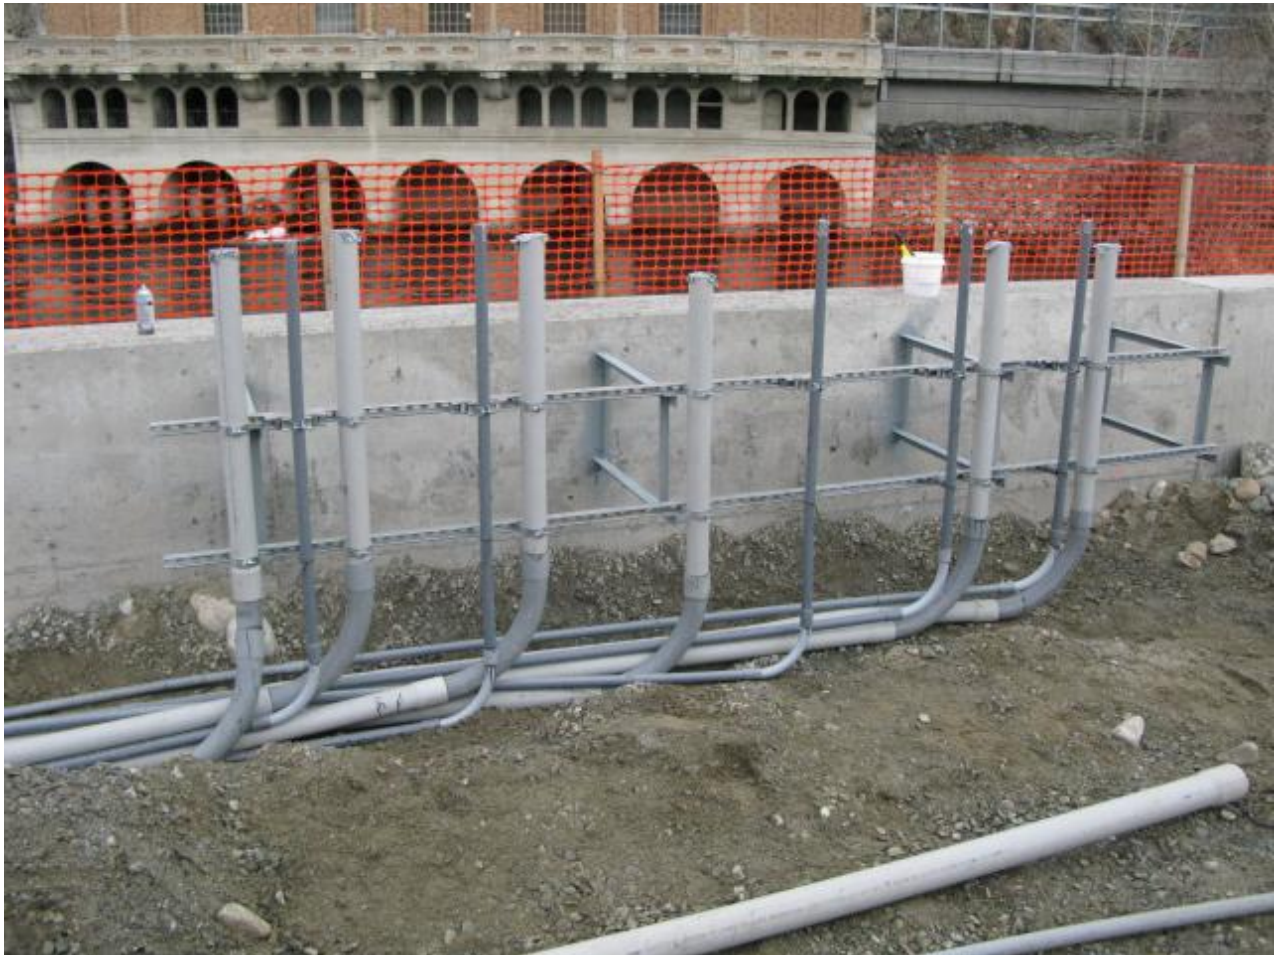
This is a photo of the conduits that will eventually penetrate inside the pump control building. Picture was taken on 3/5/09. These conduits are for pump power and control.
