Re: Chelan River Project Monthly Report

Chelan River Project – Monthly Report
Lake Chelan Hydroelectric Project – FERC No. 637
Public Utility District No. 1 of Chelan County

May 15th, 2009

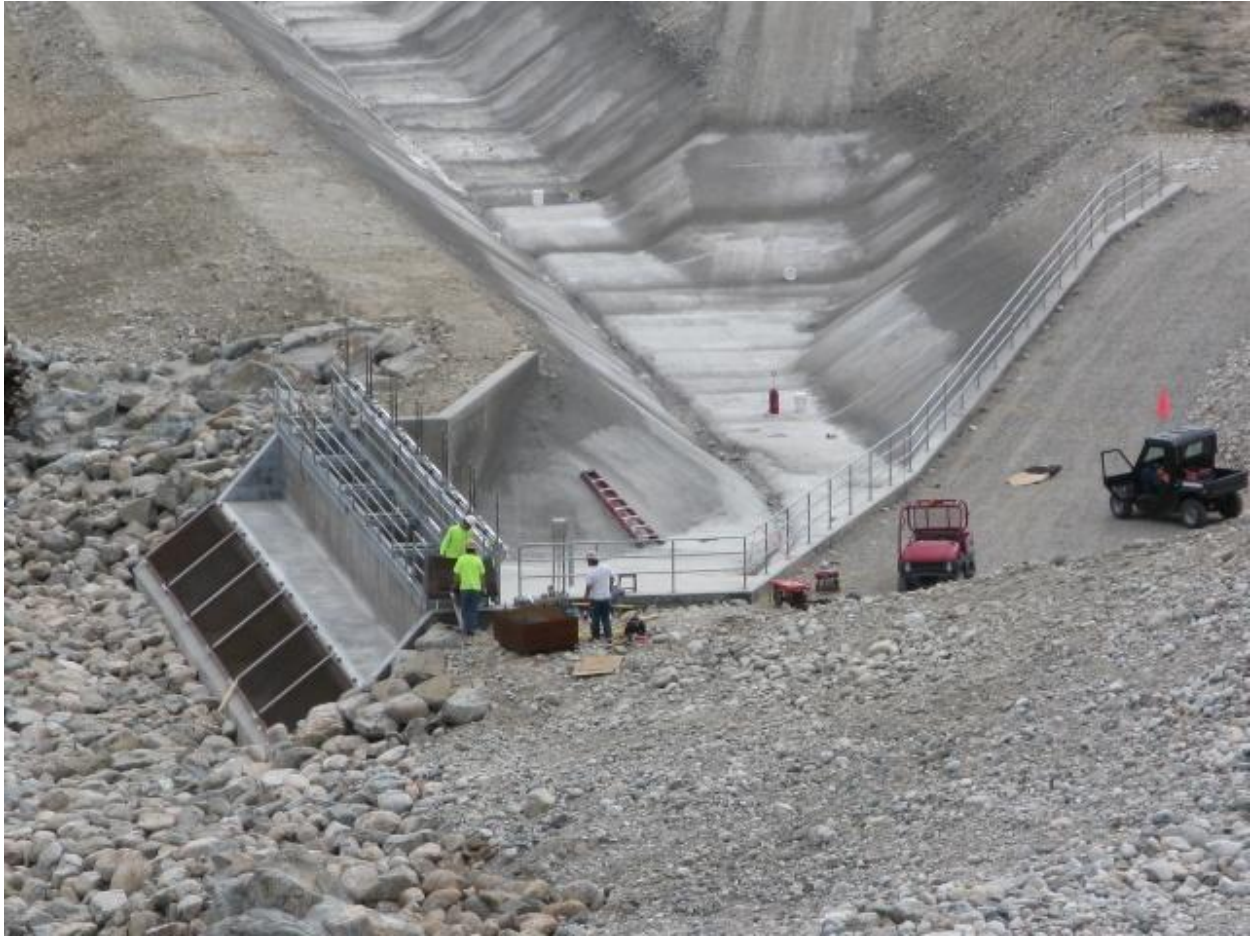
This shows the Conveyance Canal Outlet Structure, looking south, on April 22, 2009. Notice that the canal shotcrete lining has been completed. The slide gates, walkway and handrails have been installed.

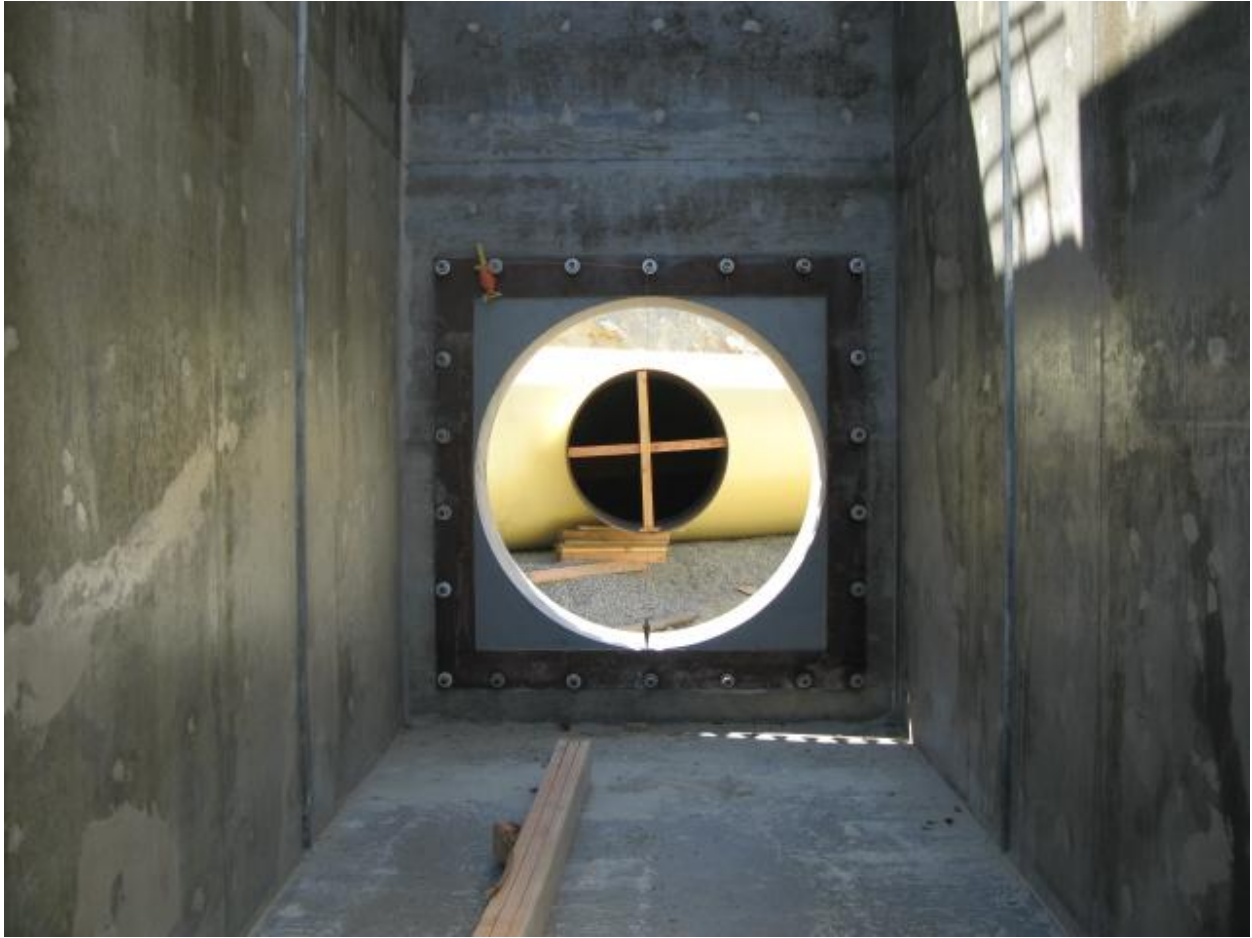
This is looking upstream through the low level outlet (LLO) outlet structure. View is through the concrete penetration for the valves, to the outlet piping. April 24, 2009.

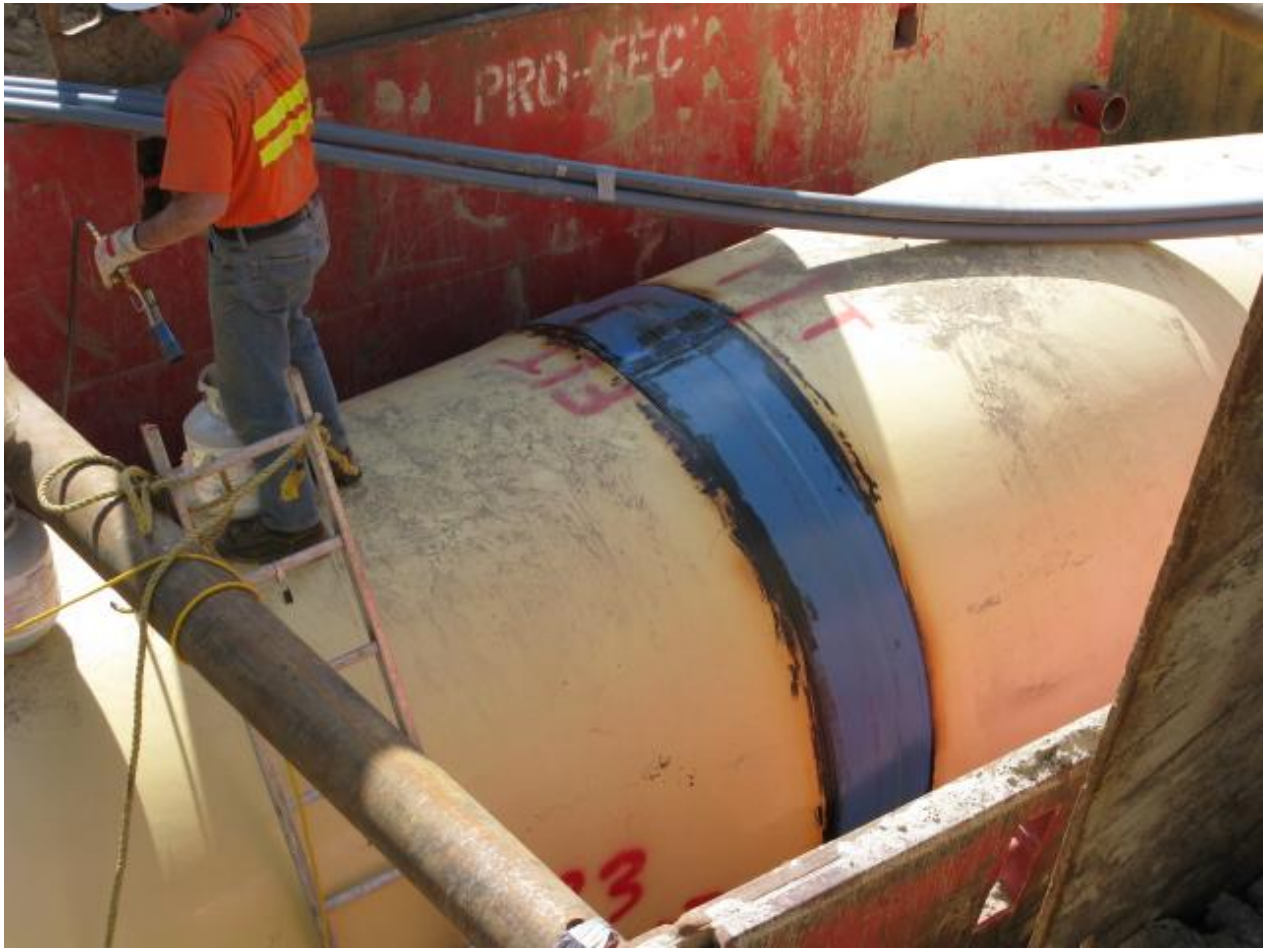
This picture shows the 85" diameter LLO piping. A completed heat-shrink sleeve has been installed over a welded joint. Picture taken on 4/16/09.

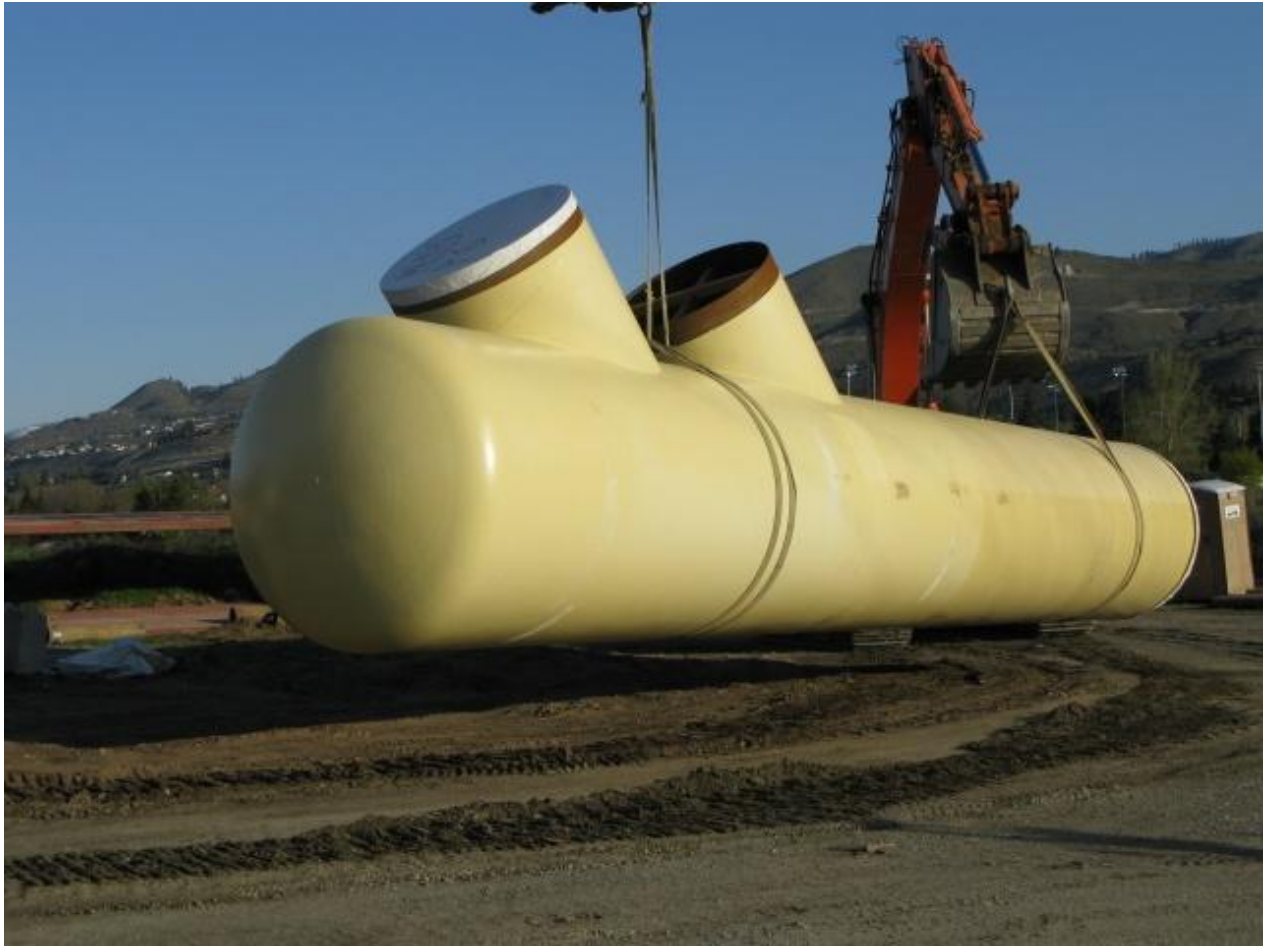
This picture was taken on 4/24/09. This is the last section of 85" diameter LLO piping, which bifurcates to two 60" diameter pipes. The 60" pipes lead to the valves at the outlet structure.

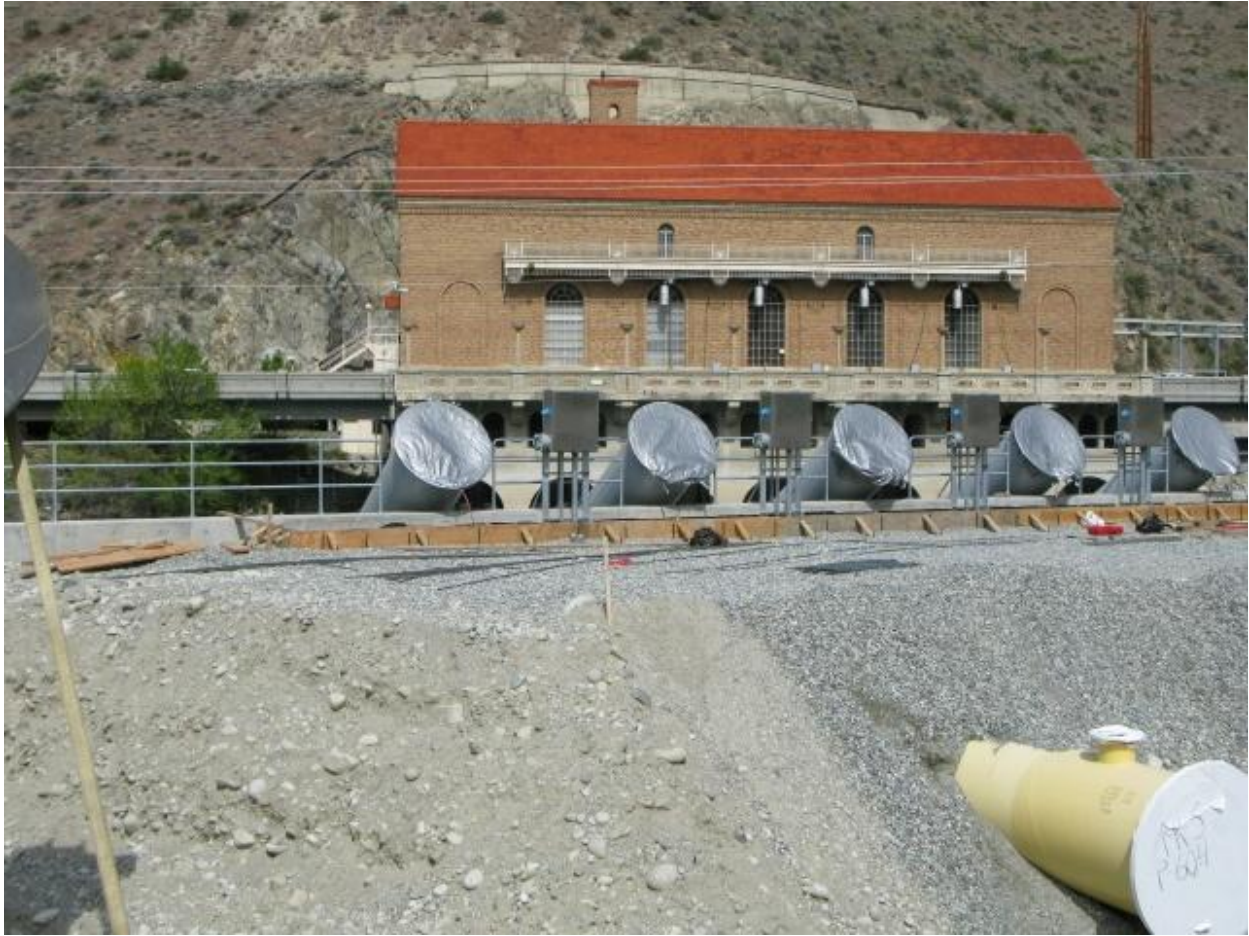
Picture taken on 5/7/09. This photo shows one of the backfilled 42" diameter discharge pipes (yellow piping). Forms are installed for the sidewalk along the retaining wall. Notice the pump tubes are covered, awaiting installation of the pumps.

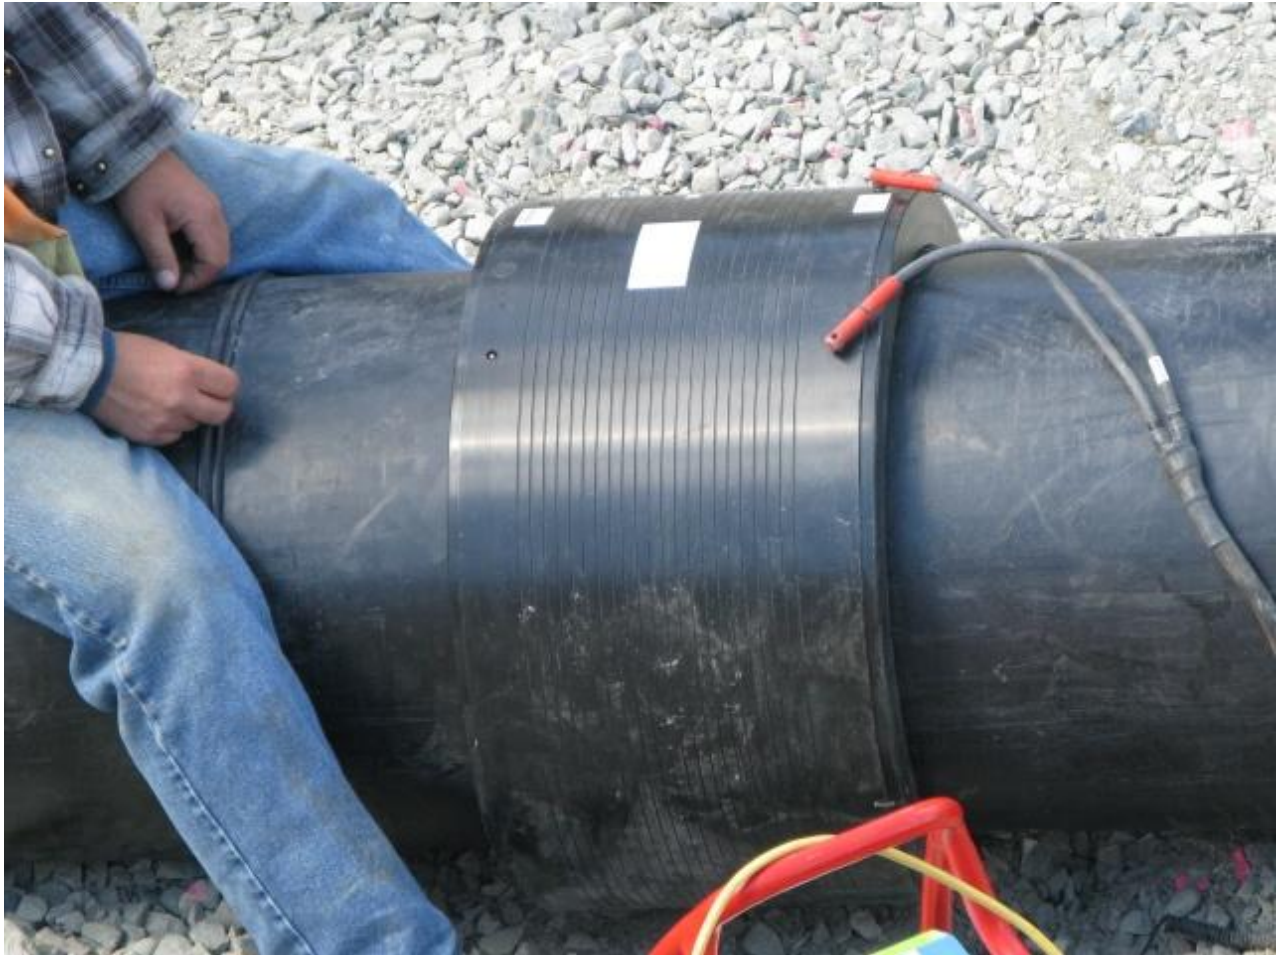
Picture taken on 5/7/09. This is a photo of the afterbay drain piping. A fusion welder is being utilized to join the sections of HDPE pipe.
