Re: Chelan River Project Final Report

Chelan River Project – Monthly Report  
Lake Chelan Hydroelectric Project – FERC No. 637  
Public Utility District No. 1 of Chelan County

January 29<sup>th</sup>, 2010

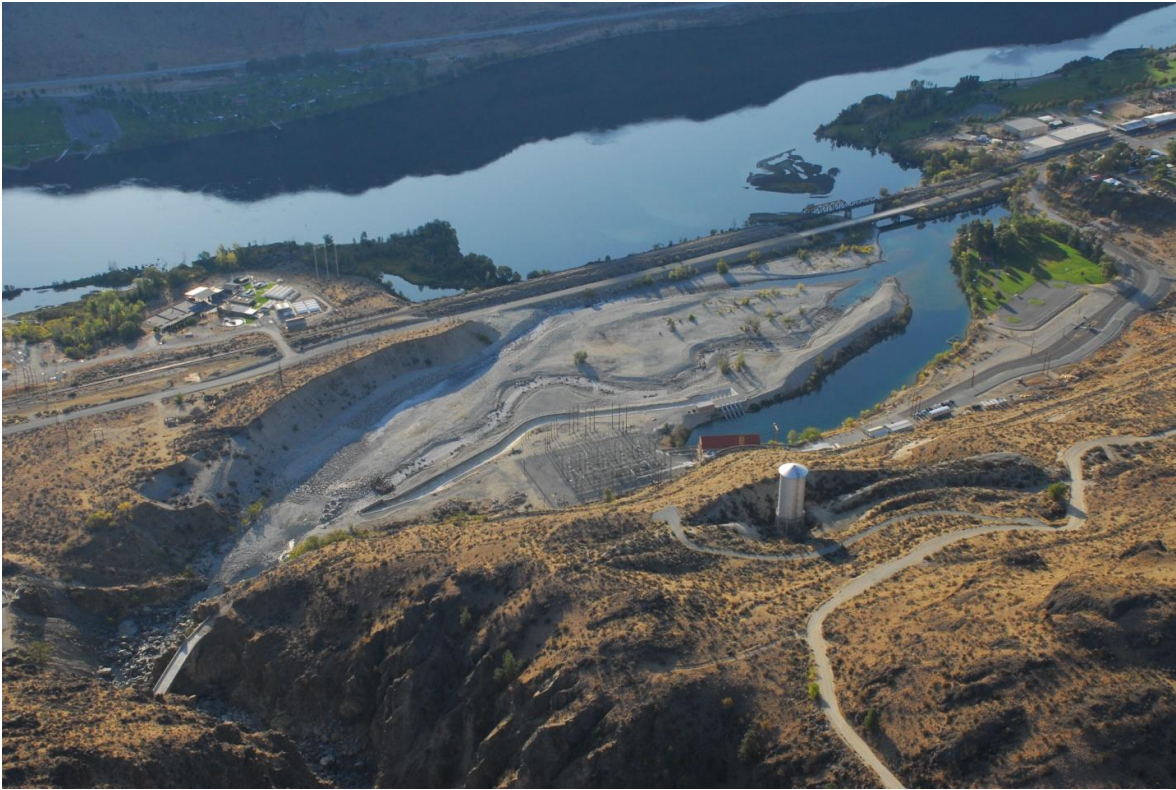
This is a view in an easterly direction, across Reach 4 of the Chelan River. In this photo, the habitat channel and conveyance canal are dry. This photo was taken Oct 5, 2009. Full operation began on Wednesday, Oct 14, 2009.

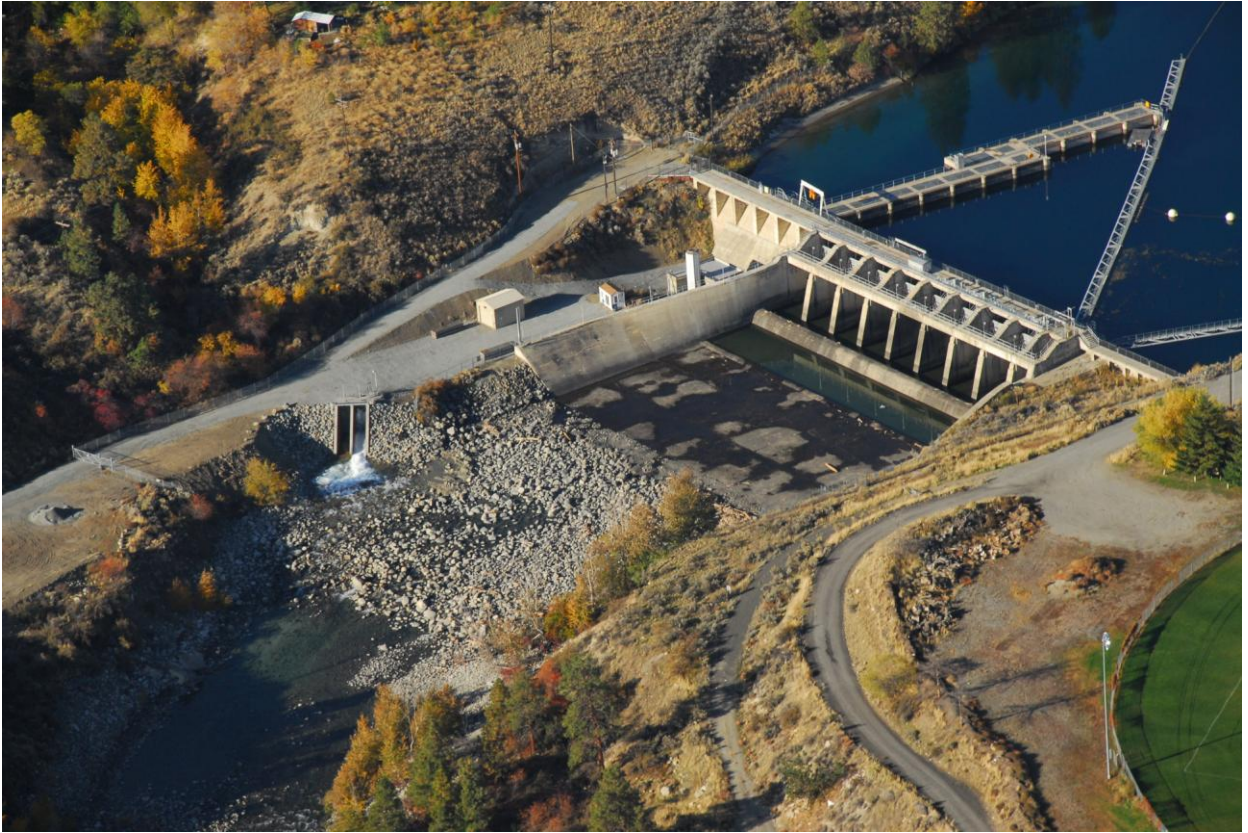
This is a view of Chelan Dam, looking southwest. The Low Level Outlet ends with a concrete outlet structure just downstream of the dam's apron on the right bank (left side of photo). The flow in this photo is 80 cfs.
