Re: **Lake Chelan Hydroelectric Project No. 637-043**  
**Article 403 – Stehekin Area Dust Emissions 5-Year Report**

**STEHEKIN AREA DUST EMISSIONS  
5-YEAR REPORT  
FERC License Order 403**

**LAKE CHELAN HYDROELECTRIC PROJECT  
FERC Project No. 637**

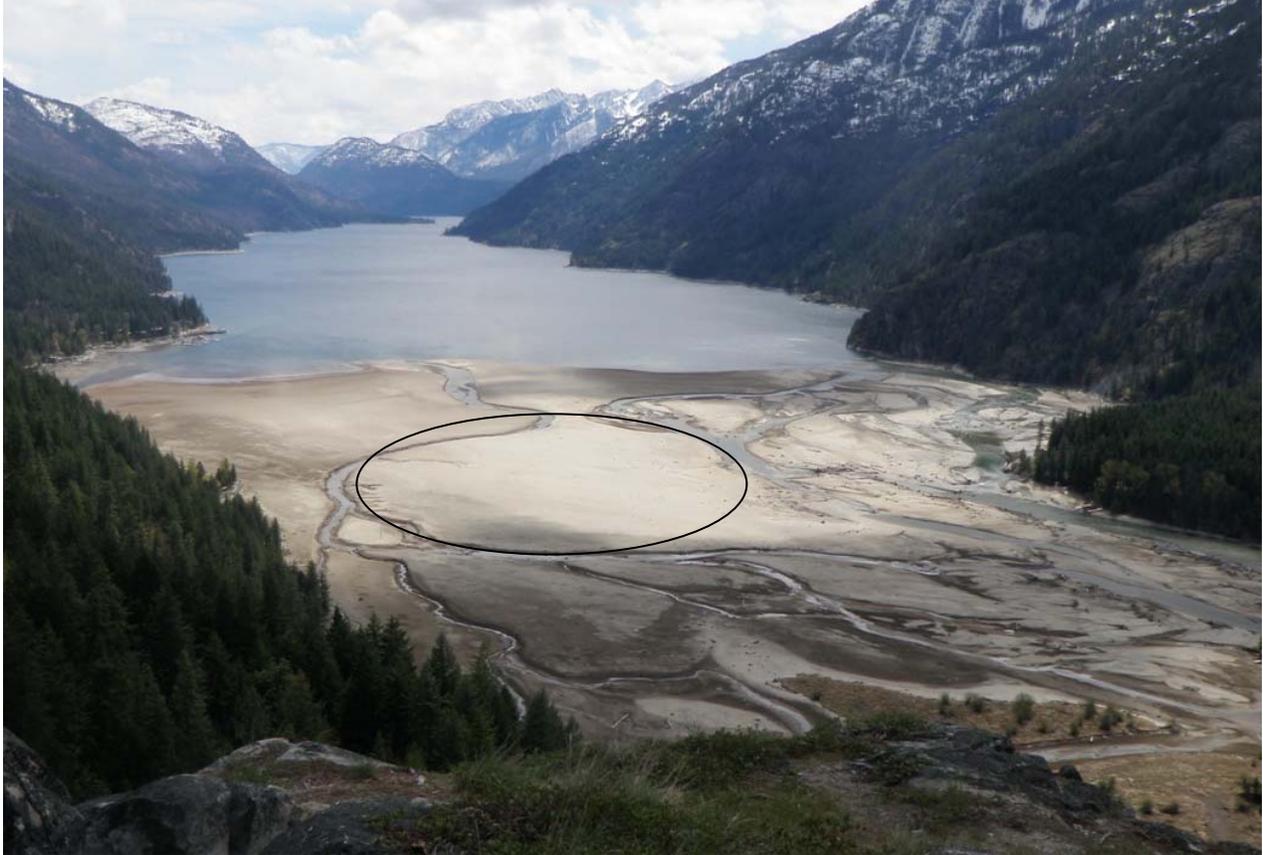
Photo 1: Stehekin Flats during spring drawdown. The ellipse indicates the primary dust source area.

- The primary area from which most of the dust originates was delineated (see photo 1). It is an area of about 19 acres that dries out relatively early.
- There were several substantial rain events. These were observed to have a significant dampening effect on the dust. For example, a rain of 0.38 inches kept the dust down all day in winds of about 20 to 25 mph. This strongly suggests that irrigation to control the dust is likely to be effective.

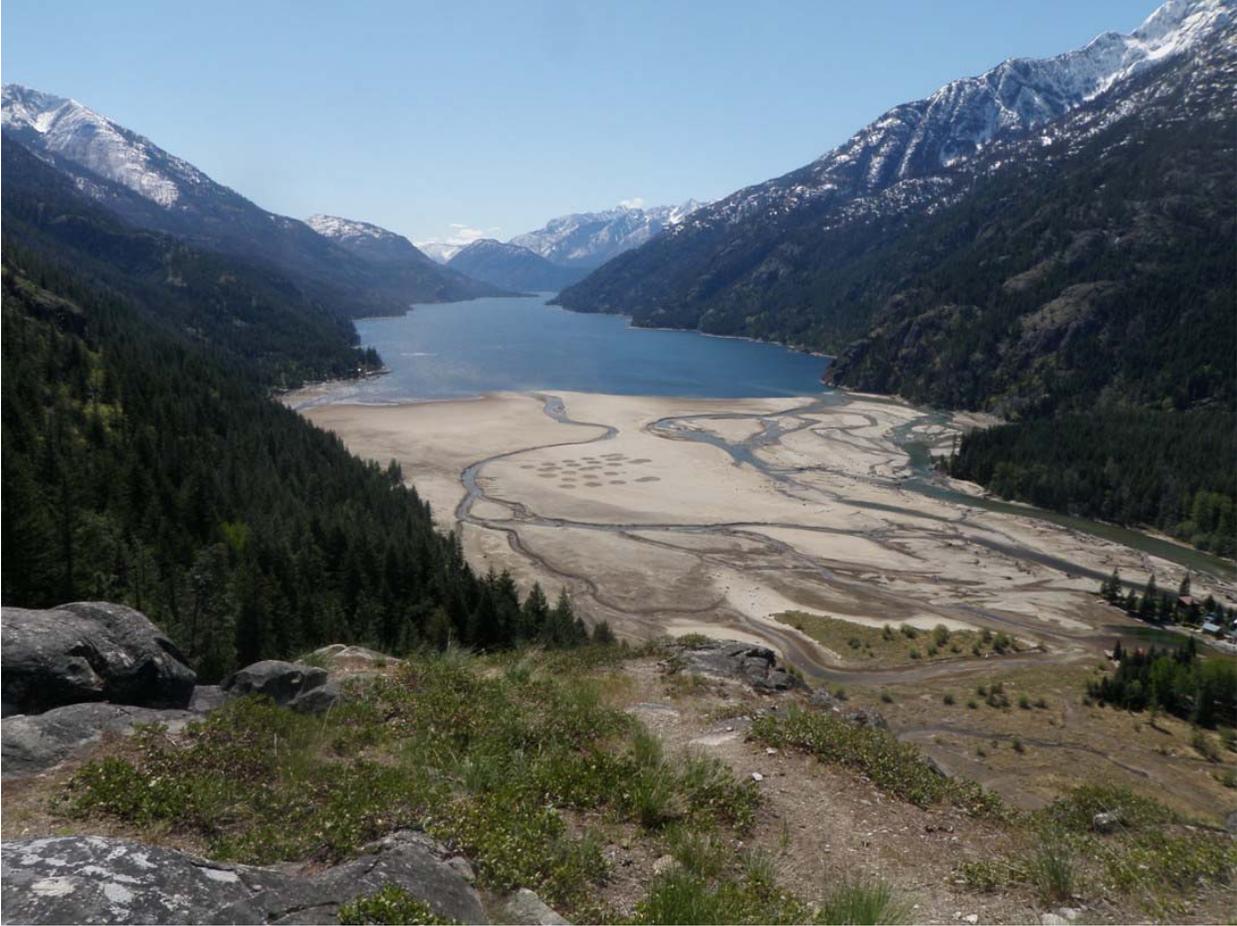
Photo 2: Stehekin Flats, exposed during spring drawdown. Note the irrigation pattern near the photo's center.

A test pattern of irrigation equipment was placed in the dust source area in the spring of 2011. The irrigation system was operated from June 2 through June 11, 2011. The system consisted of 28 rotary sprinklers, 2,800 ft of nylon hose and two Mark-3 pumps, all borrowed from the NPS's Fire Division. Each sprinkler had a wetting radius of 15 ft to 20 ft. The amount of water release was approximately 50 gallons/minute. The system covered approximately 4 acres, and wetted "islands" within the 4 acre area (see photo 2).

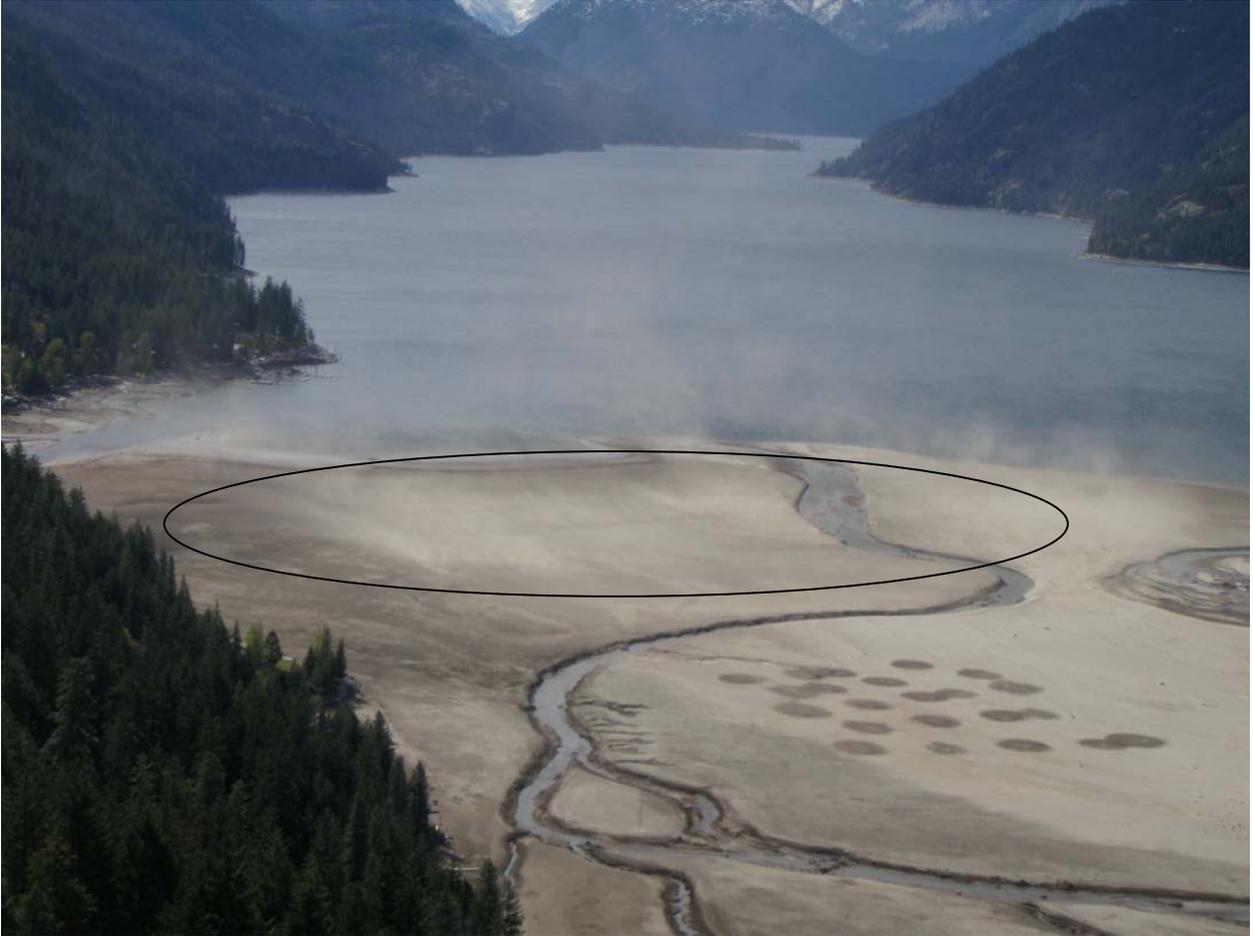
Photo 3: The “circled” area is more than 15 acres, exposed in June 2011. This area is inundated by the lake earlier in the spring of more typical years.

Based on observations during the 2011 test period, the effectiveness of the sprinklers at reducing dust at Stehekin Landing was dependent on wind direction, wind speed and lake level (see photos 4 and 5). As mentioned previously, due to spring snow conditions, the 2011 drawdown was exceptionally low. Consequently, an additional 15 acres of Stehekin Flats were exposed downlake from the sprinkler site. This contributed additional dust at Stehekin Landing (see photo 3).

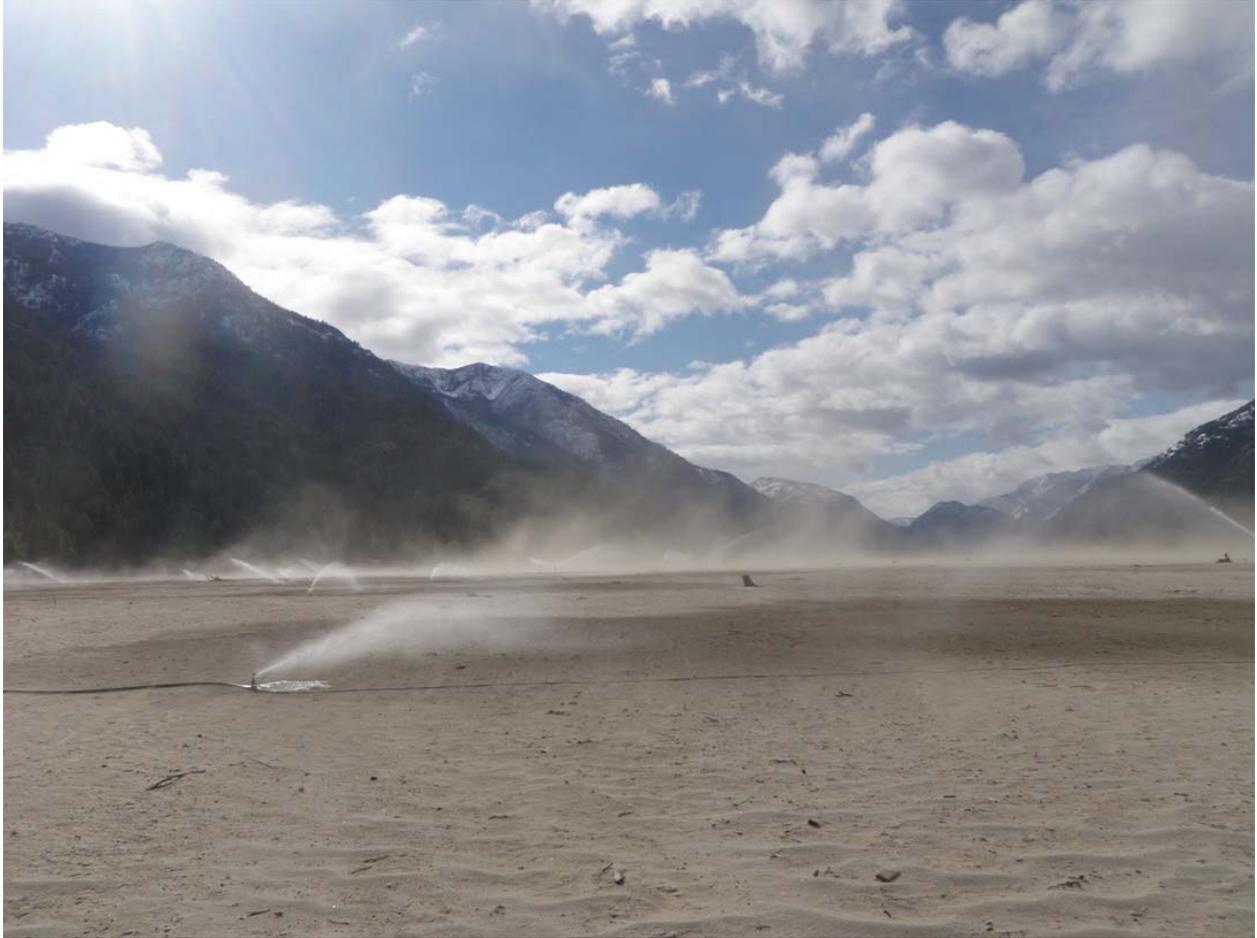
Photo 4: The primary dust source area with a wind speed of about 10 mph.

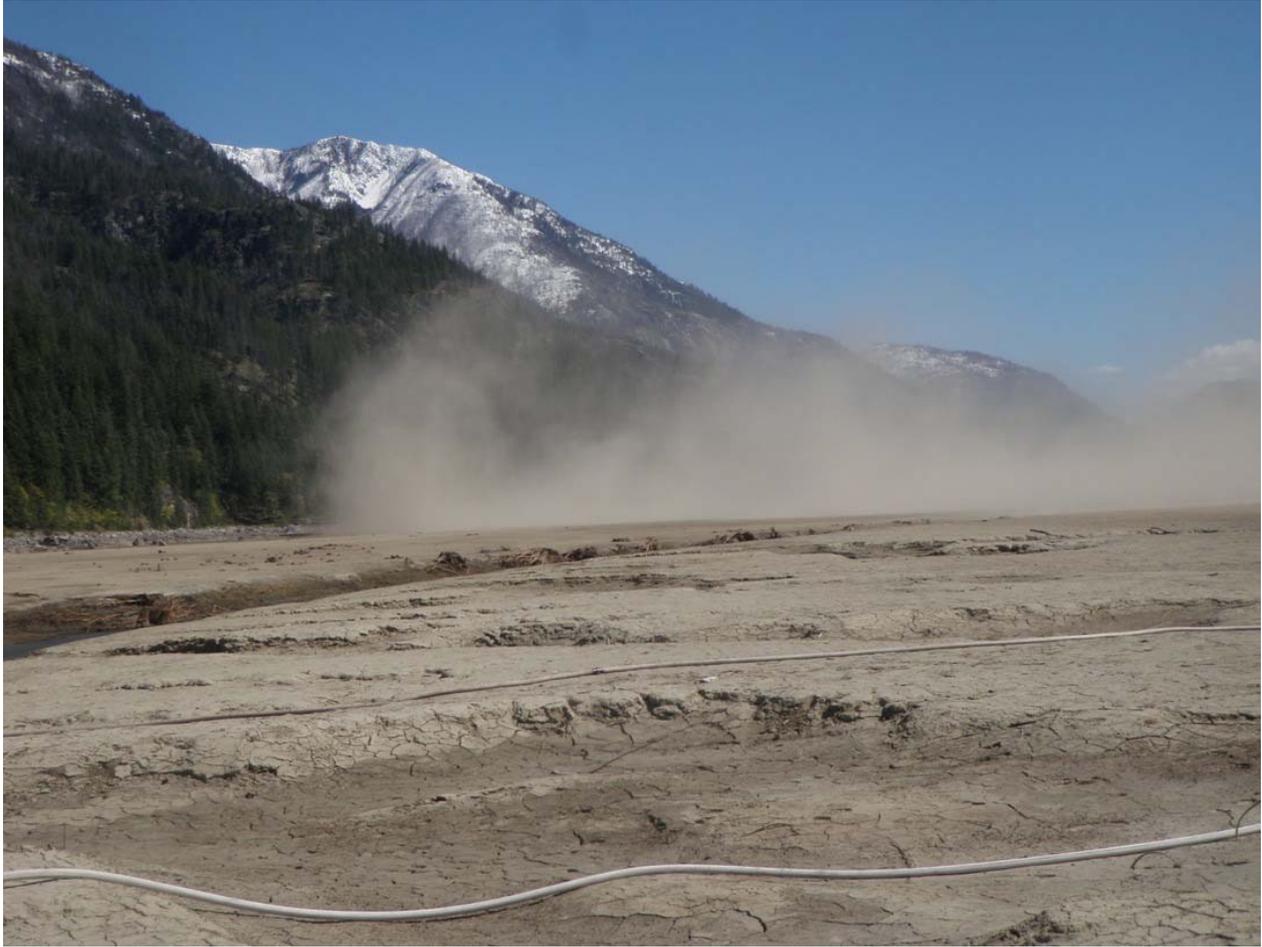
Photo 5: Dust source area with a 20 to 25 mph wind speed.
