LAKE CHELAN ANNUAL FLOW AND WATER TEMPERATURE REPORT 2011

LICENSE ARTICLES 405 & 408

**LAKE CHELAN HYDROELECTRIC PROJECT
FERC Project No. 637**

**Public Utility District No. 1 of Chelan County
Wenatchee, Washington**

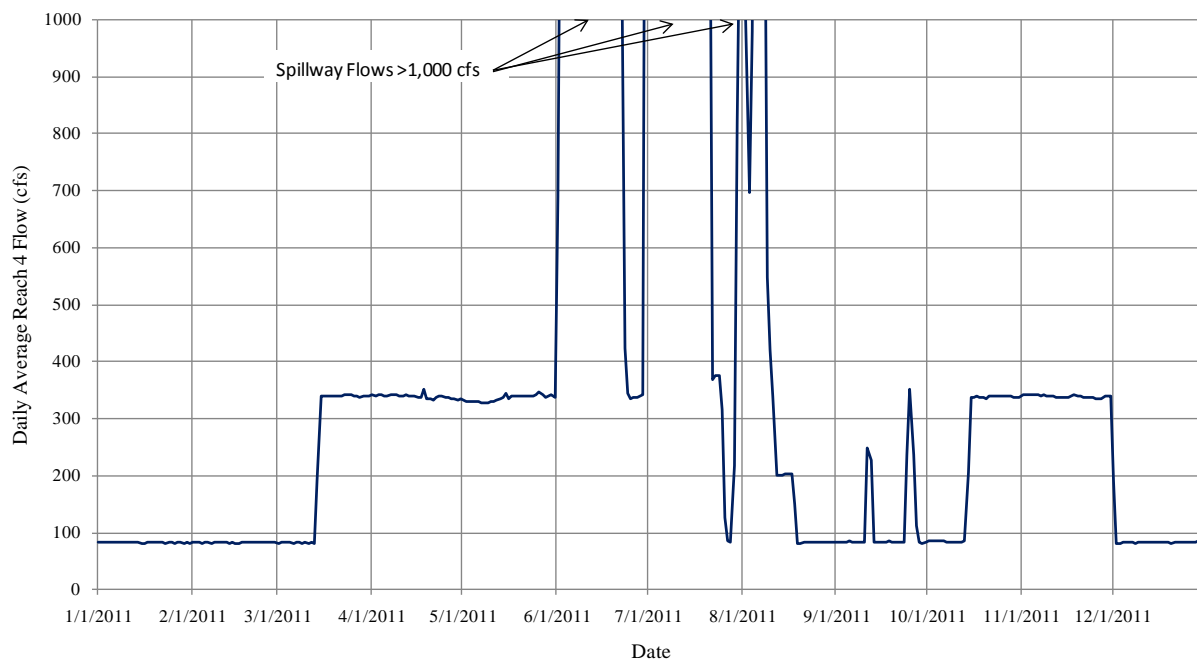
Figure 2-2. Flow Releases to Chelan River Reach 4, 2011.

Spawning flows were provided for steelhead trout from March 15 – May 14 and for Chinook salmon from October 15-November 30. The spawning flows were provided through the combination of the Low Level Outlet flows and Pump Station flows, maintaining flow levels of at least 320 cfs. At the end of the fall spawning period, flows from the Pump Station were ramped down one pump at a time to avoid fish stranding. Since “wet year” minimum flows of 320 cfs were required from May 15 – July 15, there was no ramping down of flows at the end of the steelhead spawning period. Steelhead trout adults were observed spawning in the Reach 4 habitat channel beginning on April 1. Spawning continued into May, with 20 redds counted by May 4 and one late additional redd on June 1, for a total of 21 redds. One steelhead redd was located in Reach 4 flows, but below the confluence with the tailrace. Chinook fry were present in the Reach 4 habitat channel from mid April through June. Chinook spawning began just prior to October 15 and was completed prior to November 30. There were a total of 413 redds counted in the Chelan River Reach 4, the tailrace and Columbia River at the confluence. There were 173 redds in the Reach 4 habitat channel and upstream pool, 192 in the tailrace and 48 in the Columbia River in Chelan River flows below the confluence. Five coho redds were also observed in Reach 4.

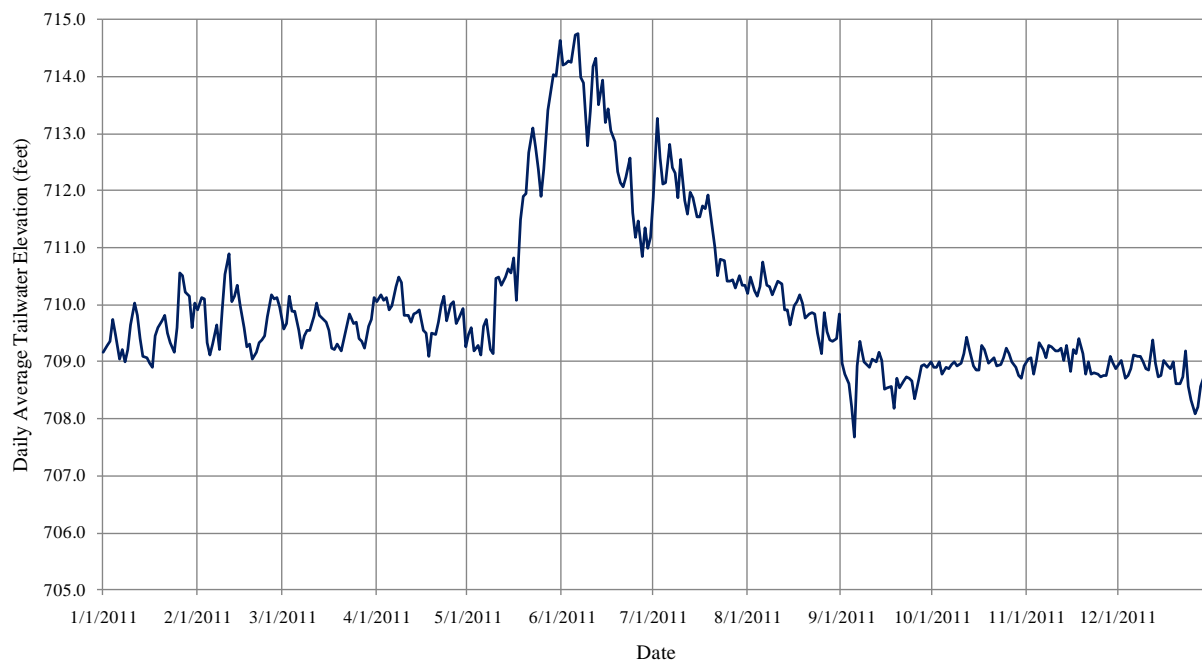
Figure 3-2. Chelan Powerhouse Daily Average Tailwater Elevations, 2011.

Water surface elevations in the tailrace can fluctuate by several feet over the course of a day due to changes in Columbia River flows that affect the backwater curve of the Rocky Reach reservoir. The water level fluctuations in the tailrace are somewhat reduced when the Chelan Powerhouse is operating. In past years, temporary dewatering of a few Chinook redds in shallow areas has been observed when the powerhouse was not operating and Columbia River flows were low. During tailrace spawning habitat construction in 2008 these areas were graded to prevent dewatering. The water levels in the tailrace remained above 708 feet most of the time and never dropped below 707 feet from January 1 – May 31 and October 15 – December 31. No dewatering of salmon redds was observed in 2011. The daily average tailwater levels measured at the powerhouse are shown in Figure 3-2.

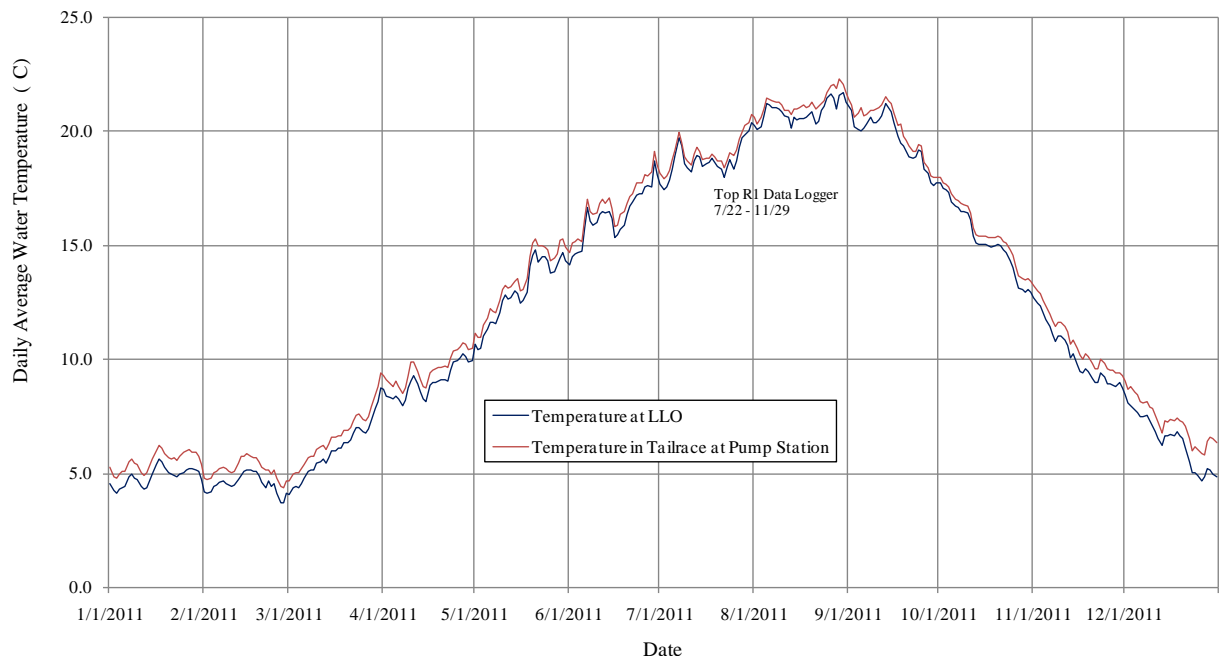
Figure 4-1. Low Level Outlet and Powerhouse Tailrace Water Temperatures.

Automated water temperature monitoring equipment is installed at two locations, within the pipe that draws water from the base of the Chelan Dam and discharges to the Chelan River through the Low Level Outlet and in the Chelan Powerhouse Tailrace from a sensor mounted on the Pump Station intake screens. These monitoring locations measure the water temperatures that reflect the coolest water available for the Chelan River (Low Level Outlet temperature) and the average of water temperatures arriving at the face of Chelan Dam as drawn through the powerhouse intakes (Chelan Powerhouse Tailrace). Water temperatures measured in the tailrace also represent the temperature of water that is being discharged to the Reach 4 habitat channel when the Pump Station is in operation.

Water temperatures from these sources (Figure 4-1) show that generally there was little stratification in water temperatures at the face of Chelan Dam. However, the Low Level Outlet temperature sensor broke off on July 22 and a new device was not installed until November 29. Temperature data from the top of Reach 1 is shown in Figure 4-1 for this time period and was predominately measuring spillway flow until August 11. The spillway flow is drawn from the upper strata of the forebay, thus stratification would not be detectable after July 22. There were a few days from mid August through early September when water temperatures released from the Low Level Outlet appear to have been cooler than the average water temperature arriving at Chelan Dam from the outlet of Lake Chelan. Daily average water temperatures measured from the top of R1 peaked at 21.7 °C on August 26 and 30, while tailrace temperatures peaked at 22.3 °C August 29, respectively.

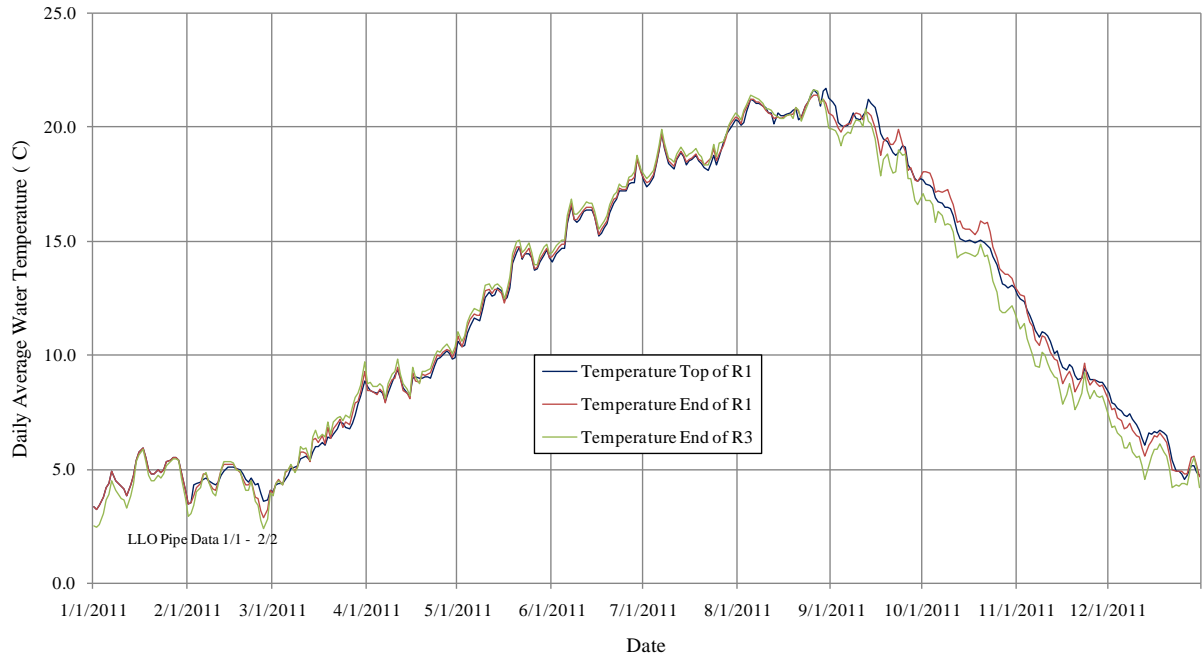
Figure 4-2. Chelan River Reaches 1-3 Daily Average Water Temperatures.

Water temperatures are monitored at three locations with temperature recording data loggers (Onset HOBO Water Temp Pro v2) that are set to record the water temperature at hourly intervals. These locations are at the top of Reach 1, which measures the temperature of water entering the Chelan River from the Low Level Outlet and the spillway. The location of this temperature logger is set below the mixing zone for these sources of water. The second location is at the end of Reach 1, which is the reach of the Chelan River that has the lowest gradient and least profile shading, thus the greatest potential for water temperature heating during the spring and summer. The third location is at the end of Reach 3, where the Chelan River exits the series of cascades and falls that are the upstream barrier to anadromous fish. The temperature loggers at each location are exchanged several times during the year to retrieve the data. These data are reported quarterly during most of the year, with monthly reporting for July, August and September. These data reports are available at <http://www.chelanpud.org/lc-Resource-Documents-WaterQuality.cfm>.

The water temperatures recorded at these locations in 2011 demonstrated small increases in water temperature during May – August, but cooling from September – December (Figure 4-2). This is not unexpected because the water exiting Lake Chelan is affected by the heat sink effect of the lake's large volume. Water in Lake Chelan is still warming from May – mid-August, but then retains this heat through the late summer and fall, thus water exiting the lake is cooler than sustainable at equilibrium with ambient solar and air temperature conditions through the summer, then tends to be warmer than sustainable through fall and early winter. The maximum daily average water temperatures recorded in 2011 were 21.7 °C, 21.4 °C and 21.6 °C, respectively from upstream to downstream locations. The highest hourly temperatures recorded were 22.1 °C, 23.2 °C, and 23.8 °C, respectively for the same locations.

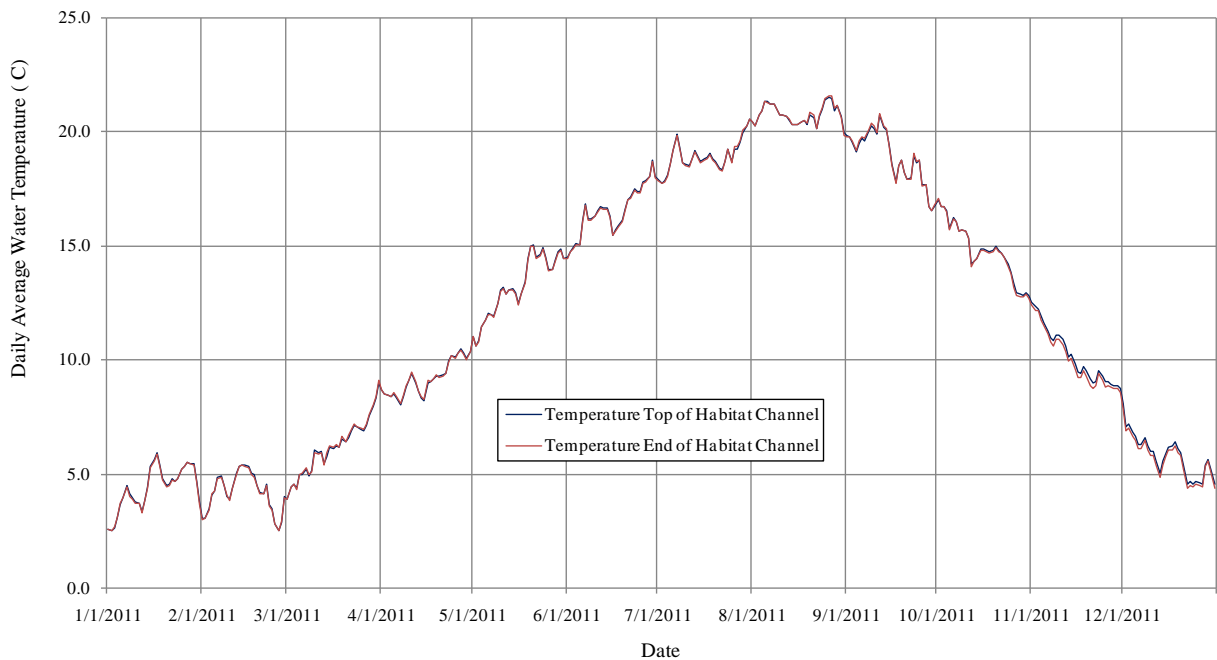
Figure 4-3. Reach 4 Habitat Channel.

Water temperatures are monitored at hourly intervals at two locations (Onset HOBO Water Temp Pro v2), at the upper and lower end of the habitat channel. The upper location records the water temperature from the pool below the end of Reach 3 and the mixed flows from that source and the Pump Station, when the pumps are in operation. The monitoring location at the end of the habitat channel is at the point where habitat channel flows enter into the tailrace, just upstream from where mixing of these flows is expected.

The daily average water temperature data from these locations did not show any evidence of heating as water passed through the habitat channel, despite the lack of any shade from vegetation under current, newly constructed, conditions (Figure 4-3). The maximum daily average temperatures recorded were 21.5 °C at the top and 21.6°C at the end of the habitat channel. The maximum hourly temperatures were 23.8 °C and 23.9 °C at the upper and lower ends of the habitat channel.
